The Road Inventory for Cape Hatteras National Seashore

Road Inventory Program

Prepared By:
Federal Highway Administration
Eastern Federal Lands Highway Division
August 1999

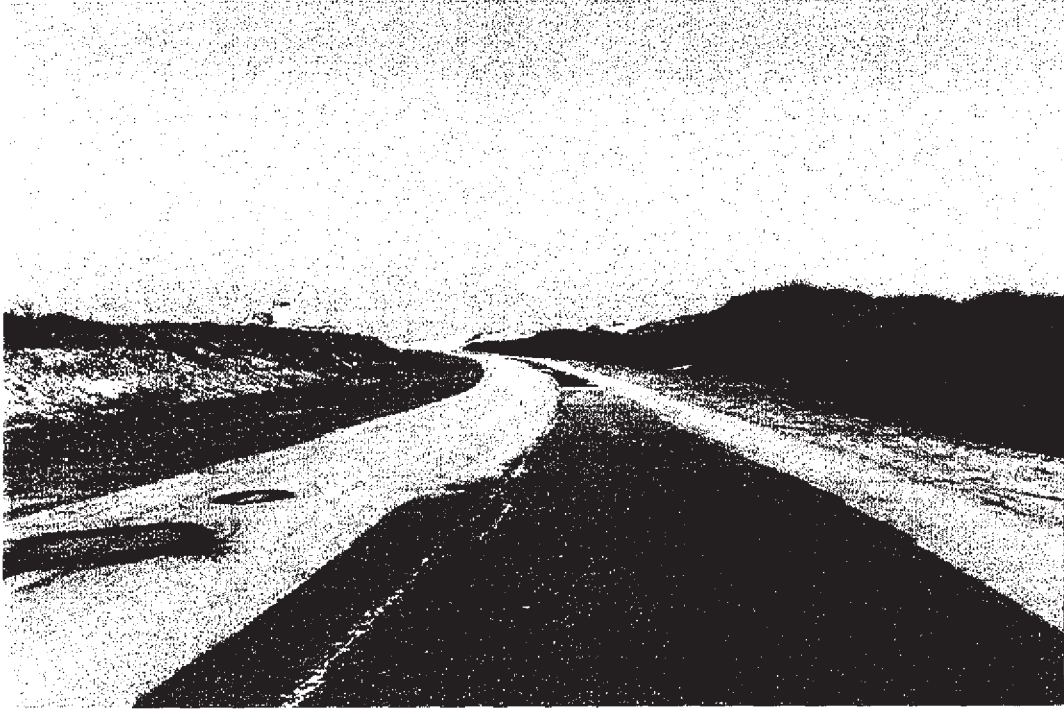
PARK NUMBER: 5190
ROUTE NUMBER: 210
DATE: 05/99

Photo #1 - MP 0.00 - Poor road condition.
