Coastal Hazards & Sea-Level Rise Asset Vulnerability Assessment for Castillo de San Marcos National Monument and Fort Matanzas National Monument

Summary of Results

NPS 343/186743, NPS 347/186743 November 2022

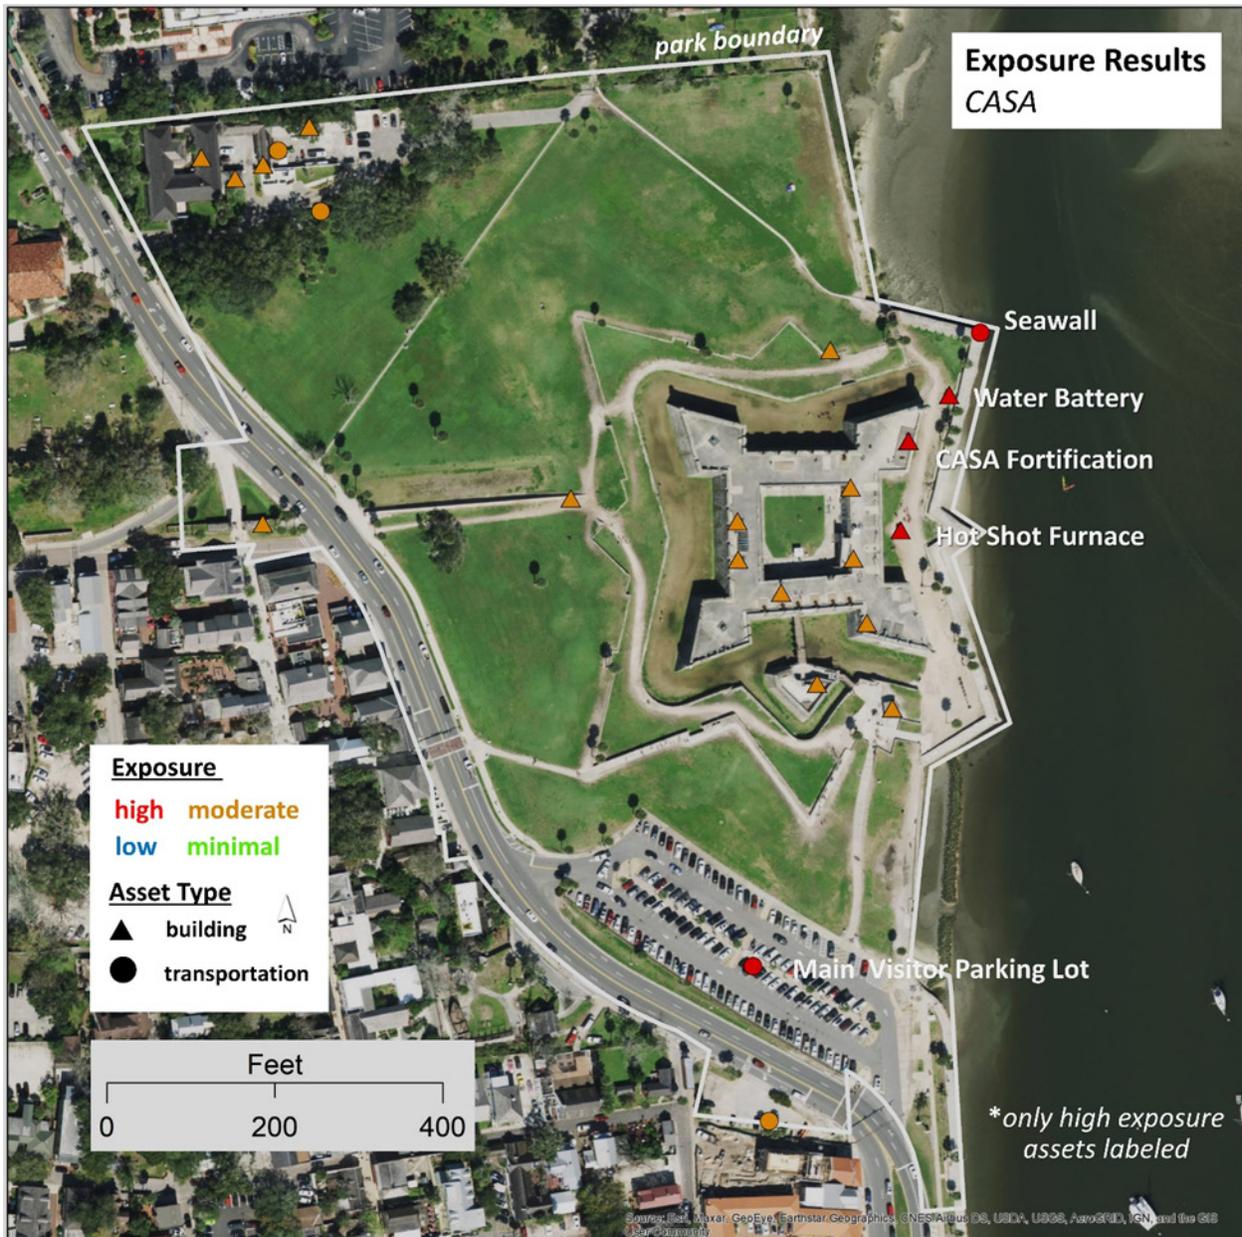
The majority (80%) of assets analyzed at CASA-FOMA have either high or moderate exposure to the evaluated coastal hazards (Table 2, and Figures 1-2). Nearly one-third (31%) have high exposure and almost half (49%) have moderate exposure. Six assets (one building/structure and five transportation) at CASA-FOMA are within all evaluated exposure zones, including the FOMA Fort, CASA Seawall, FOMA Waterfront Systems (both Fort and VC side), FOMA Fishing Road, and FOMA Rattlesnake Island Parking. Only 20% of assets have low exposure, all of which are located at FOMA.

Figure 1. CASA exposure results summary. Only high exposure assets are labeled. Background map is ESRI streaming imagery.

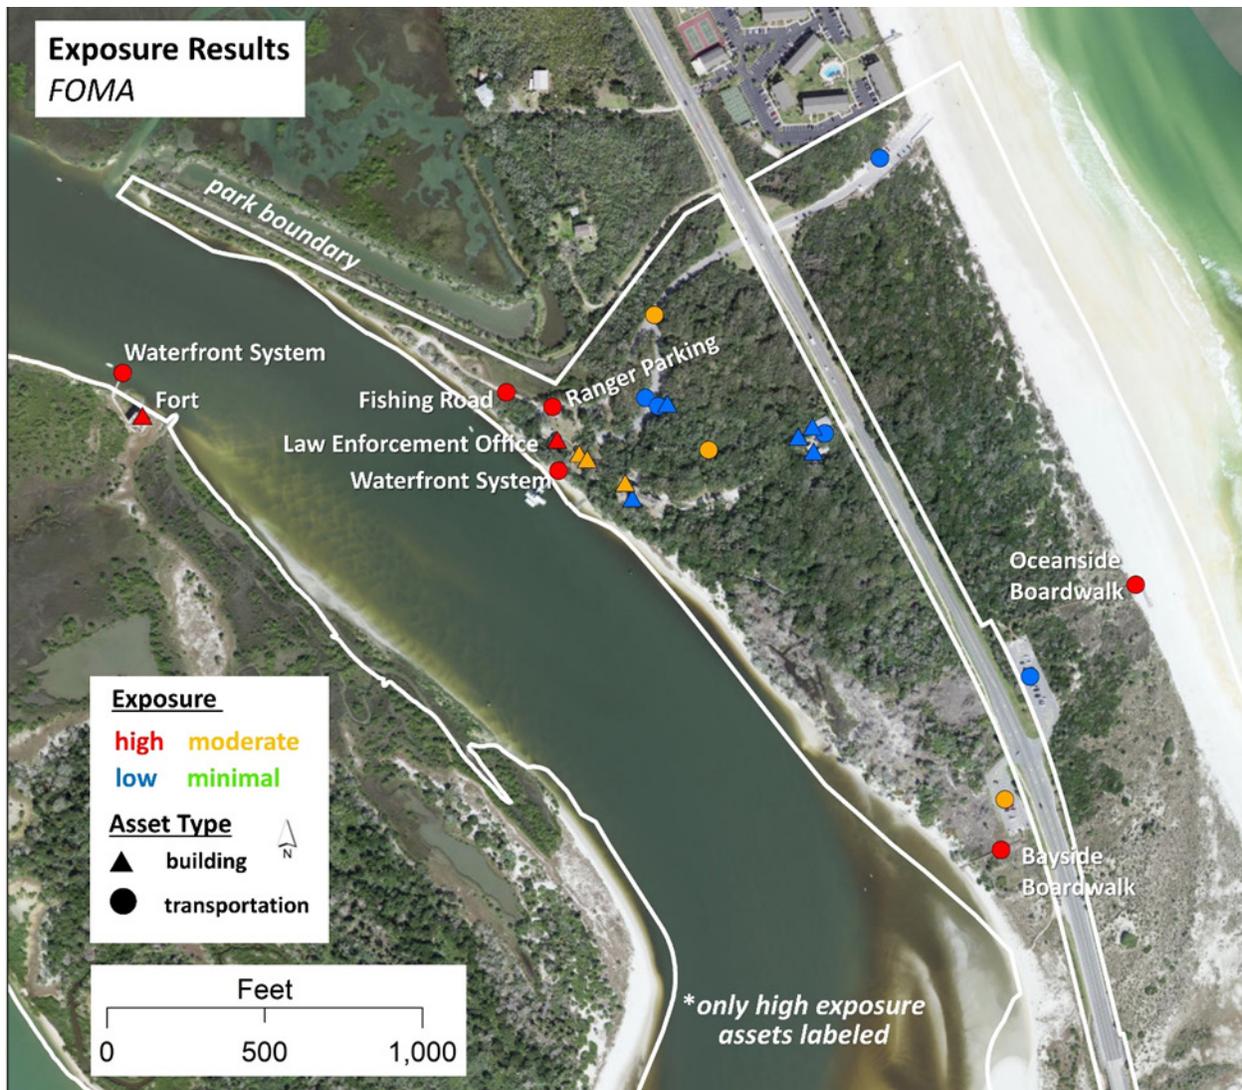
Figure 2. FOMA exposure results summary. Only high exposure assets are labeled. Background map is ESRI streaming imagery.

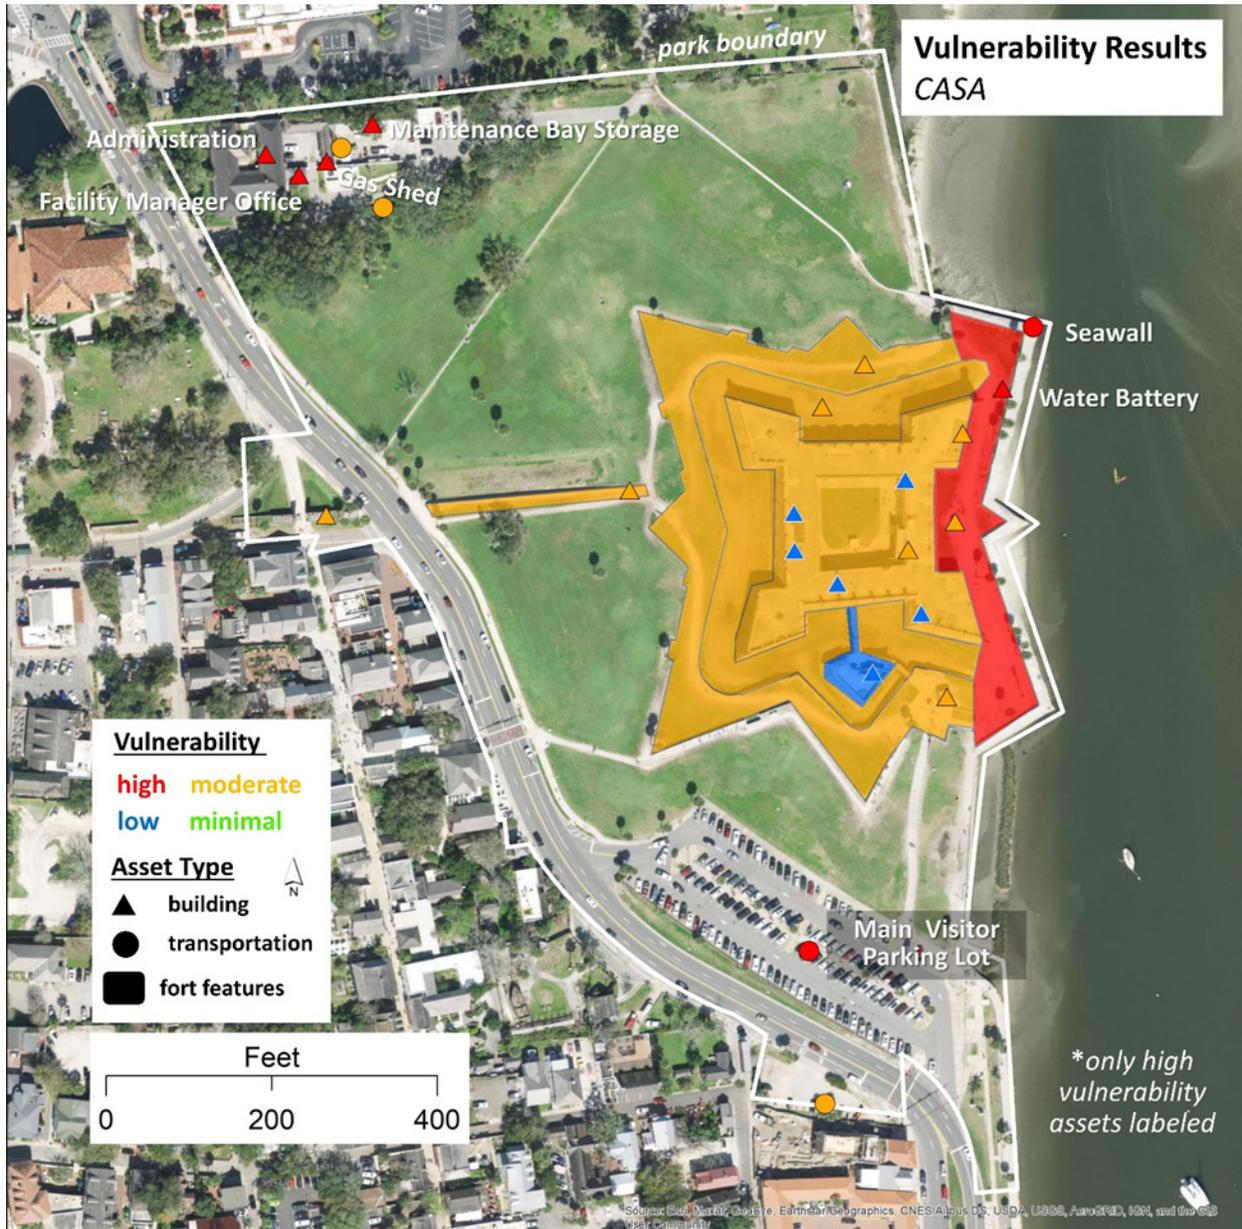
The vulnerability results for CASA-FOMA are distributed relatively evenly between high, moderate, and low rankings, with approximately one-third of evaluated assets in each category (Table 4, and Figures 3-4). Five assets at FOMA (Law Enforcement Office, Rattlesnake Island Parking, Oceanside and Bayside boardwalks, and VC Side Waterfront Systems) have both high exposure and high sensitivity. The CASA Administration Building, CASA Water Battery, CASA Seawall, FOMA Law Enforcement Office, and FOMA VC Side Waterfront System are the only evaluated assets with high vulnerability and a high asset priority index ($API \geq 70$ as reported in FMSS).

Figure 3. CASA vulnerability results summary. Only high vulnerability assets are labeled. Background is ESRI streaming imagery.

Reducing the vulnerability of assets at CASA will likely need to focus on sensitivity changes. Relocation is unlikely in this area, as non-fortification related assets are already located as far inland

as possible within park lands (Figure 3). Many of these buildings could become moderate vulnerability with adaptation or actions such as raising the elevation (the building or ground level), improving the condition/storm resistance, or adding more effective protective engineering. Relocation could be a potential adaptation strategy for a number of buildings at FOMA. Several buildings located near the riverfront could be moved further inland to reduce exposure (Figure 4). Elevating assets in the current location (or in a new location) could also reduce sensitivity.

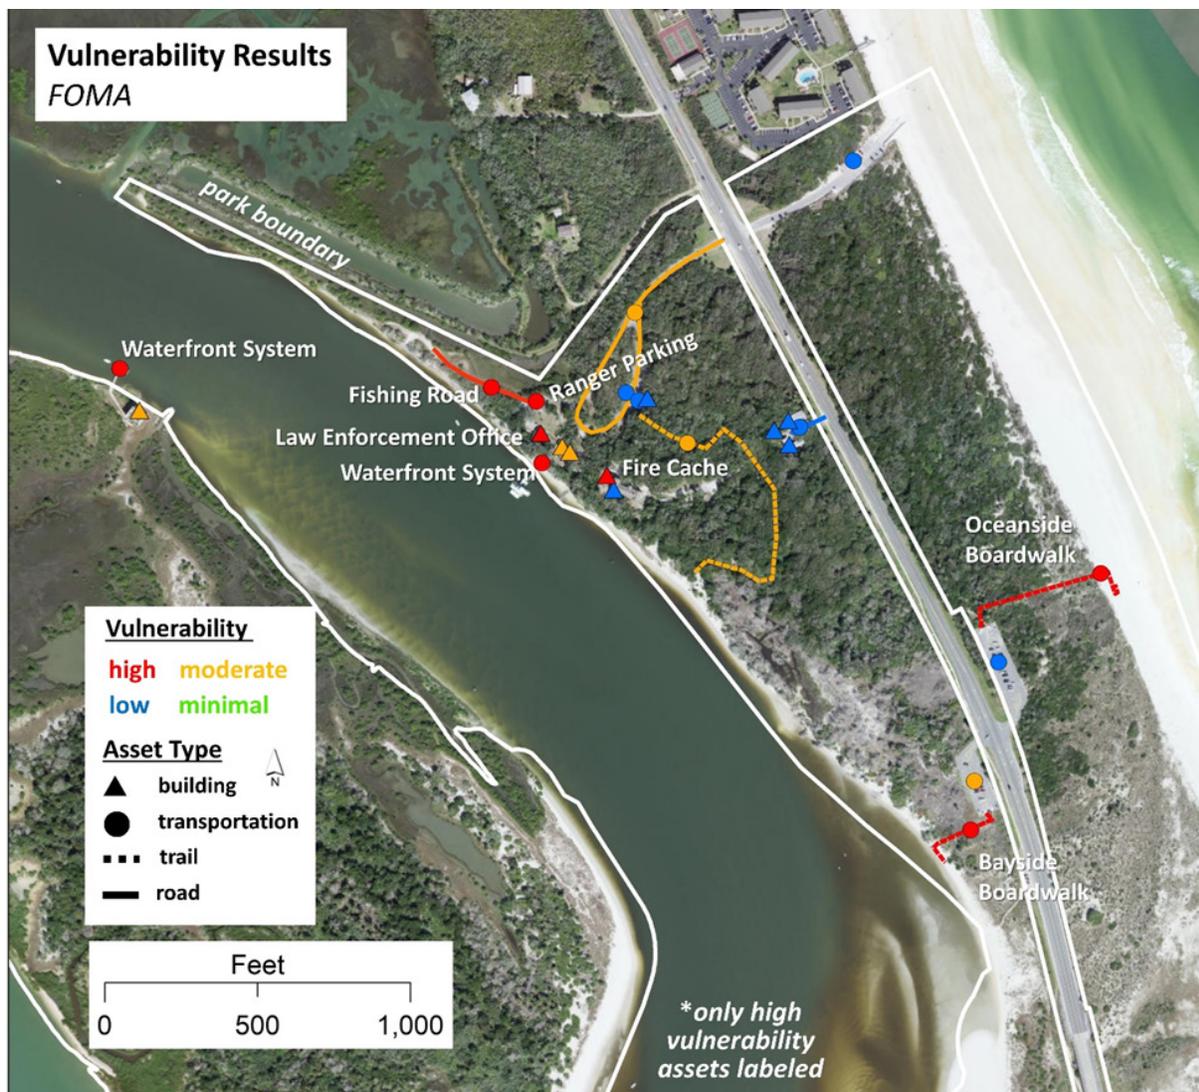
Figure 4. FOMA vulnerability results summary. Only high vulnerability assets are labeled. Background is ESRI streaming imagery.
