# Coastal Hazards & Sea-Level Rise Asset Vulnerability Assessment for De Soto National Memorial

## *Summary of Results*

NPS 388/186745, November 2022

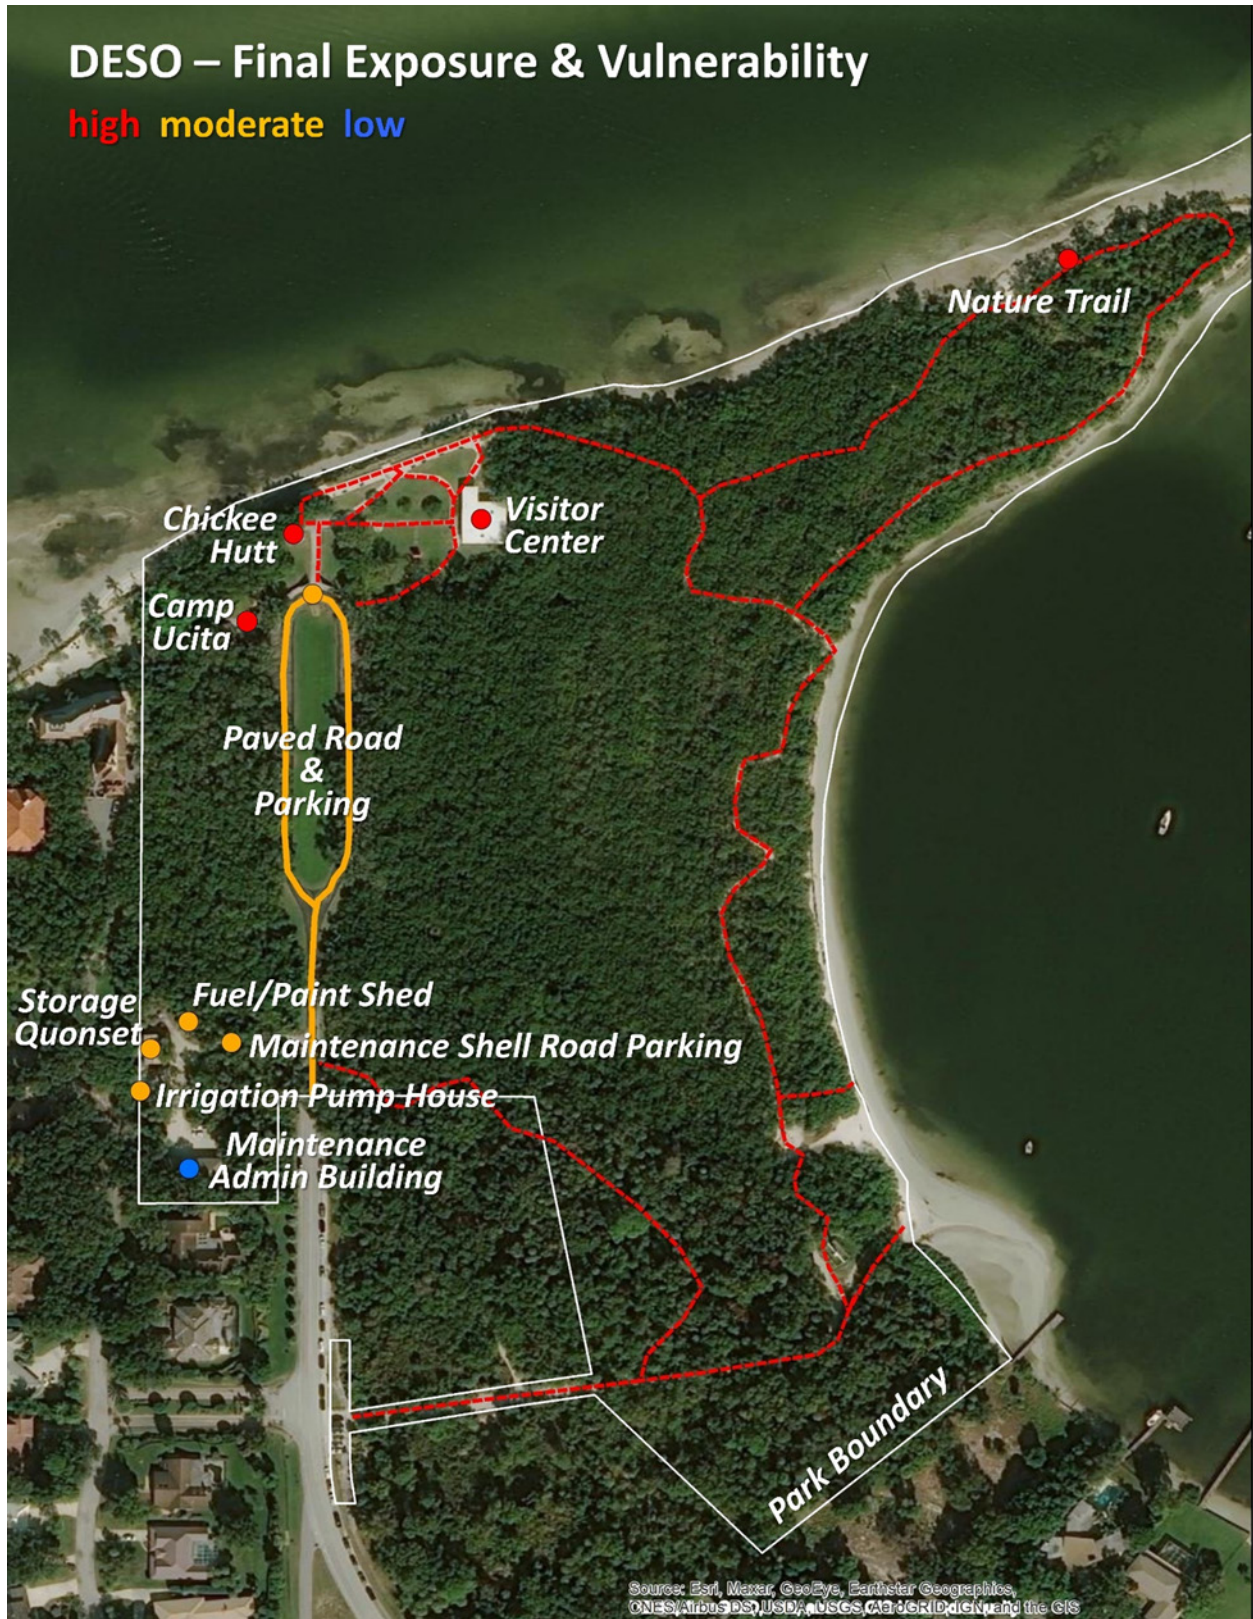
The vulnerability results at DESO are identical to the exposure results, as all assets evaluated scored a moderate for sensitivity (Table 4, and Figure 1). This lack of variability in sensitivity means that the vulnerability of assets at DESO is most influenced by exposure. Nine assets evaluated at DESO have high (four assets) or moderate (five assets) vulnerability to the assessed coastal hazards, and only one asset has low vulnerability. Two of the assets evaluated have high vulnerability and a high asset priority index ( $API \geq 80$ , as reported in FMSS), the Visitor Center and Nature Trail.

**Figure 1.** DESO exposure and vulnerability results. Background is ESRI streaming imagery.
