# Coastal Hazards & Sea-Level Rise Asset Vulnerability Assessment for George Washington Birthplace National Monument

## *Summary of Results*

NPS 332/187362, January 2023

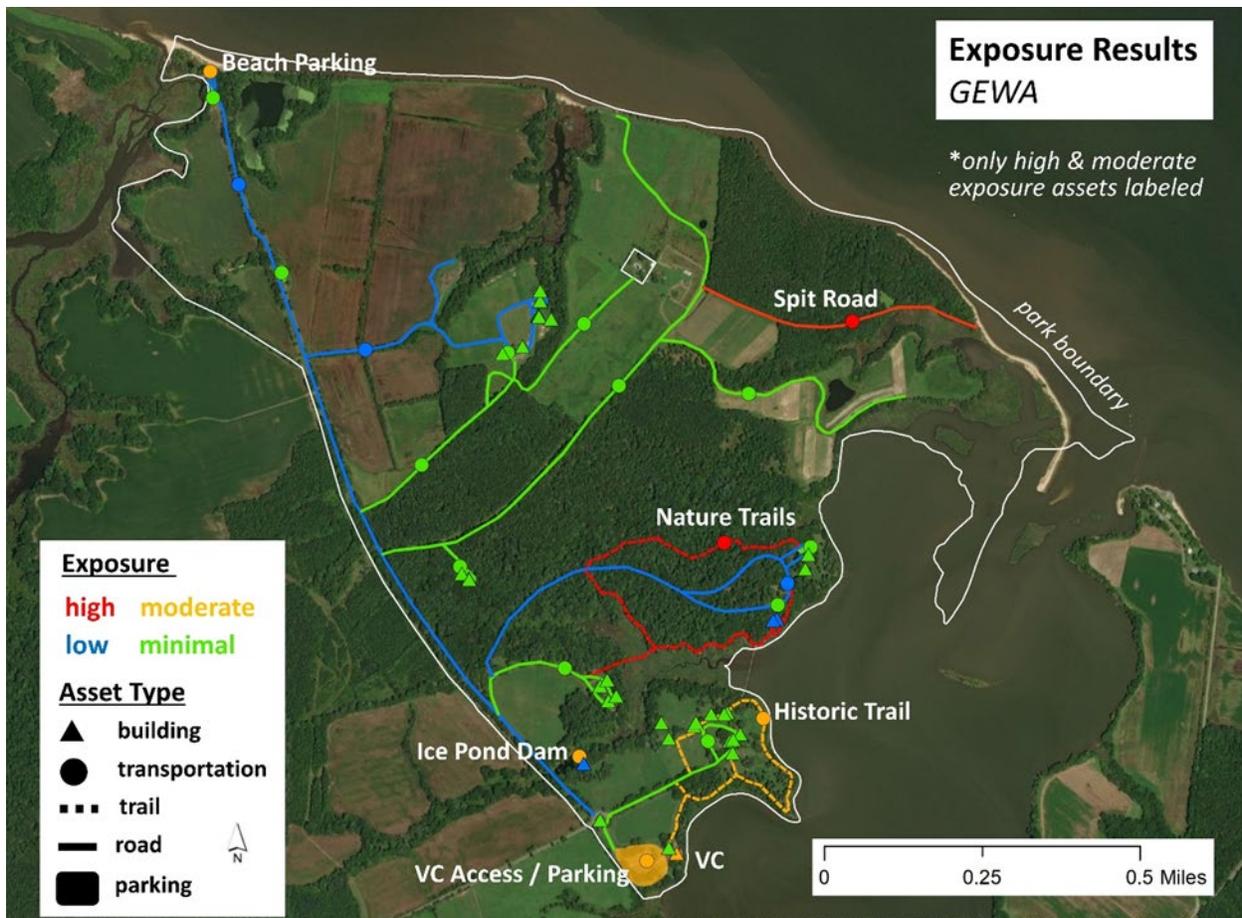
Only two of the assets analyzed at GEWA have high exposure to the evaluated coastal hazards (Nature Trails and Spit Road). Five assets have moderate exposure, and six have low exposure (Table 2, and Figure 1). The majority (76%) of the assets analyzed have minimal exposure. These results are primarily a result of the park’s higher elevation areas (most of the park is 15 to 25 feet above sea level) leading to lower exposure overall to coastal flooding and SLR.

**Figure 1.** GEWA exposure results summary. Only high and moderate exposure assets are labeled. Background is ESRI streaming imagery.

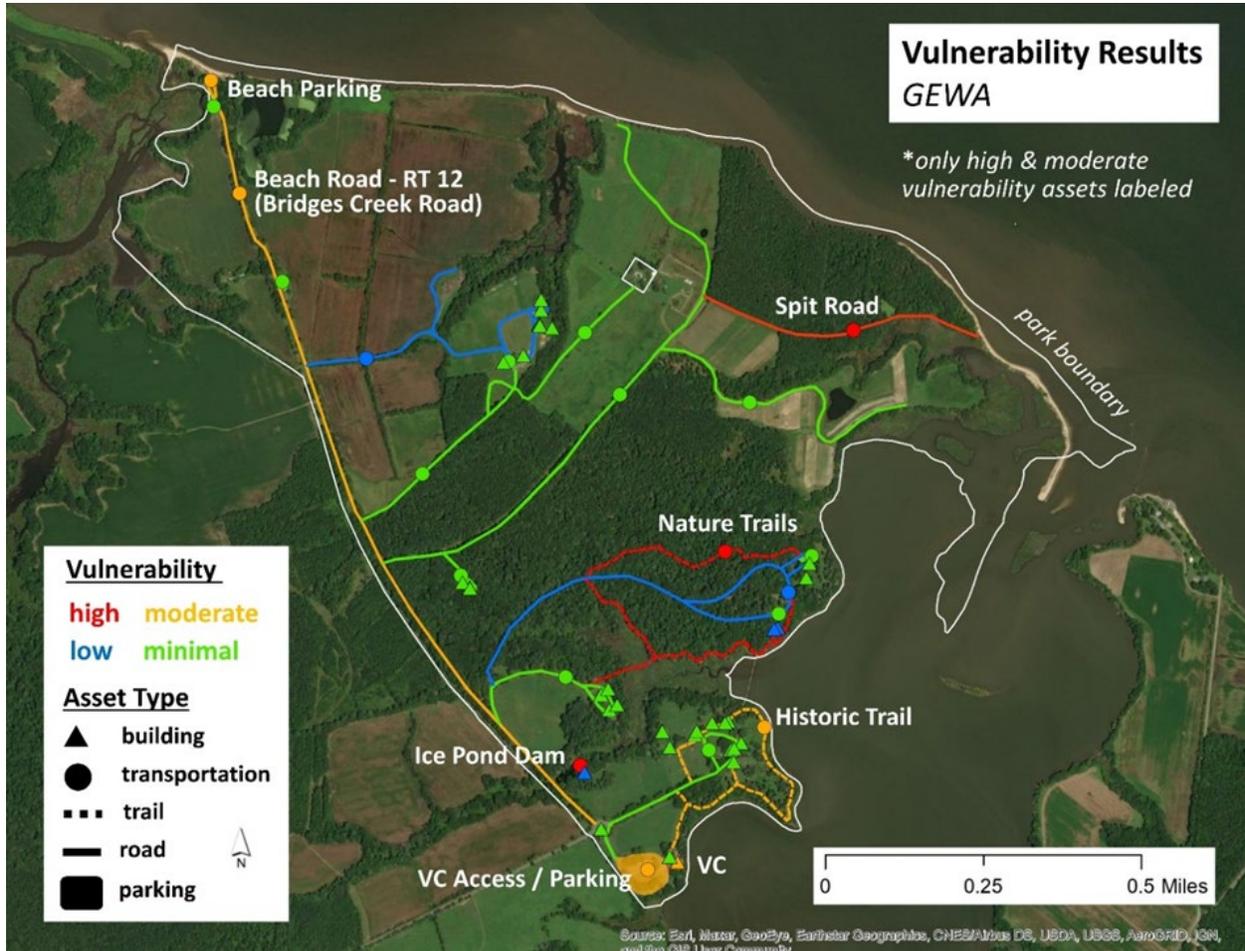
The majority (76%) of assets analyzed at GEWA have minimal vulnerability to coastal hazards and SLR (Table 4, and Figure 2). Only three assets have high vulnerability: the Spit Road, Nature Trails, and Ice Pond Dam. Only two assets (Ice Pond Dam and Beach Road) have high or moderate vulnerability and a high asset priority index (API  $\geq$  70, as reported in FMSS). These results are primarily due to the lower overall exposure to coastal hazards and SLR.

**Figure 2.** GEWA vulnerability results summary. Only high and moderate vulnerability assets are labeled. Background is ESRI streaming imagery.
