**ASBESTOS-CONTAINING MATERIALS
SURVEY REPORT
FOR
NATIONAL PARK SERVICE
UNITED STATES DEPARTMENT OF THE INTERIOR
GOLDEN GATE NATIONAL RECREATION AREA
SAN FRANCISCO, CALIFORNIA**

Prepared By:
**MACTEC ENGINEERING AND CONSULTING, INC.
396 Plasters Avenue, Atlanta, Georgia 30324**

SEPTEMBER 28, 2012

MACTEC Project Number 6141-10-0320

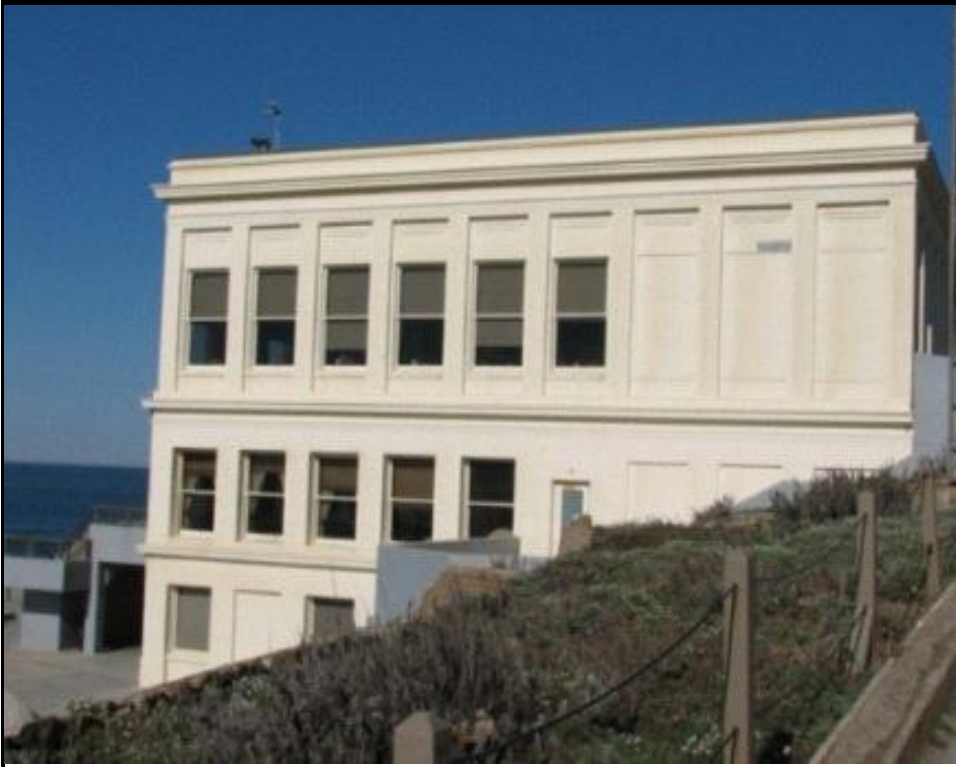
Building 38099 - Cliff House

Building Use: Cliff House

Building Size: 29418 SF

Construction Date: 1909

ACM Assumed

Future Asbestos Clean-up Costs: \$14,450
