THE CLIFF HOUSE

Golden Gate National Recreation Area
San Francisco California

HISTORIC STRUCTURE REPORT

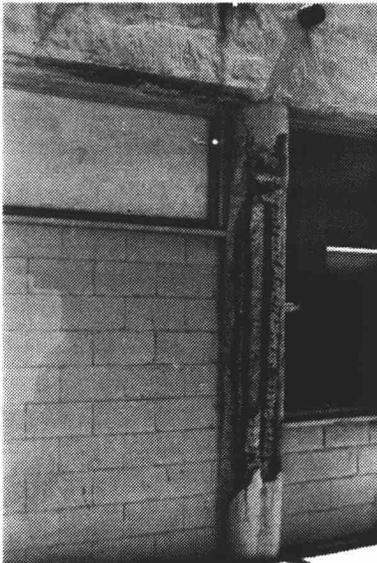
The lower level terrace itself is currently in very poor condition, one area having already been cordoned off. Structural repair of this area is essential and should be given the highest possible priority.

Figure 55. Lower terrace, deterioration of west wall. 1986.

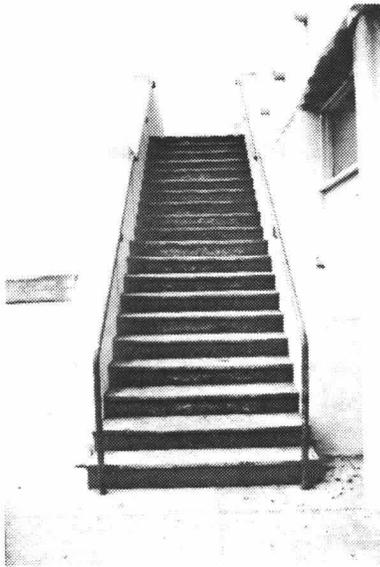
Figure 56. West side, deterioration of the stair between the lower and upper terrace. 1987.

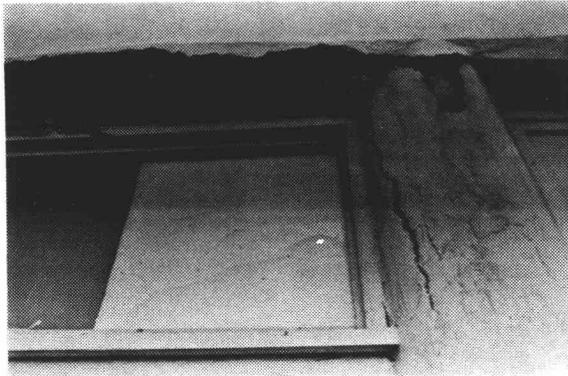
Concrete. Concrete wall surfaces on the west facade upper viewing platform built in 1954 are badly deteriorated primarily due to inadequate concrete cover over the reinforcing and poor water runoff details. The extent of the damage is probably much greater than that presently observable. The wide spread cracking in all the columns and wall surfaces suggests widespread moisture penetration and steel corrosion. At this point the amount of chipping off damaged concrete, sandblasting of steel, installation of

Figure 61. Deterioration of west wall, perimeter beam and column. 1987.

new epoxy-coated reinforcing, and patching in new concrete would be so extensive that demolition and replacement of this element will be the most appropriate course of action.

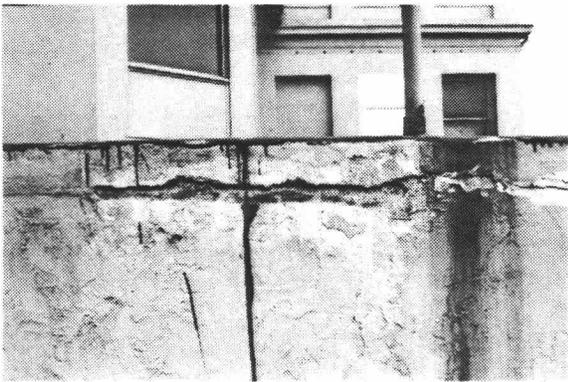
Figure 62. Upper Terrace, deterioration of perimeter beam, north side. 1987.

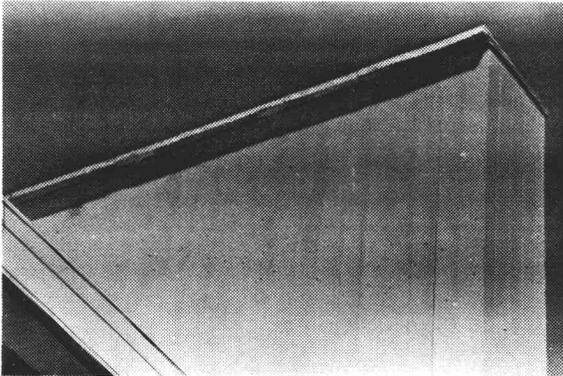
Vertical wood siding installed on the pylon at the east facade, after brick veneer was removed, is badly cupped and is allowing moisture penetration into the framing. The entire pylon should be resheathed, possibly in more weather-resistant materials.

Figure 64 (Left, top). Pylon. Note cupped vertical siding, indicating moisture penetration. 1987.

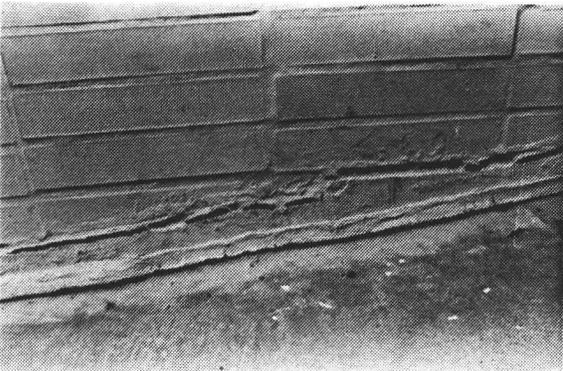
Brick. Brick veneer installed on the south and east facades in 1949 has a number of problems. Cracking can be observed on the bricks at the south wall. The cause of this cracking is not known. However, it may be due to

Figure 67 (Right, bottom). South facade, cracks in brick facing, requiring further analysis. 1987.

moisture problems in the wood back-up wall, or possibly due to thermal movement in the brick. Specific repair measures should be developed after investigation of the condition of the backing and its connection to the brick.

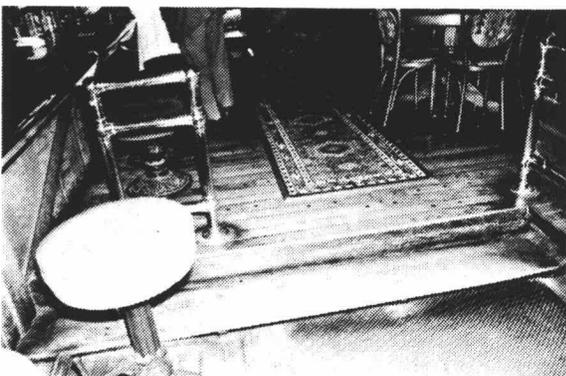
Figure 68. Disabled access barriers in the P.T. Barnacle restaurant. 1987.
