HISTORIC STRUCTURES REPORT

ARCHITECTURAL DATA SECTION

CHARCOAL HOUSE

Hopewell Village National Historic Site

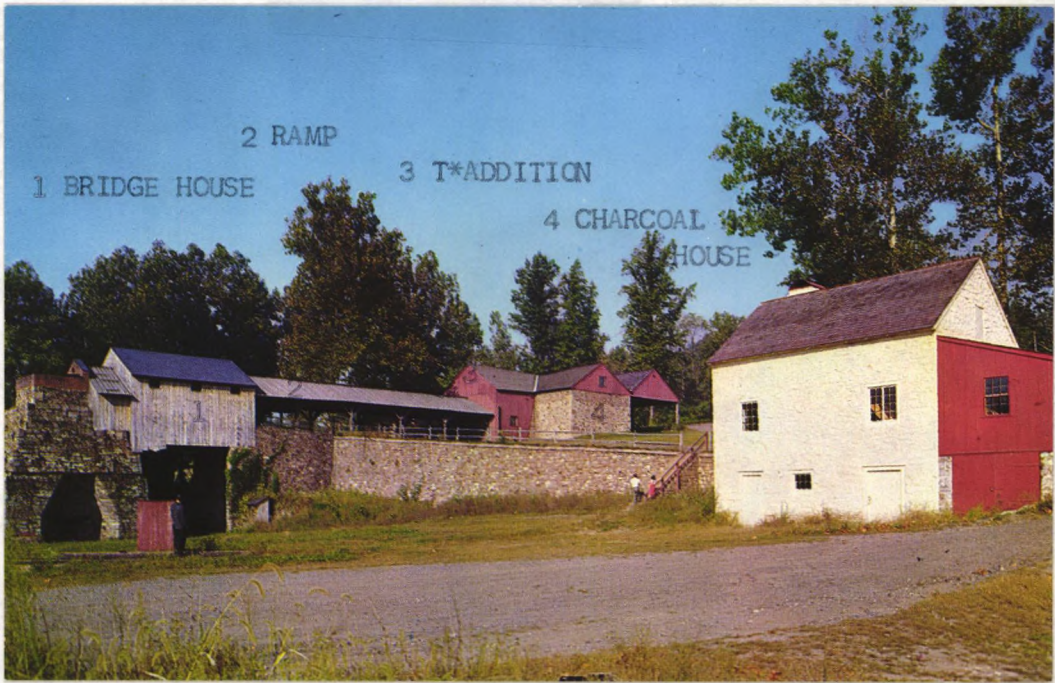
How the areas above the connecting (ramp) shed roof and the entrance into the charcoal house were closed before 1880 is unknown. A pre-1935 photo shows the charcoal house without doors.<sup>16</sup>

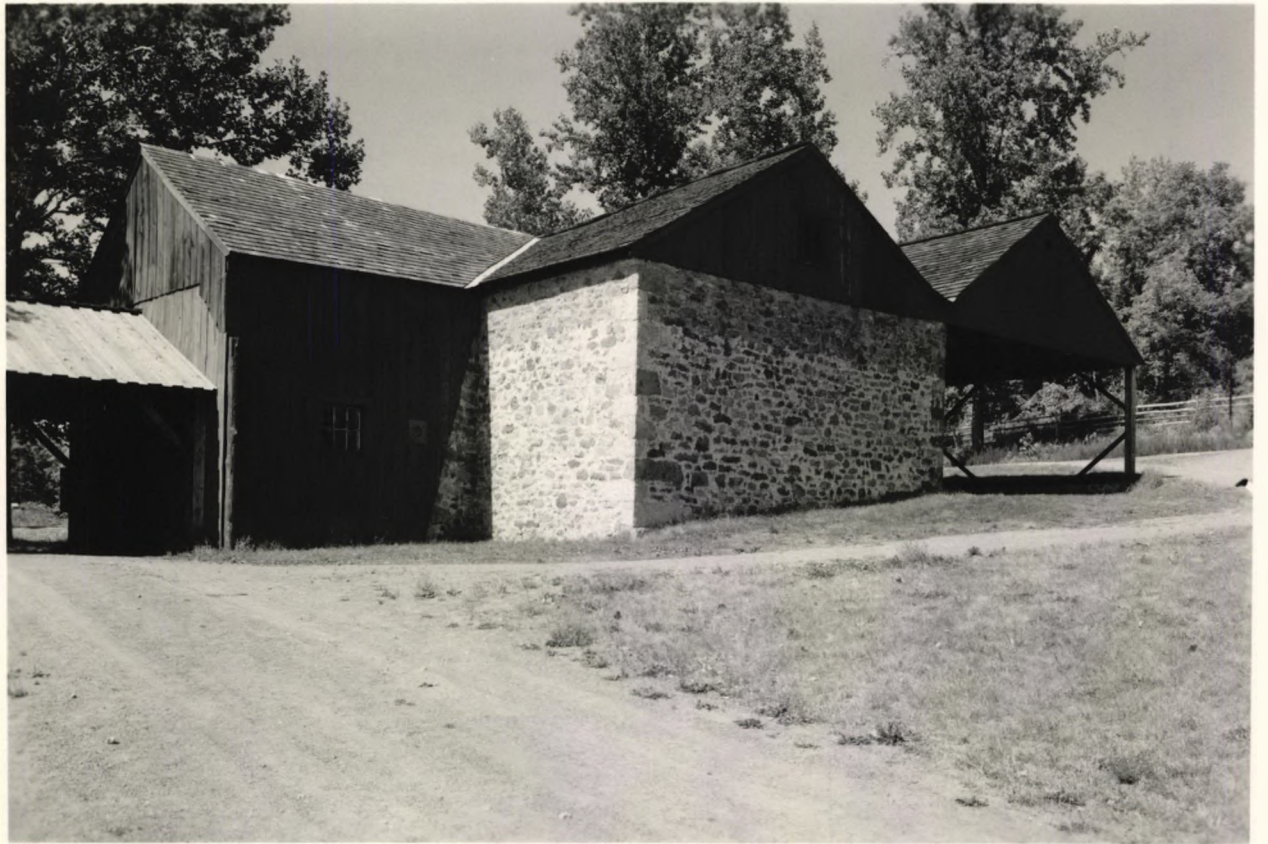
ILLUSTRATION NO. 1

The Charcoal House from the southeast.  
The 1880 frame annex and the reconstructed  
connecting shed are shown in this photograph.  
The proposal for the restoration of the Charcoal  
House includes the removal of the frame annex  
and the extension of the connecting shed to the  
opening of the Charcoal House. The east gable  
of the reconstructed Charcoal Shed is at the right.

1. The removal of the entire roof structure and the restoration of the roof area.
2. The removal of the 1880 south frame annex and the extension of the connecting shed into the south opening of the Charcoal House.
3. The removal of the windows in the north wall and the restoration of the original pairs of doors in their place.
4. The repointing of the masonry as required.
5. The provision of two (2) pairs of doors for protection on the south opening into the connecting shed.
6. The painting of the exterior woodwork and the whitewashing of the exterior stone walls as indicated on the 1887 "Stokes" photograph.
