HISTORIC STRUCTURES REPORT

ARCHITECTURAL DATA SECTION

SPRING AND WASH HOUSE

Hopewell Village National Historic Site

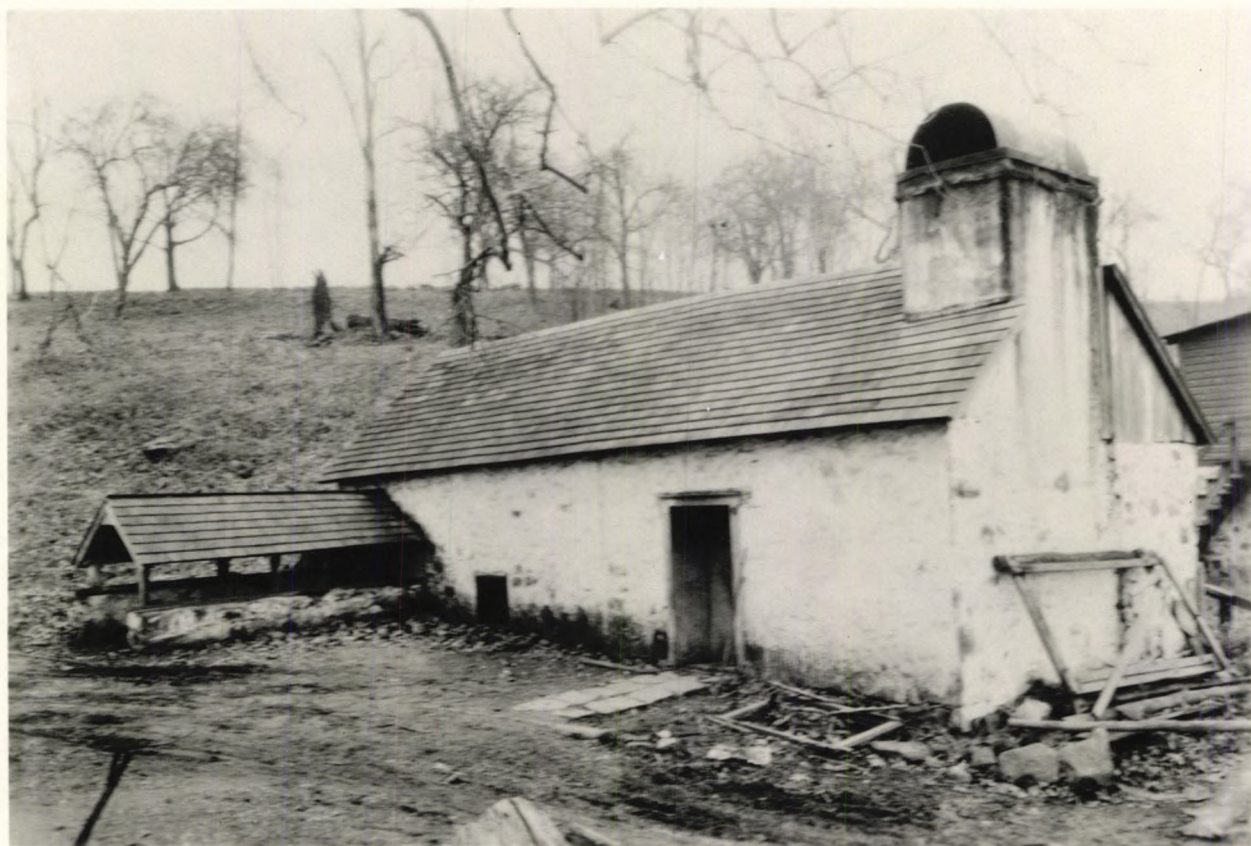
In this photograph a deep fissure may be noted in the stone wall to the right of the chimney. Repairs made to this wall destroyed the original opening through which the water left the building.

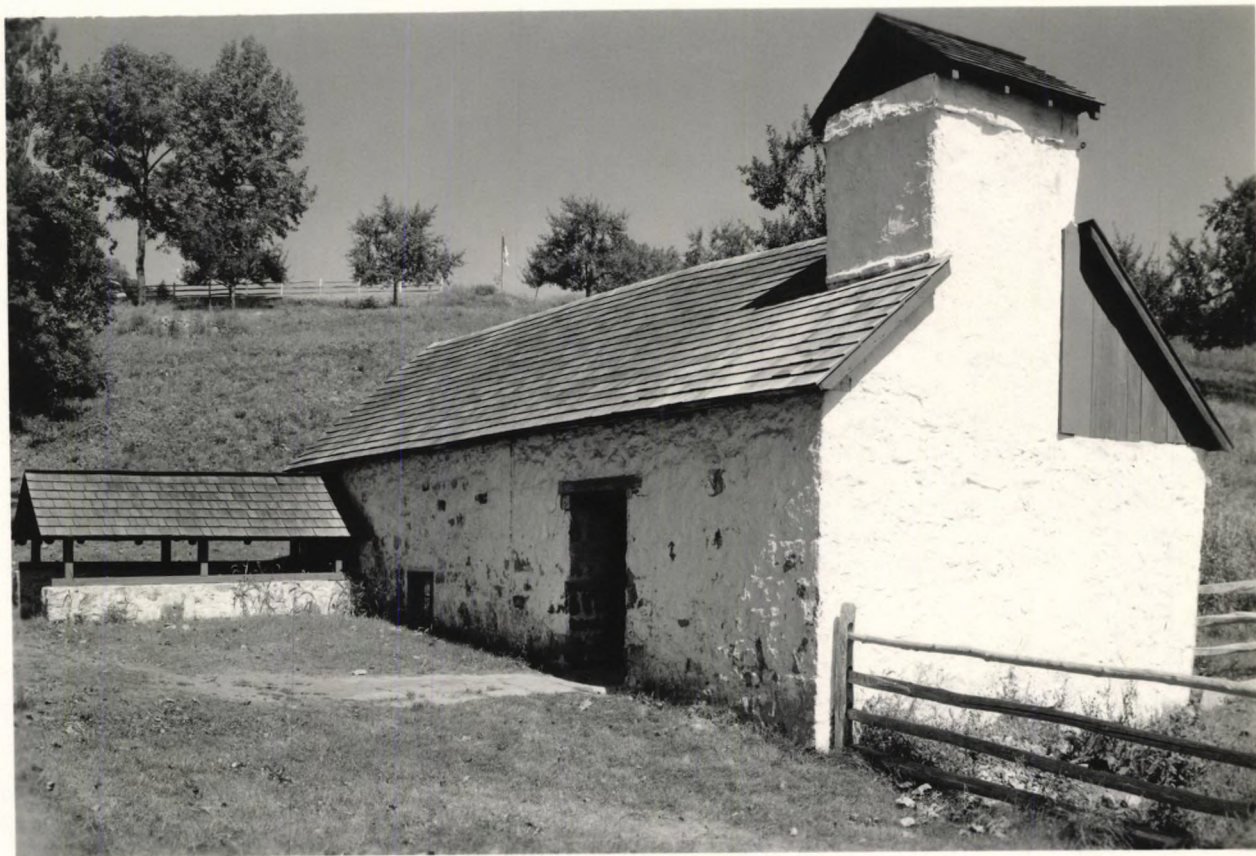
ILLUSTRATION NO. 2

Recent photograph of the Spring-Wash House from the same location as Illustration No. 1. The door and frame to the Wash House portion was removed for architectural investigation. The excavation behind the fence at the right marks the location where the spring water leaves the building. An early cast iron pipe carried the water under the former Meadowbank Road (now abandoned) to a ditch which emptied into French Creek.

The wood chimney hood was added several years ago. A replacement of the metal hood shown in Illustration No. 1 is recommended.

The chimney will require little except for a half-round sheet iron hood to replace the existing wood shingle cover. The metal hood to match that shown in photograph No. 1.

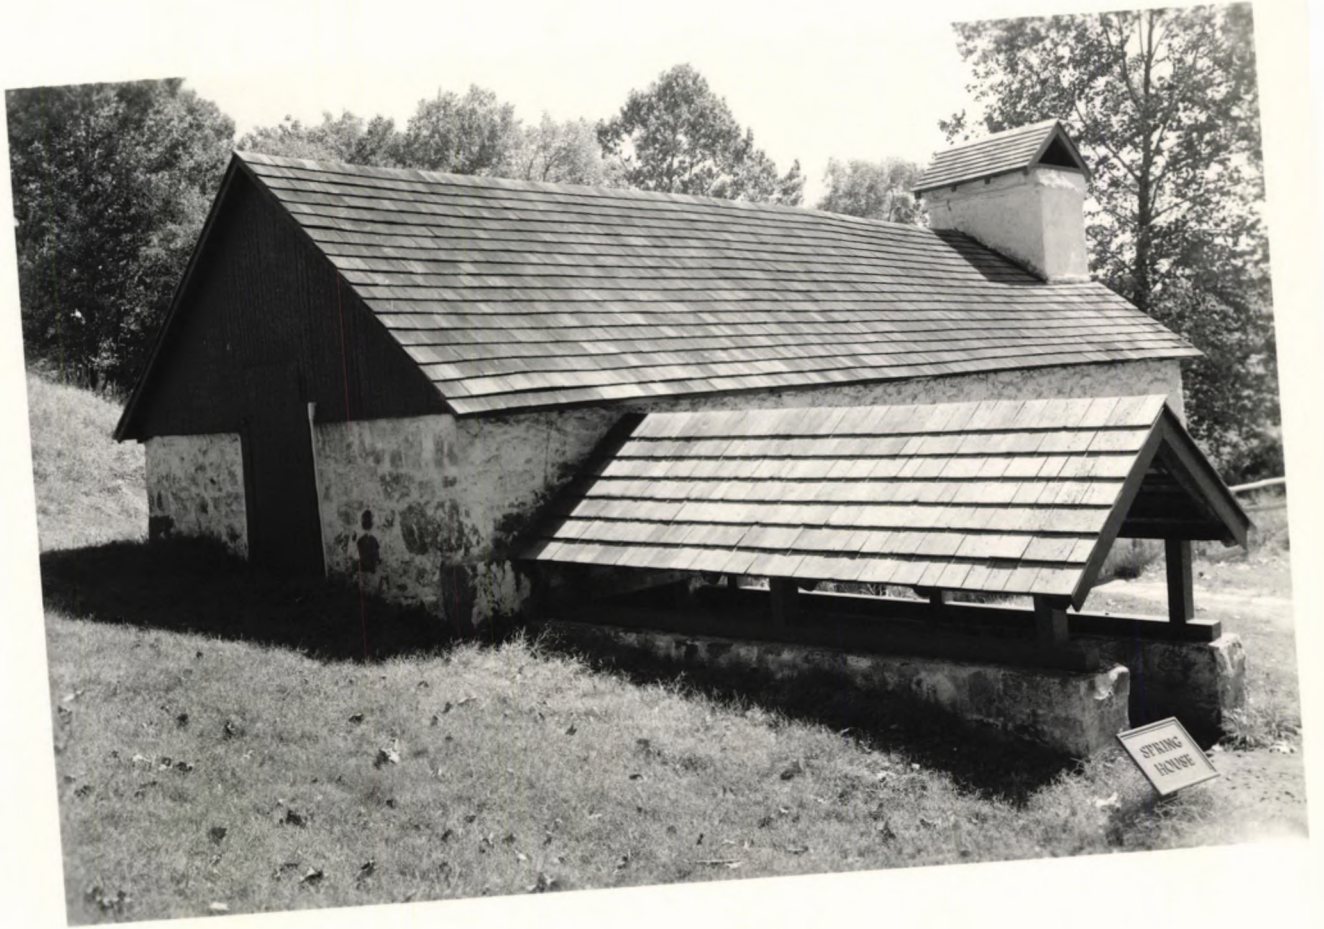
ILLUSTRATION NO. 3

The northwest corner of the Spring House.
The door shown on the left is the entrance to the
loft. The overhanging eave will be removed and the
narrow tongue and groove boarding will be replaced
with wide sheathing.

The existing wood gable ends should be replaced with wide tongue and groove vertical pine sheathing.

The roof shingles are in good condition. The extended eaves on the gables should be removed and a tapered beaded fascia applied to the wood siding on both gables.

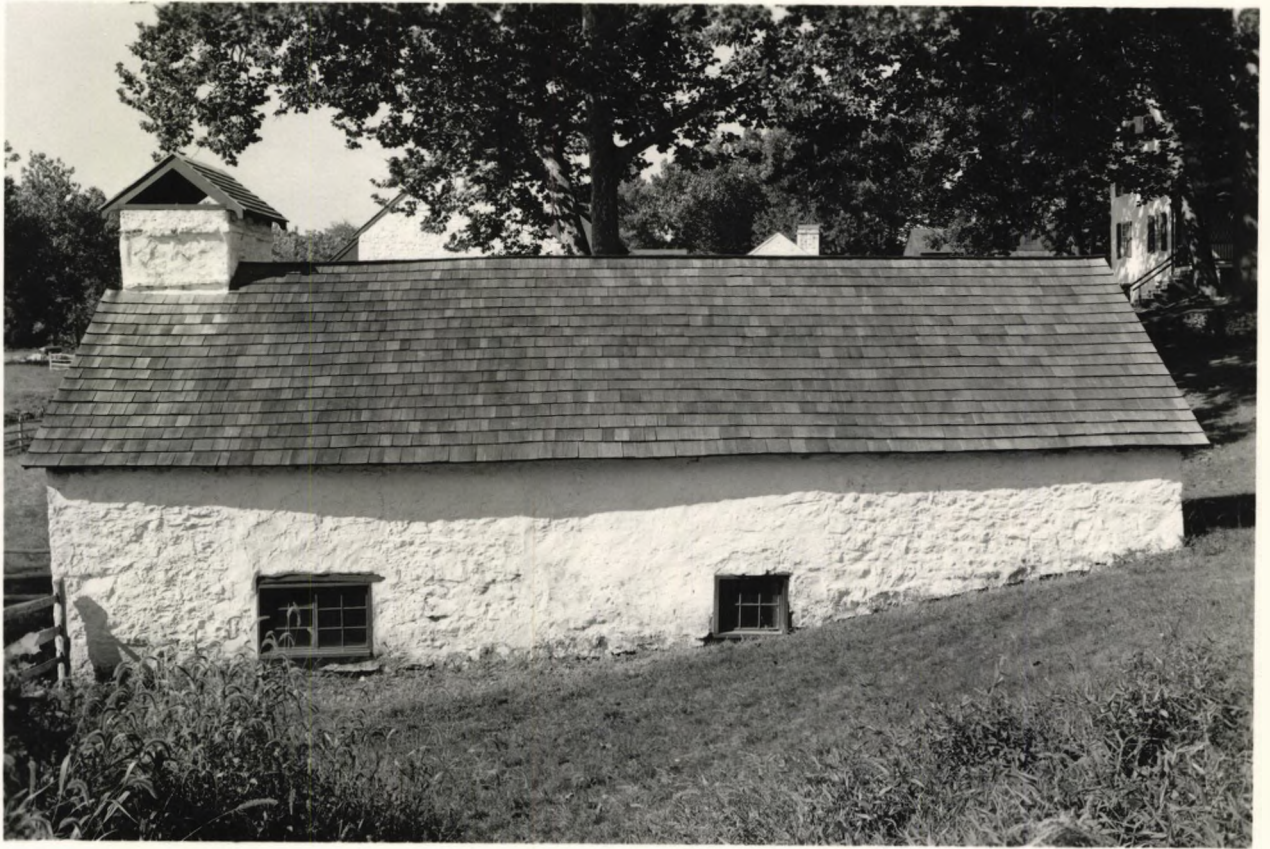
ILLUSTRATION NO. 4

A view of the Spring-Wash House from the east, showing the relation of the lower floor windows with the grade level on the hill. The window frames and sash are not original.

All door and window frames will have to be removed and replaced with mortised, tenoned and pegged oak frames. The sizes of the openings indicate that the window sashes were individually made. The present frames have been fabricated to accommodate stock sash. The windows and sash will be detailed on the working drawings.

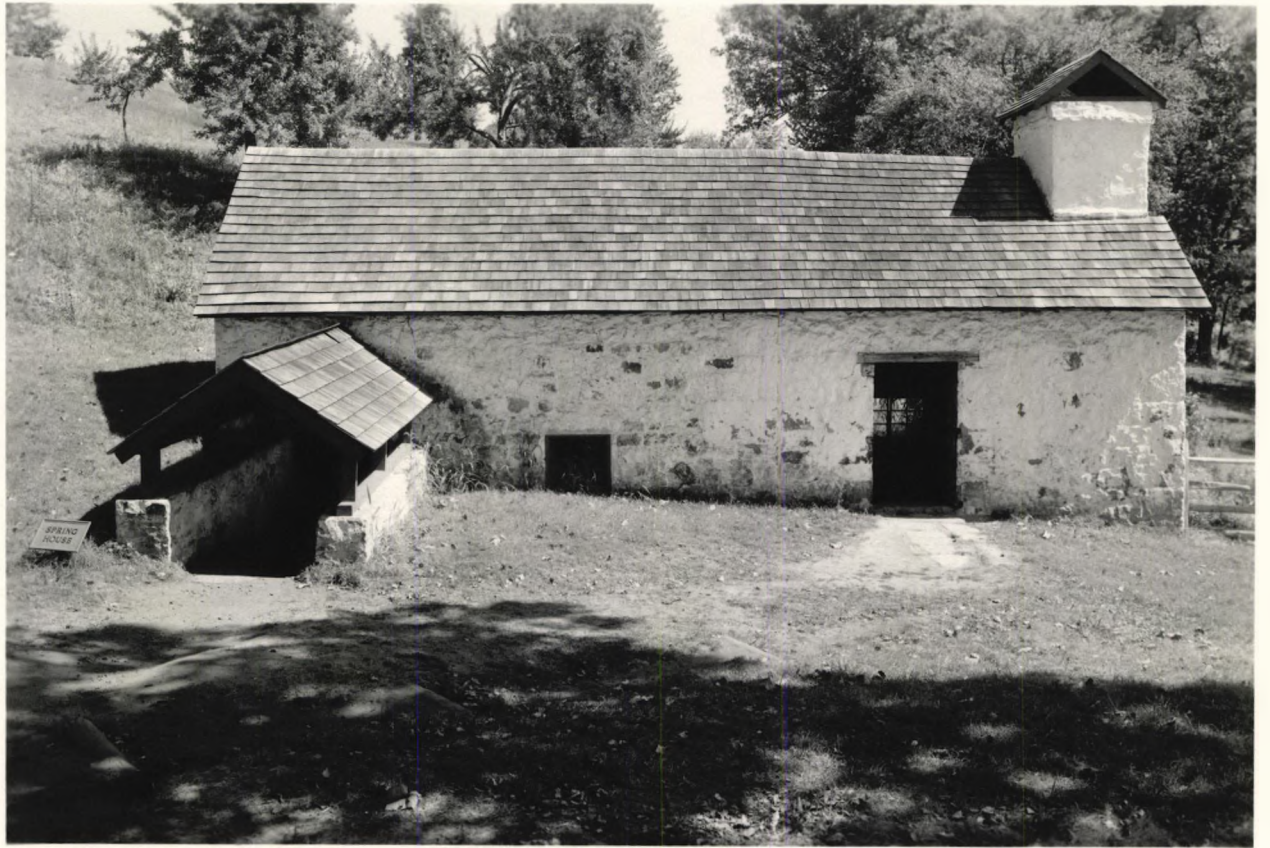
ILLUSTRATION NO. 5

The Spring-Wash House from the west, showing the entrance to the spring room on the left and the entrance to the Wash House on the right. A joint in the wall to the left of the wash room door marks the extent of the original structure. The Wash House portion at the left was added after the Spring House portion.

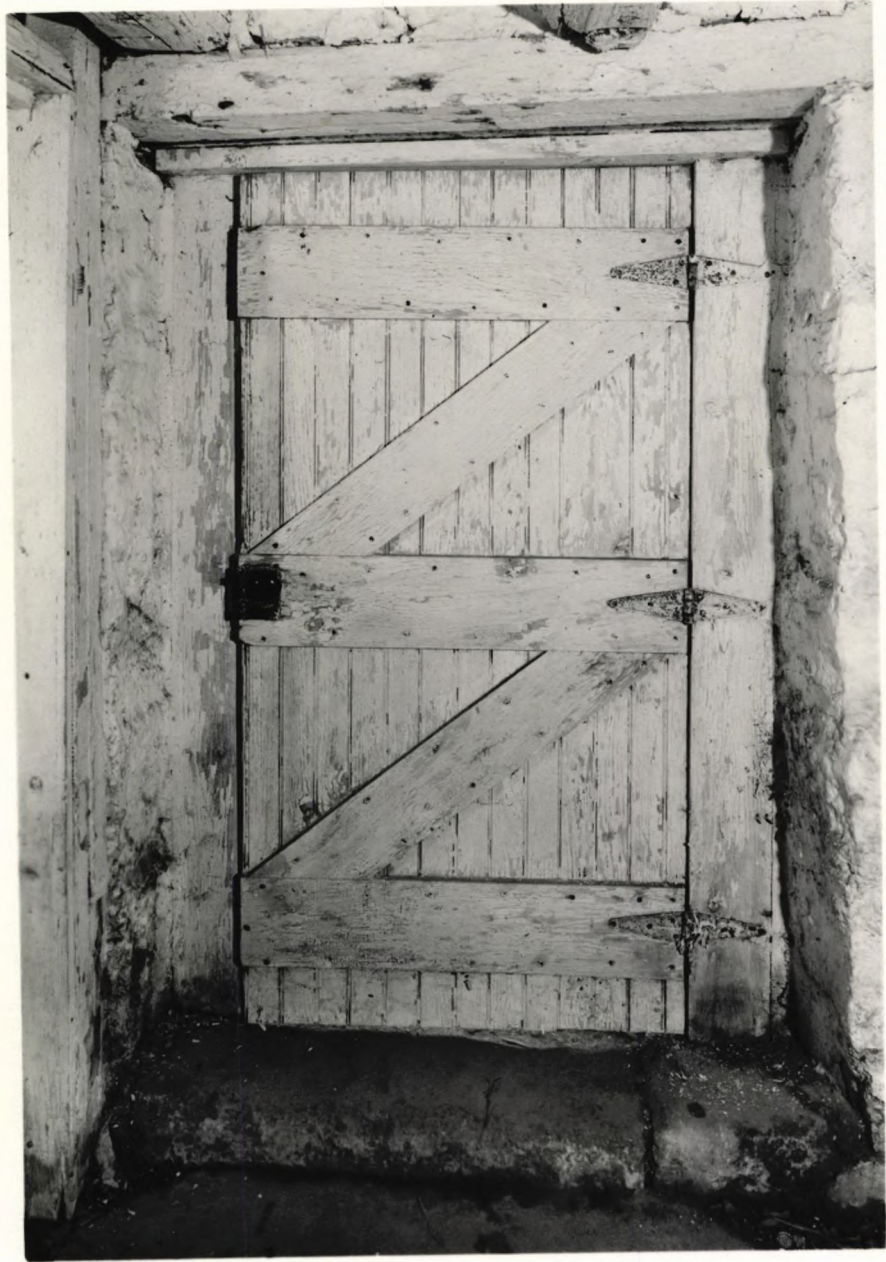
ILLUSTRATION NO. 6

The door frame to the Spring House section has built-up jambs six inches wide and is not original. The original door was obviously wider to permit barrels of meat to be set in the Spring House for cooling.

Interior of entrance door to Spring House.
The existing door and frame are late period replacements. The original door was wider than the present one as indicated by the masonry jambs and the stone door sill.

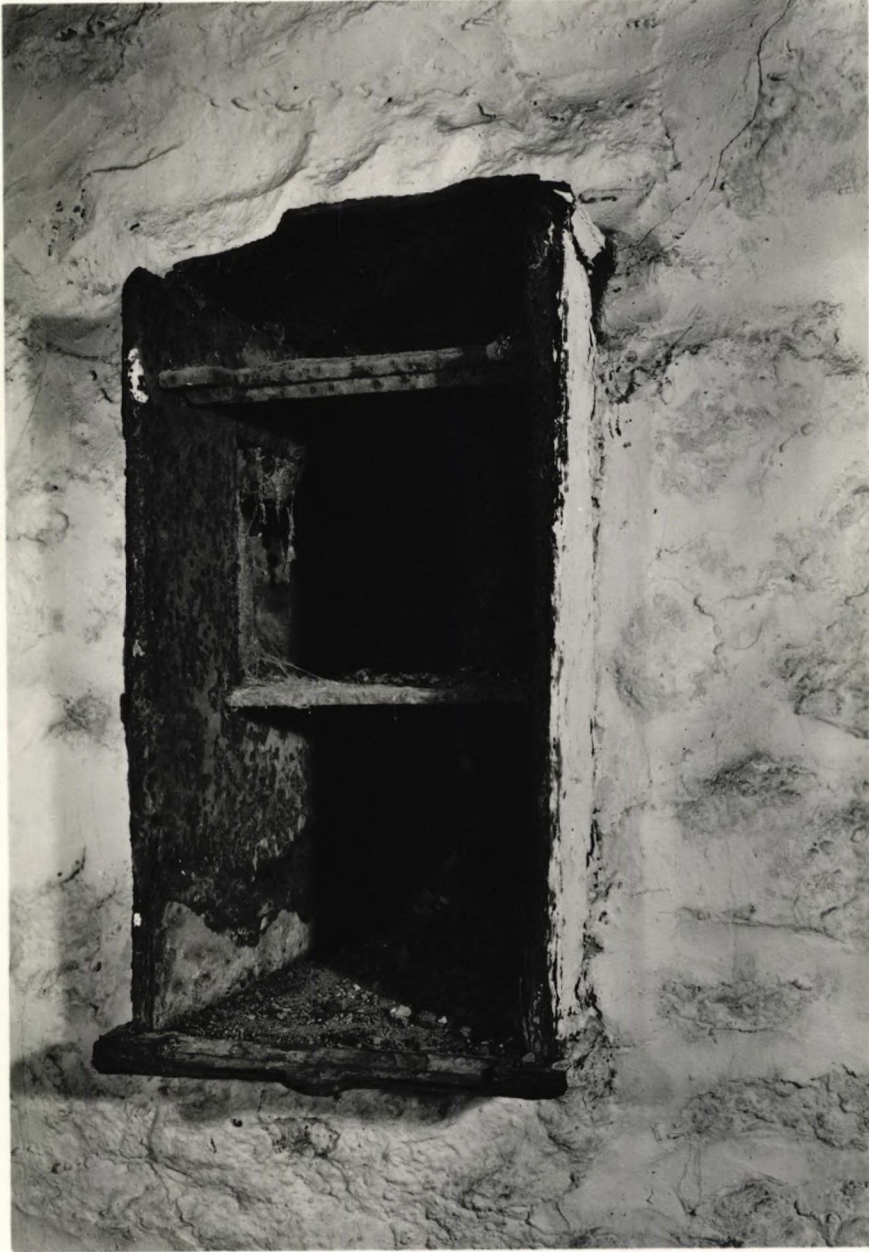
ILLUSTRATION NO. 7

A ten plate stove was inserted into the wall of the spring room near the door, apparently to be utilized as storage space. It does not appear to have been built-in with the wall. The uneven stones around it indicate it was inserted after the building was erected.

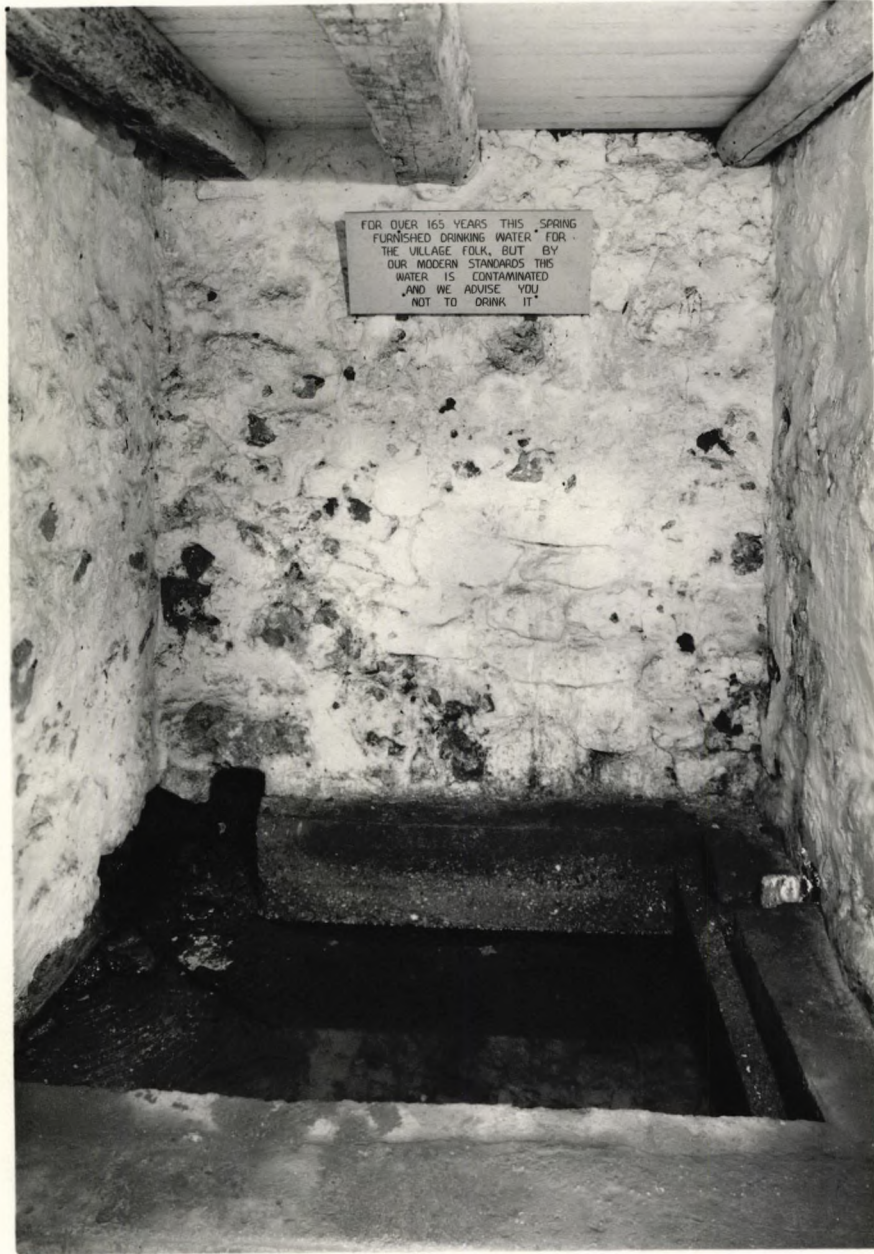
ILLUSTRATION NO. 8

The interior of the spring room. The spring water enters the building through the broken wall at the left. The concrete curbs and floor were laid in the 1930's by the C.C.C. workmen.

In the spring room the existing concrete curbs will have to be removed. Some repair of the stone wall at the

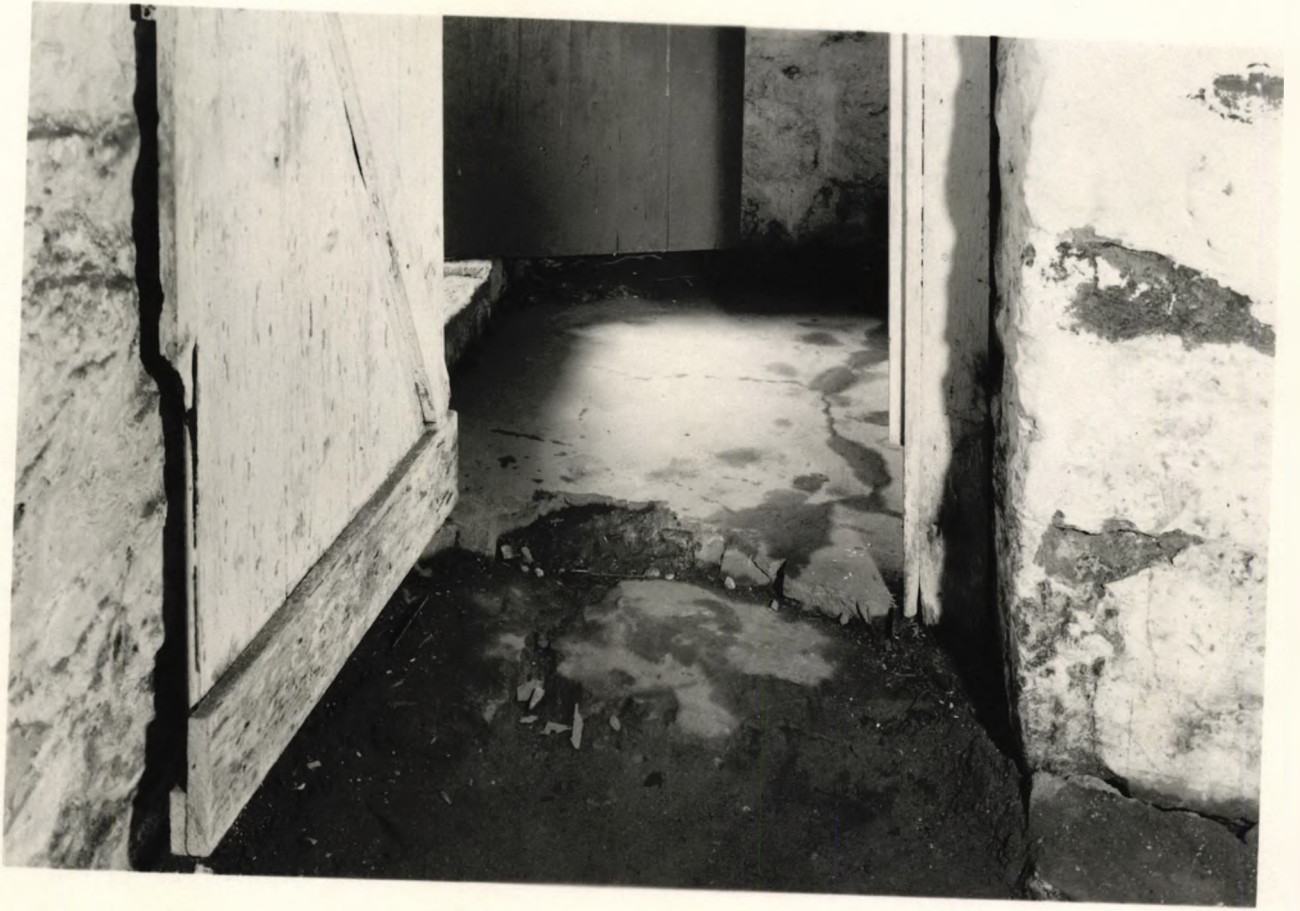
ILLUSTRATION NO. 9

Photograph of door sill between the spring room and the cooling room. The old stone floor is in place in the spring room under the concrete. The door and frame are late period replacements.

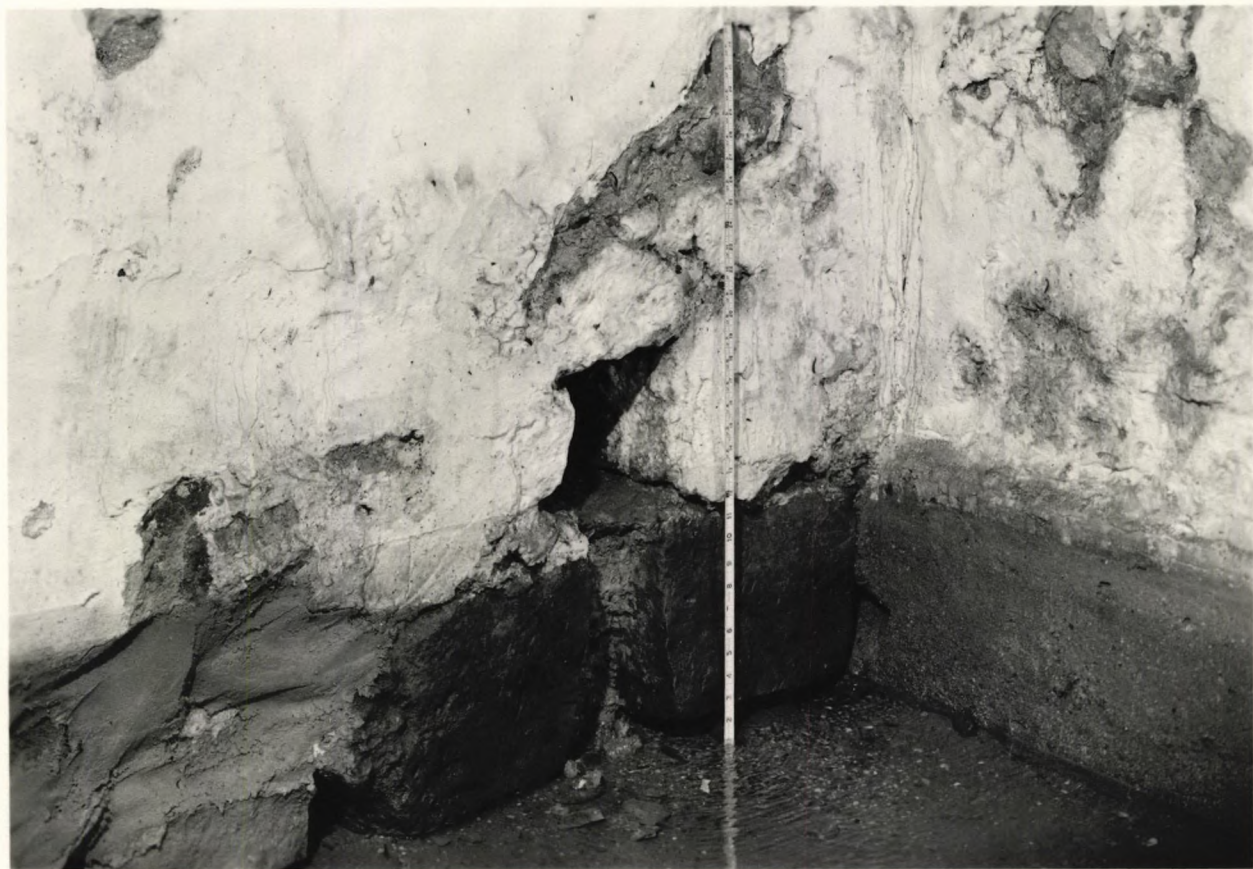
ILLUSTRATION NO. 10

The slot in the stone wall for the passage of the water between the spring room and the cooling room. On the cooling room side, shown in this photograph, a slot cut into the lower stone and the wrought iron hook above, mark the location of a water gate to regulate the flow of water.

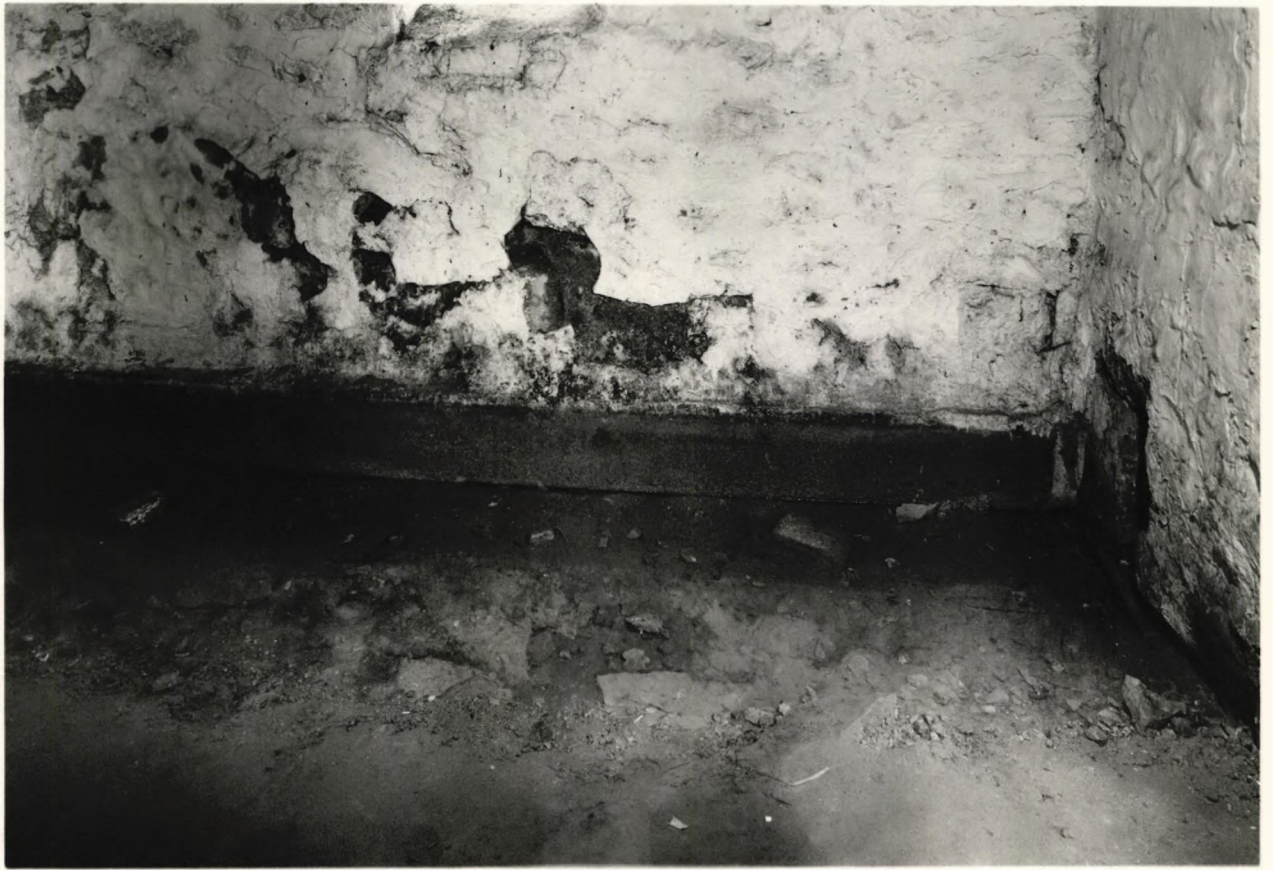
ILLUSTRATION NO. 11

The remains of the cooling run in the center room. The sides of the stream were destroyed when the concrete floor and curb were removed during the winter of 1963-64. A few stones remain to mark the original width of the stream.

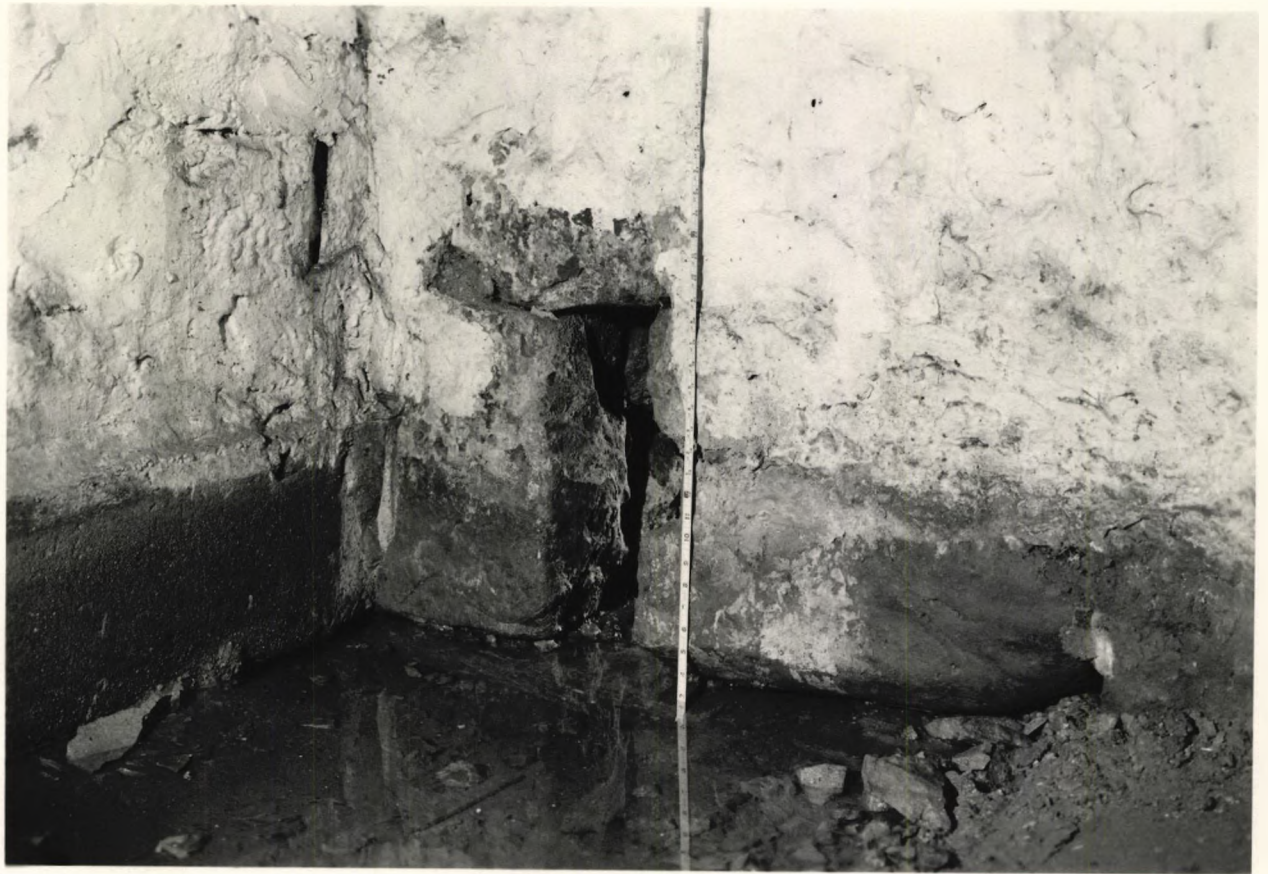
ILLUSTRATION NO. 12

The slot between the cooling room and the wash house. The photograph was taken on the cooling room side. There is no indication of a water flow control gate on this opening.

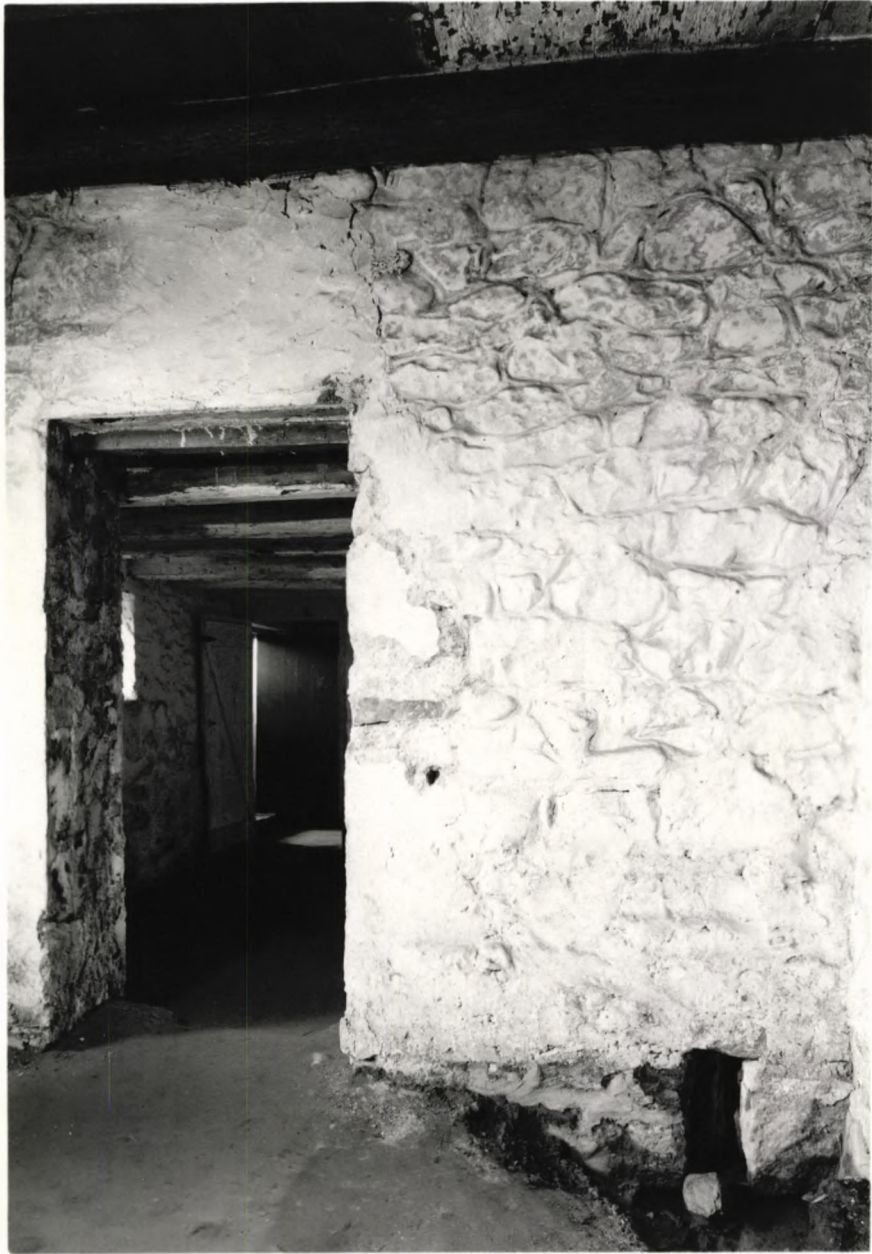
ILLUSTRATION NO. 13

The stone wall in the Wash House showing the original pointing of the Spring House. The wall shown was the exterior of the south wall of the original building. The Wash House was added later. The door opening was cut into the original wall to provide access to the Wash House. Cement mortar in the door opening shows repairs made to stabilize the openings in the 1930's.

Repairs made to the interior of the stone walls should match the old work as closely as possible. The stone and concrete area around the door between the cooling room and the Wash House should be removed and reconstructed to match the original.

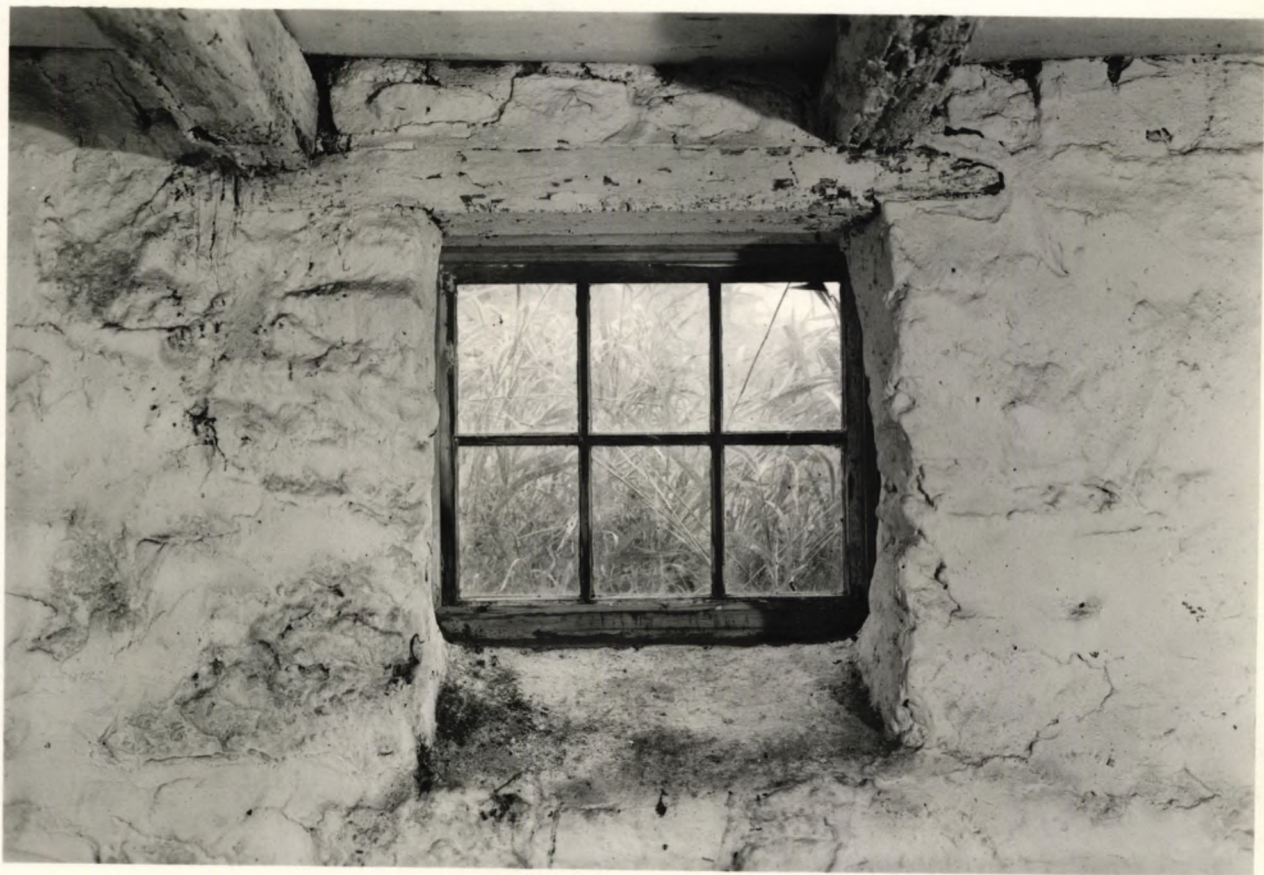
ILLUSTRATION NO. 14

The east window in the cooling room. The sill on this window slopes sharply. Note the log joists and the wood window lintel.

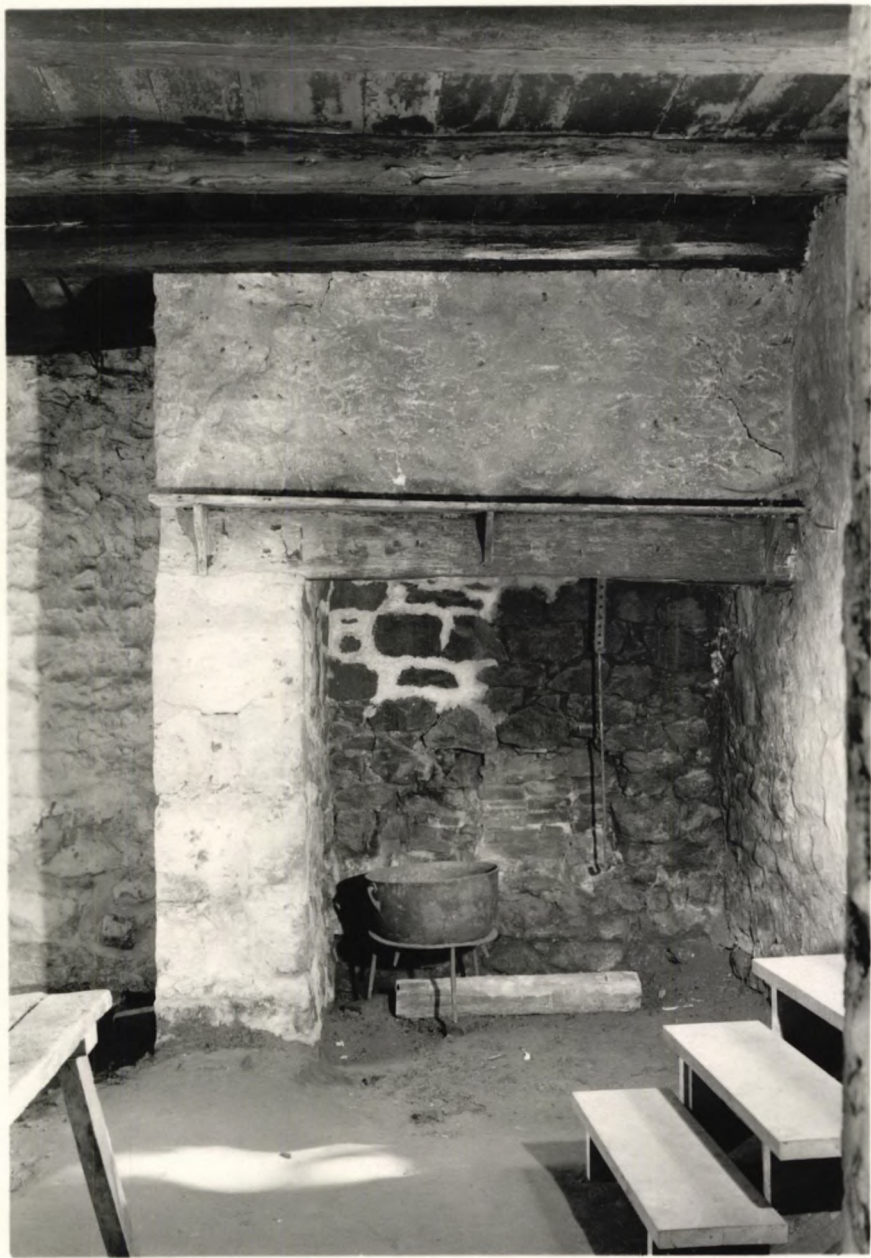
ILLUSTRATION NO. 15

The interior of the fireplace was plastered and shows signs of whitewashing. The back wall has a large area of crude fire brick patching where the stone wall has been burned-out.

The fireplace in the Wash House. The concrete flooring has been removed. The wood steps are temporary. The level of the old wood floor is on a line with the top of the log in the fireplace.

The inset of fire brick in the back of the fireplace marks the repair of burned-out stone.

A hearth of substantially large stones is to be built. A mark on the front of the fireplace indicates the hearth and floor level. Remaining foundation stones indicate the hearth to have been 25 inches wide.

The rear wall of the fireplace will require rebuilding. The interior of the fireplace is to be rough plastered and whitewashed. The mantel must be carefully cleaned of white-wash and grime to determine its condition and then be restored.

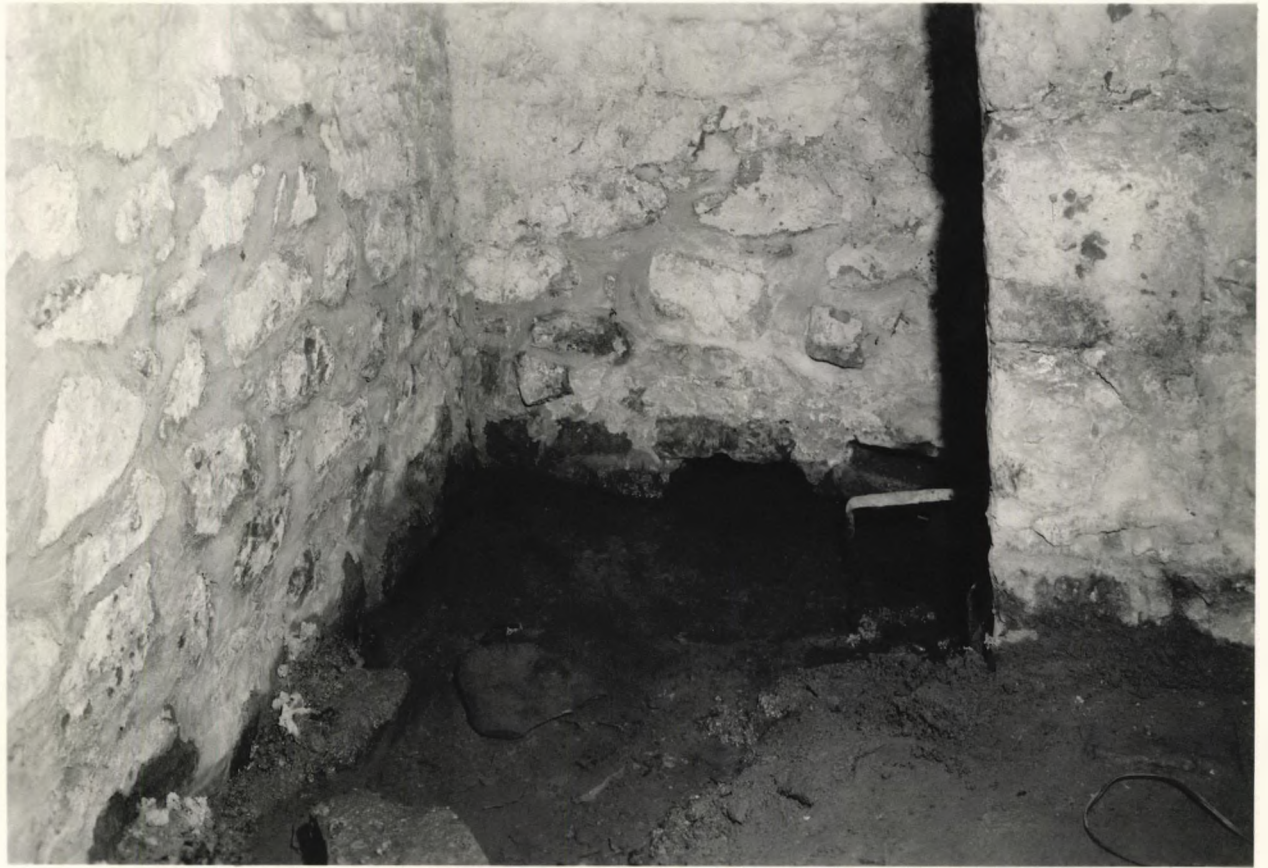
ILLUSTRATION NO. 16

The "Water-box" area of the Wash House. This area to the left of the fireplace once had a wood gate against the wall to regulate the water level. The stubs of the upright for the gate remain below the water line. The purpose of the bent tire iron is not known.

The stream of water leaves the building at this point. The opening in the wall was broken to permit the water level to be lowered for the recent removal of the concrete flooring.

The running spring is to be covered by the wood floor in the Wash House except at the corner where it widens out for the "Water-box" by the fireplace. A stone retaining wall is recommended under the wood floor to contain the water flow and prevent erosion of the earth under the wood floor.

A slot for the flow of water and its regulation will have to be made in the south wall at the "Water-box." The old iron pipe (or a replacement) will convey the water from the building under the old Meadowbank Road to the ditch.

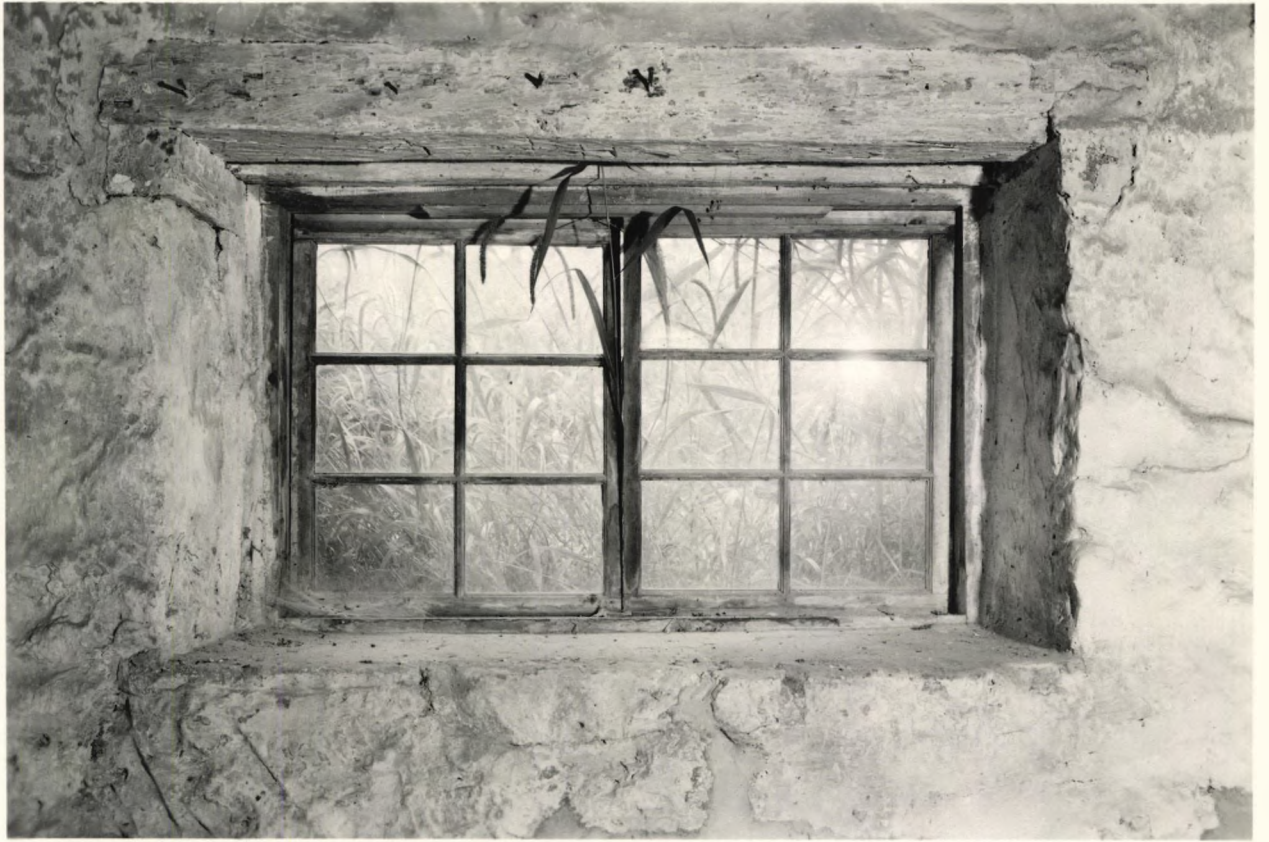
ILLUSTRATION NO. 17

The window in the east wall of the Wash House section suggests sliding sash similar to those found in the Office-Store. The present frame is a replacement, therefore the restoration of the sash must be somewhat conjectural. The fact that fire was kept burning under the water cauldrons suggests the need for cross-ventilation in summer. The present stock sash placed on end is fixed.

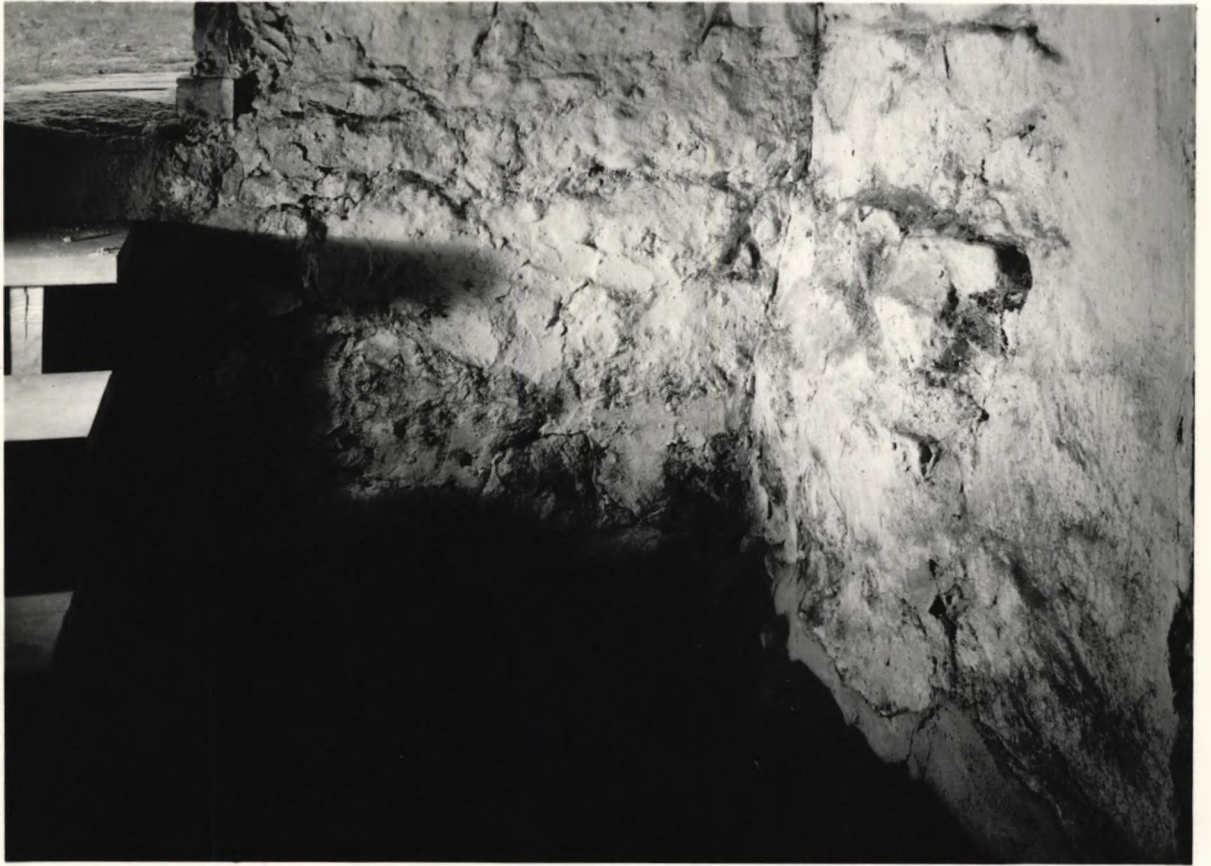
ILLUSTRATION NO. 18

The ledges in the northwest corner of the Wash House. The projection at the right is actually the footing of the older portion of the Spring House. The imprint of a board on the west wall is said to have been a built-in work bench which utilized the old foundation projection.

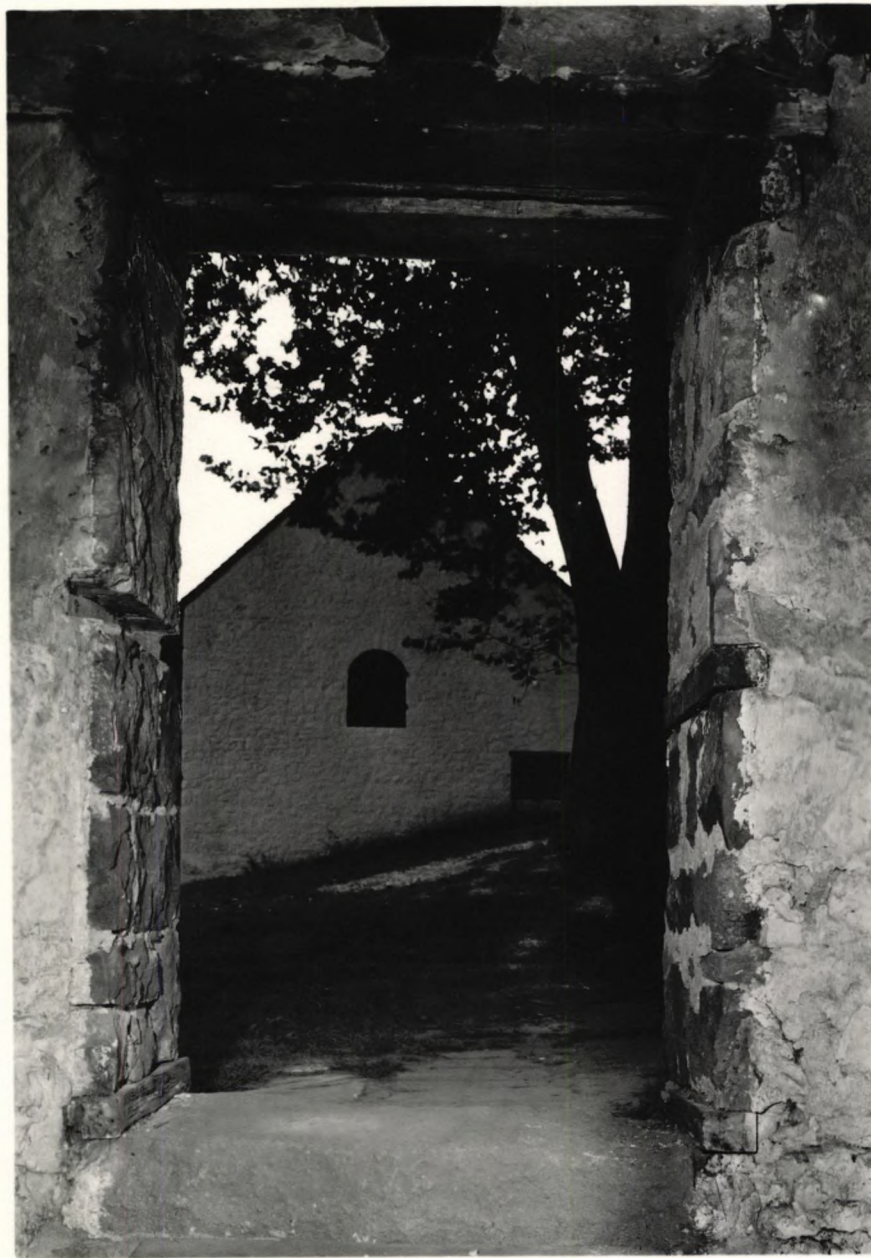
ILLUSTRATION NO. 19

The interior of the entrance door to the Wash House. The framing of this door is different from the other doors in the Spring House portion. Wood jambs were placed against the wood blocking and the interior had a trim in the form of a single architrave.
