HISTORIC STRUCTURES REPORT

ARCHITECTURAL DATA SECTION

SPRING AND WASH HOUSE

Hopewell Village National Historic Site

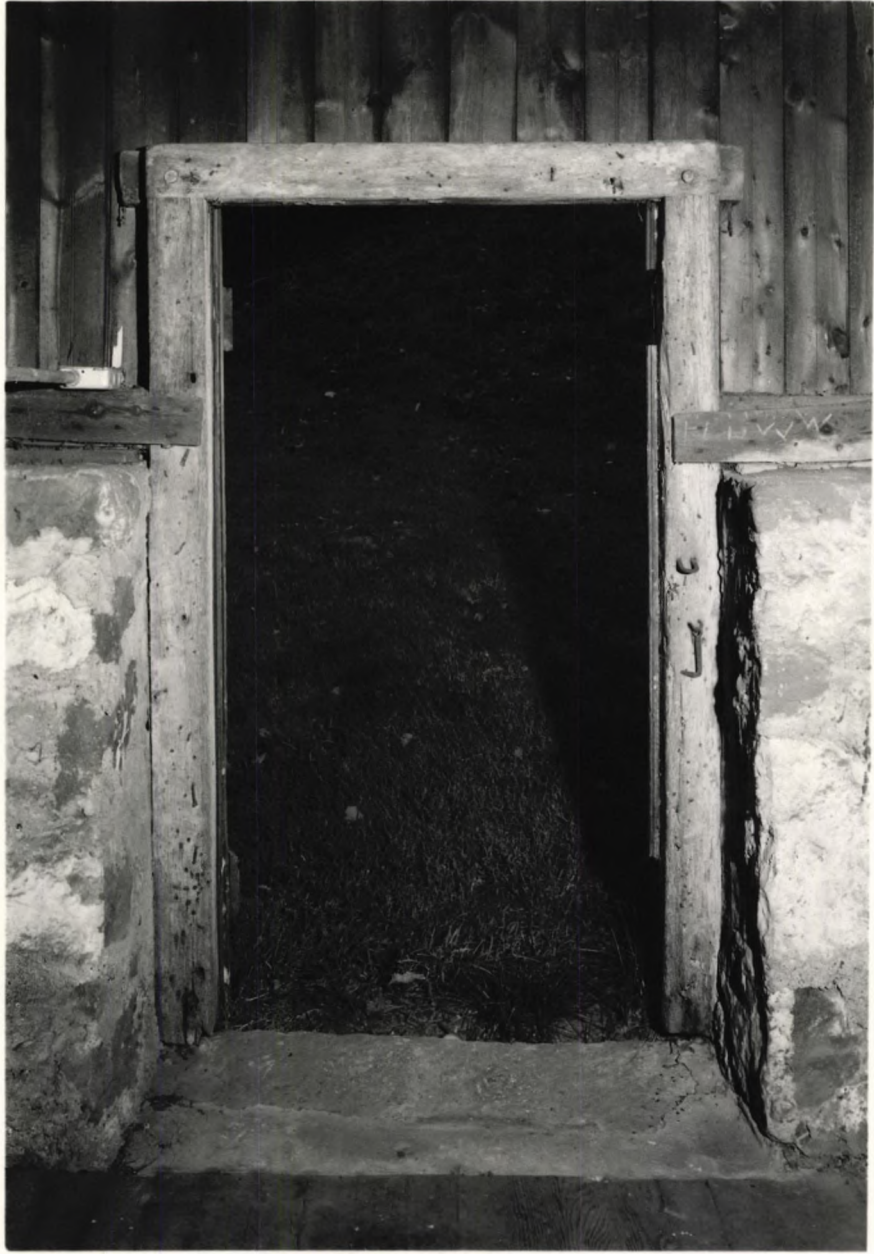
ILLUSTRATION NO. 20

The interior of the door to the loft portion of the building. The old oak frame appears to have been reused from a masonry building according to the "ears" at the head.

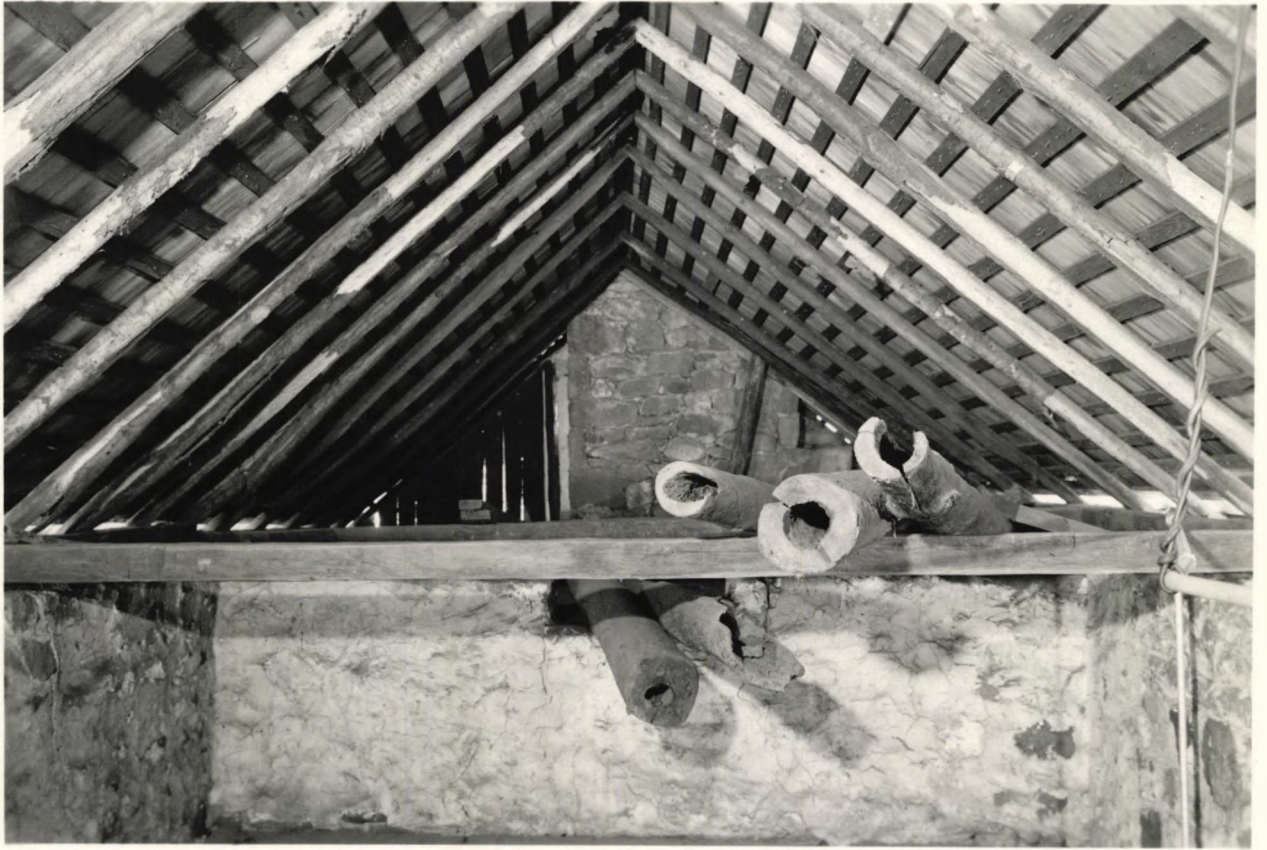
ILLUSTRATION NO. 21

Interior of the loft portion of the Spring-Wash House. The stone wall with the opening through which the wood water pipes protrude is the former loft window of the original Spring House. The flooring of the loft portion of the Wash House addition is higher than the loft floor of the Spring House portion.

The loft flooring as has been noted is not original. Wide pine T & G flooring in random widths, hand planed on both
