HISTORIC STRUCTURES REPORT

PART III

TENANT HOUSES #1 AND #2

TENANT HOUSE #2, BUILDING #20

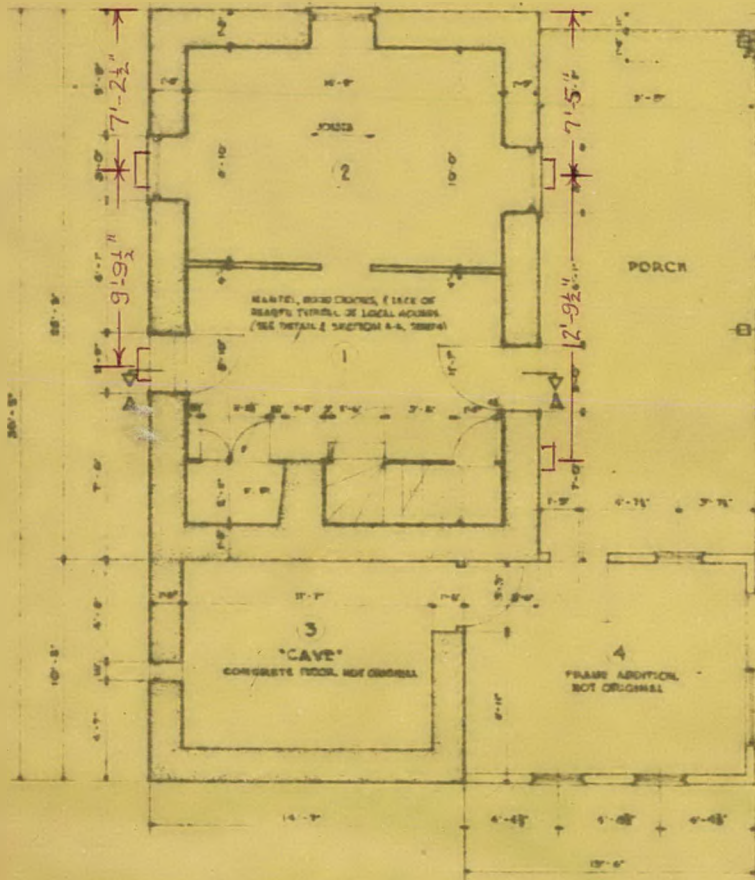
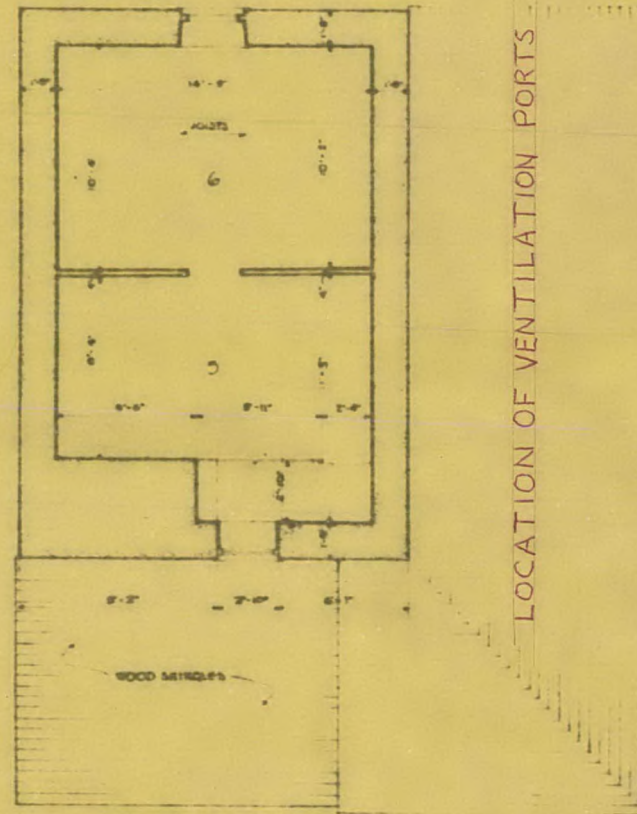
TENANT HOUSE NUMBER 2  
EXISTING CONDITIONS

LOCATION OF VENTILATION PORTS

The condition of the crawl space under the first floor was much drier than in Tenant House #1. The dirt floor was excavated to the base of the foundation and this was backfilled with 6" of rough slag. The interior of the foundation wall below floor level was repointed. Two ventilation ports were installed in the east and west walls to allow better air circulation in the crawl space under the floor. The location of these is shown on the attached drawing.

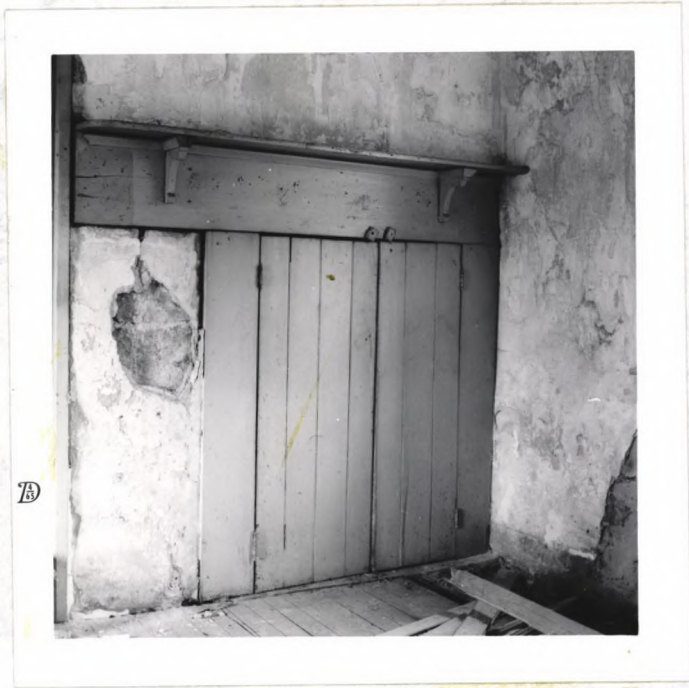
Fireplace in Tenant House #2 while existing floor was being removed. Note absence of a projecting hearth. The woodwork was completely replaced in this building after a fire in the late 19th Century.

No hearth extending from the fireplace was found and it was decided to install the new flooring similar to the old.

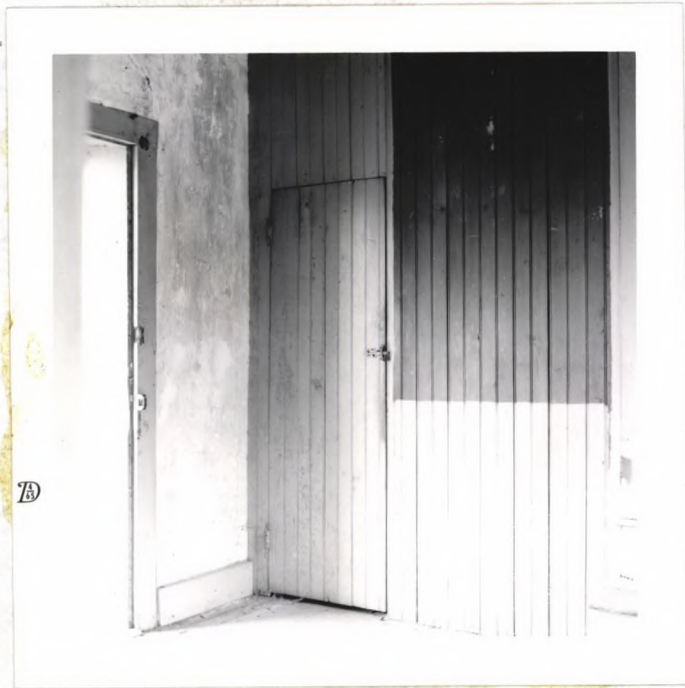
View of closet and stairway. The beveled tongue and groove siding sometimes called "Philadelphia Fencing" is of late origin. Hardware in this building is also of late origin.

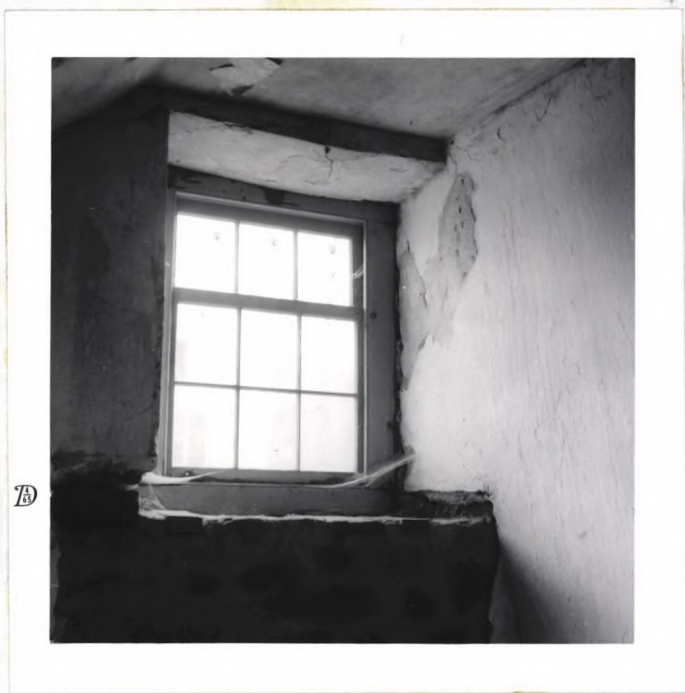
This window on the second floor was installed during rehabilitation to the building exterior in 1958. Note the absence of a window seat and also the dubious condition of the lintel above the window.

A new window seat and oak lintel were installed in the south window adjacent to the chimney.

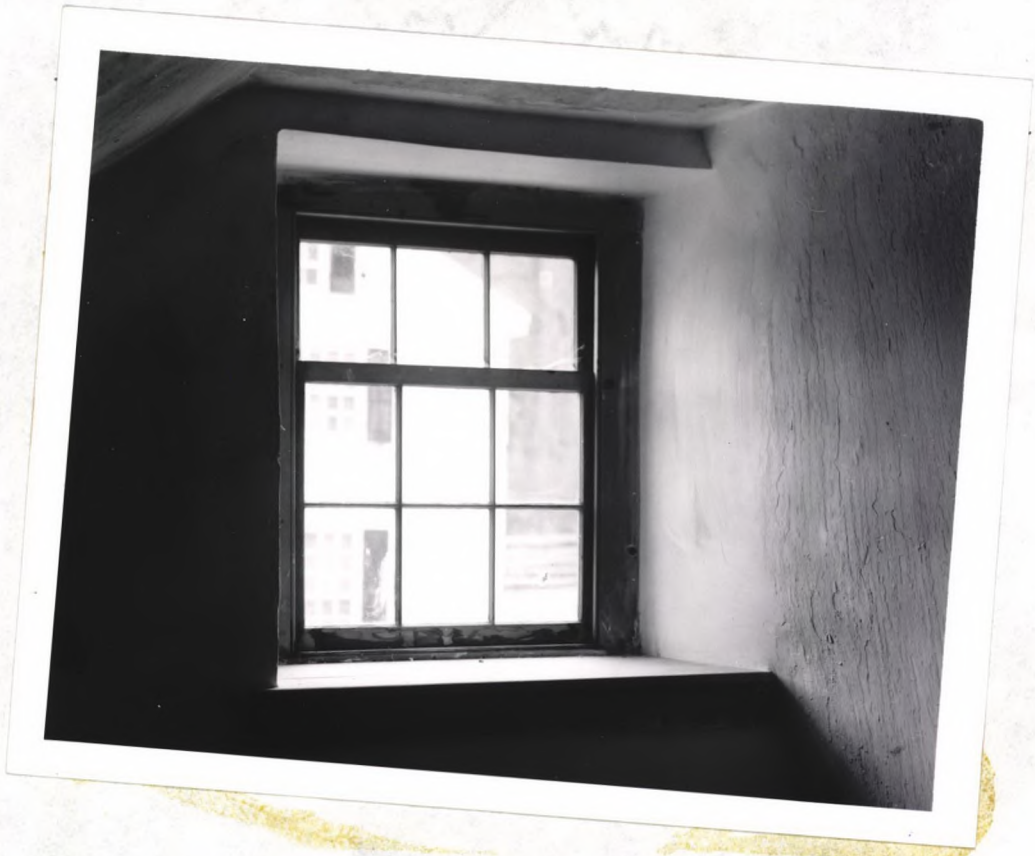
Same view showing completed work after repair of cracked lintel.

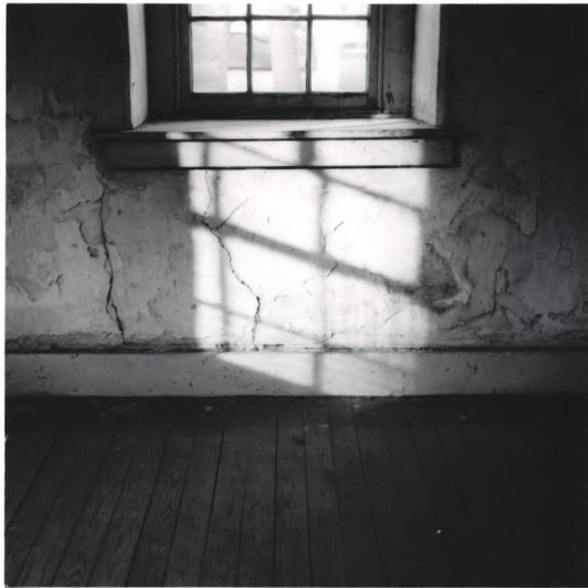
Condition of wall under north window on first floor prior to  
repairs.

Some minor patching was done to the walls.
