STATUS OF HISTORIC STRUCTURES REPORT

HOPEWELL VILLAGE
PARK 376/134742

Tenant House #1

TENANT HOUSE #1. BUILDING #19

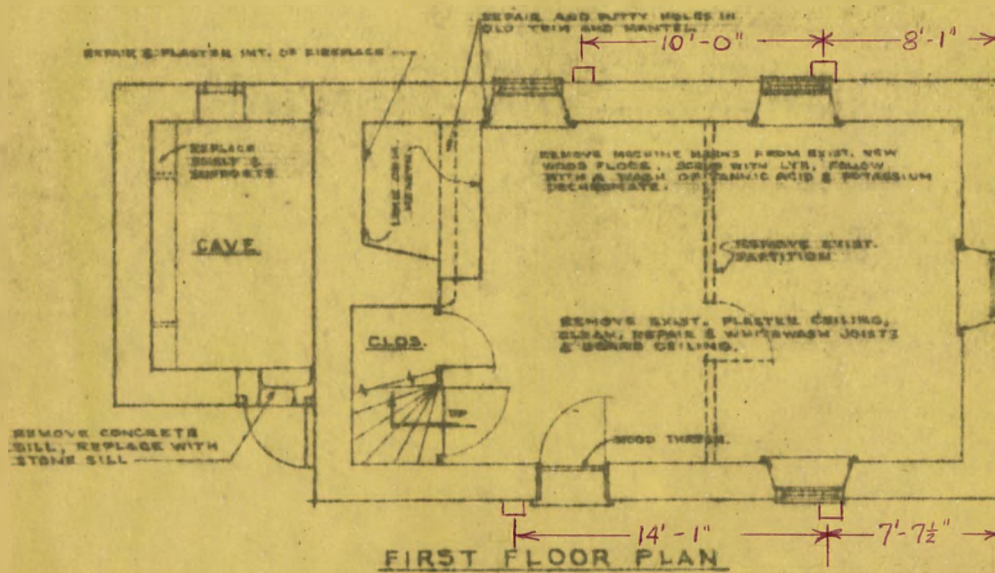
LOCATION OF VENTILATION PORTS

To provide better air circulation under the floor 4 ventilation ports were installed in the foundation. These were made as unobtrusive as possible and their locations in the foundation is shown on the attached drawing.

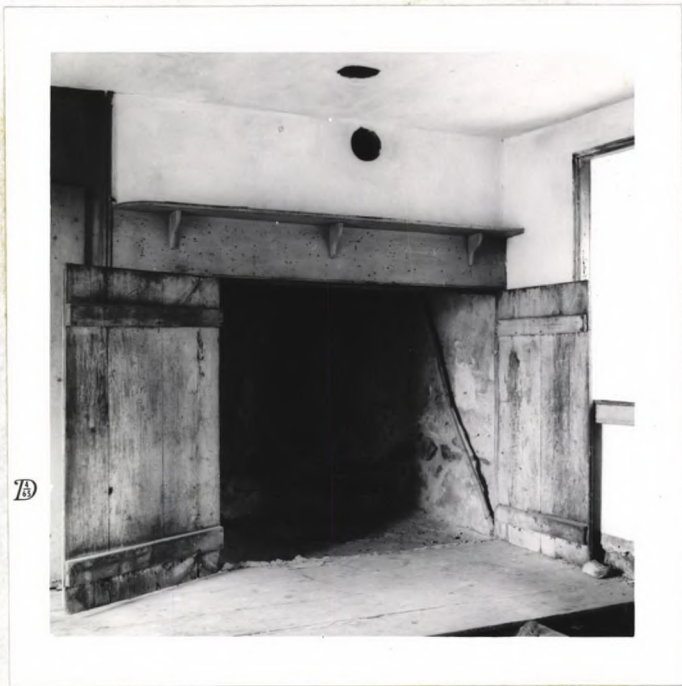
Evidence of a hearth was found under the existing floor.

View of the fireplace in Tenant House #1 showing how the existing flooring covered the old fireplace hearth.

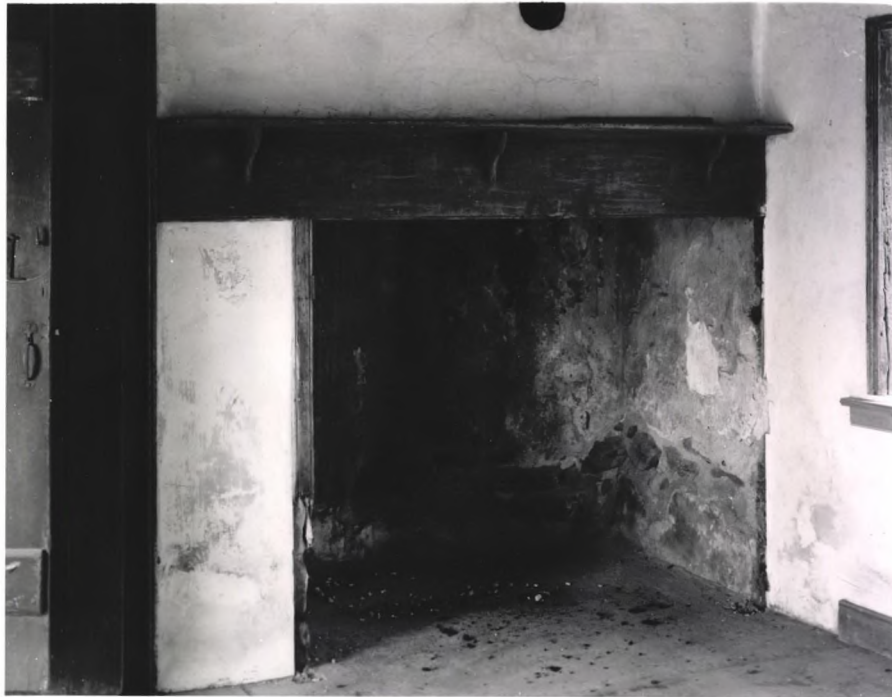
Fireplace and restored hearth after repairs. Doors which were not original were removed.

This hearth was replaced and the new floor was butted to the stone hearth. An extra joist was set on piers to support the floor near the hearth.

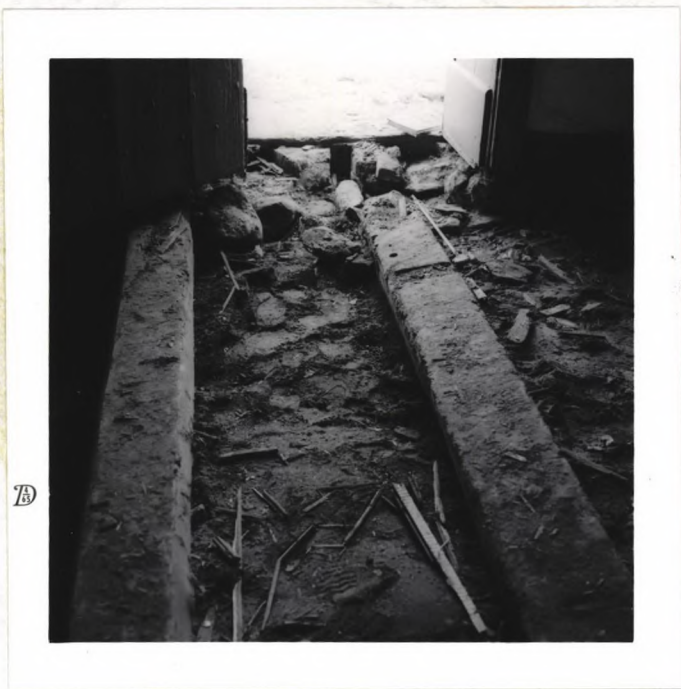
After removal of the floor the evidence of a hearth can be clearly
seen as shown here.

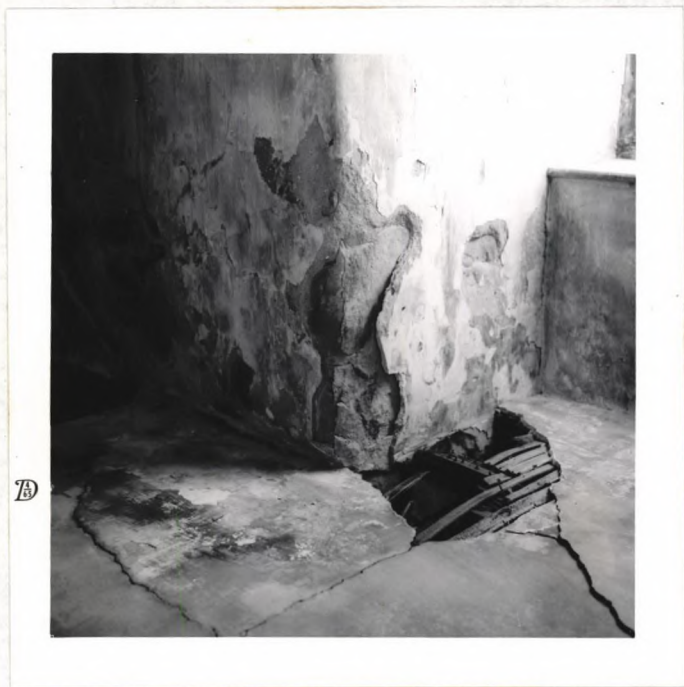
Same area as shown in previous photograph. Rotted members have been replaced and are ready for lathe and plaster.

roof had caused rotting of the collar beams and erosion of mortar so that some of the chimney stones were loose and the ceiling in this area was about to collapse. The exterior leak had been repaired in 1958 but nothing had been done to the interior. The plaster, rotted lathe, and collar beams were removed and this entire section of ceiling was replaced. (See photographs.)

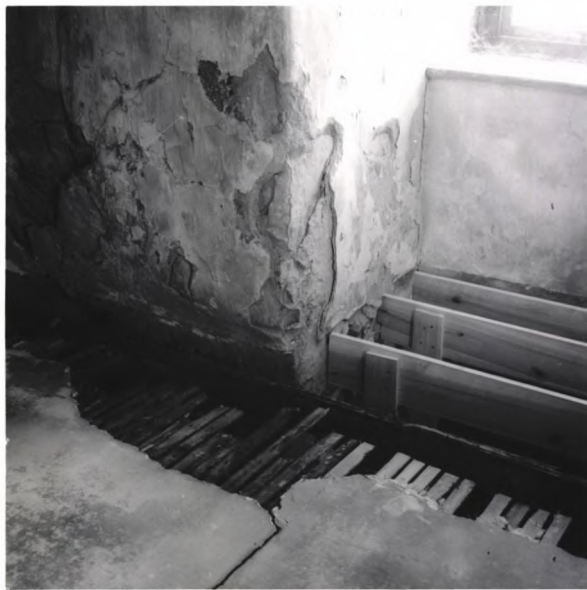
Same area again after repairs were completed.

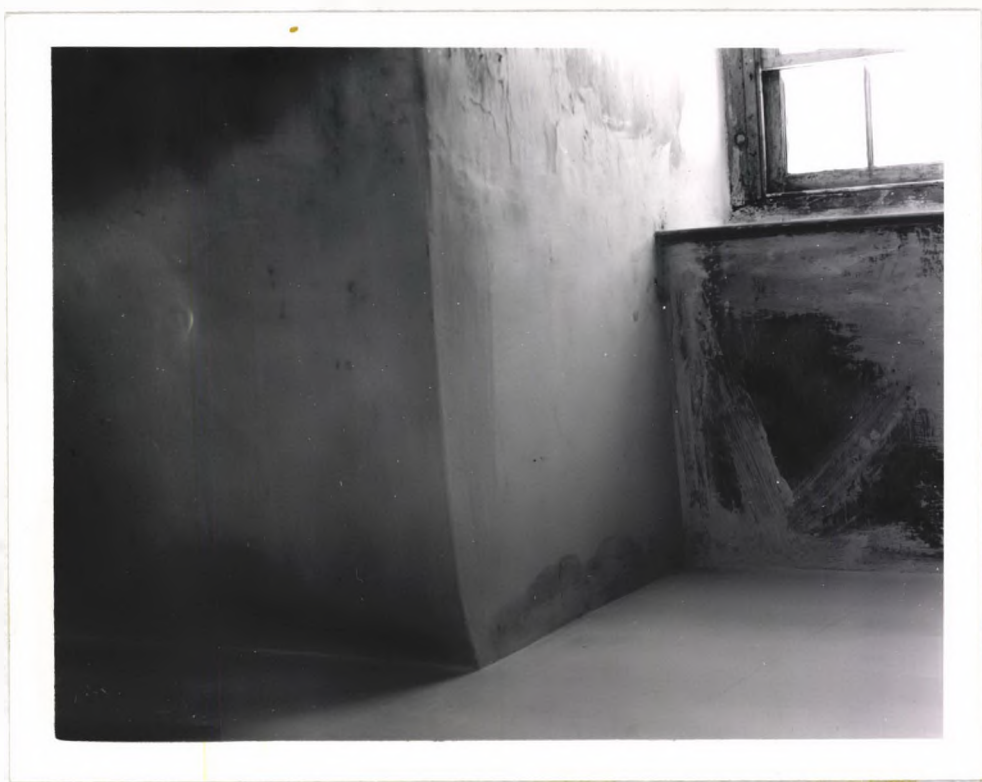
Another view showing extent of ceiling repair on second floor
over stairwell.

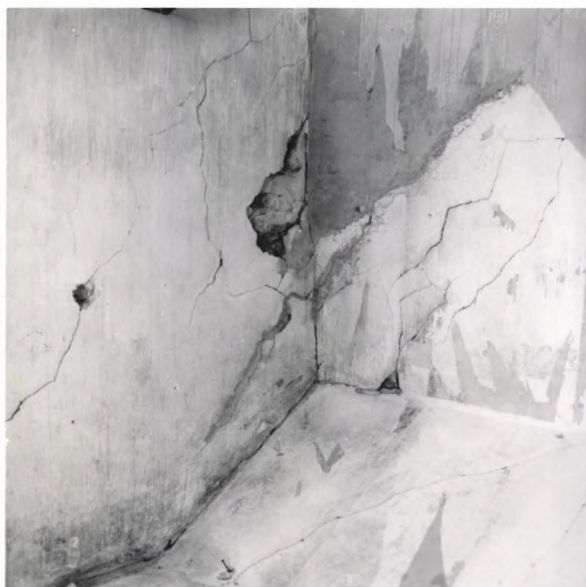
View of same corner as in previous photograph after repairs.
