HISTORIC STRUCTURES REPORT - PART I

LLOYD HOUSE (BUILDING 71) 207

Hopewell Village NHS
Elverson, Pa.

HISTORIC STRUCTURES REPORT
ARCHITECTURAL DATA SECTION, PART 1
PRELIMINARY TO THE REHABILITATION OF
THE LLOYD HOUSE
(BUILDING 71, Tract 21)

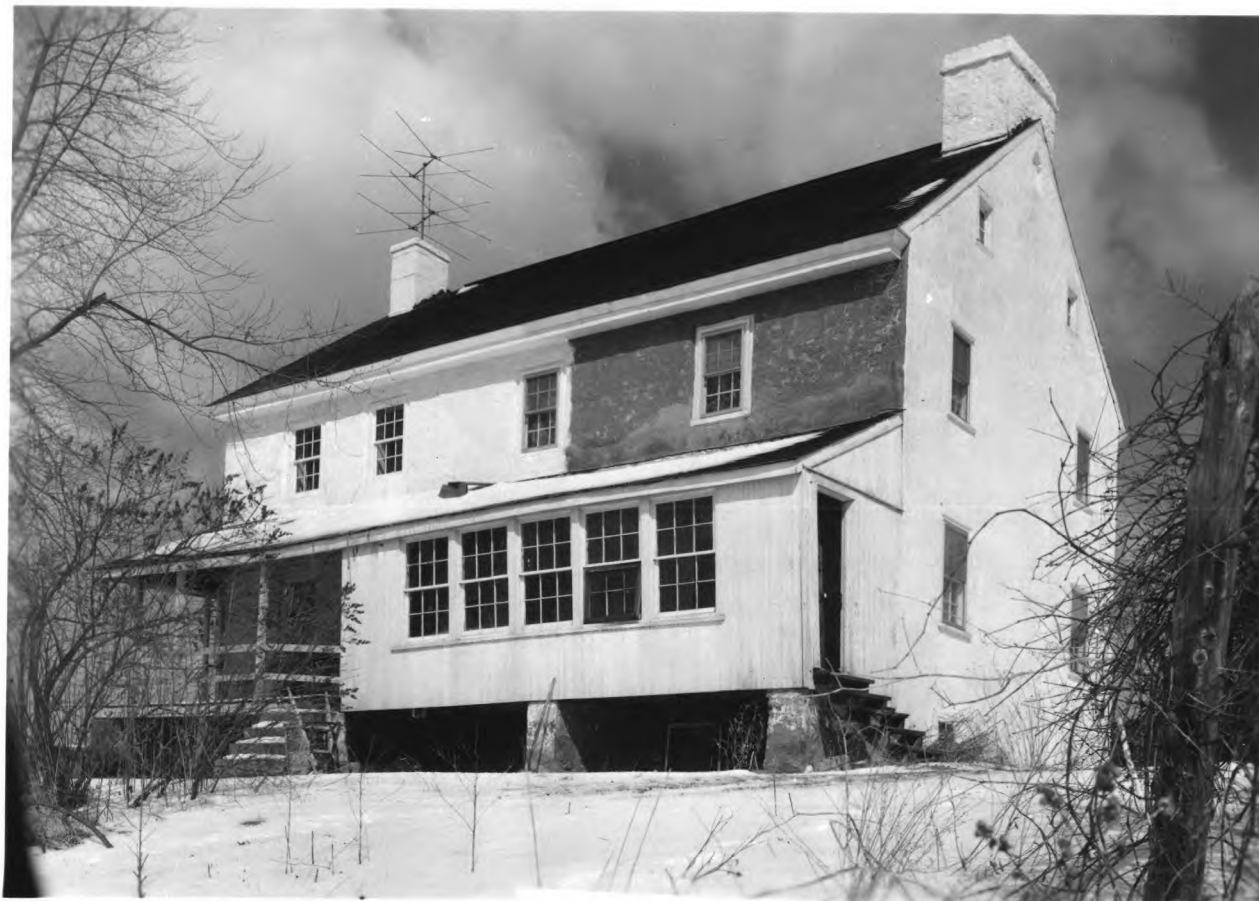
PHOTOGRAPH NO. 1

The porches are later additions. The rear porch of more modern construction has deteriorated so as to have become unsafe because of the rotted condition of the joists, flooring and roof.

South elevation. The enclosed portion of the porch approximately marks the length of the original house. Here can be seen the failing porch. The dark area over the porch merely indicates an incompleted paint job.

1. Reconstruct the rear porch, omitting the present modern enclosure which is out of character with the house.

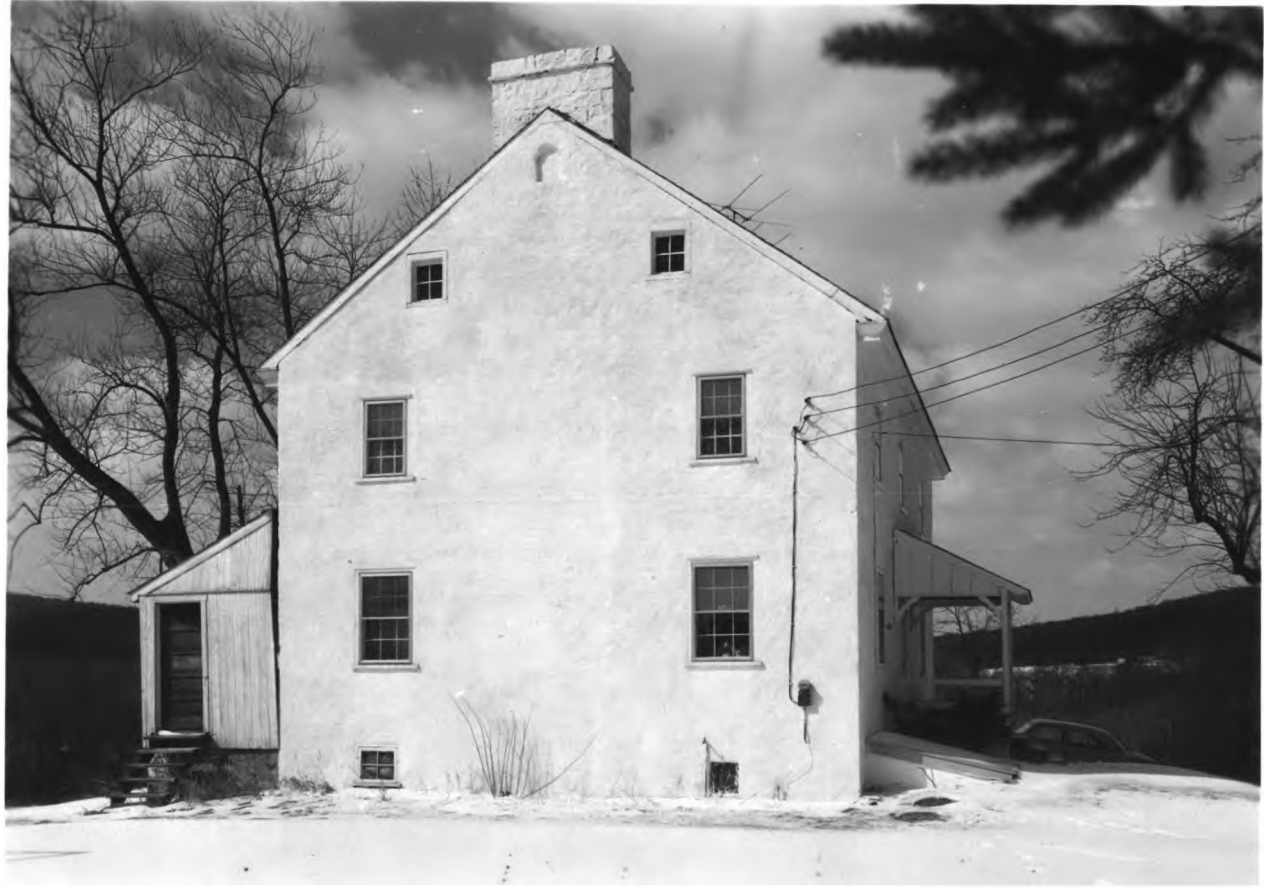
PHOTOGRAPH NO. 2

East elevation. At the left is the rear porch which is slipping away from the house and which must be replaced. The replacement to be in the period of the house.

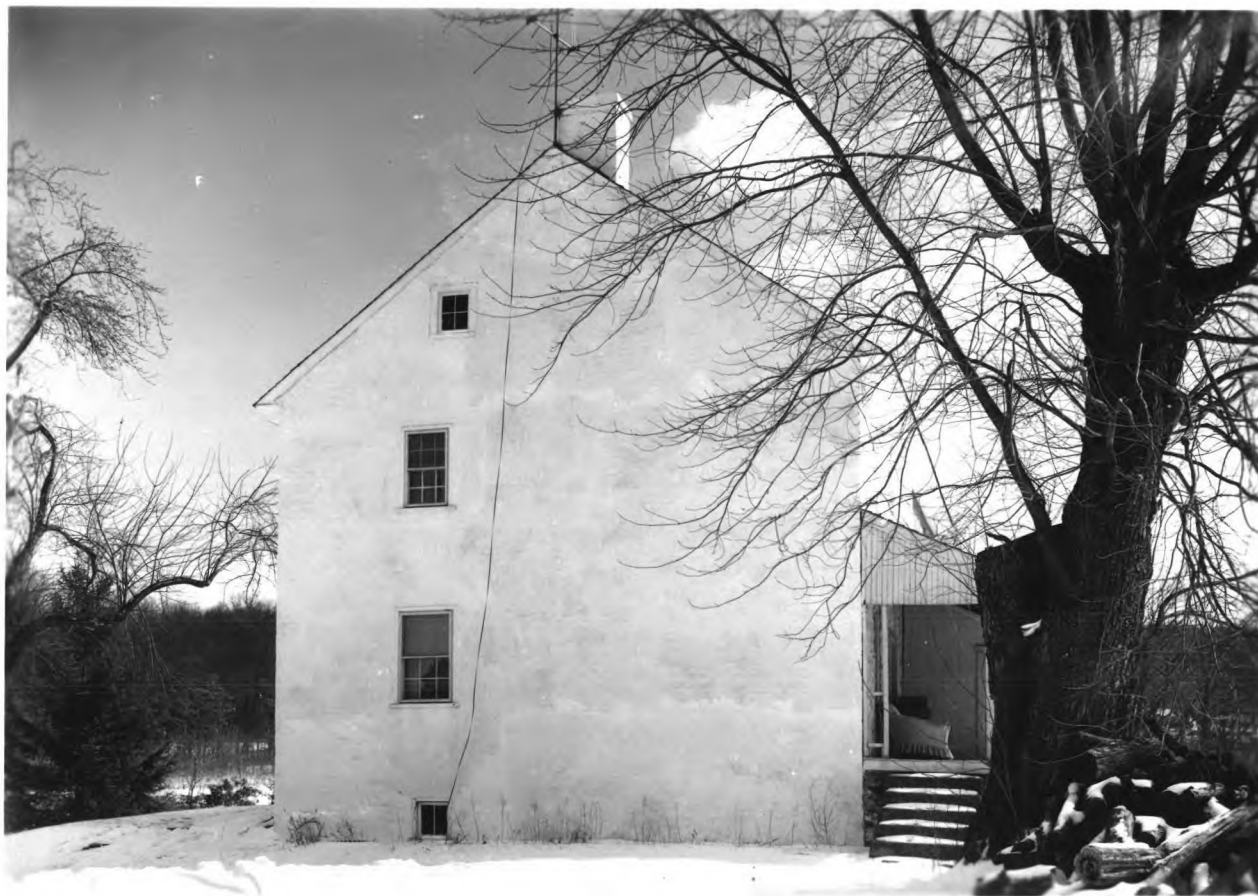
PHOTOGRAPH NO. 3

The west elevation. This end of the house was added to the original early in its history.
