HISTORIC STRUCTURES REPORT
ARCHITECTURAL DATA, PART III

RESTORATION
OF
THE VILLAGE BARN

HOPSWELL VILLAGE NATIONAL HISTORIC SITE
Hopewell, Pa.

by
Norman M. Souder
Architect
November 1962

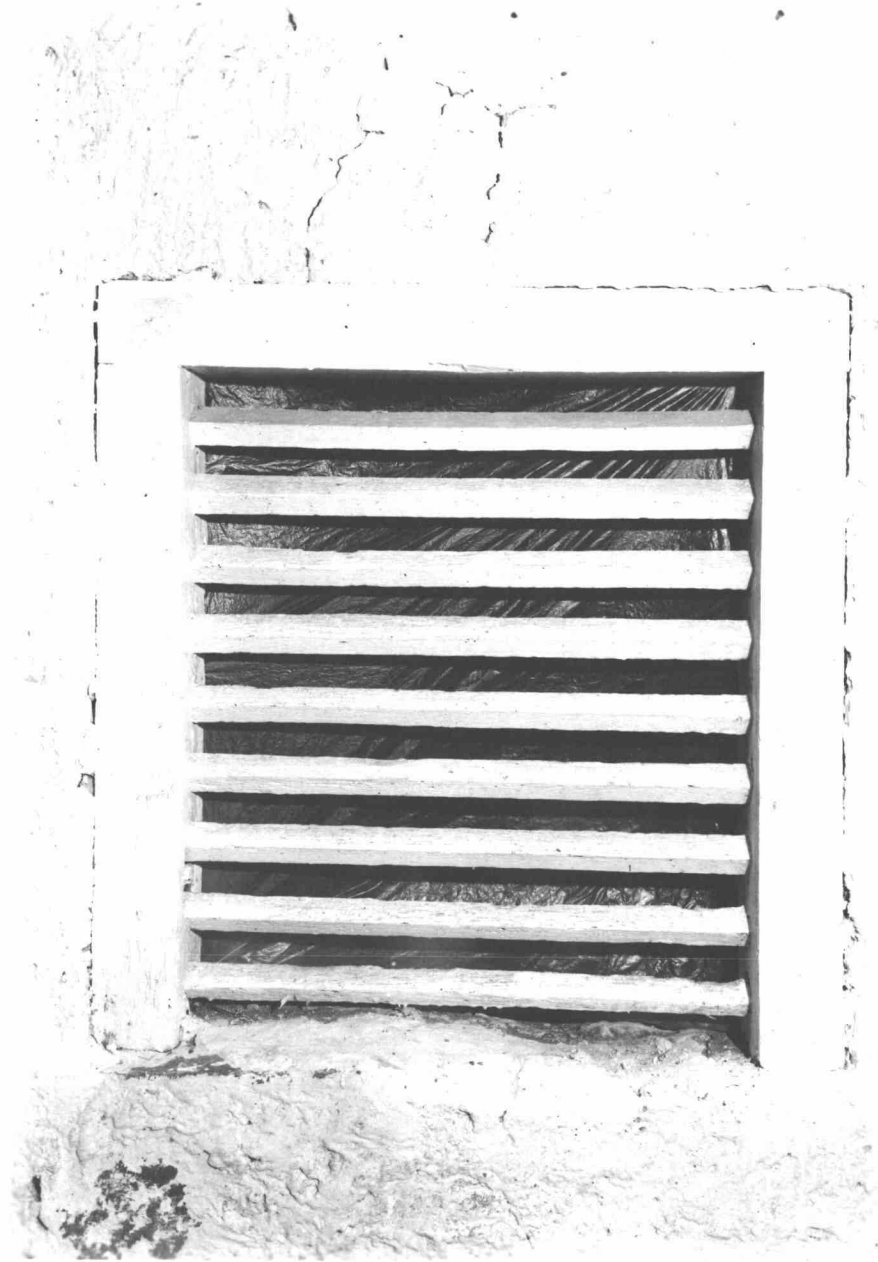
ILLUSTRATION NO. 3

During the process of the removal of the stone fill from one of the north windows of the stable level the old frame was found in place but badly decayed. A copy of the old frame was made as the replacement.

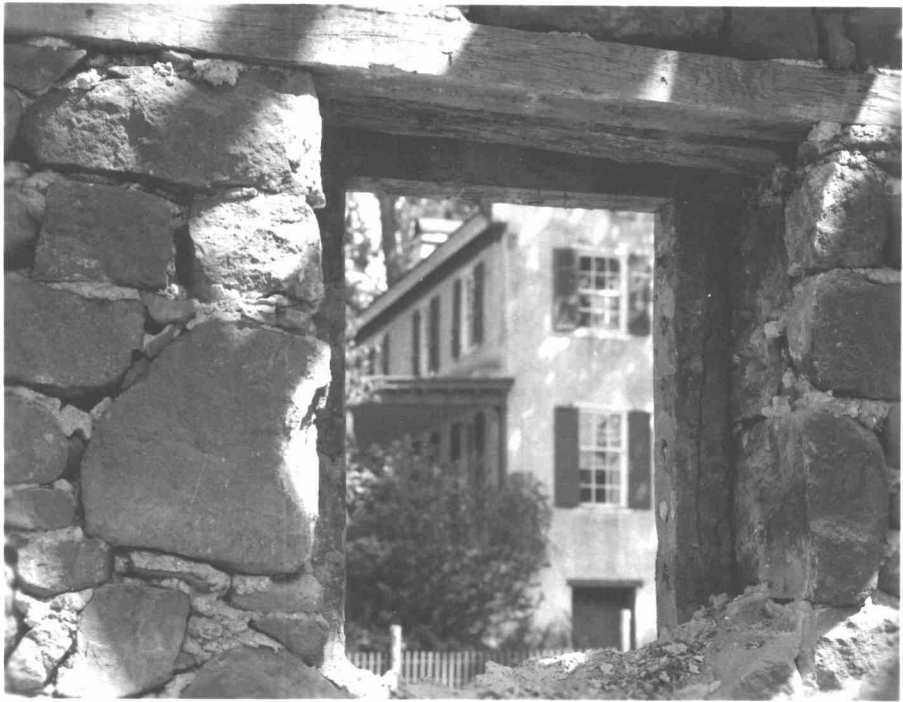
ILLUSTRATION NO. 12

The re-opening of the old west window in the new level. The relation of the modern windows to the old can be noted here.

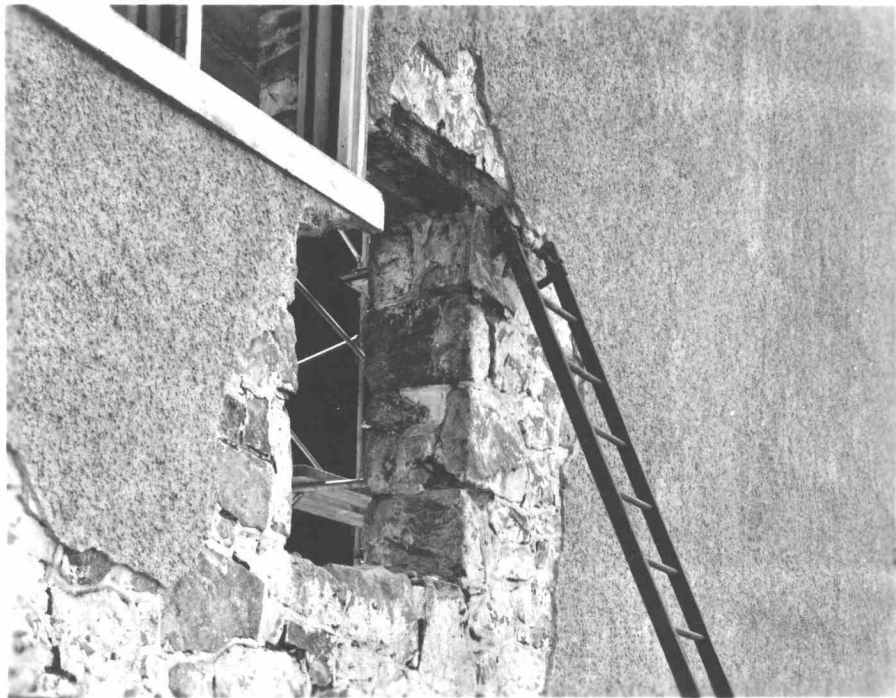
ILLUSTRATION NO. 13

The stone east wall stabilized before the modern
portico was completely removed.

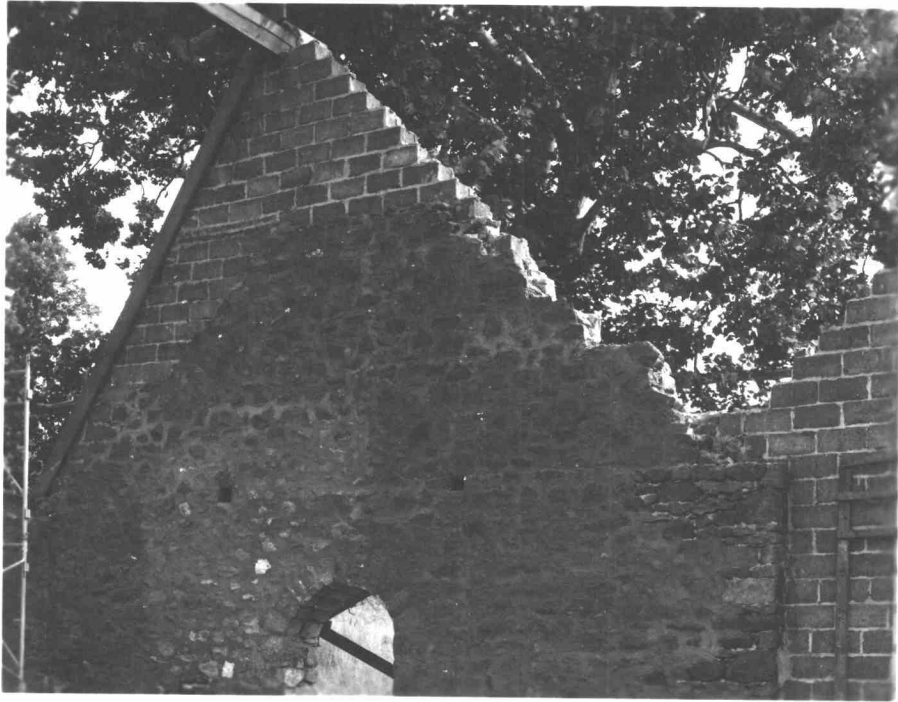
ILLUSTRATION NO. 14

The wrought iron pintles and hasp eye anchors in the stone walls were found in place. In most cases the shank and pintle were broken off flush with the face of the wall. Whether they were broken deliberately as a safety measure when the wood jambs were installed or were gradually broken in the passage of years and as the result of hard usage is not known. In each case a wrought copy was placed in the location of the old anchor. This accounts for the staggered appearance of the hinges on the stable doors. Due to the joints in the rubble stonework occurring in different places the pintle placing depended on the available stone joints.

One of the pintle anchors removed from the stone wall.
The pintle pin and part of the shank has been broken off.
These pintle anchors were reproduced and inserted into the
stone walls in the location of the old pintles.

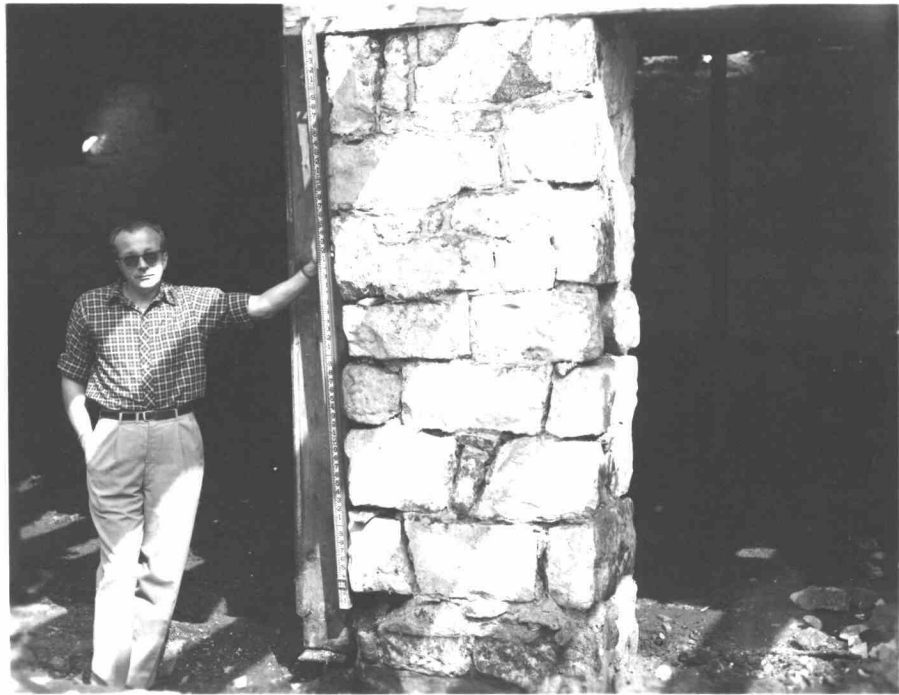
ILLUSTRATION NO. 17

Restored south stable wall with original pier
reconstructed. The door and window openings are restored
as are the draw bars in the doorways shown in partially
closed position.

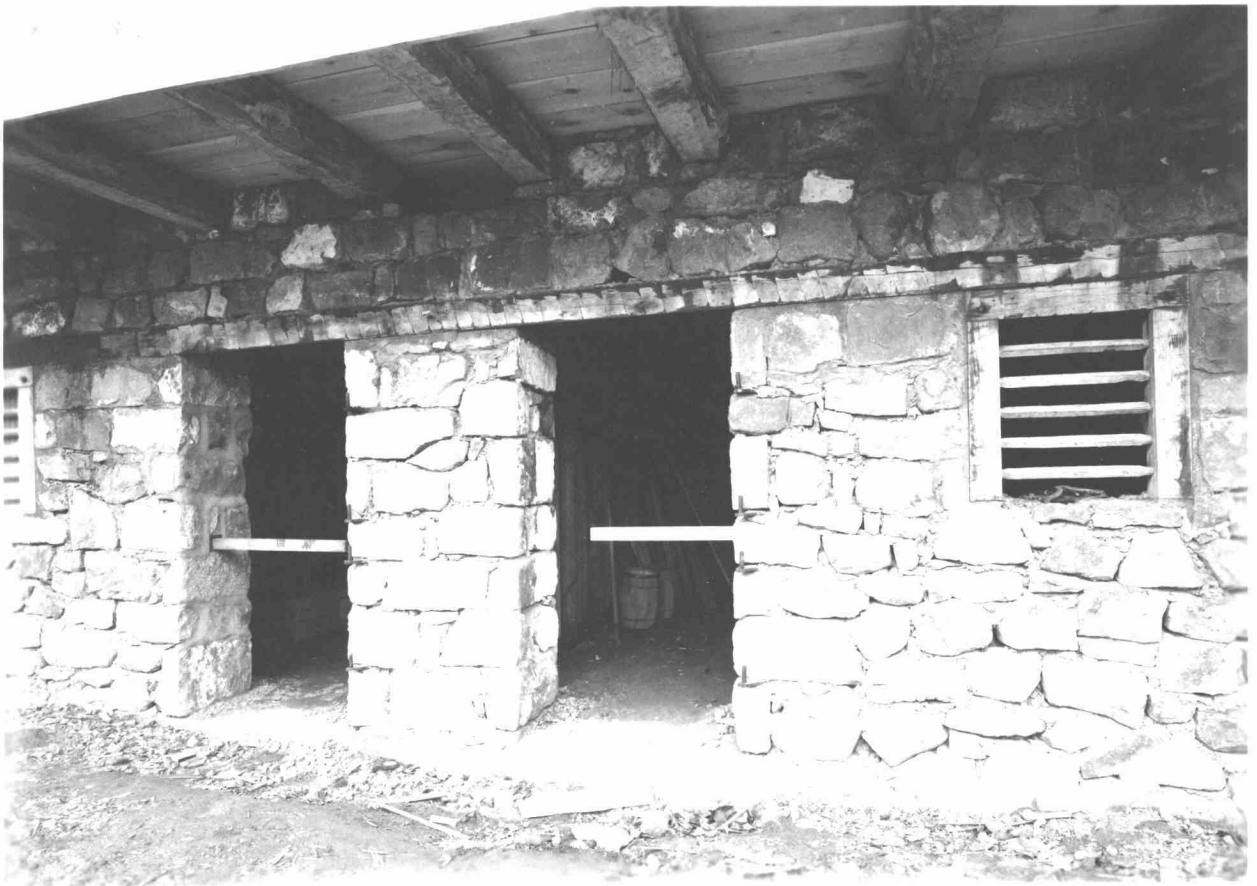
ILLUSTRATION NO. 18

The old stone portions remaining after the removal
of the modern barn.
