HISTORIC STRUCTURES REPORT

RESTORATION OF THE VILLAGE BARN - STRUCTURE NO. 2

HOPWELL VILLAGE NATIONAL HISTORIC SITE

DECEMBER 11, 1962

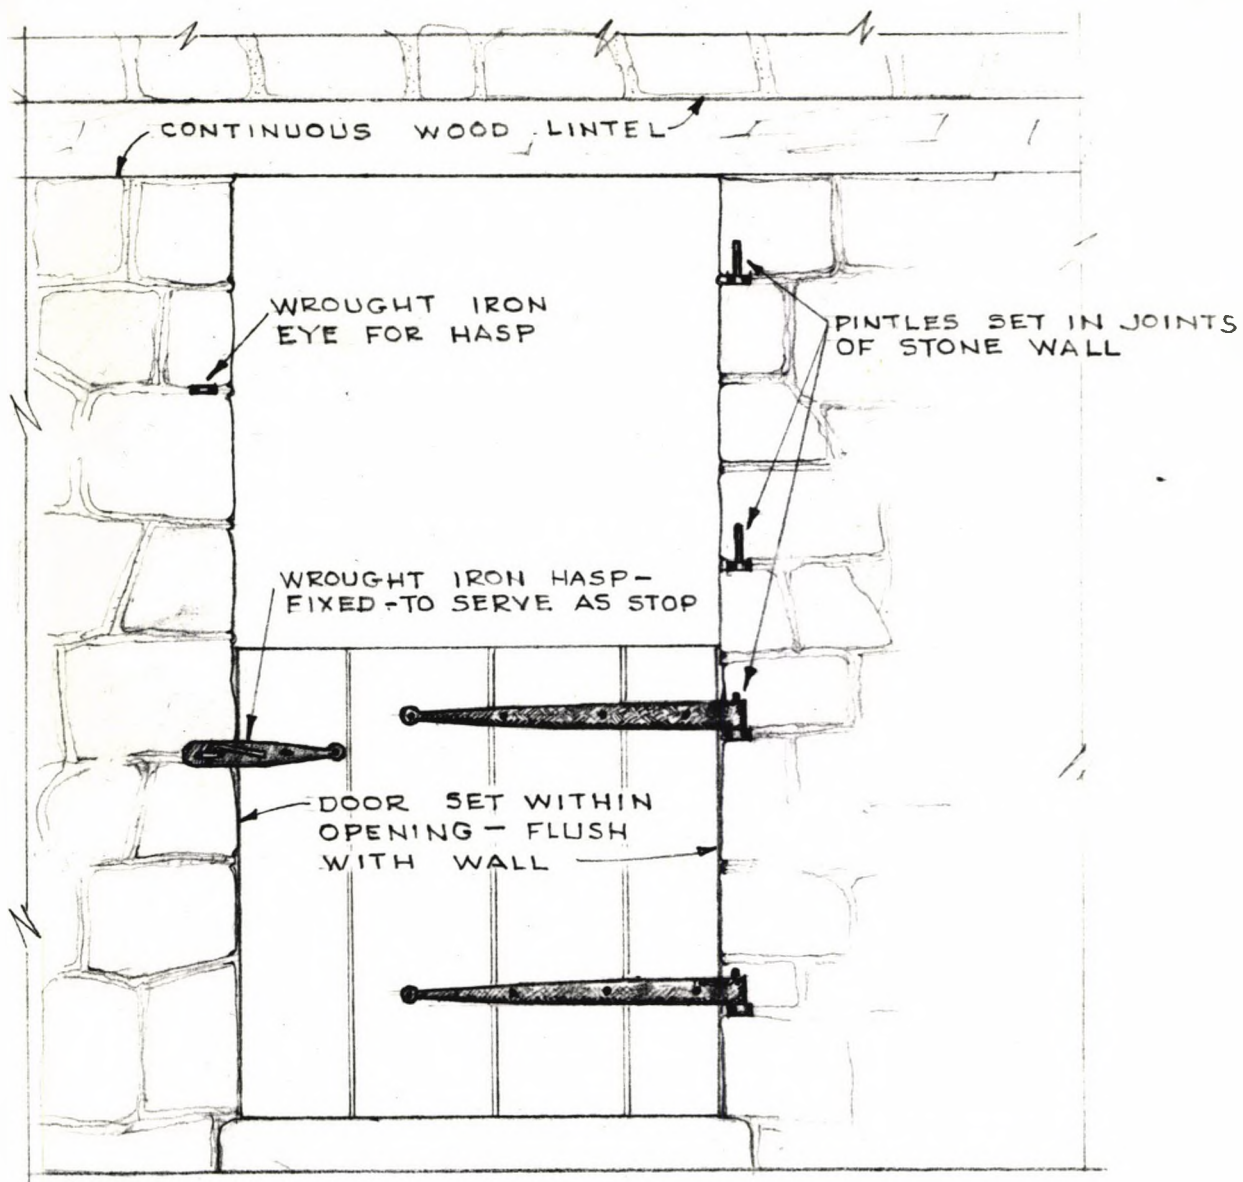
The wrought iron pintles and hasp eye anchors in the stone walls were found in place. In most cases the shank and pintle were broken off flush with the face of the wall. Whether they were broken deliberately as a safety measure when the wood jambs were installed or were gradually broken in the passage of years and as the result of hard usage is not known. In each case a wrought copy was placed in the location of the old anchor. This accounts for the staggered appearance of the hinges on the stable doors. Due to the joints in the rubble stonework occurring in different places the pintle placing depended on the available stone joints.

HASP EYE AND PINTLE WITH ANCHOR FOR SETTING IN STONE JOINTS. ORIGINALS WERE FOUND IN PLACE BUT BROKEN. COPIES WERE MADE FOR THE RESTORATION.

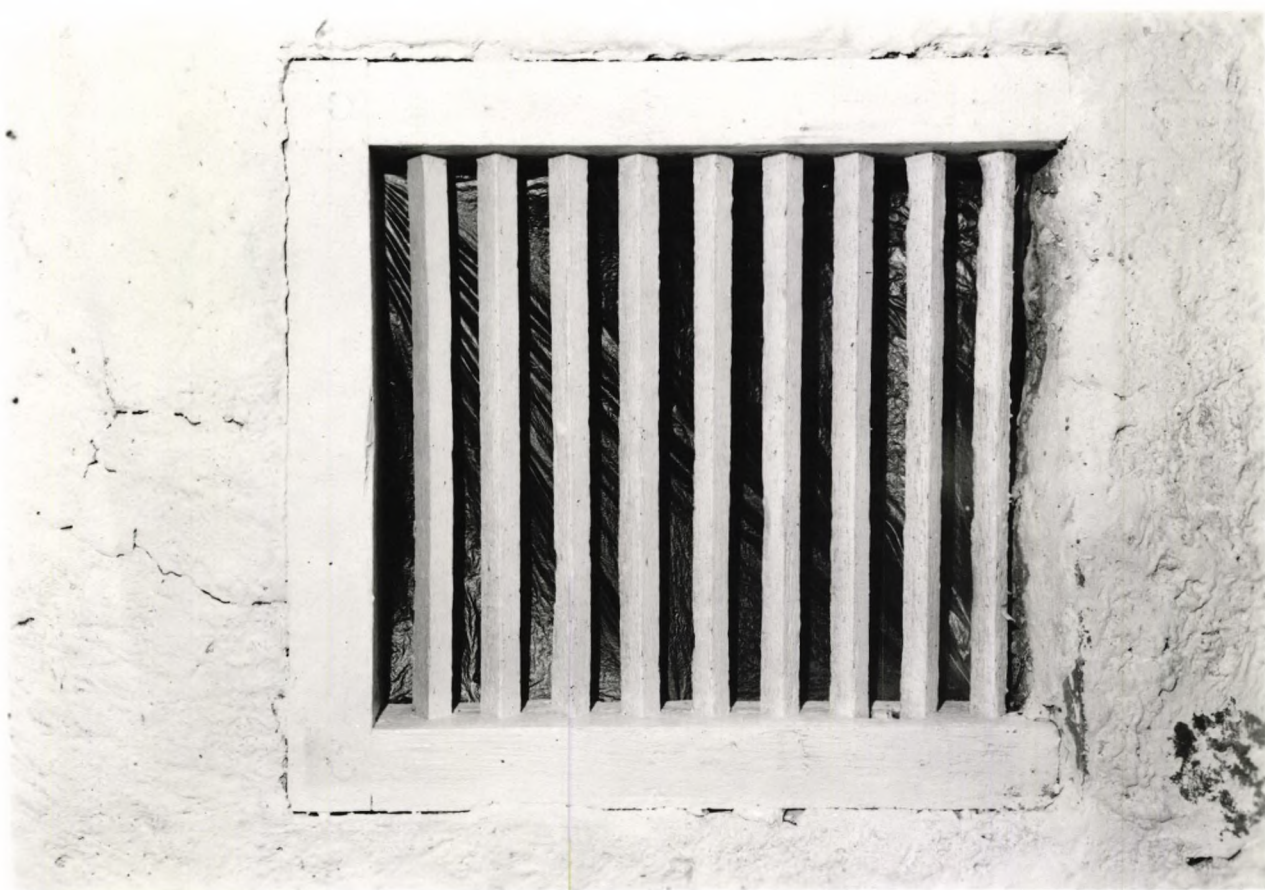
ILLUSTRATION NO. 8

During the process of the removal of the stone fill from one of the north windows of the stable level the old frame was found in place but badly decayed. A copy of the old frame was made as the replacement.

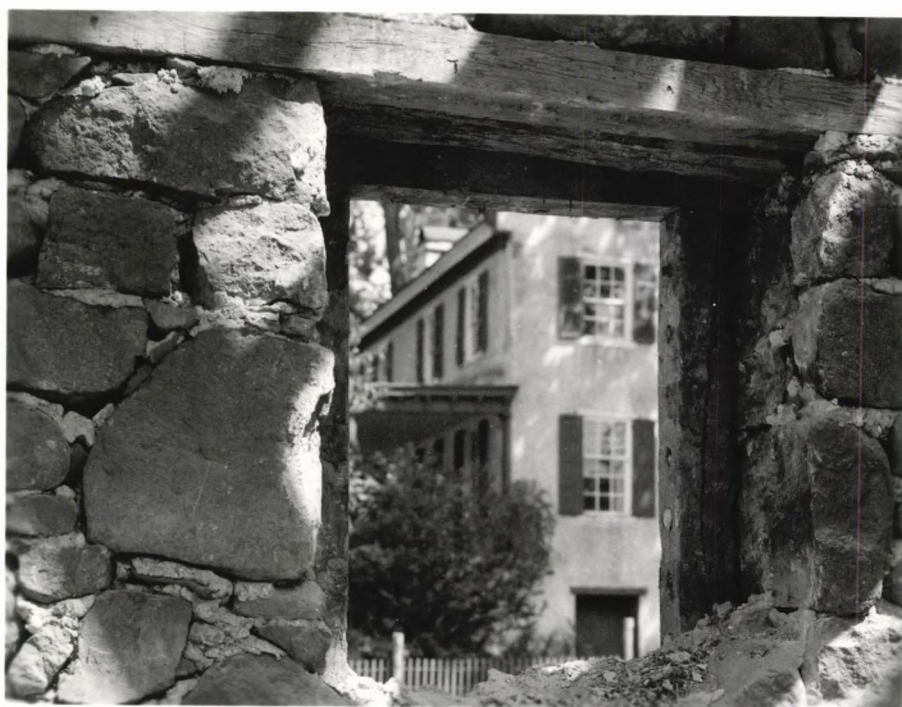
ILLUSTRATION NO. 12

The re-opening of the old west window in the mow level. The relation of the modern windows to the old can be noted here.

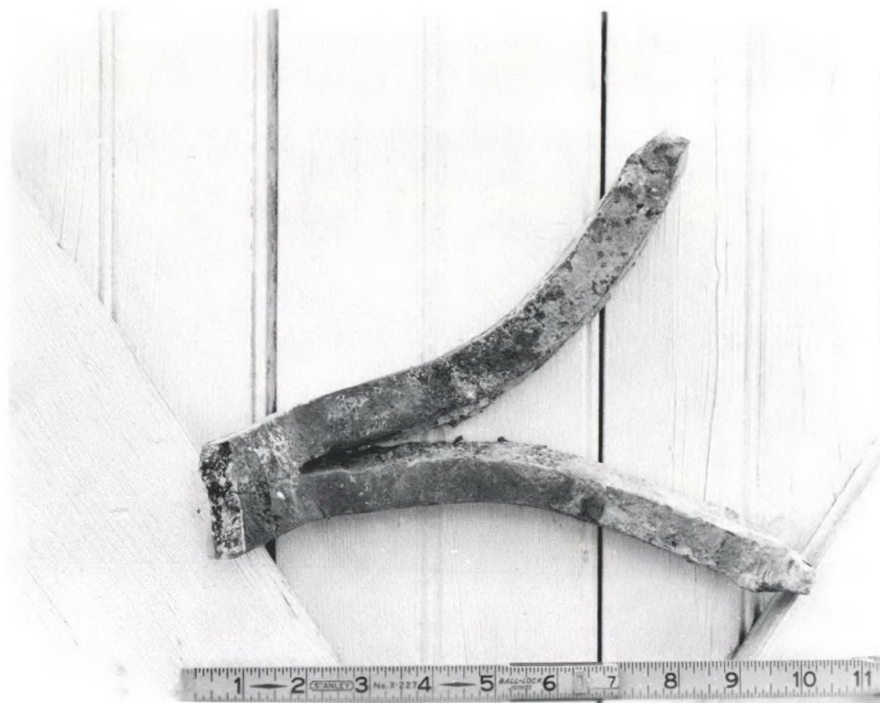
ILLUSTRATION NO. 15

When the wood jambs were removed from door #6 which had been increased in size in the late period wood sleeve was found containing an oak slide, or draw bar, which had been cut off due to the doorway having been enlarged. Further investigation revealed spaces or evidences of such bars at each of the remaining stall doors. None were found at the manger aisle doors.

The remains of the wood draw bar found in the jamb
of the enlarged doorway.

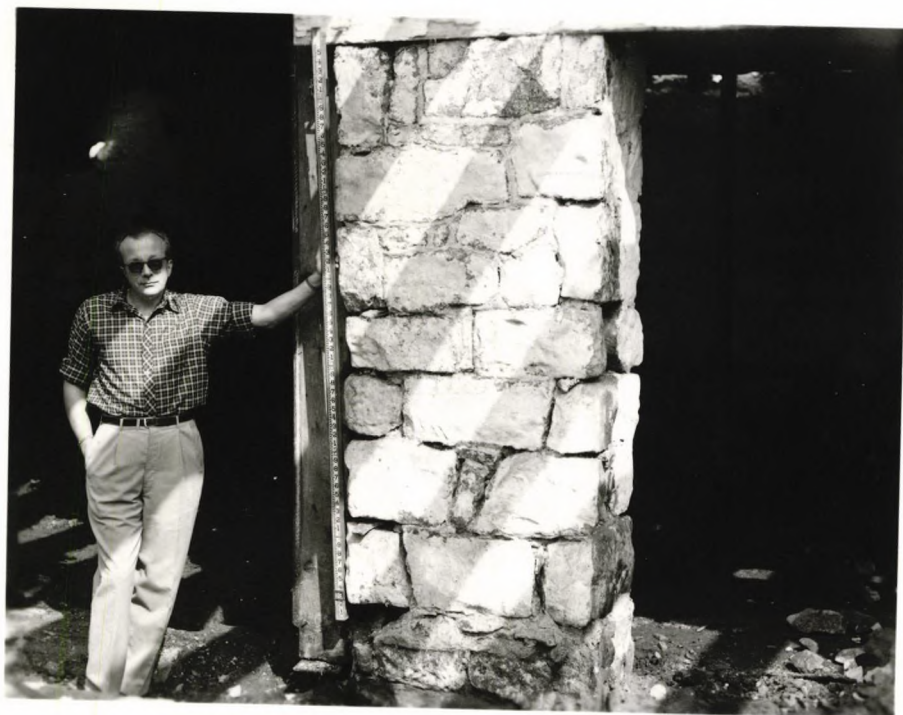
ILLUSTRATION NO. 17

Restored south stable wall with original pier reconstructed. The door and window openings are restored as are the draw bars in the doorways shown in partially closed position.
