STRUCTURAL REPORT
FOR THE
BILLINGS CARRIAGE BARN
WOODSTOCK, VERMONT

MARCH 30, 1988

Billings Carriage Barn
Woodstock, Vermont
Project #8806

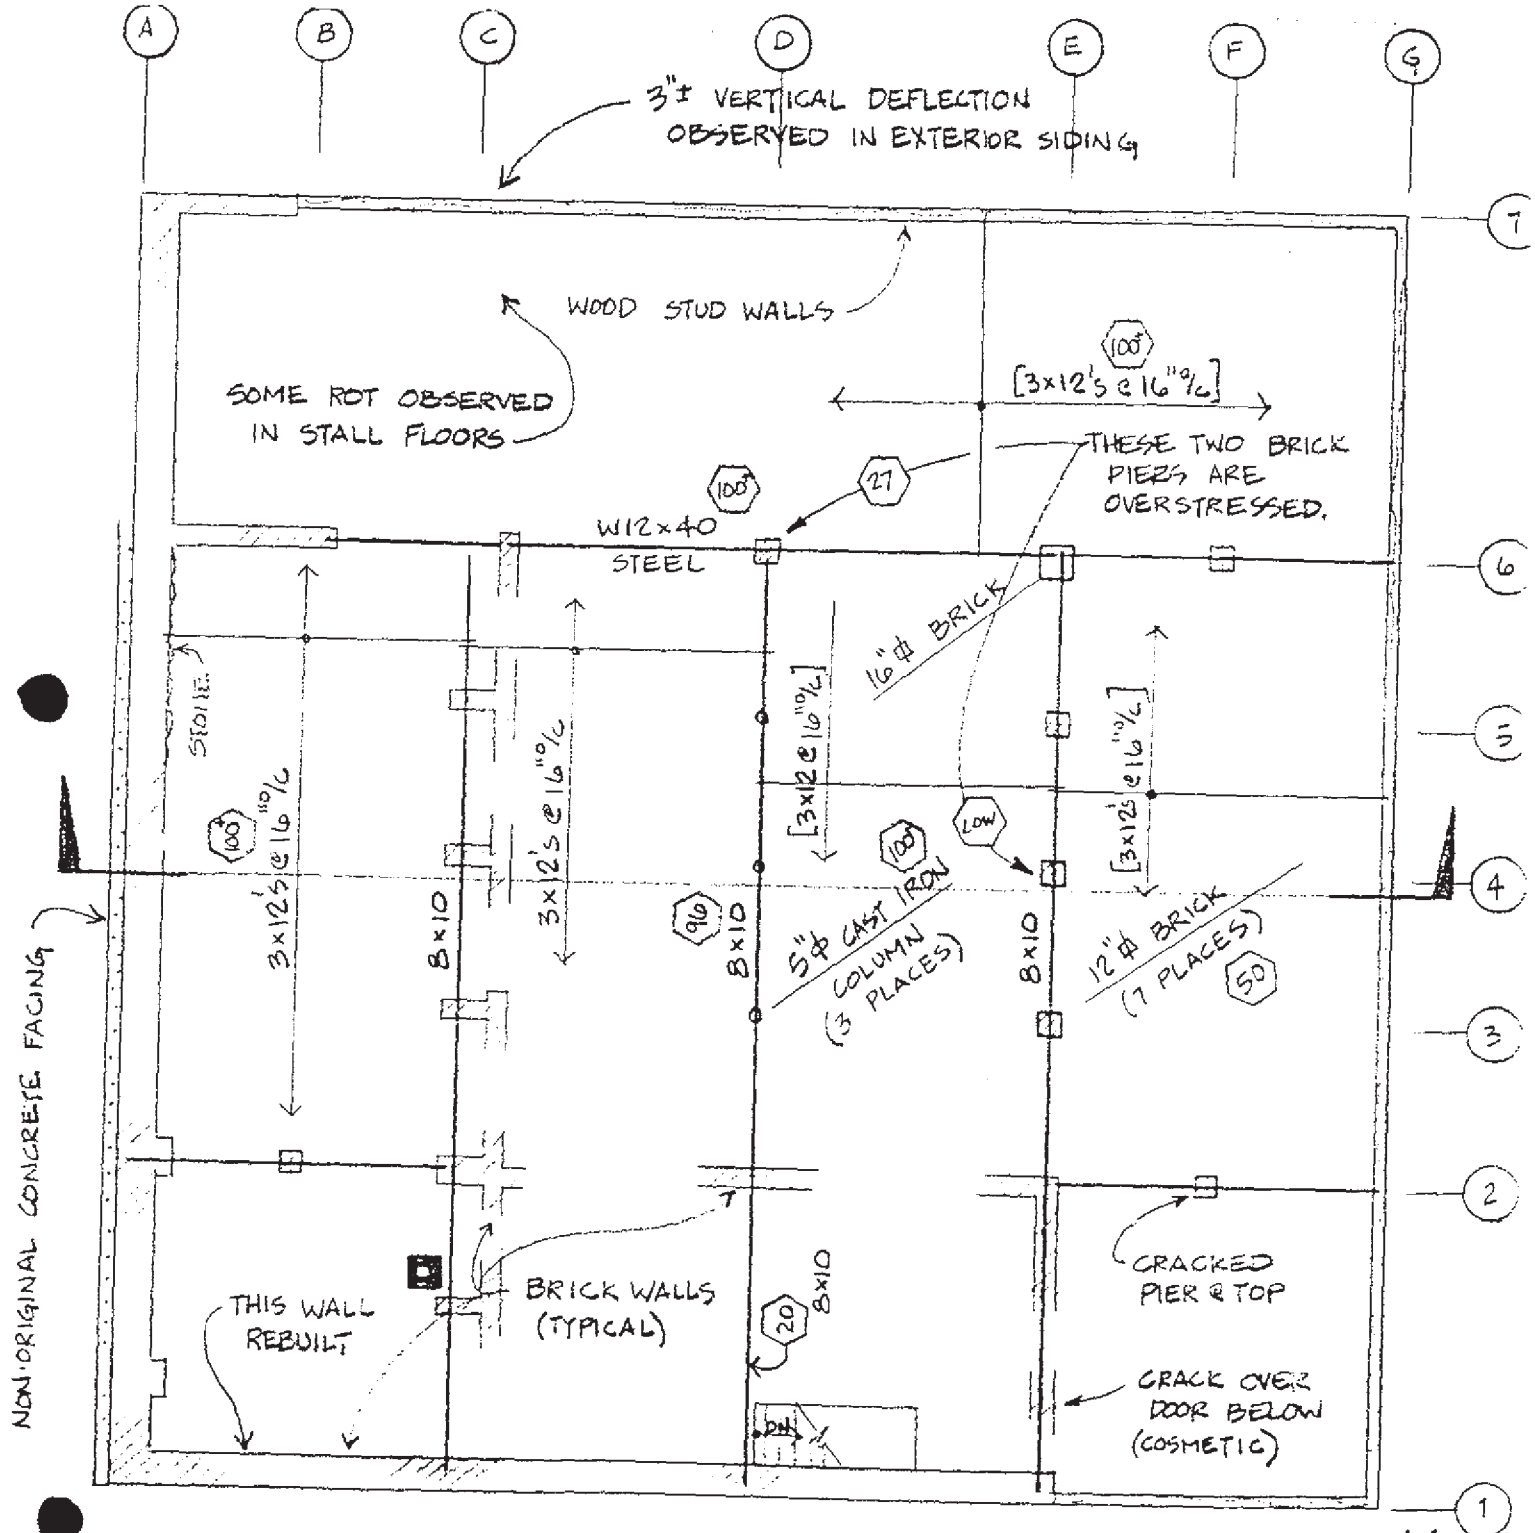
FIRST FLOOR FRAMING PLAN - SCALE 1"=10'±

- A. 8x10 Wood Beam - The 8x10 between D1 and D2 spans twice as far as the typical 8x10 and consequently has a much lower Live Load Capacity.

- B. 12x12 Brick Piers - Two of the brick piers (Grids D6 and E4) are overstressed. E4 was undersized in the original design and the condition at D6 became a concern when the two adjacent brick piers were removed during past renovations (when the W12x40 steel beam was installed).

Our recommendation is to replace all of the brick piers (7 locations). Two are overloaded, the one at F2 is cracked at the top and there is some evidence of "dead" mortar and soft brick throughout this level. With temporary shoring, the replacement should be straightforward and considering the importance of these piers, should be done.

- D. Floor Beneath Stalls - This section of floor is the northern most 10'± of the building between A and D. There is some evidence of rot and, considering its use, it is not surprising.

6. Wall Construction - There is a noticeable (3"±) vertical deflection in the exterior clapboard siding at grid C7 (Refer to Sheet #1) and some distress noted at Grid C6 (Refer to Sheet #2). We were not able to remove wall finishes to observe the framing in the walls but this distress is probably related to the concentrated loads at the bearing of the loft level wall trusses.

We recommend this be strengthened by either increasing its size or adding a support near centerspan.

We recommend this floor be exposed prior to any major renovation to verify the condition of the floor framing beneath the floor boards.

The walls at C6, C7, E6 and E7 should be opened to expose the existing construction and reinforced if necessary.

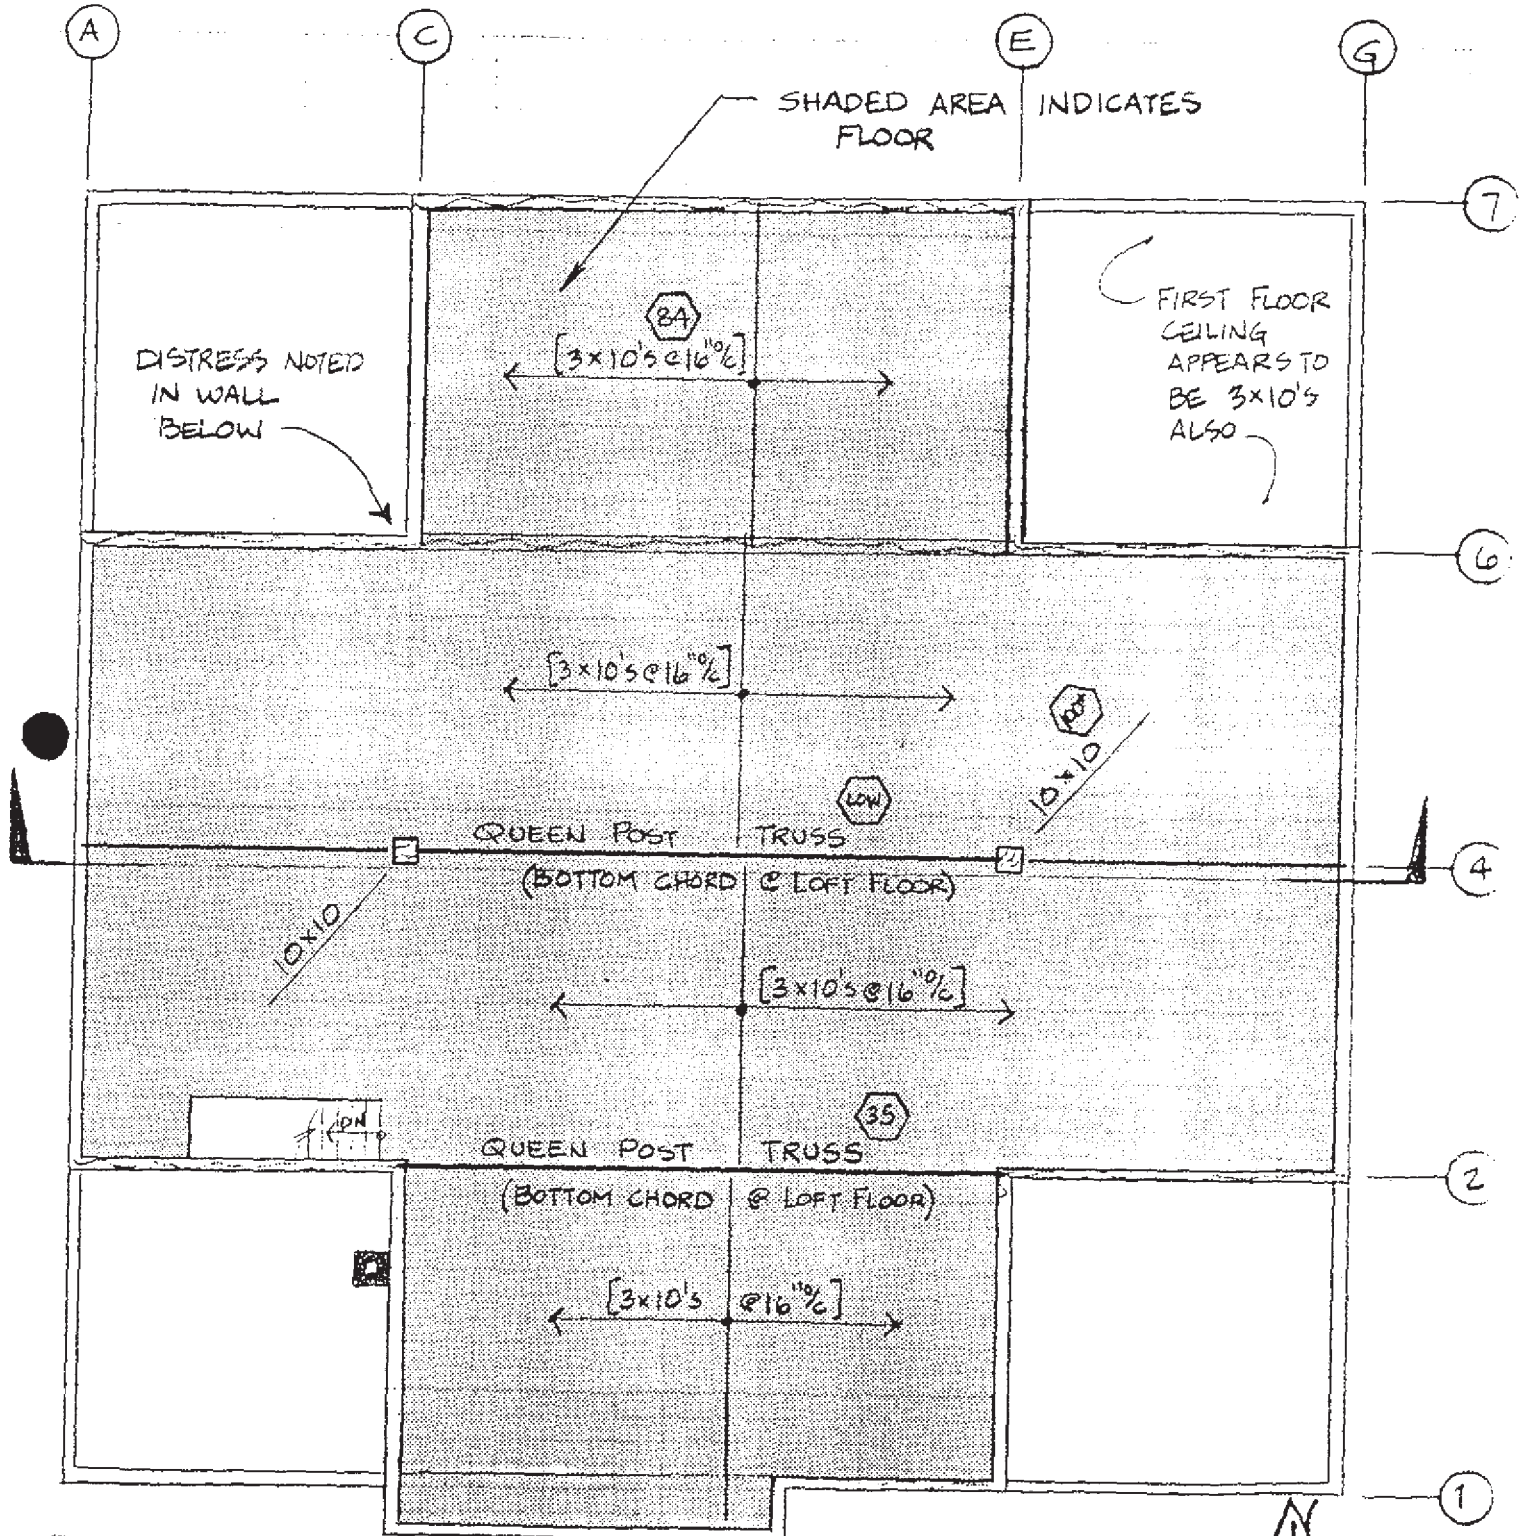
LOFT FRAMING PLAN

3. Chimney - There is a brick chimney in the southwest section of lower roof that is susceptible to damage from sliding snow and ice. Although the masonry chimney is braced to the roof, we recommend a proper sized cricket be constructed to minimize the possibility of damage.
4. Loft - As noted in Item 1, the Queen Post Truss on the 4 line is overstressed by the 4 skewed 6x6 struts that support the valleys of the roof. Even without the loads from the struts (as on the 2 line) the Queen Post Truss has a relative low (35 psf) Live Load Capacity.

We recommend that the 4 line truss be strengthened if any loft level live loads are added and that the 2 line truss be strengthened if the loft level is used for more than attic type loading. The strengthening would involve replacement of the vertical rods with steel of higher strength and better bracing of the top chords. We were not able to observe the bearing conditions of these trusses. They should be exposed to verify their capacity.

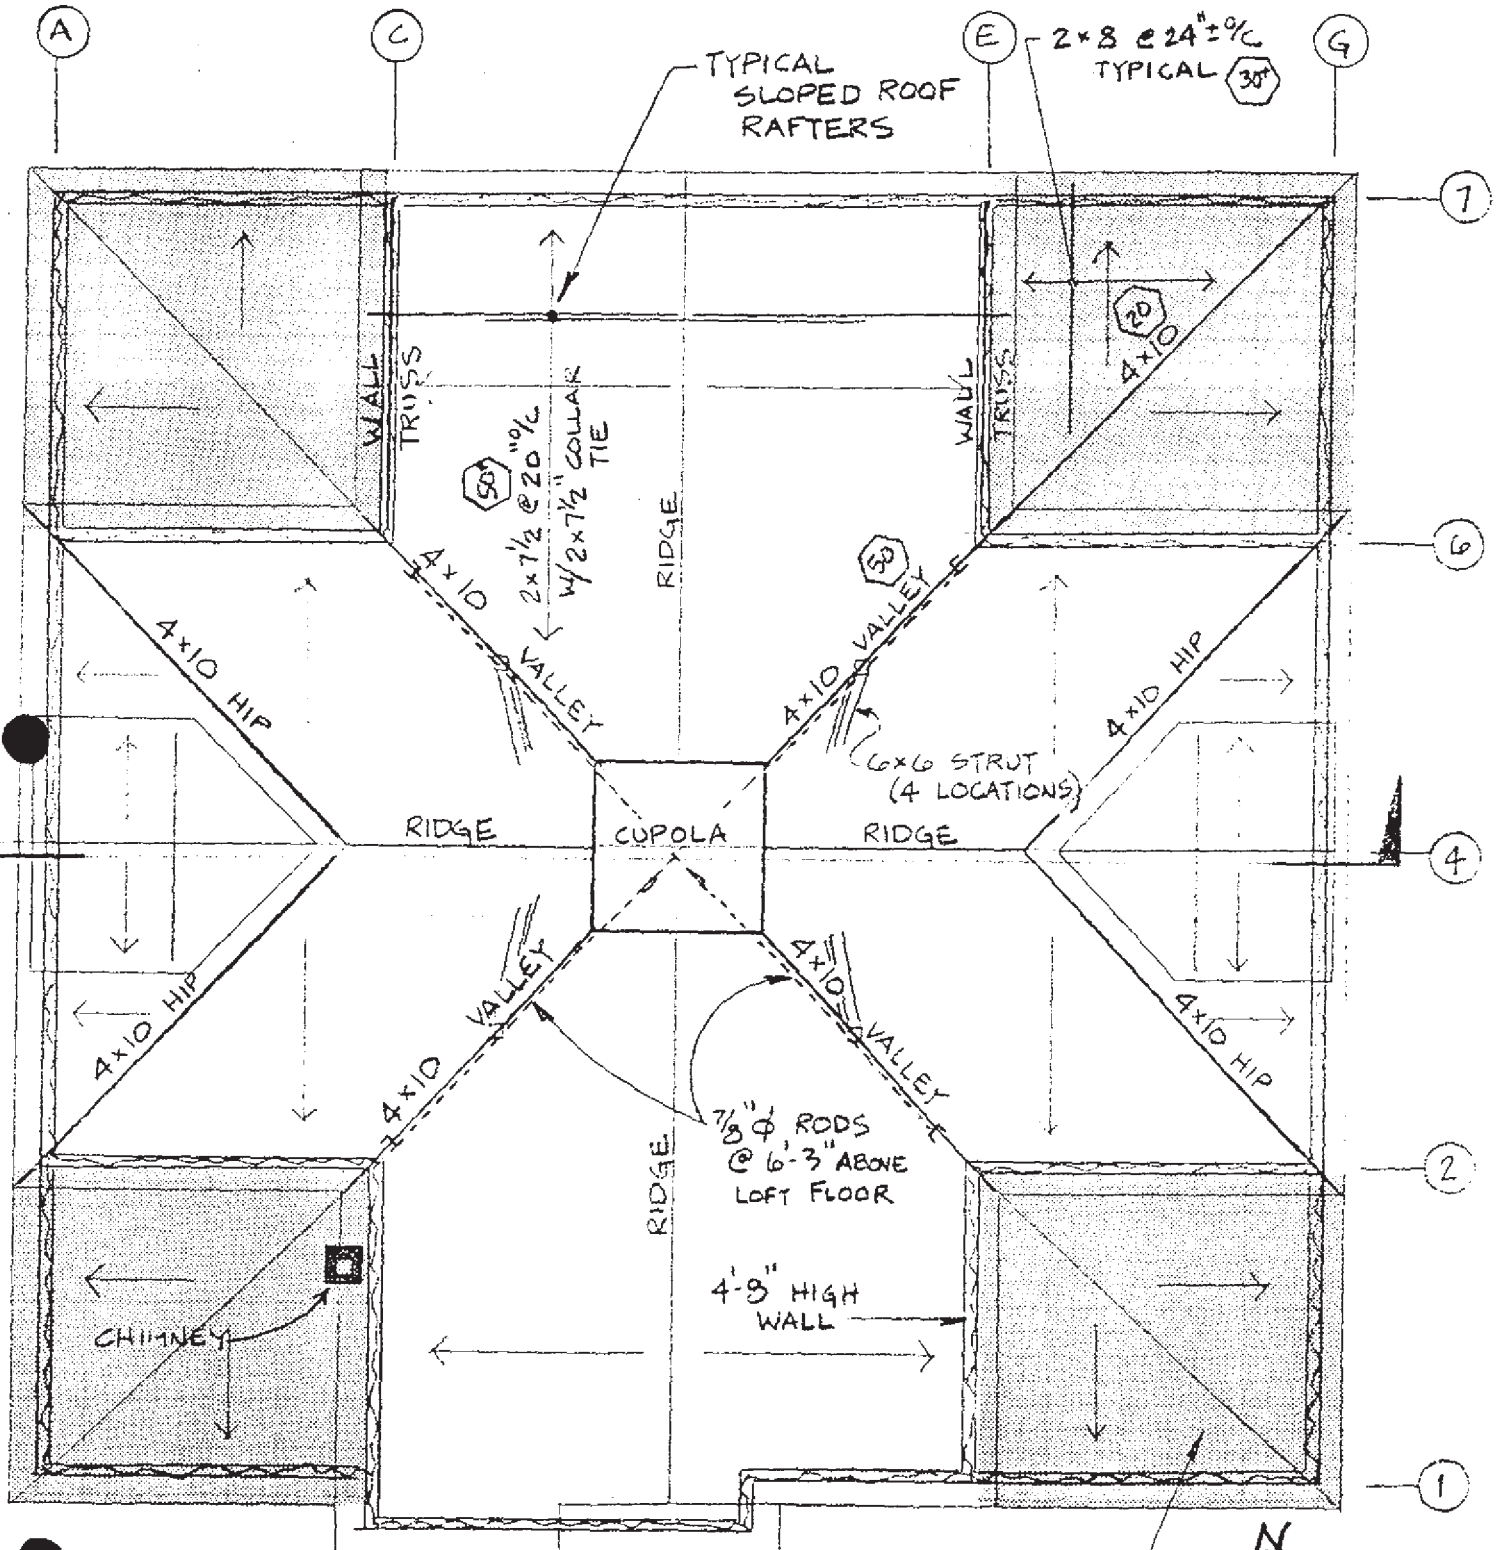
ROOF FRAMING PLAN

1. Main Roof - The original design made no provision for the horizontal thrust at the lower end of the four valley beams. This thrust has resulted in a very noticeable (up to 3") outward movement where these valleys are supported at Grids C2, E2, C6 and E6. This problem is compounded by the fact that the loft level knee walls are also not restricted from outward movement as they support the sloped roof rafters.

2. Lower Flatter Roofs - These sections are not capable of safely supporting the anticipated drifting and sliding snow from the main roof. These roof sections (refer to Sheet #3 for location) are a good example of how wood has an ability to re-distribute loads when overloaded. The presence of wood blocking (presumably installed after the original construction) transfers some roof loads down to the first floor ceiling joists. This improves the roof's capacity but, since the blocking appears random the condition still requires improvement.

We recommend that the roof be properly stabilized. The solution is not simple. A detailed study will be required that considers proposed future use as well as proper structural design. Conceptually, the corrective work could involve more or larger horizontal rods, reinforced knee walls, reinforced valley beams or even a new line of support that could be established by extending the 10x10 wood columns at C4 and E4 up to the roof. Acceptable structural solutions will be restricted by the proposed final use of this level.

We recommend these sections be strengthened. The work might involve removal of the roofing and wood deck due to restricted work space or perhaps could be done from underneath if carefully thought out. This work should be coordinated with the knee wall stabilization work mentioned in Item 1.
