TREATMENT REPORT: STABILIZATION OF THE LIVE OAK MINE
MOJAVE NATIONAL PRESERVE, SAN BERNARDINO COUNTY, CALIFORNIA

THE SCHOOL OF ENGINEERING

April 2015

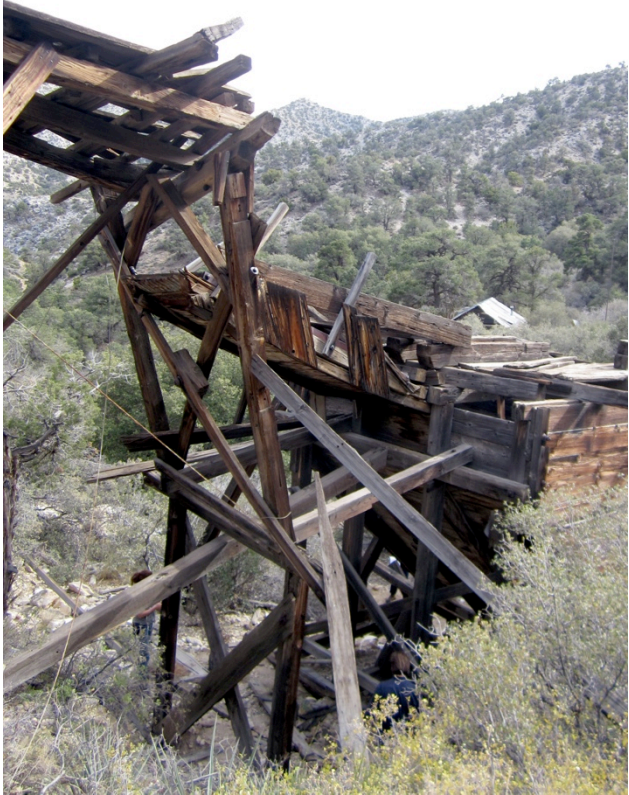
Figure 2: Rotation of the ore bin (bottom right) caused bent 1 to buckle at the intermediary horizontal member, leading to partial collapse of the bent (tall structure left of center), dropping of the ore chute (at center), and dropping of the ends of the stringers supporting the roadway (top left).

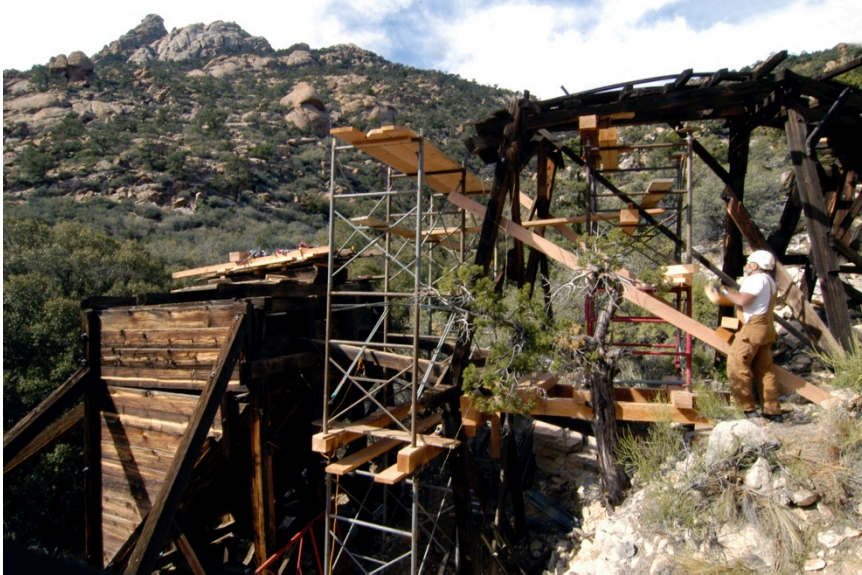
Figure 3: Structural staging was erected to support the structure.

trestle bent 1, and trestle bent 2 (see Figure 3). Once the ore chute and roadway were properly supported, they could be partially disassembled and stored for reinstallation.

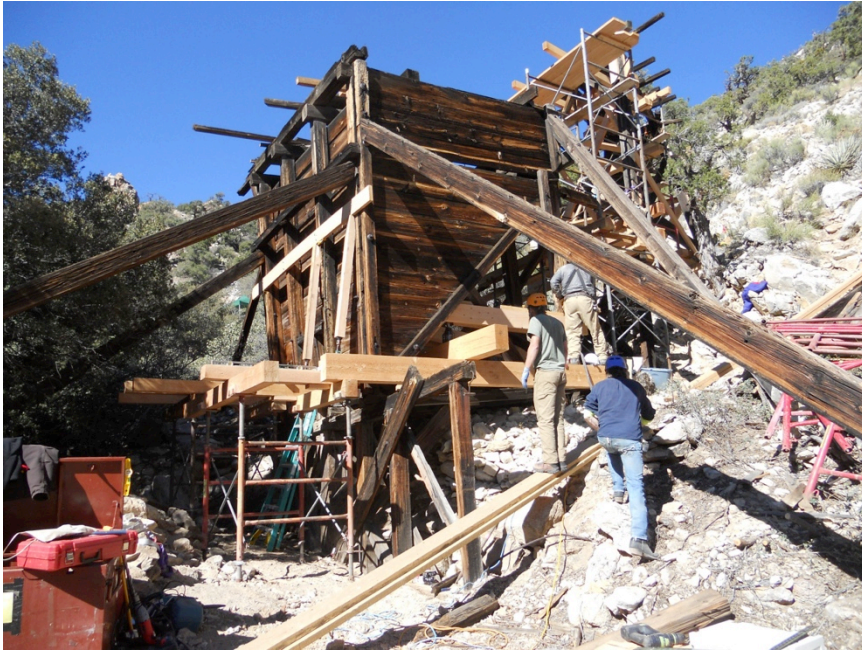
Figure 5: The south end of the ore bin was lifted using a combination of structural staging, cribbing, and screw jacks, allowing for repairs and plumbing of the subframe

Settlement of the subframe and the resulting tilt of the bin itself contributed to many of the other areas of concern for the mine structure. As such, repair of the subframe and replumbing of the bin were necessarily some of the first items addressed in the repair work. After removal of the ore chute, which was at a high risk for collapse, the ore bin was supported using temporary beams bearing on structural staging located on the bin's south side. Once the weight of the ore bin had been lifted off of the subframe (Figure 5), repairs could be made to the sill, columns, and the cap timber located at the top of the subframe, while allowing an opportunity to reposition the substructure with respect to the ore bin so that load paths through the base of the structure could be properly aligned.

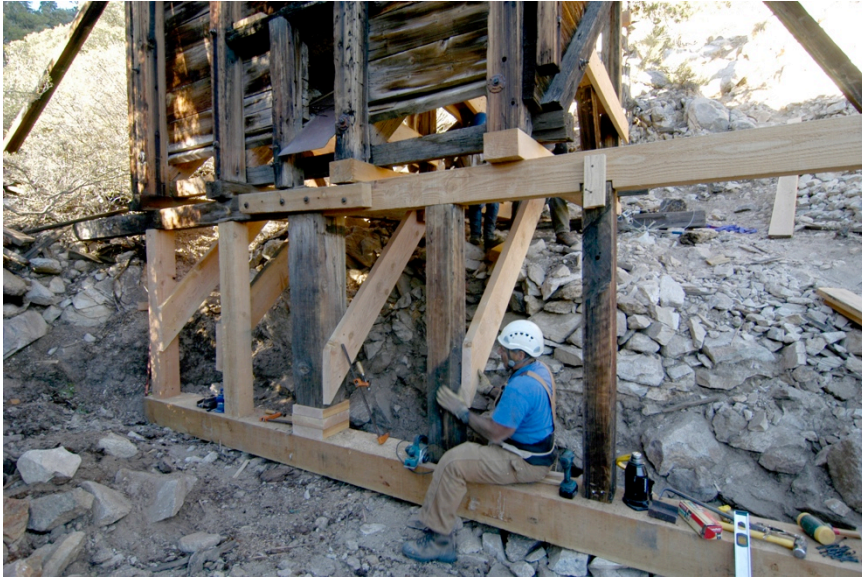
Figure 6: Replacing the braces between the hopper girders and the ore bin subframe. The two easternmost hopper girders were deteriorated along their length, and were replaced in kind (ends visible above the subframe).

support their respective loads. The hopper braces were found to be in poorer condition and were all replaced in kind.

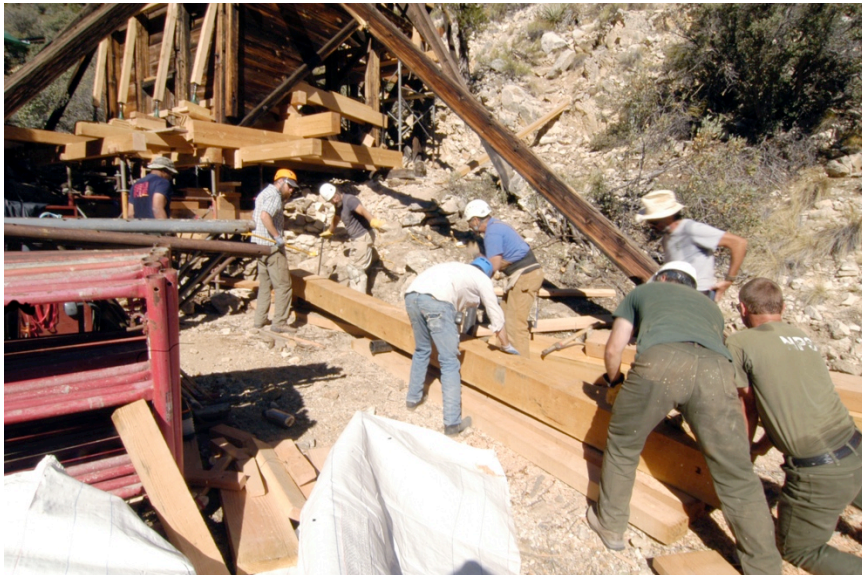
Figure 7: The replacement sill for the ore bin subframe was moved into place using ABS plastic pipe rollers

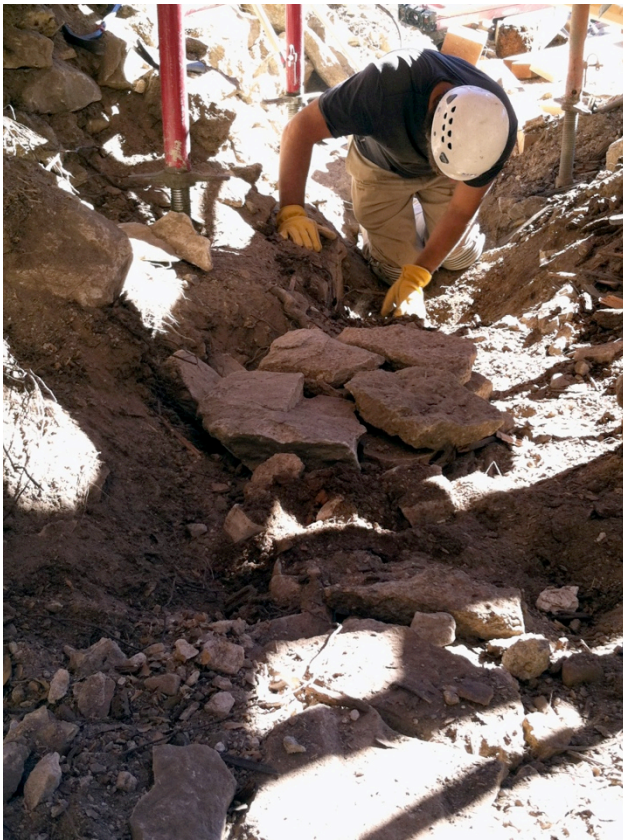
Figure 8: Stone from the area around the base of the ore bin was dry stacked to provide a foundation for the replacement sill. This will facilitate drainage and help to slow future deterioration.

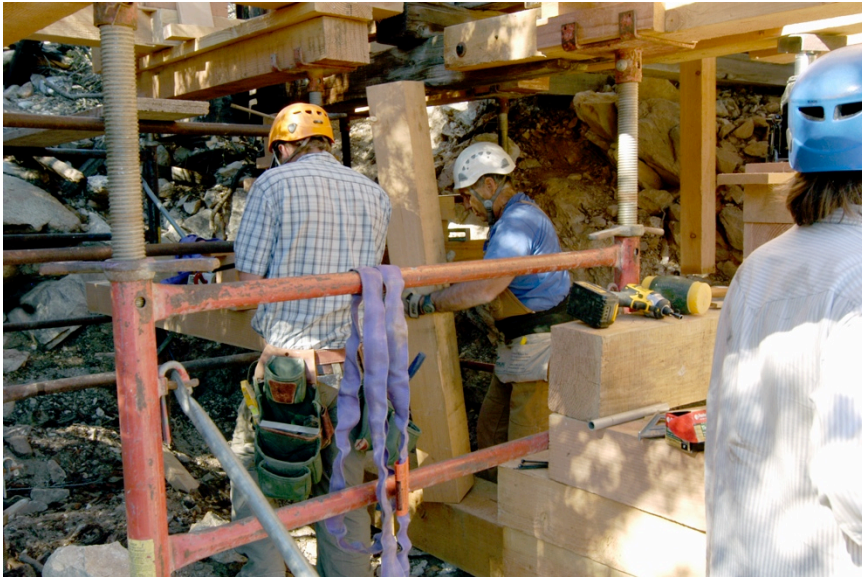
Figure 9: Setting the replacement post, second from the west, in the ore bin subframe. The first and second posts from the west were deteriorated along their lengths and were replaced in kind.

The two western posts in the subframe were also replaced in kind due to an advanced level of decay (see Figure 9), along with some of the diagonal bracing used to stabilize this portion of the structure, much of which had deteriorated significantly either around their hardware, or where the ends lay in contact with the ground (see Figure 9). During the second repair visit, new wood was scarfed into the 12x12 supporting column at the center of the subframe, and a secondary column was added just to the right of it to carry the end of the half-lapped replacement cap timber (see Figure 10). Moisture content of the existing sills throughout the mine structure were uniformly high, and replacements will be exposed to moisture levels conducive to decay. Ongoing maintenance should focus on this area, among others.

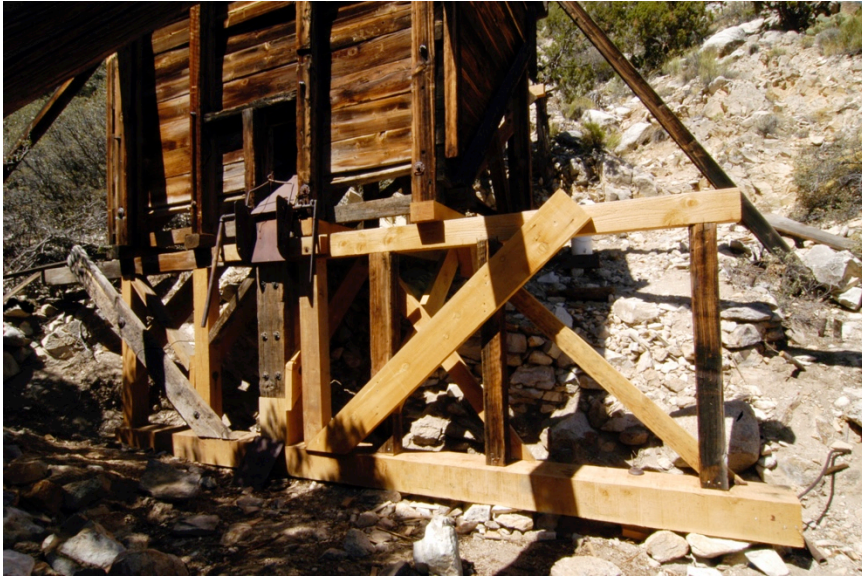
Figure 10: The completed subframe. The east half of the cap timber was replaced in kind, as were the two westernmost posts, and diagonal braces. New wood was scarfed into the end of the center post, and a column was added to the right to help support the end of the replacement cap timber.

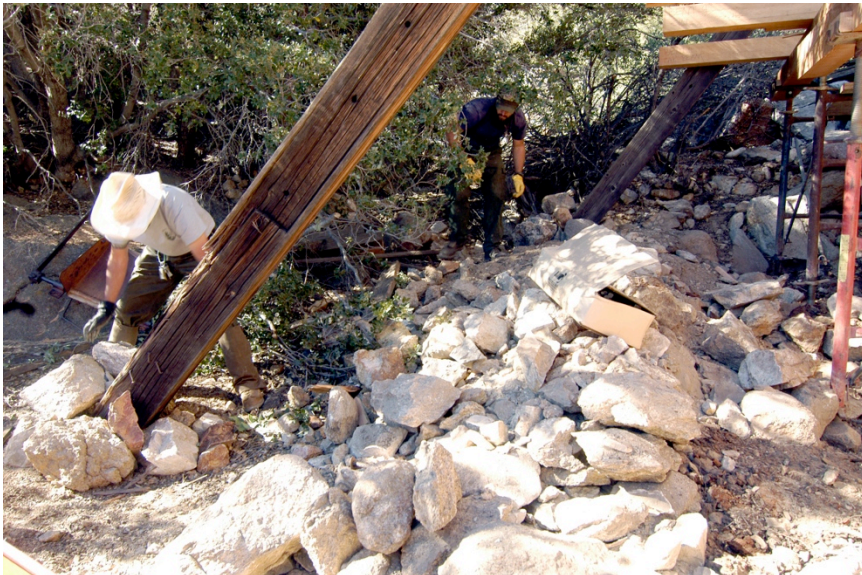
Figure 11: Resetting the ore bin braces after the bin was returned to a plumb condition.

Long timber bracing to the ore bin had been installed while the mine was in operation; decayed portions at grade were removed and the posts were reset (see Figure 11).

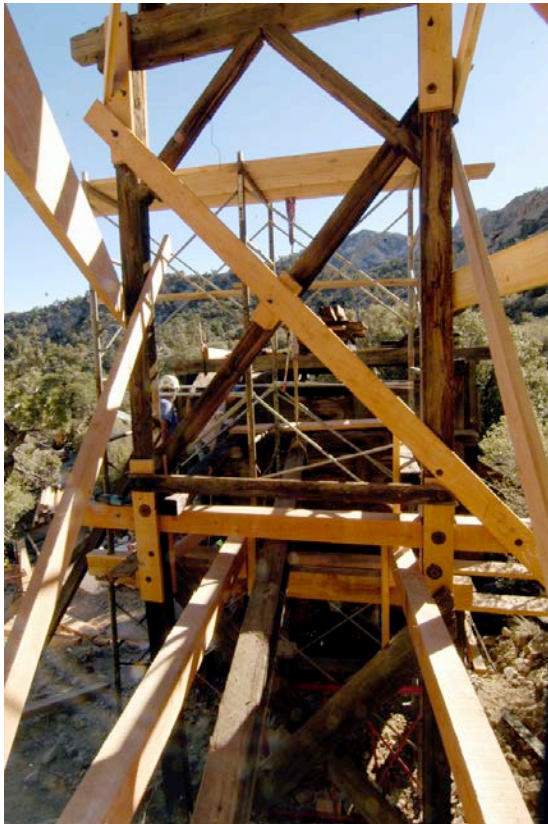
Figure 12: The intermediary sill in bent 1 was replaced in kind (below the diagonal bracing). Three of the diagonal braces, the diagonal brace spacers, and all of the vertical braces were also replaced in kind and reattached using either original hardware or custom reproductions.

Many of the smaller braces on the bent were broken, partially lost to decay, or badly deteriorated around their fasteners. Broken or damaged braces were repaired either by reattaching undamaged portions of the existing members, or replacing in kind. Repairs were reattached using a combination of original hardware or custom reproductions in cases where the originals were damaged or lost.

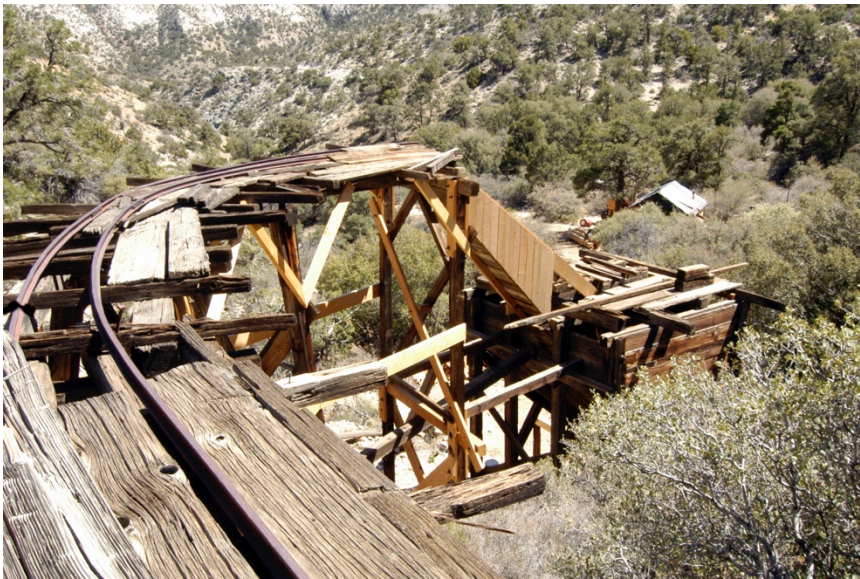
Figure 14: The completed ore chute. Enough of the ore chute was rebuilt to brace bent 1, and several members were in good enough condition to be reused. Surviving remnants were copied to sheath the sides.

Repairs made to the ore bin subframe and the trestle bents brought structure as a whole back to an even and plumb condition, allowing for reinstallation of the ore chute. Some parts of the chute, such as siding, were missing, and others had been either lost to decay or damaged as a result of partial collapse. Enough of the chute was rebuilt to brace bent 1 using a selection of original timbers, and much of the remainder of the chute was replaced in kind. The original sheet iron and corrugated metal were reinstalled at the base of the chute (see Figure 14). The original angle of the ore chute as it descends from the roadway to the ore bin was inferred by evaluating existing evidence at the site.

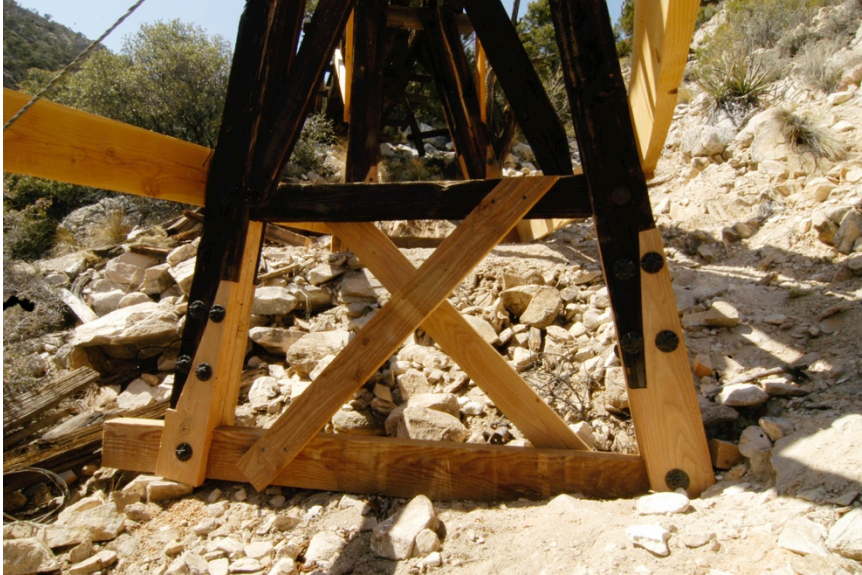
Figure 15: Scarfed repairs in bent 3. Lower cross bracing and the sill were replaced in kind. Spacers were added between the dimensional lumber posts between the scarfs to support the repairs.

Sills were replaced and column bases repaired on bents 3 and 4 (see Figures 15 and 16).

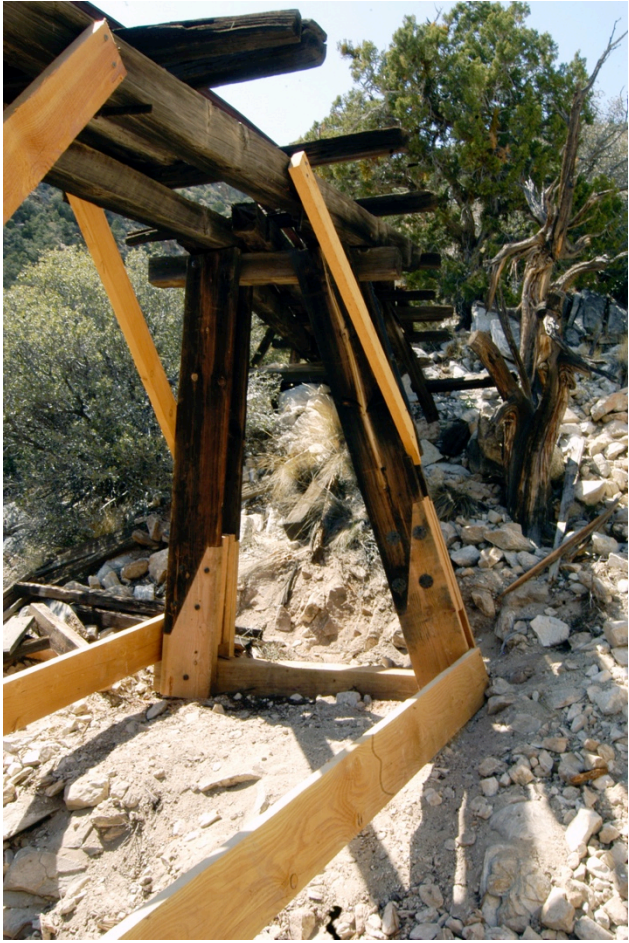
Figure 16: Scarfed repairs at trestle bent 4. The sill was largely lost to decay and replaced in kind. Spacers were added between the dimension lumber posts to support the repairs.

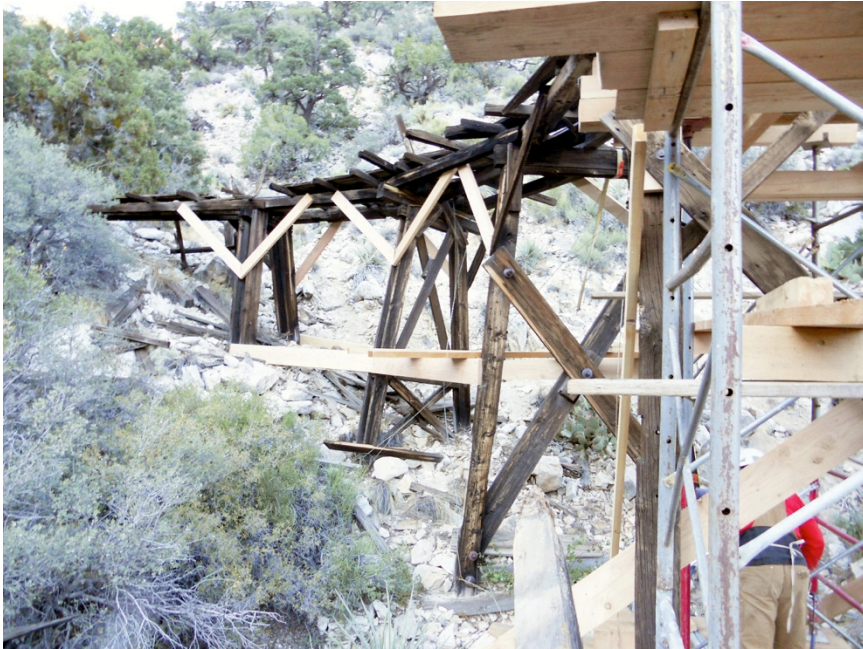
Figure 17: Much of the diagonal and longitudinal bracing between the trestle bents was damaged or missing. Braces were replaced in kind when they could not be salvaged or reattached securely.

The trestle portion of the mine structure is strengthened and stabilized with longitudinal bracing between bents and diagonal bracing between bents and the roadway. At the time of the initial inspection, several of these members were missing, broken, or partially detached. During repair, members in good condition were secured in place, and missing or broken bracing was replaced in kind (see Figure 17). Bracing was fastened using corrosion resistant structural screws.

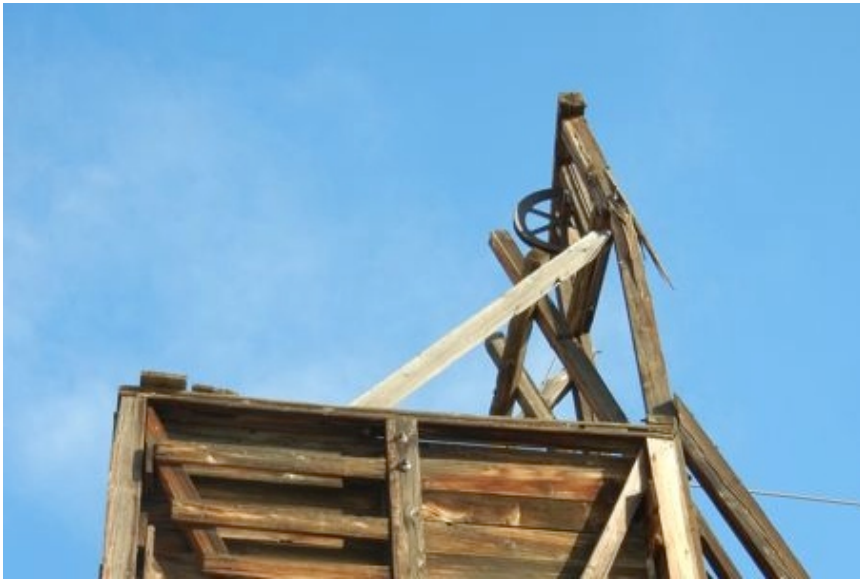
Figure 19: One of the columns supporting the sheave at the top of the structure has failed.

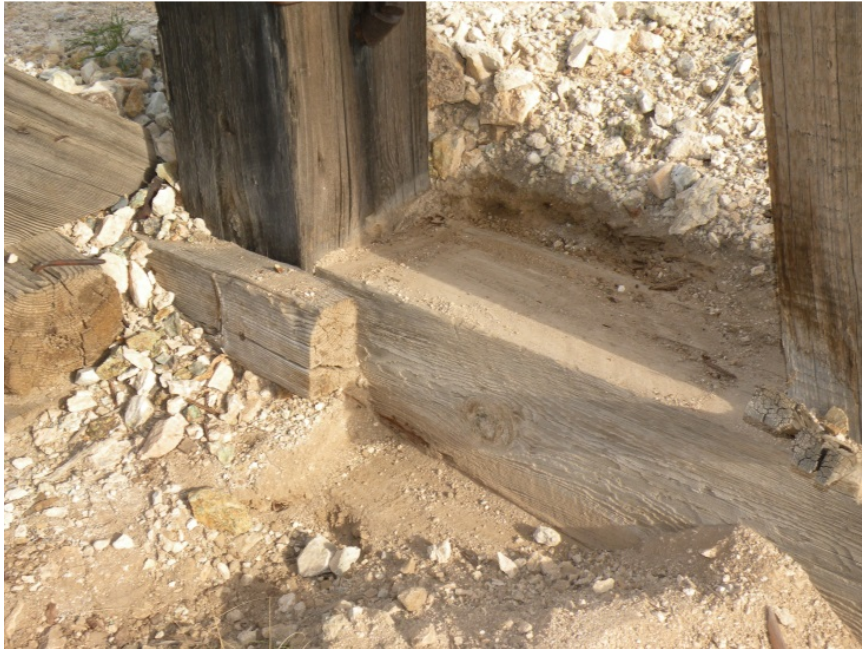
Figure 20: The interior of this sill has decayed, and leaves it providing little to no support for the columns and braces above.

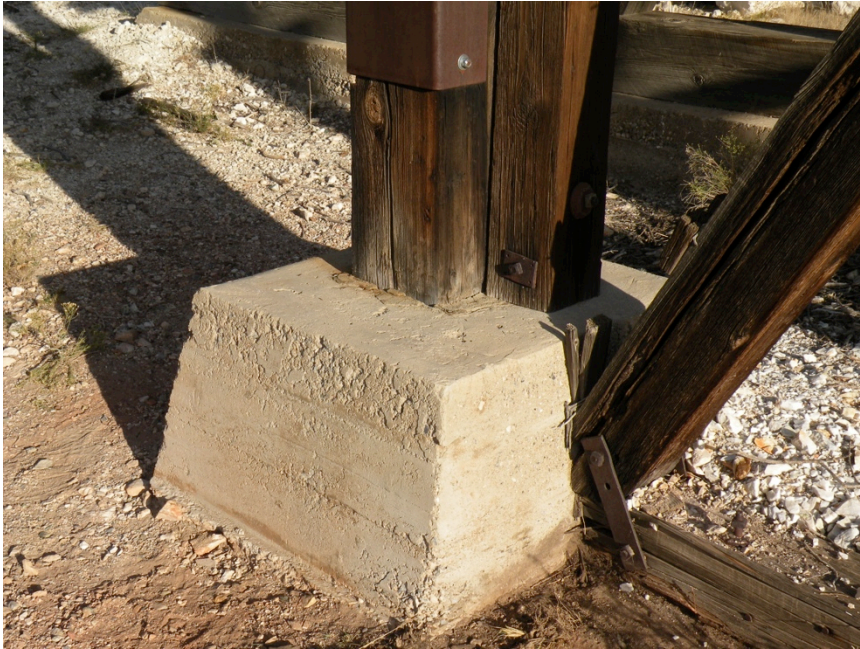
Figure 21: The base of the larger (12x12) column is decayed where it is embedded in the concrete pier. The diagonal brace terminating in the pier is deteriorated around its connection and has lost most or all of its original capacity.

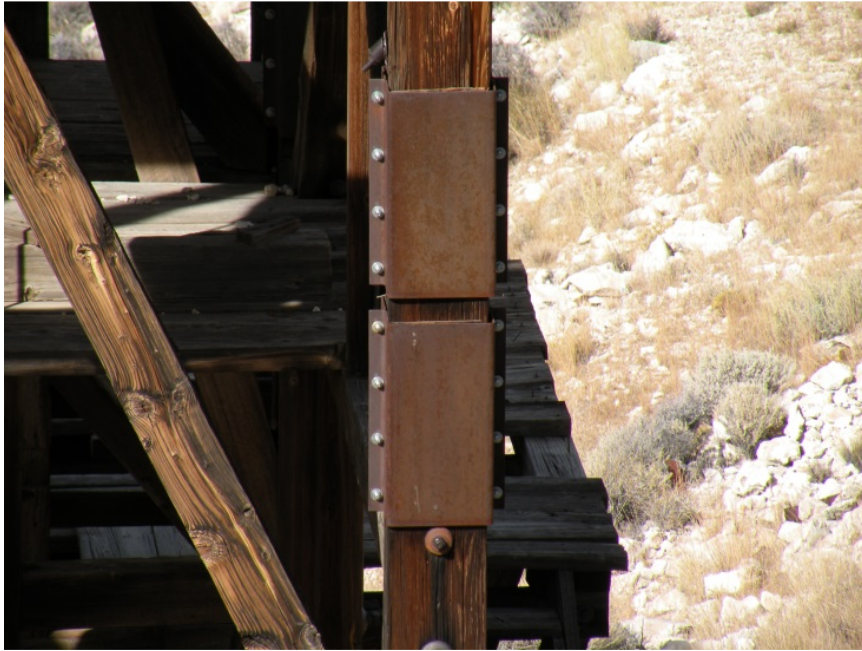
Figure 22: Steel plate clamps installed on columns will result in decay of the columns.

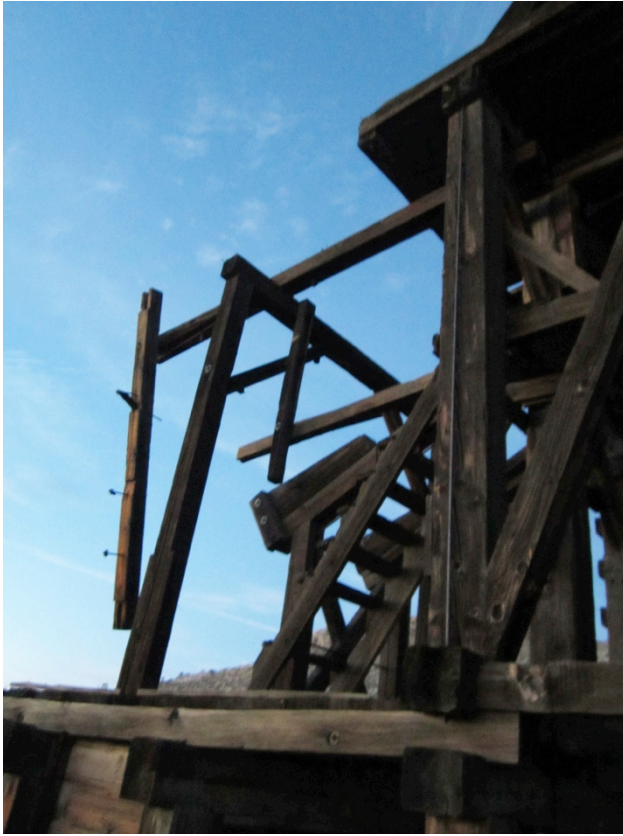
Figure 23: An 8x8 girt on the north side of the structure is partially detached and is at risk for falling (far left).

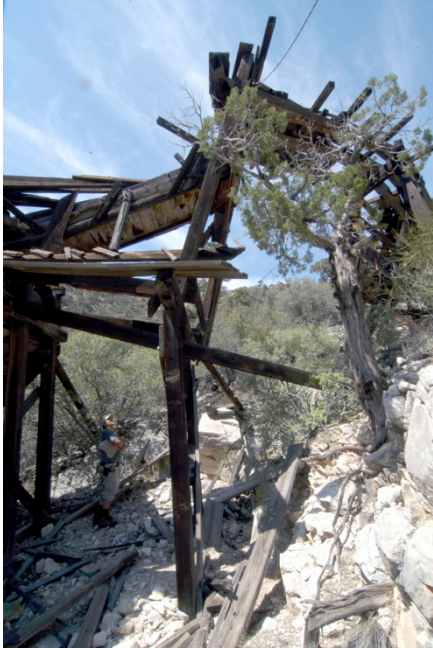
Figure 26: Rotation and subsidence in the ore bin had caused the tallest bent in the trestle, bent 1, to buckle at its intermediary sill.

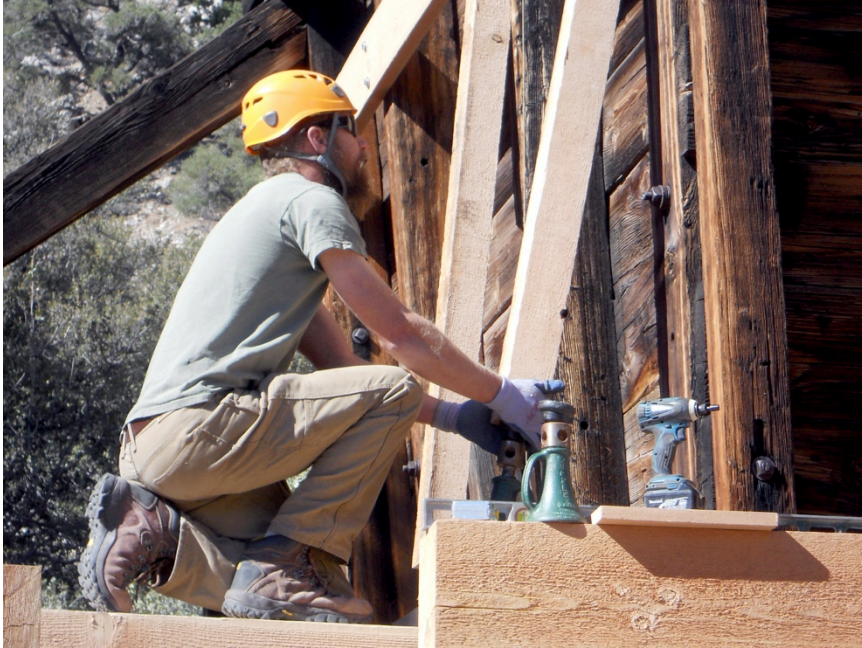
Figure 30: A temporary ledger was installed on the south side of the ore bin. Posts were set against the ledger and raised using screw jacks, lifting the south side of the ore bin. This allowed for repair work to the ore bin subframe and corrected the bin's out of plumb condition.

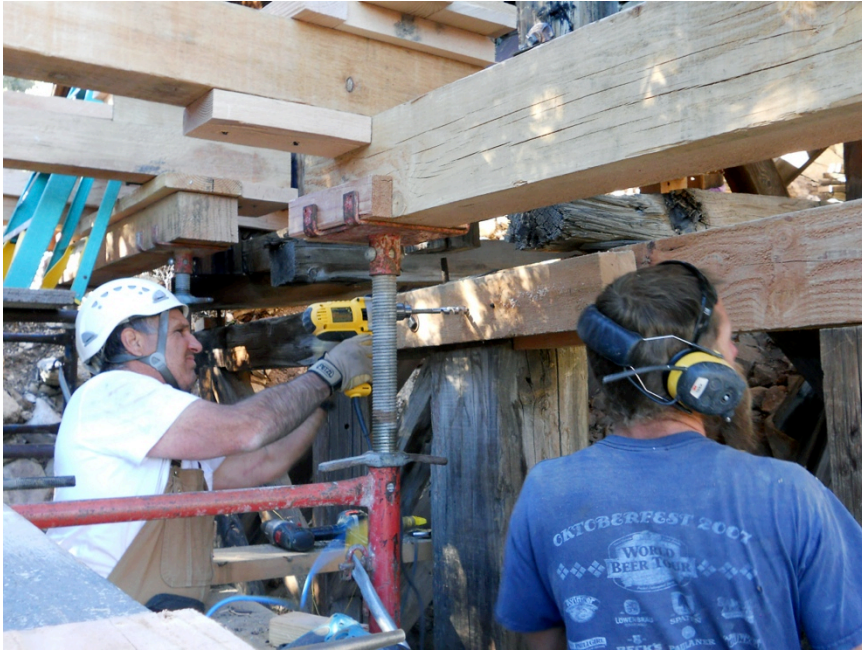
Figure 32: The eastern half of the subframe's cap beam was damaged and replaced in kind. The members strengthening the joint between the two cap beam halves were also replaced in kind (both sides of the beam). Here, holes are drilled into the replacement members so hardware can be reinstalled.

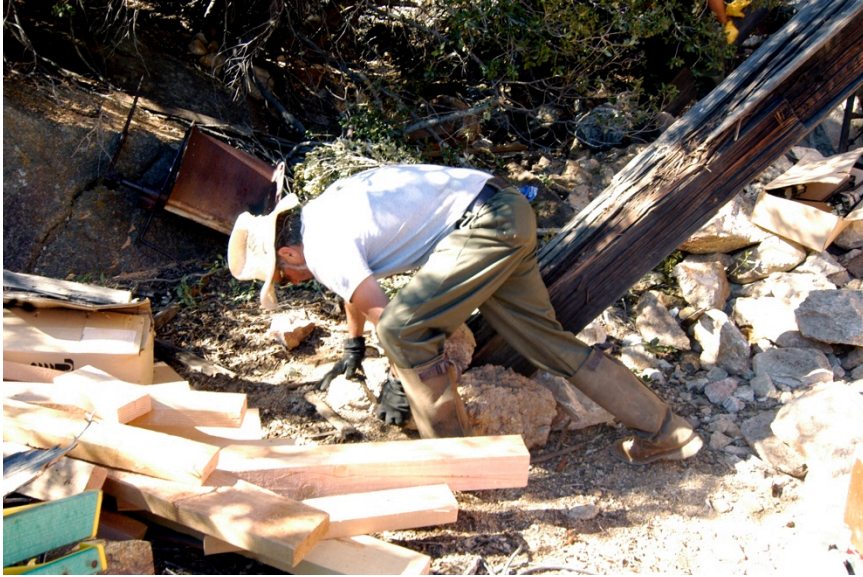
Figure 36: the bottoms of the braces had decayed from prolonged contact with the ground. Decayed portions were removed and the ends were reset in stone.

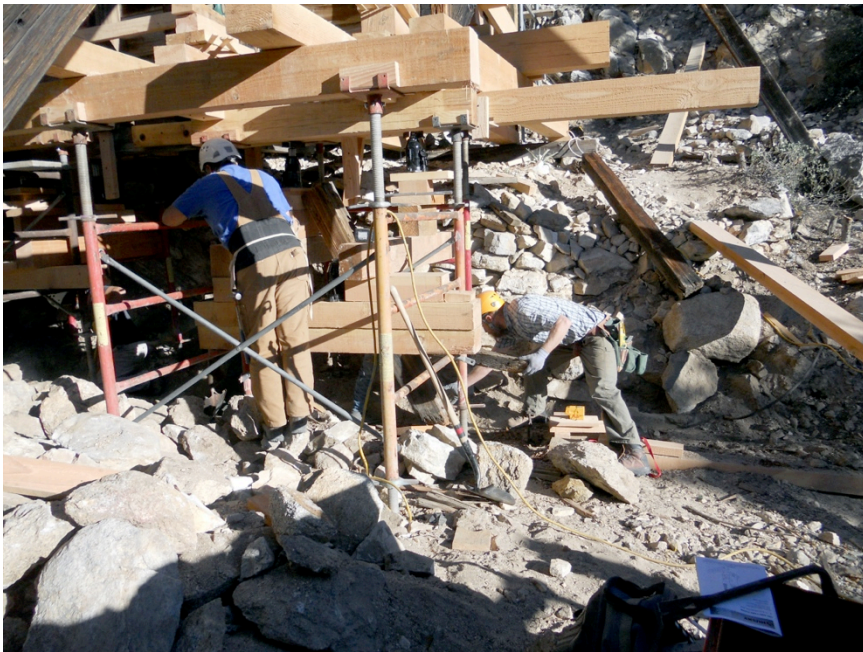
Figure 37: The ore bin subframe sill was largely lost to decay, and was replaced in kind. Here, remnants of the sill are removed.

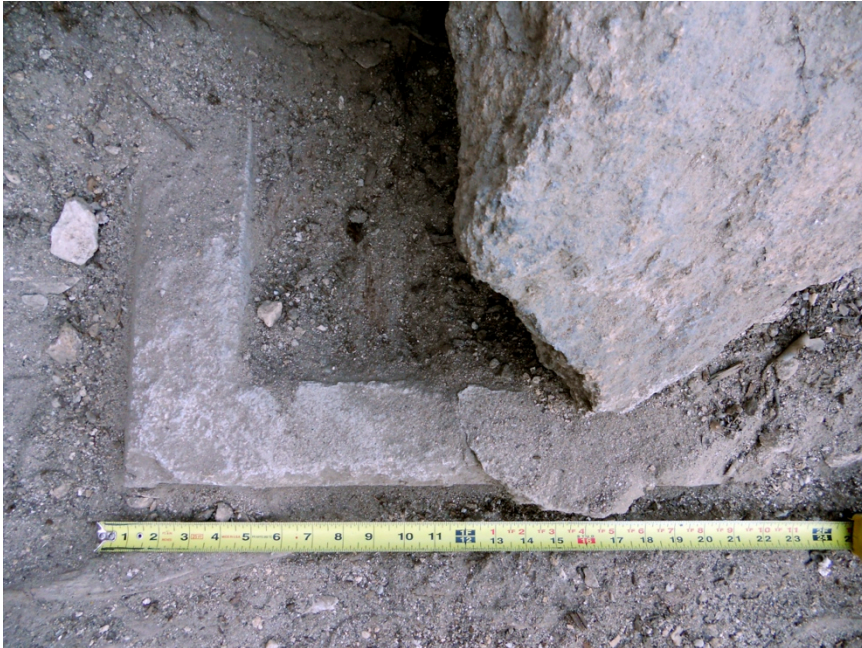
Figure 39: Two small concrete footers were uncovered during the removal of the decayed sill, and may have been used to provide additional support to the sill. The footers were left in place. See Appendix B, sheet XXX for approximate locations of the footers.

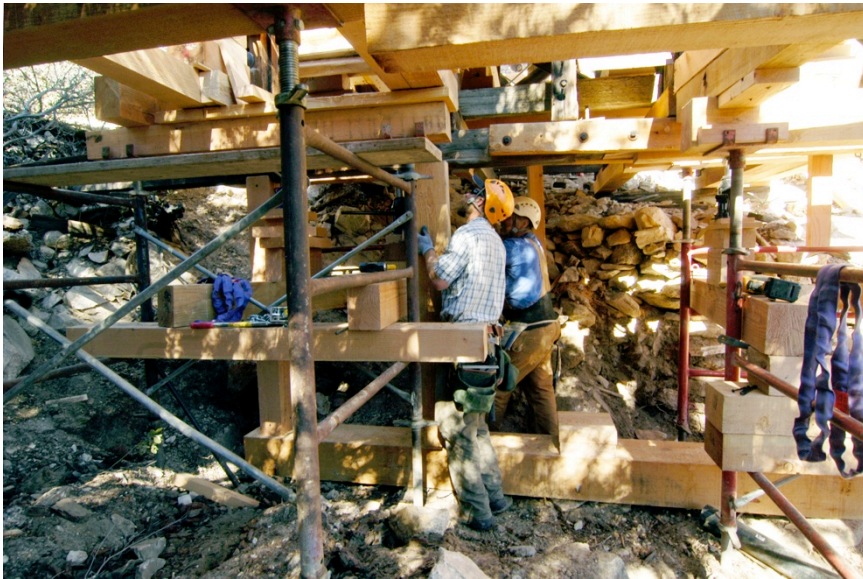
Figure 43: The two westernmost posts in the subframe were badly decayed and had lost significant portions of their length. The posts were replaced in kind after installation of the new sill. Here, the second post from the west is moved into position.

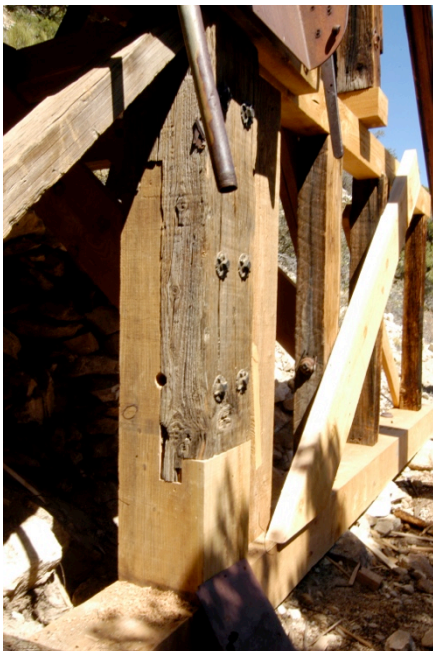
Figure 45: The center post was decayed at its bottom. The decayed material was removed and new wood was scarfed into the bottom of the post. A smaller post, just visible to the right of the scarfed repair, was installed to help support the end of the east half of the cap beam. This work was completed during the second repair visit.

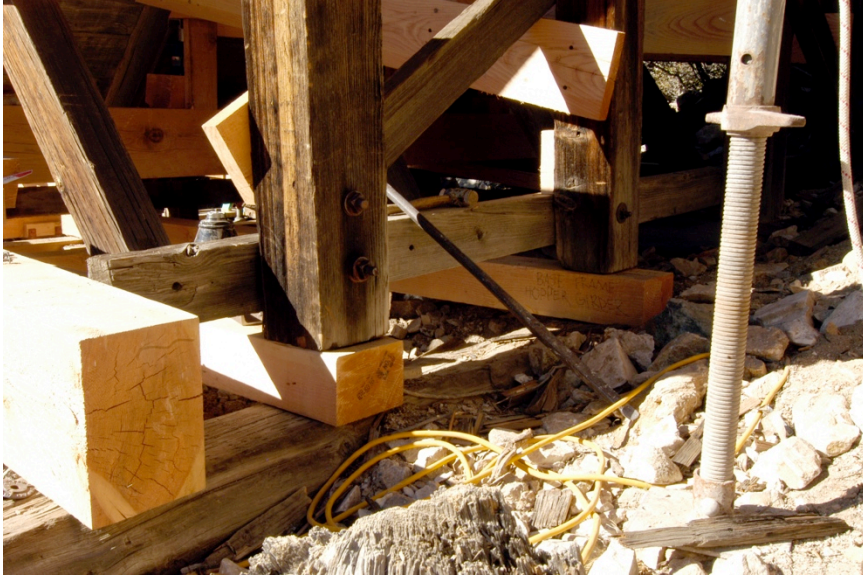
Figure 46: The two eastern hopper girders in the ore bin were decayed along their lengths and were replaced in kind.

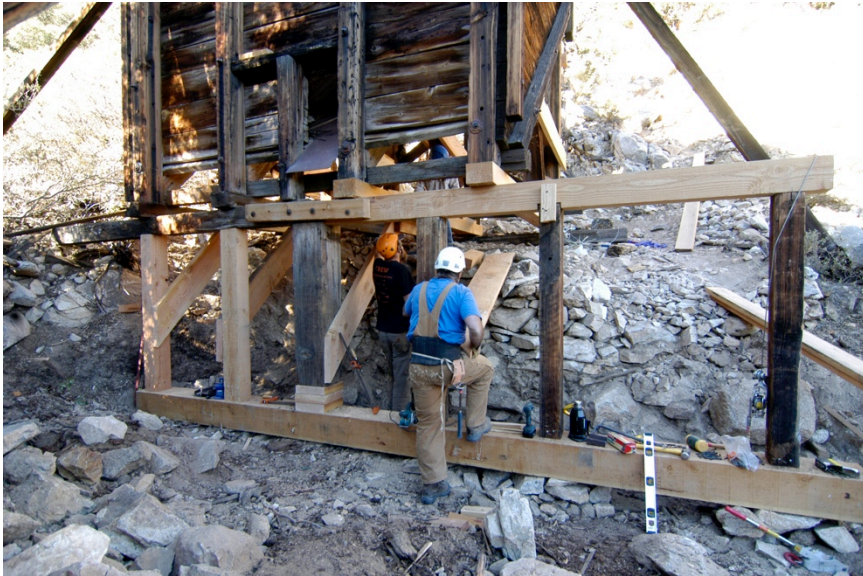
Figure 47: All four of the braces connecting the hopper girders to the subframe were in poor condition and were replaced in kind.

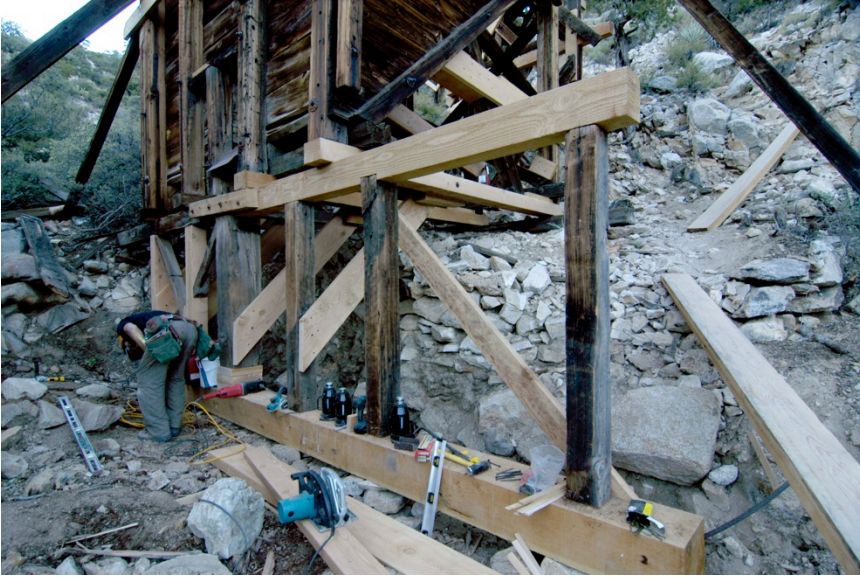
Figure 48: Much of the smaller diagonal bracing (at front) in the subframe was also decayed or damaged. Members were either reattached or replaced in kind.

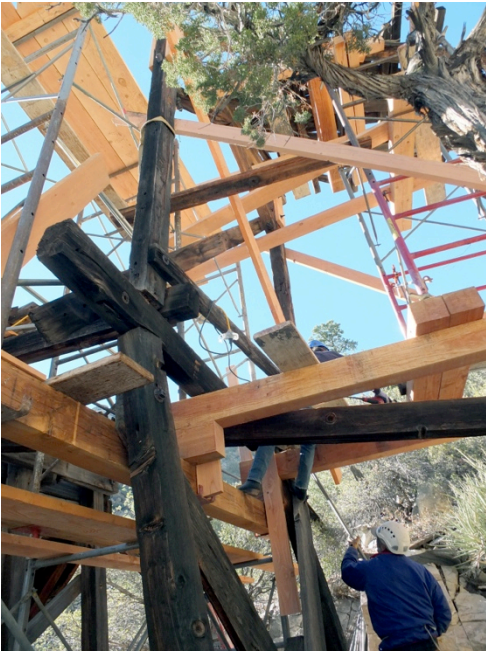
Figure 49: Subsidence and rotation in the ore bin had caused bent 1 to buckle. Structural staging and cribbing stabilized it so repair work could be completed.

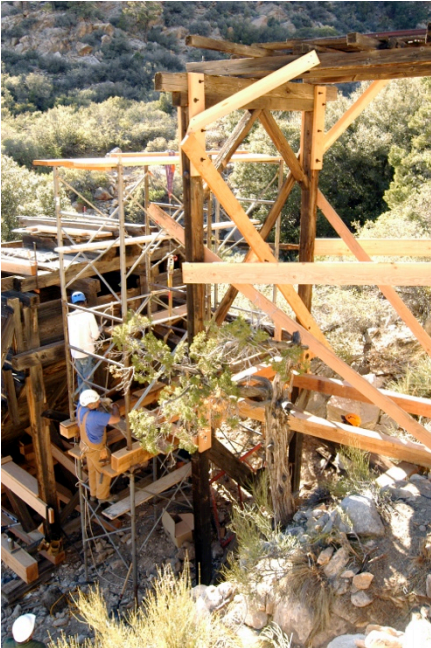
Figure 55: Three diagonal braces and all of the vertical braces connecting the cap beam and the upper posts and the intermediary sill and the lower posts were damaged and were replaced in kind.

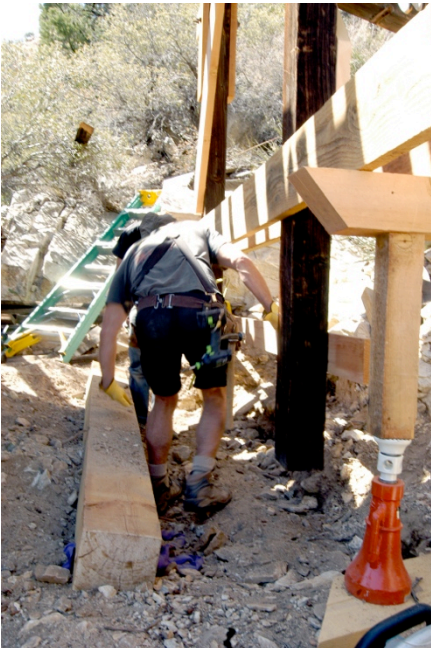
Figure 57: During the second repair visit, the sill for bent 1, which had been largely lost to decay, was replaced in kind.

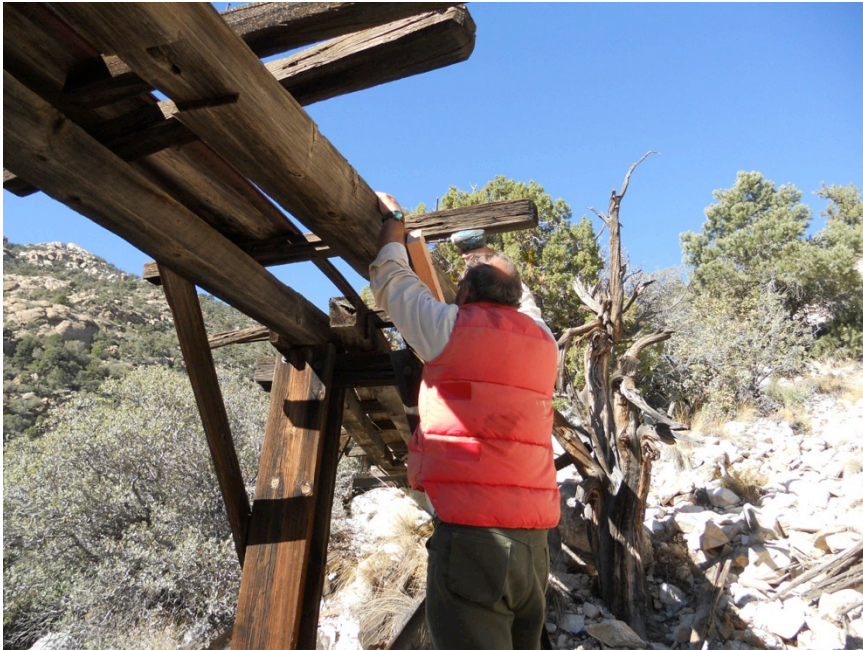
Figure 58: Diagonal and longitudinal bracing in the trestle provide stability in this portion of the mine structure. Many of the braces had partially or completely detached, and were damaged or decayed at their ends. Those braces that could not be securely reattached were replaced in kind.

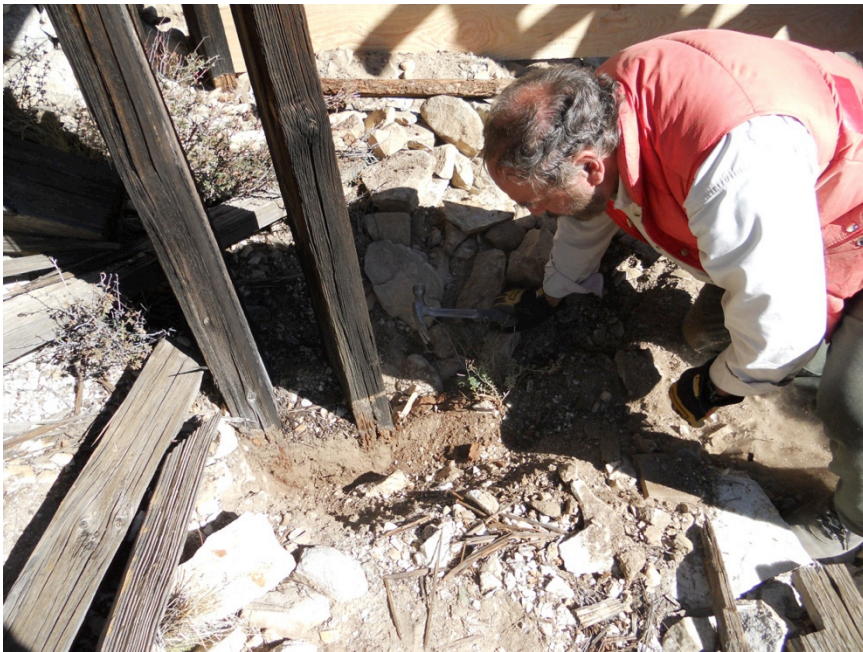
Figure 61: The sills at bents 3 and 4 had been largely lost to decay due to prolonged debris build-up

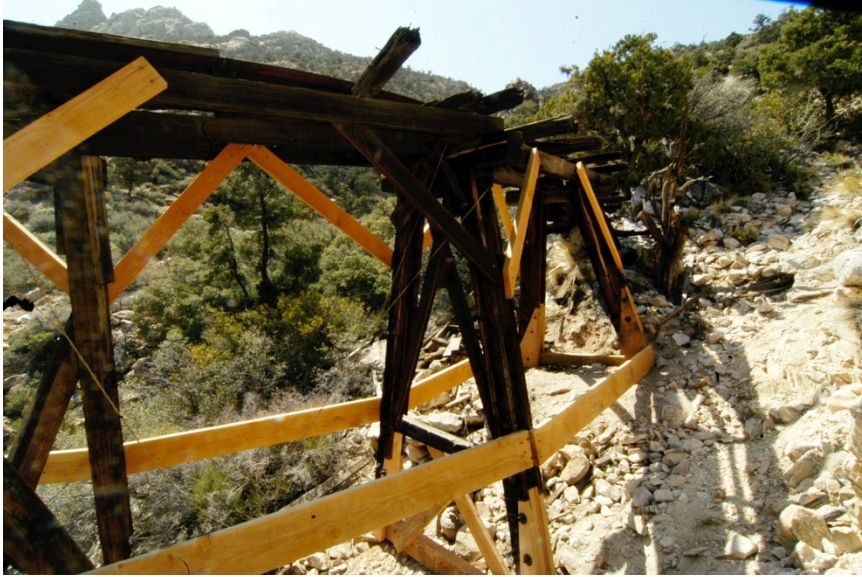
Figure 62: New wood was scarfed into the columns of bents 3 and 4 and their sills were replaced in kind. Spacers were placed between the repairs in the dimensional lumber posts and through-bolted. See Appendix B, sheet XXX for details of the repairs.

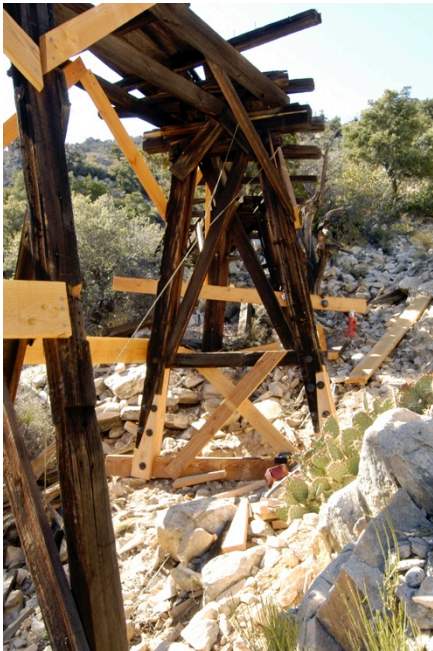
Figure 63: The lower set of cross bracing in bent 3 was decayed and was also replaced in kind.
