HISTORIC BUILDINGS SURVEY REPORT - PART I

WICK HOUSE

NORWISTOWN NATIONAL HISTORICAL PARK

Walter E. Hugins
Park Historian

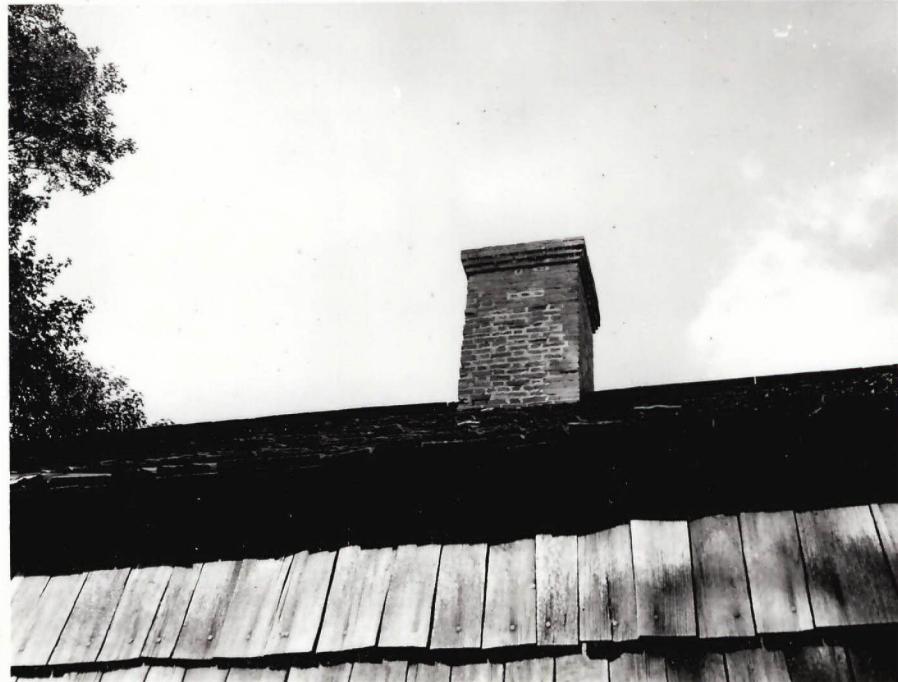
1. Exterior view of chimney, showing the deterioration of brickwork.

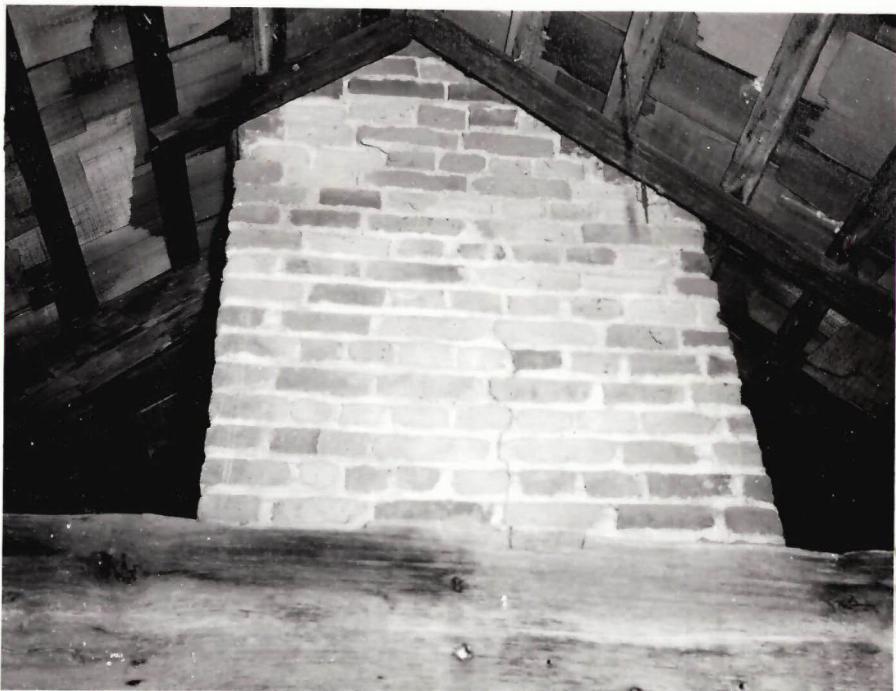
2. Chimney in attic, showing crack in brickwork.

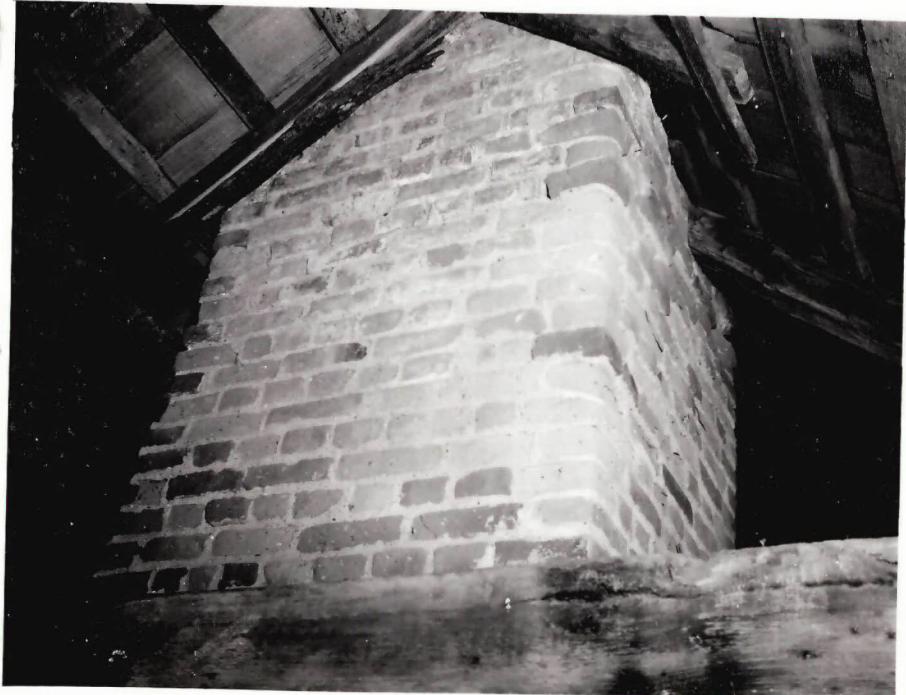
3. Chimney in attic, showing missing brick.

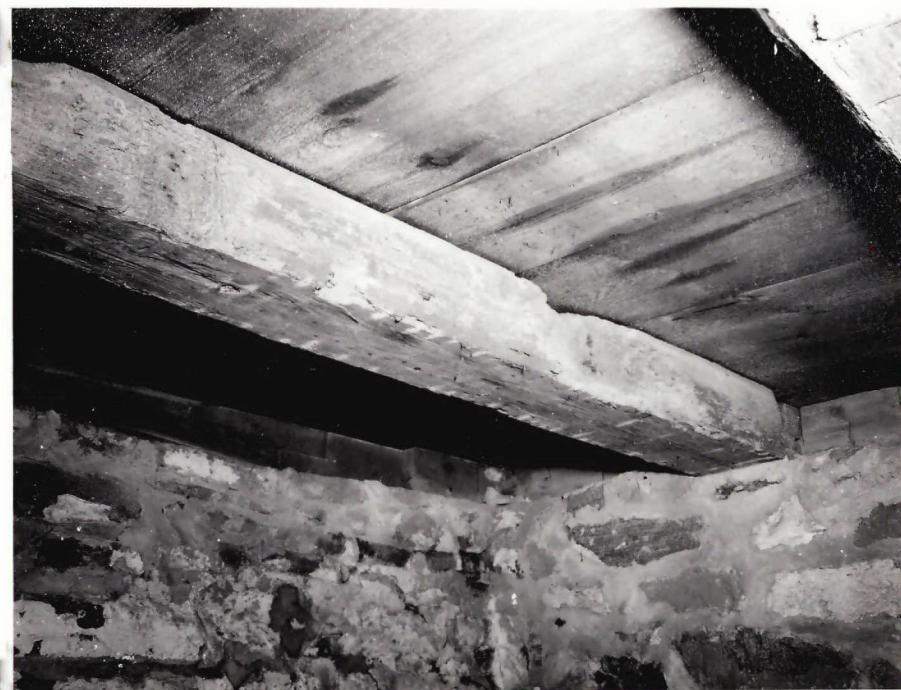
4. Condition of floor joists in cellar.

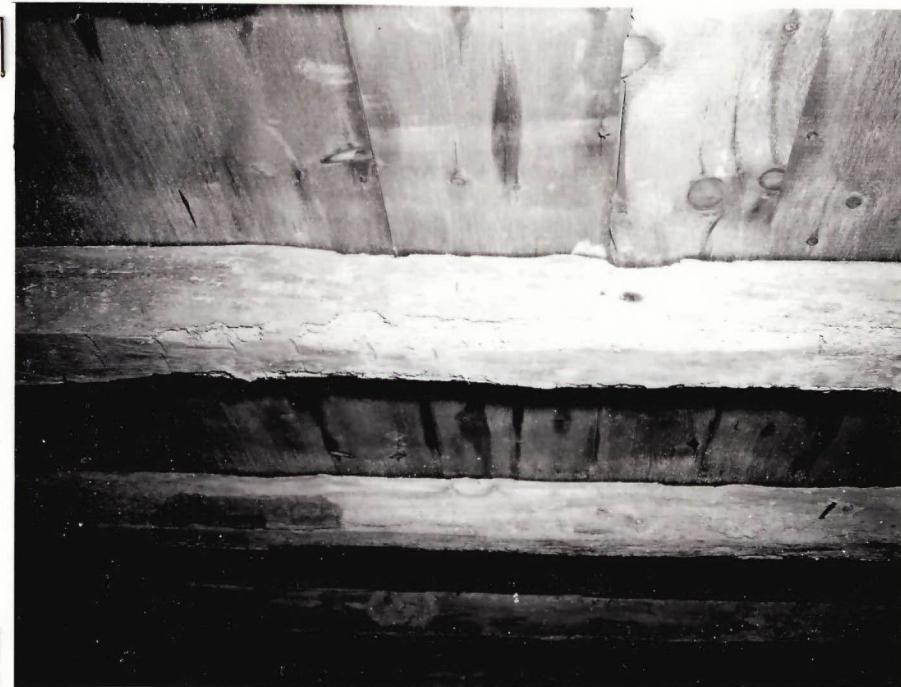
5. Another view of floor joists.
