The Road Inventory of Muir Woods National Monument

Road Inventory Program

Prepared by: Federal Highway Administration Eastern Federal Lands Highway Division March 1999

Muir Woods National Monument in California

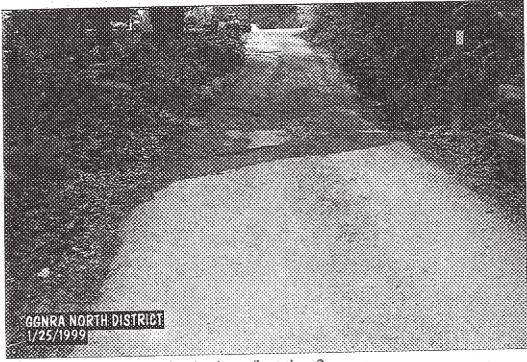
Photo # 01 Typical pavement section showing potholes.

Photo # 01 Potholes at beginning of section 2.

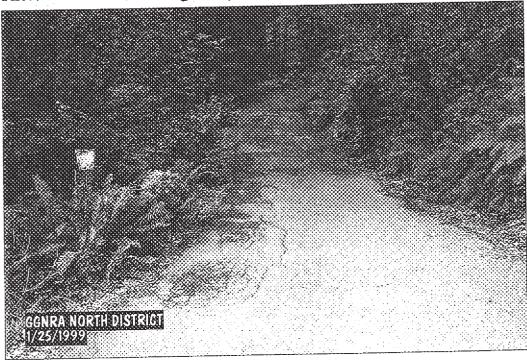
Photo # 02 Alligator cracking upper area section 2.
