**INTERIOR FINISHES ANALYSIS OF  
SECOND AND THIRD FLOOR HALLS AT  
THEODORE ROOSEVELT HOME**

**Sagamore Hill National Historic Site**

Marie L. Carden  
Architectural Conservator  
Cultural Resources Center  
North Atlantic Region  
National Park Service  
U.S. Department of the Interior

January, 1993  
Revised February, 1993

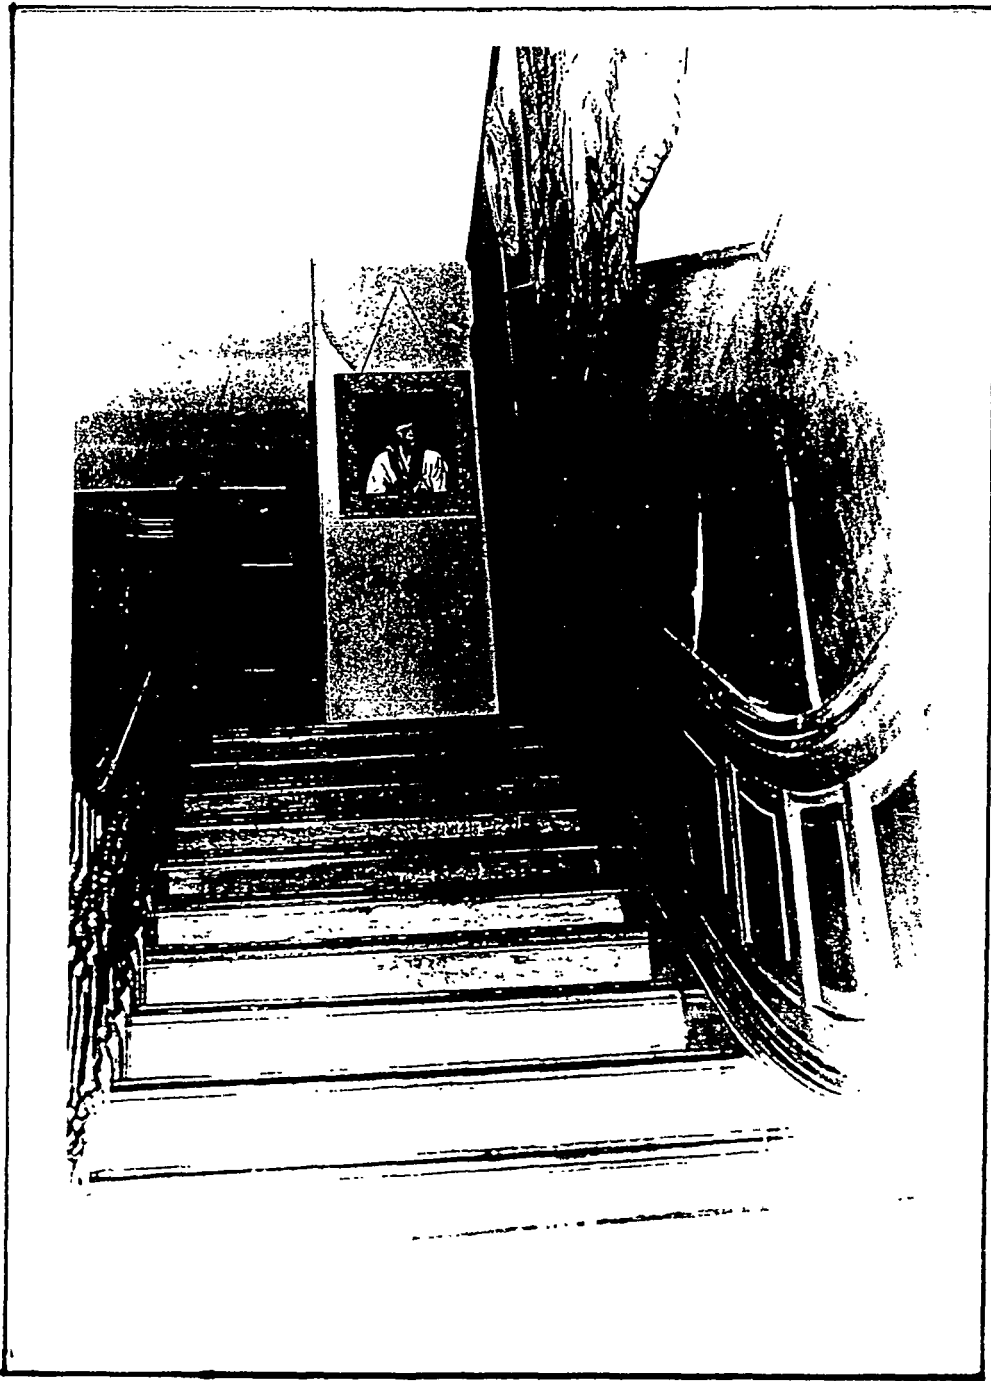
photograph of the second floor hall this wall is seen as rectangular in shape (fig. 1). Archways were indicated in the original Lamb and Rich drawings by dotted lines. However, this particular one did not have the word "arch" written across it, as the others did (see Appendix A, second floor plan), further indicating that the opening was not built as an arch.

Fig. 1. Main staircase; Front Hall  
(Room 101) looking east, 1948.  
Photographic collection, SAHI NHS.  
After 1948, the rectangular wall at the top  
of the stairs was changed to an arch.
