HISTORIC STRUCTURES REPORT

SAGAMORE HILL

Restoration of Porch, Stabilization of  
Staircase, Masonry Pointing and Painting

Prepared by  
Norman M. Souder  
Architect  
August 1964

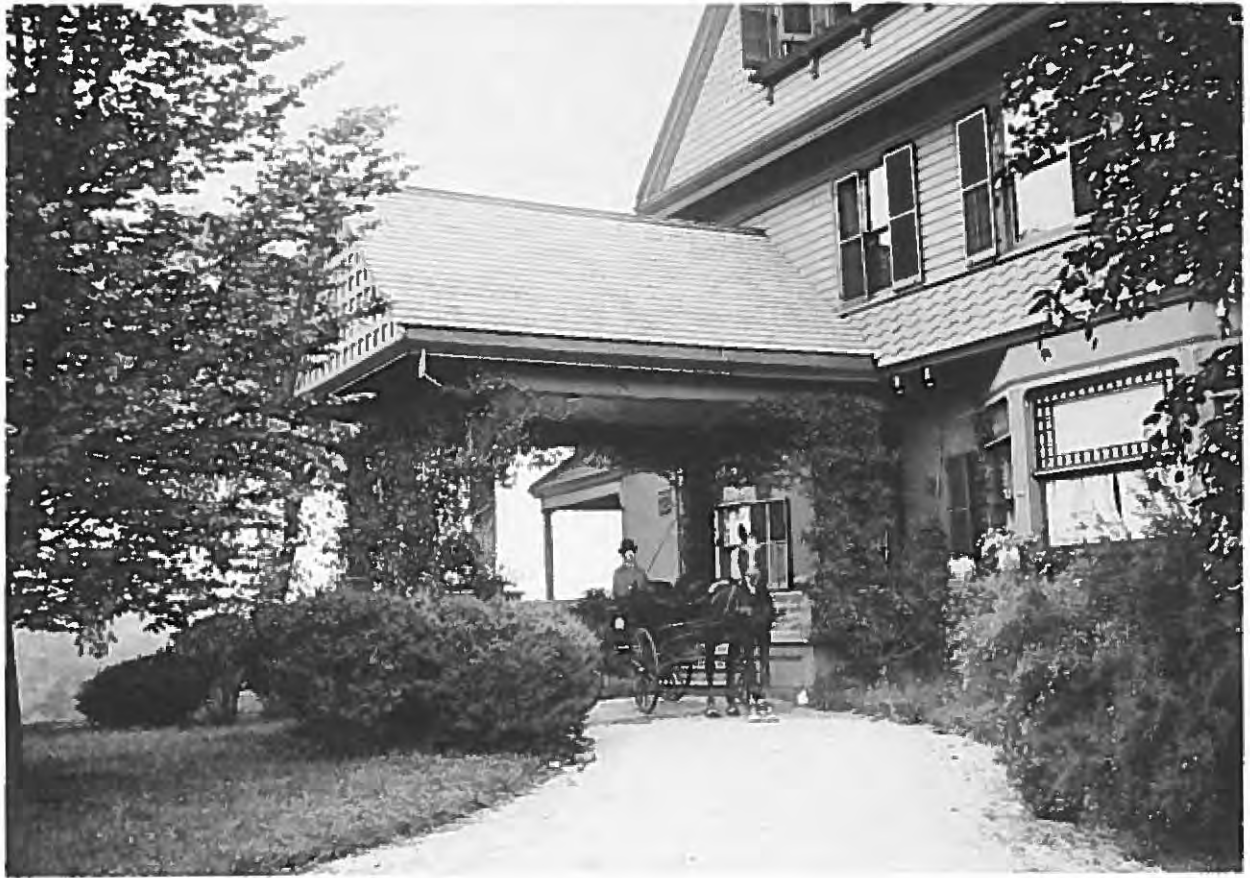
ILLUSTRATION NO. 9

Most of the pedestals show evidence of various steps of decay. The result of the decay has shifted the base of some of the columns far out of plumb.

The failure of the porch can be seen on this photograph. The decayed pedestals, weakened sills and piers have caused several of the columns to shift out of alignment. The peeling paint on the porch ceiling above the drawing room door was caused by leakage in the small porch on the second floor opening off Mr. Roosevelt's bedroom.

1. The replacement or reinforcing of the floor framing as required.
2. The replacement of damaged and previously patched areas of wood flooring to match original.
3. The repair and/or replacement of the wood column pedestals and newels as required.
4. The reproduction and replacement of damaged trim, mouldings, bosses, and railings to match the originals.
5. The realignment of columns and pedestals after the floor structure has been completed.
6. The repair and resetting of balustrade sections.
7. The stabilization of the roof structure as required and the reiraming of the roof area in the northwest inside corner to direct water away from the house walls.
8. The repair and replacement of flashings as required.

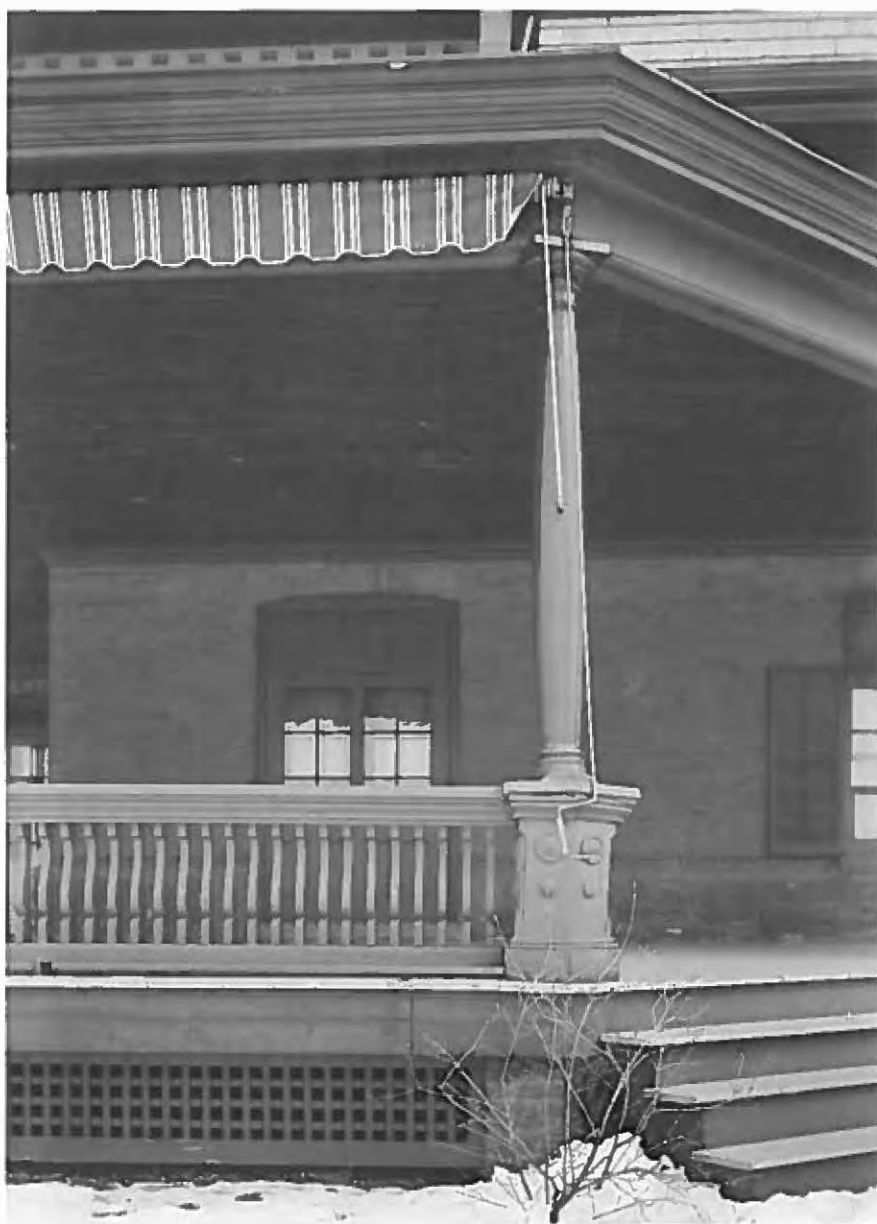
instead of the extension of the porch roof. The rafters of the pergola are rotted and the pedestals of the open railing are also badly decayed.

The corner of the porch on the north side of the house where the Trophy Room was added. The pergola rafters are decayed and will require replacement. Note the heaving of the porch floor in the foreground.

9. Removal of the damaged asbestos shingles and the restoration of the wood shingle roof.
10. Replacement of the pergola rafters on the porch at the north wing.
11. Replacement of missing parts in the latticed panels around the foundation.
12. Replacement of flooring and damaged parts of east and north porches.

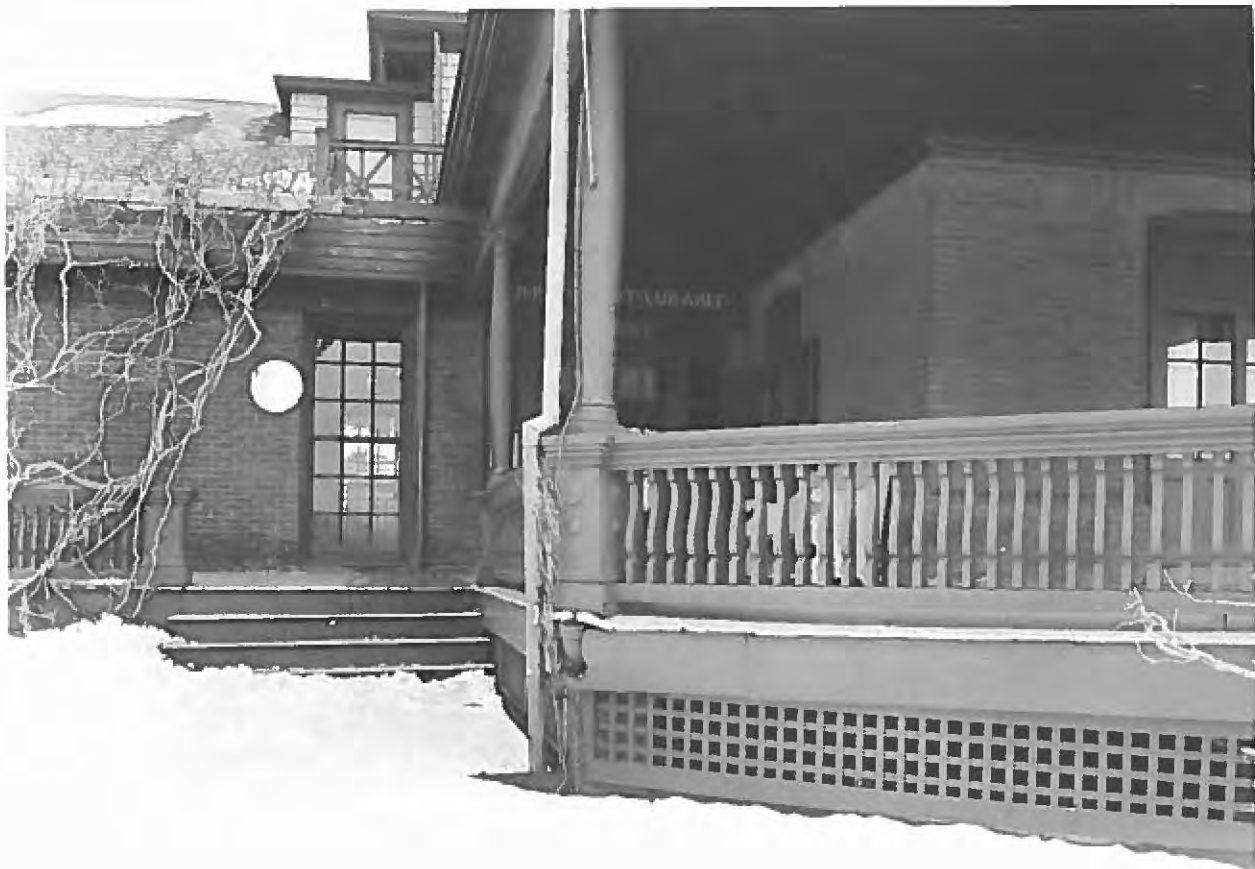
slope toward the house wall above the hall ceiling has resulted due to snow and rain being collected in this corner. The drop in the roof, together with several holes in the flashing adjoining the second floor gallery, has resulted in leaks in the entrance hall below, causing damage to the plaster and wood paneling.

The northwest corner of the porch, showing the partially collapsed pedestal next to the Trophy Room bay on the left. The railing on the roof, near the center of the photograph is the deck opening from Mr. Roosevelt's bath room. To the right of this point, the porch roof is sloping in toward the house wall, causing water damage to the interior. At the right of the second floor railing there are large holes in the metal flashing.

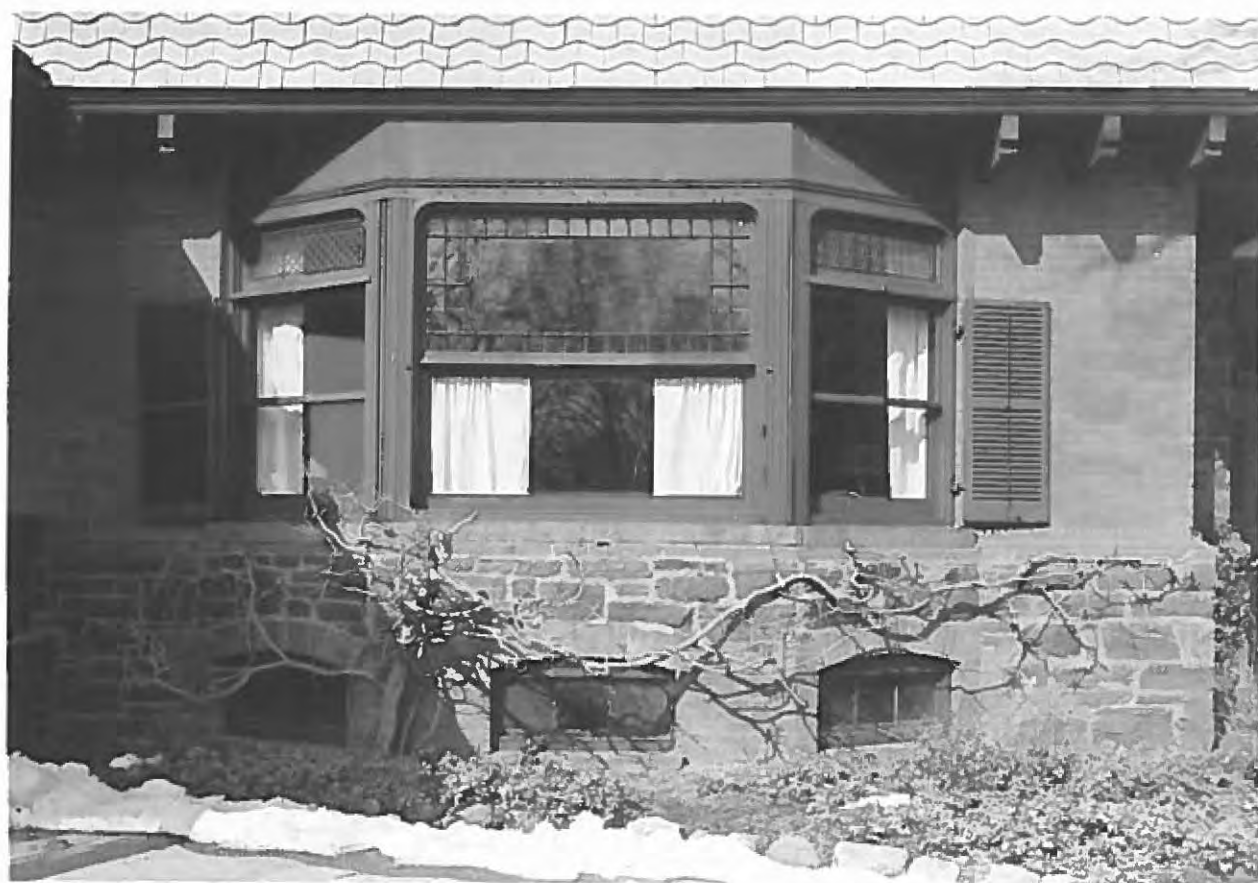
Detail of the condition of the masonry  
at the library bay window.

1. The cleaning of the cavities and loose areas in the mortar of the texture and color and pointing pattern of the original.
2. Resetting of stone, brick and sills at areas such as the library bay window and over the bulkhead cellar entrance.
3. Removal of late patching and replacement to match original.
4. Repointing of foundation under west porch while porch floor is being replaced.
5. Removal of existing red paint on exterior brick walls and the repointing of brickwork as necessary. The coating of the cleaned brick with a waterproof silicone solution.

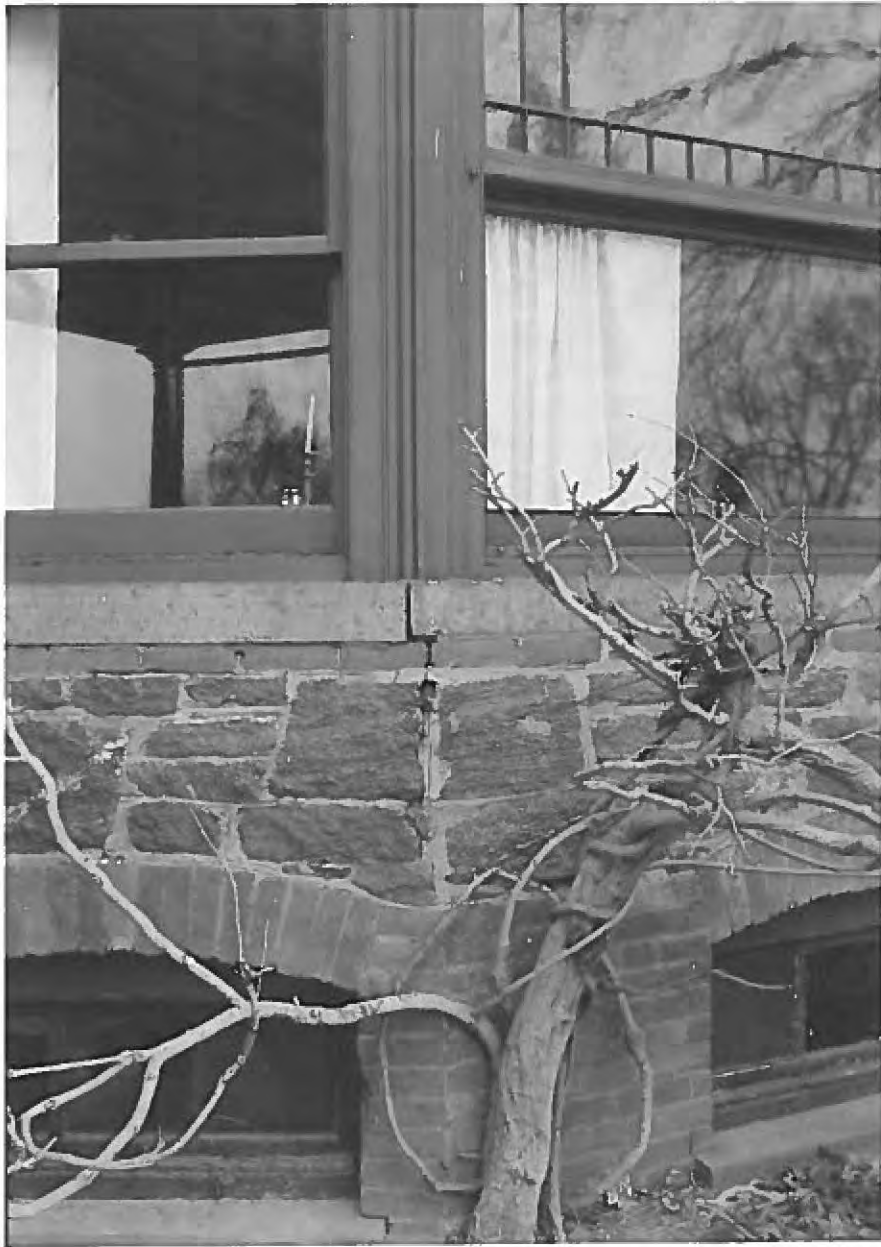
The stone walls of the foundation, the brick walls of the first floor and the brick chimneys show much deterioration of the mortar joints. The brick areas immediately surrounding the basement windows in the stone portion, together with sizeable holes in the stone joints, the area immediately over the bulkhead to the basement in the northeast corner and the wall and window sills of the library bay window are in need of immediate repointing. There is evidence of past attempts at pointing on all exterior foundation walls. In these patches no effort was made to match the original mortar in texture, color or style. The old mortar is of a reddish sandy texture with small lumps of lime imbedded. The pointing between is of the ribbon type. Where the patching is obvious, a modern cement mix was used and a single line made by the point of the trowel.

Photograph showing the condition of the  
stone and brick joints on the south side of the  
house, near the library chimney.

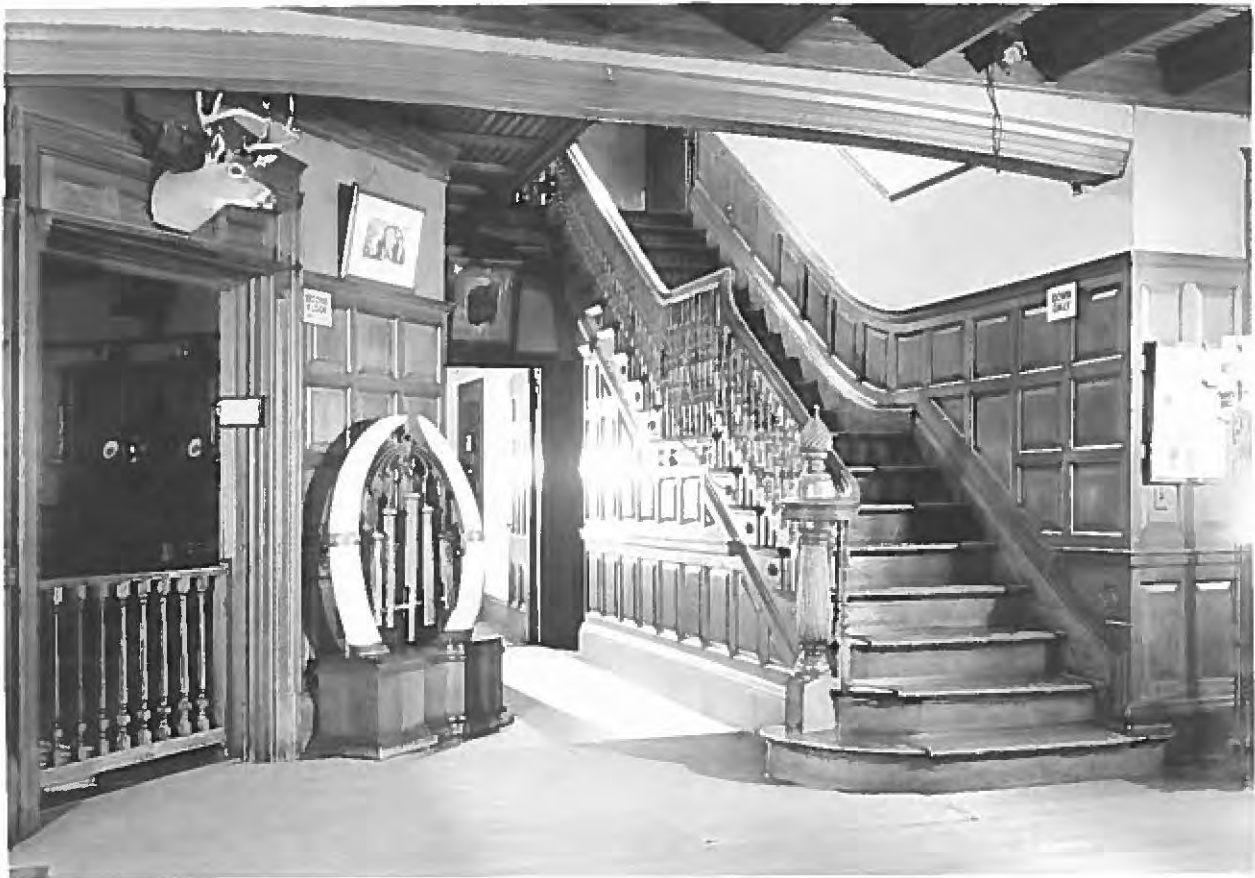
Detail photograph of the newel on the main staircase. Note the wear on the lower tread and broken nose mould on the second riser.
