**INTERIOR PAINT ANALYSIS
GENERAL PHILIP SCHUYLER HOUSE**

**Saratoga National Historical Park
Schuylerville, New York**

By
Maureen K. Phillips

January 1998

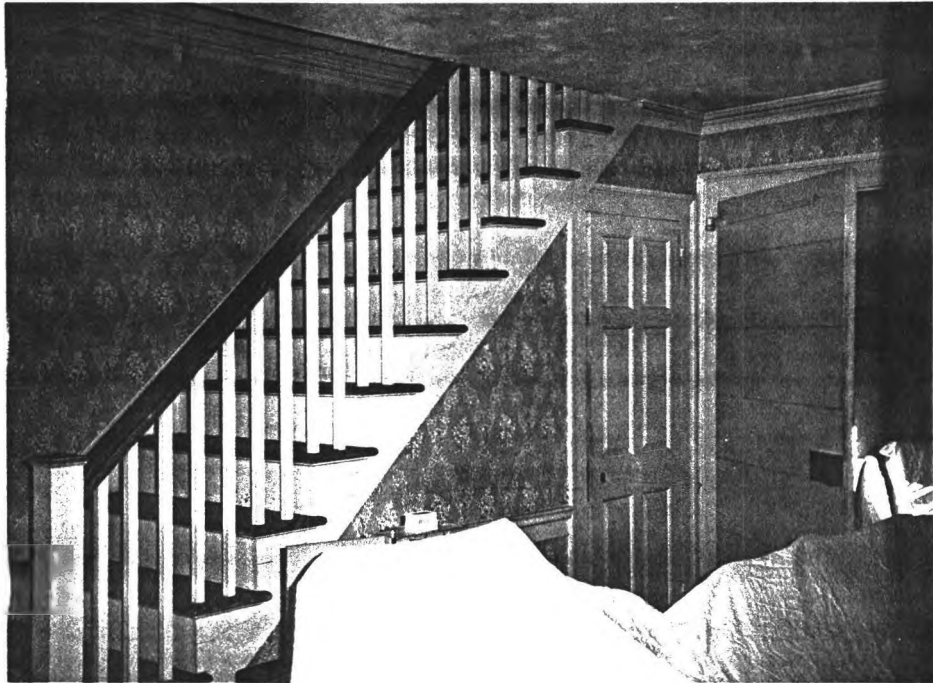
In the original plan of the house, a staircase to the second floor was located along the north wall of the reception hall, with a walk-in pantry on the south wall of the dining room was situated on the other side of the stair wall. In the 1840s the hall staircase was relocated to the east (rear) wall of the room, and the space occupied by the dining room pantry was annexed to become part of the reception hall. The reception hall underwent extensive restoration in 1956, and as a result, many of the extant features appear to date from that time: the extant plaster walls and ceiling were removed; the circa-1849 staircase was removed, the pantry area was restored to the dining room and the north wall in the hall was rebuilt in its original location; the staircase was reconstructed in its original location along the (now new) north wall of the hall (fig. 2); and the walls and ceiling were replastered.

The paint analysis revealed the extent of the 1956 work and the resulting paucity of historic paint evidence remaining in the room. Twenty of the twenty-five paint samples removed from features in the room display paint stratigraphies that date to after 1956. Not surprisingly, all the staircase features sampled (except those taken from the bridging beam and trim around the stairwell - see discussion below) display only post-1956 stratigraphies.¹⁰ Also displaying only post-1956 stratigraphies were all samples taken from cornices, chair rails, baseboard, and ceiling, as well as samples from the surrounds to four of the five doorways and four of the doors. These results suggest that all the aforementioned features were replaced when the plaster walls were demolished and then replastered. However, while it is probable that many of these features are modern (post-1956) reproductions, some may be original or early features that were stripped of paint during the 1956 work. For example, while the *HSR* records that the then-extant door in the main doorway (D101) probably dated to the 1787 renovations, the paint sample taken from the existing door displays only post-1956 paint layers, and the wood substrate viewed under the microscope is extremely clean and light-colored, e.g., it does not appear to be 210 years old.¹¹ However, there is no record that the door in D101 was replaced in 1956 (or later) with a reproduction. Therefore, even though the extant door appears to be a reproduction, it may date to 1787 and have had its paint history stripped in 1956.

Figure 2. Reception Hall (Room 101), View of Northeast Corner Showing 1956 Reconstructed Staircase (1997).

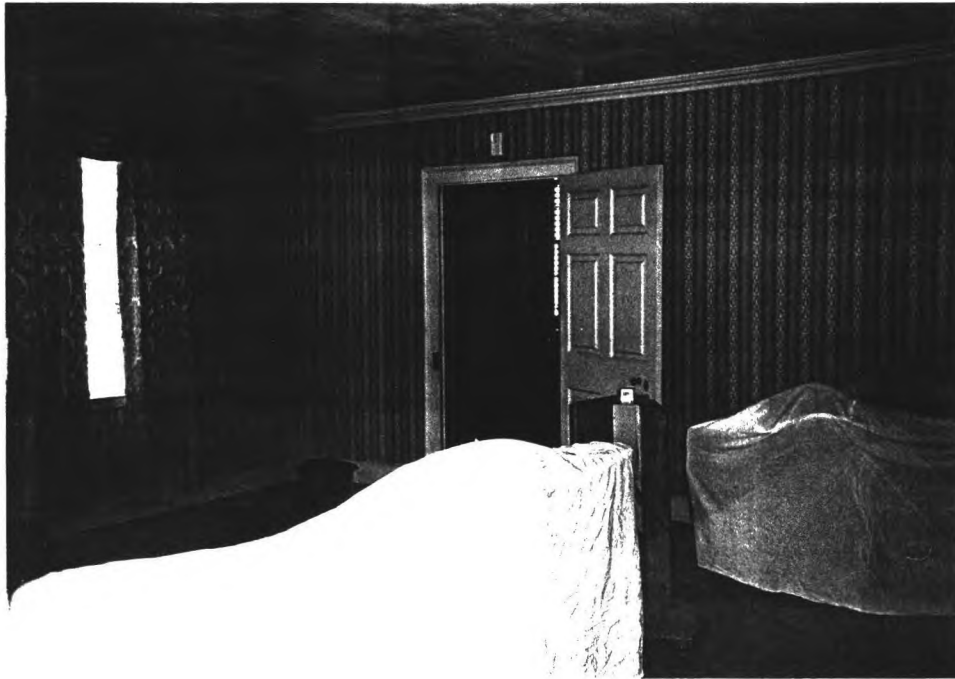
The woodwork in the parlor would not have been painted gray at the same time that it was papered with the salmon and gold-color wallpaper that is currently hanging on the walls in the room. According to the *HSR*, this paper was the first of eight layers found on the plaster walls before they were demolished in 1956 and was thought to have been the paper installed in circa 1789. Enough sheets of the original wallpaper were saved to paper the west wall of the room. The remaining walls were covered with a reproduction paper based on the document paper (**fig. 3**). However, the report also states that a ninth layer of wallpaper was found on the fireplace walls, apparently sometime after the first eight had been removed (although this is not clear). This paper has a light gray background with a pattern of small wheat sheaves in green, and was reproduced for use in the dining room. It is possible that the gray-color wallpaper, rather than the extant salmon and gold wallpaper, was the first (circa-1789) paper hung in the room, and that the woodwork was painted gray to match. Analysis of the wallpaper fragments removed from the parlor will help clarify the dating of both the wallpaper and of the paint evidence found in the room.

Samples removed from four features in the parlor (the sash to W105 and the baseboard on the west wall, the surround to the parlor doorway (D107) on the north wall, and the cornice over the fireplace on the south wall) each had nine layers of paint - the lengthiest stratigraphies of all the samples from the room. The first paint layer in each of these samples is a tan-cream color that is very similar to the first layer found in samples from three features in the reception hall and to the fourth layer found in the sample from reception-hall side of the parlor door that contained the circa-1777 and circa-1787 paint layers. This tan-cream layer is therefore thought to date to after 1787, possibly to the 1840 renovations, as are the features on which it is found as the first layer. The surround to window W105, and the sash in window W108 on the south wall, have stratigraphies that date to the circa-1958 NPS restoration work. The mantel displays only one layer of paint, reflecting that it was installed in the room in 1960.¹³

Figure 3. Parlor (Room 102), View of Northwest Corner Showing Surviving Early Wallpaper on Left (West) Wall and Reproduction Wallpaper on Right (North) Wall (1997).

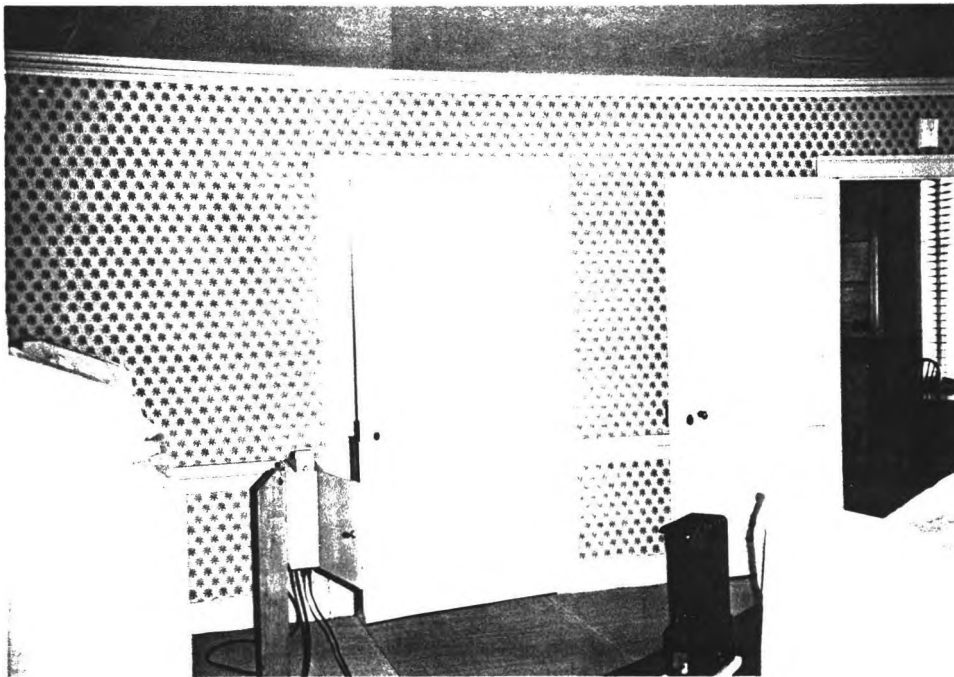
The woodwork in the dining room (Room 103 - **fig. 4**) of the Schuyler House is thought to have been painted cream in 1777 and light green in 1787. Very little paint evidence remains in the room, and it is again from one sample that the early paint colors have been determined. That sample, removed from a section of baseboard on the south wall, contains the most extensive stratigraphy of all the samples taken from the three front first-floor rooms in the main portion of the house. The *HSR* recorded that in 1956 "a few short sections of six inch beaded baseboard" that dated to the 1777 construction of the house had survived (page 20), and it seems likely that the paint sample was removed from a section of this early baseboard. The sample contains 19 layers of paint. The first layer, which is thought to date to circa 1777, is a cream color (Munsell 2.5Y 8/4) that is darker than the circa-1777 light-cream first layer found in sample with the longest stratigraphy in the reception hall, and lighter than the circa-1840 tan-cream four layer found in the same sample. The second paint layer, thought to date to circa-1787, is light green (Munsell 2/5 GY8/2). This green layer was finished with varnish to add gloss, a common decorating practice for dining rooms in the eighteenth and early nineteenth centuries.

Of the other paint samples removed from the room, one from the cornice shows the first-layer of tan-cream that may date to circa-1840. The remaining samples all display stratigraphies that date to 1958 or after, including a sample taken from a sash in the window opening (W111) on the south wall that replaced a doorway in 1960,¹⁴ and a sample removed from a sash in a window opening (W102) that the authors of the *HSR* thought dated to 1787 (see **ANALYSIS - Overview**, above).

Figure 4. Dining Room (Room 103), View of North Wall Showing Circa-1958 Pantry Door and Reproduction Wallpaper (1997).

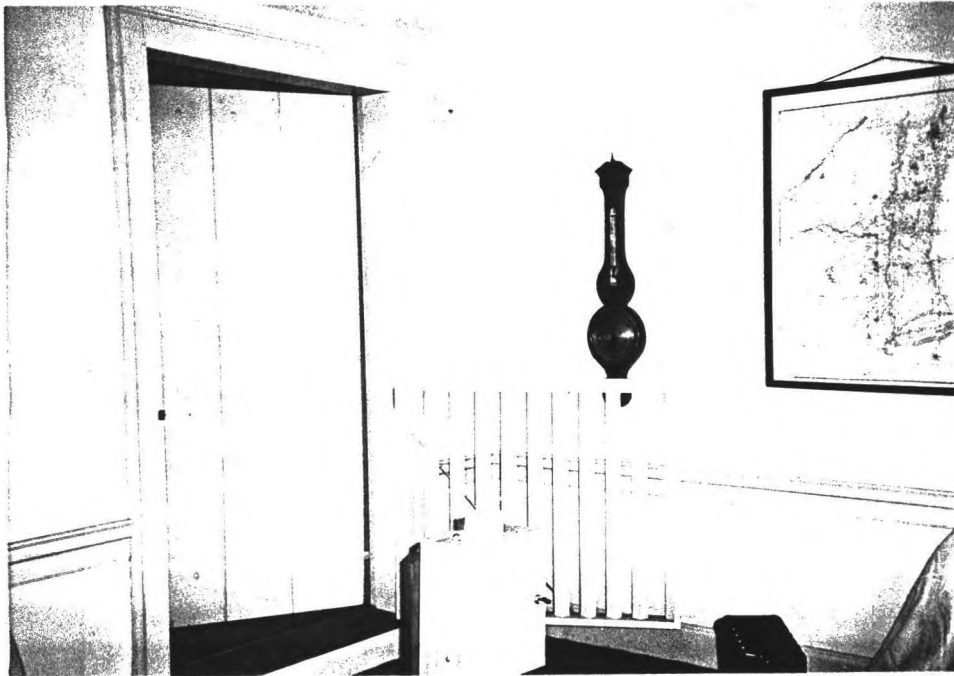
While the original "father's office" was probably built in 1787, the extant room (fig. 5) was reconstructed by the NPS in 1960.¹⁵ It is therefore not surprising that the paint samples removed from all the features in this room contain only a white primer coat and two layers of light-cream paint. These paint layers were used in the comparative dating of paint layers in samples removed from features in the other rooms of the main house.

Since the office is a 1960 reconstruction, there is no evidence that would help determine the room's early paint scheme. It was probably finished simply, with painted walls (instead of wallpaper) as well as woodwork. Since the room is adjacent to the reception hall, the woodwork in the office was probably painted to coordinate with the paint color in the hall, which in 1787 is thought to have been gray.

Figure 5. Circa-1959 Office (Room 104), View of Northwest Corner (1997).
