INVESTIGATION OF THE OLD MILL AND TAVERN IN
SHENANDOAH NATIONAL PARK 134/133244

By: Thor Borresen

Shenandoah NP

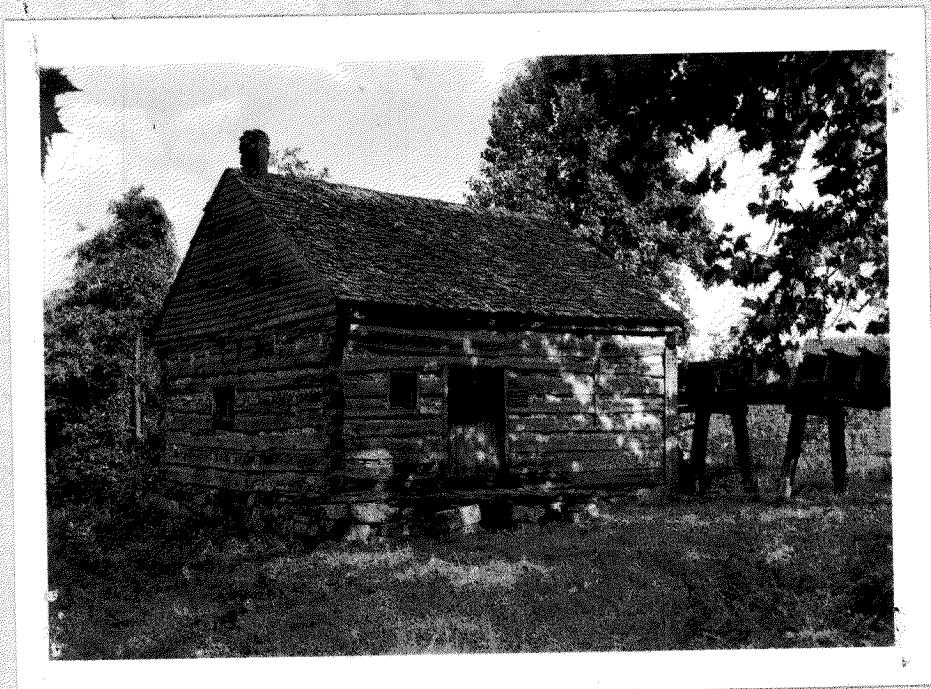
Old Mill #1

replacing, the cabin is in good condition and is quite large (see photograph No. 1).

This view shows the front and east end of the mill.
A section of the old flume can be seen, right center.

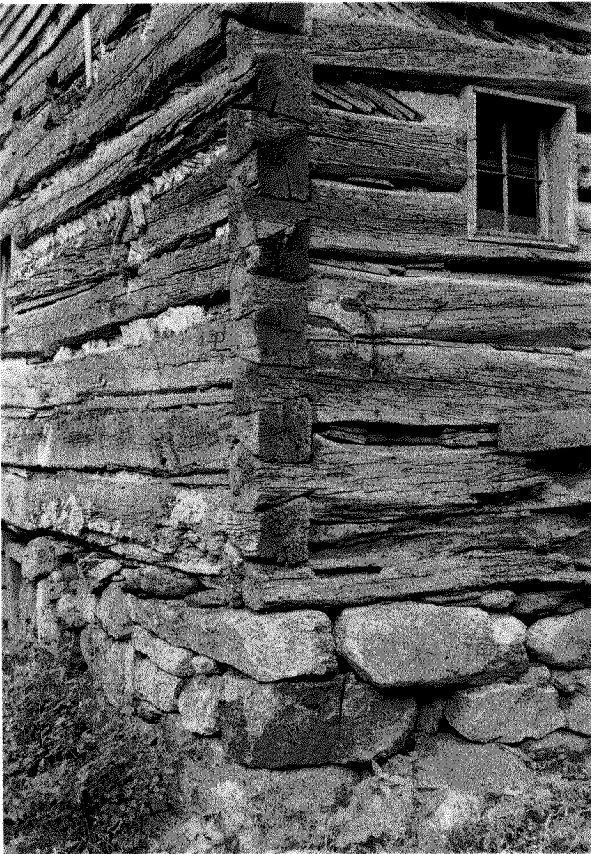
Old mill # 2;

The cabin rests upon a dry stone wall. Due to the sloping hill on which it is built, it was necessary to construct a rather high rear wall. This wall will need considerable repair. Several of the stone piers on which the machinery rests within the basement of the building also need repairs. The corner joints of the cabin are of the dove-tail mitre cut, which prevents water from leaking into the interior of the building. The fitting of the mitre cuts is excellently done (see photograph No. 2).

Instead of using the customary flat stones or saplings for chinking the logs, small pieces of flat wood or boards have been used, the whole plastered over with clay (see photograph No. 2). The end of the building facing the water wheel has been clapboarded over the logs. This was done in order to protect the logs and to prevent the water splashing over the water wheel from washing out the chinking between the logs (see photograph No. 3-4). The water wheel is constructed of oak and is about 18 to 20 feet in diameter. There is much work to be done on the wheel in order to put it in good working order. However, it appears that all parts are there, although much of it will have to be renewed. It will permit us, however, to get accurate measurements of any part that must be replaced if the restoration is not delayed too long. The interior of the mill is in good condition; the machinery appears to be all there and has been well cared for.

This shows the mitre-dovetailed corners of the mill.
Note, instead of flat stones or caplings for chinking the
walls, small handsplit wooden blocks is used to hold
the clay.

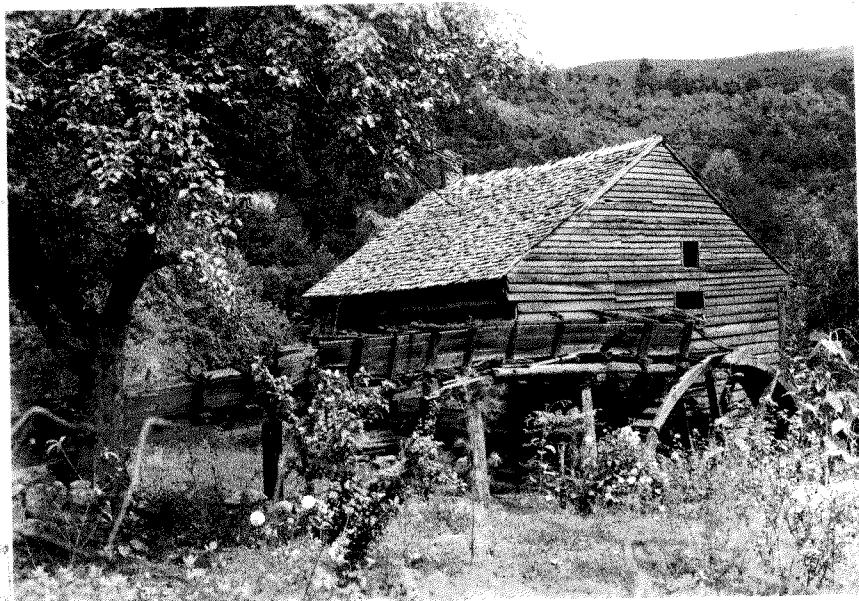
Old Mill # 2;

The water flume is still there, though in a dilapidated condition (see photograph No. 1-5-4). However, enough remains to give us an accurate dimension of all its parts. The dam is located a few hundred feet south of Spotswood trail. The old wooden culvert, or flume, crossing the trail is still there. The top of the culvert forms the bridge over which all the traffic formerly passed.

This view shows the west end of the mill. Note entire side of the building clapboarded in order to protect the logs and chinking from water splashed by the water wheel. Note also the present condition of the flume.

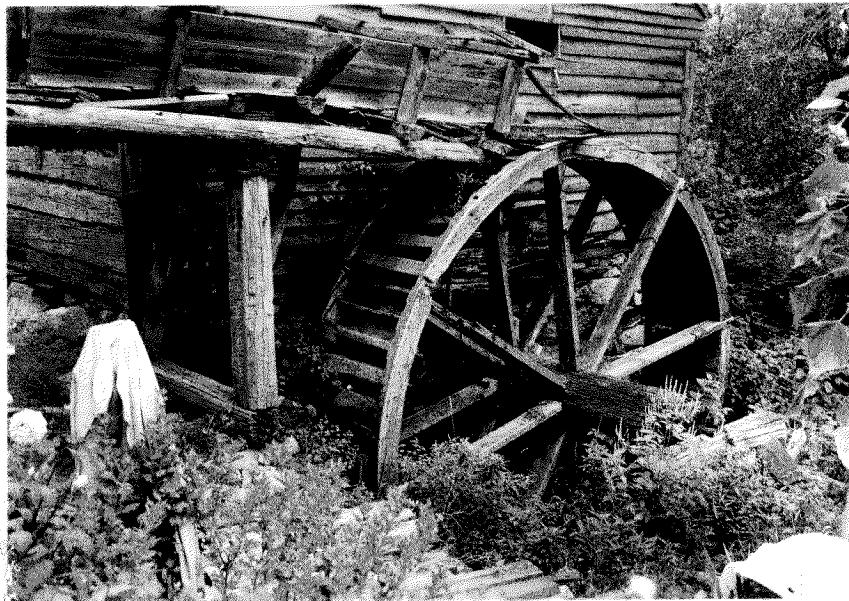
old mill # 4

This view shows the present condition of the water wheel, and wooden drive shaft. The entire shaft and a large part of the wheel needs to be replaced.

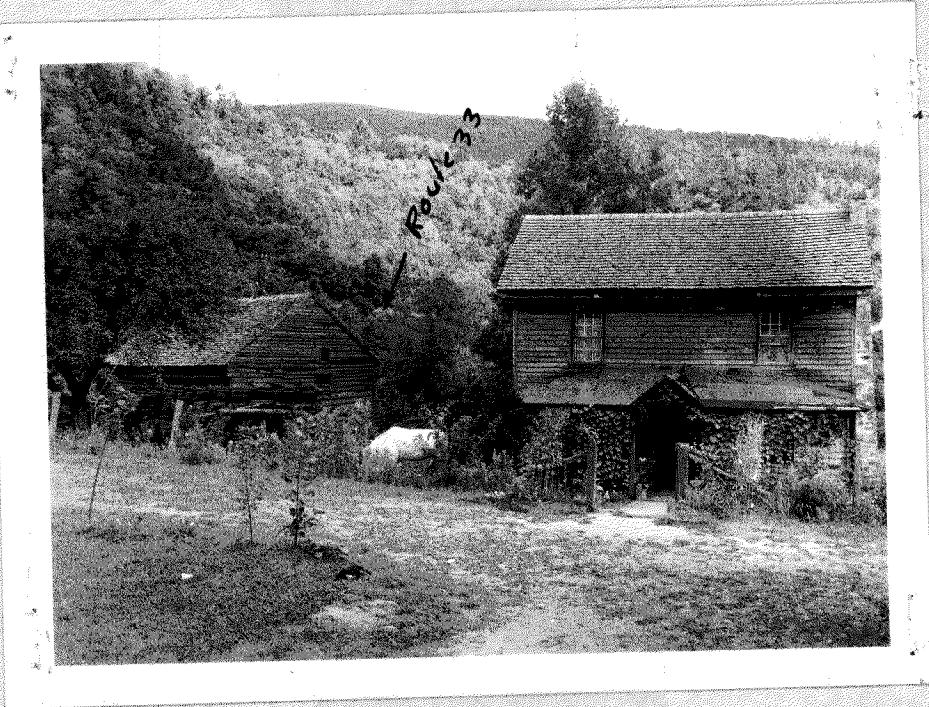
old mill & 3;

The old mill has an ideal location and a very artistic setting directly under the Shenandoah Mountains. The new highway, Route 33, is about a quarter of a mile distant (see photograph No. 9). There are ample parking facilities in the immediate vicinity of the mill.

This view shows the old mill (left center) in its relation to Route # 33, the Millers house right center. The Old Spotswood Trail is shown passing in front of both structures.

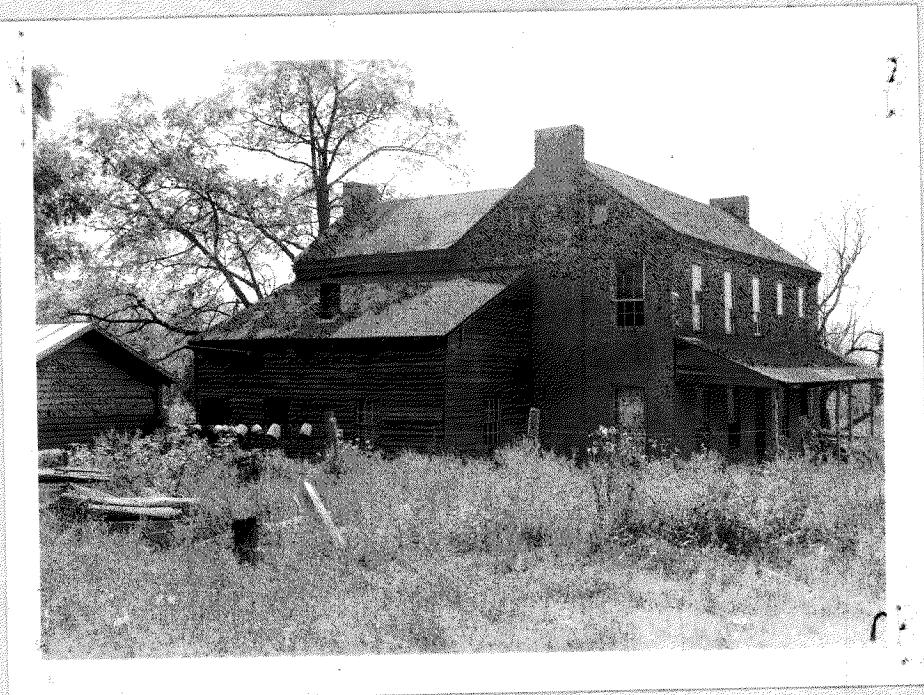
Old Tavern # 15

This view shows the front, and the east end of the structure. The front faces the Old Specwood Trail. Both the front porch and the lean-to are later additions.

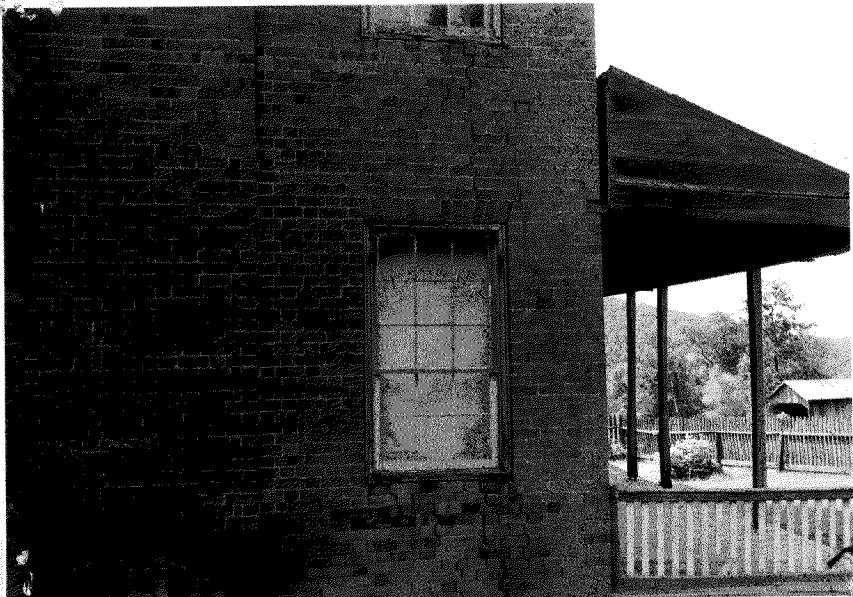
Old Tavern # 2;

This view is a close up of the east wall, and shows the condition of the masonry wall.
Note how the present porch is separating from the structure.

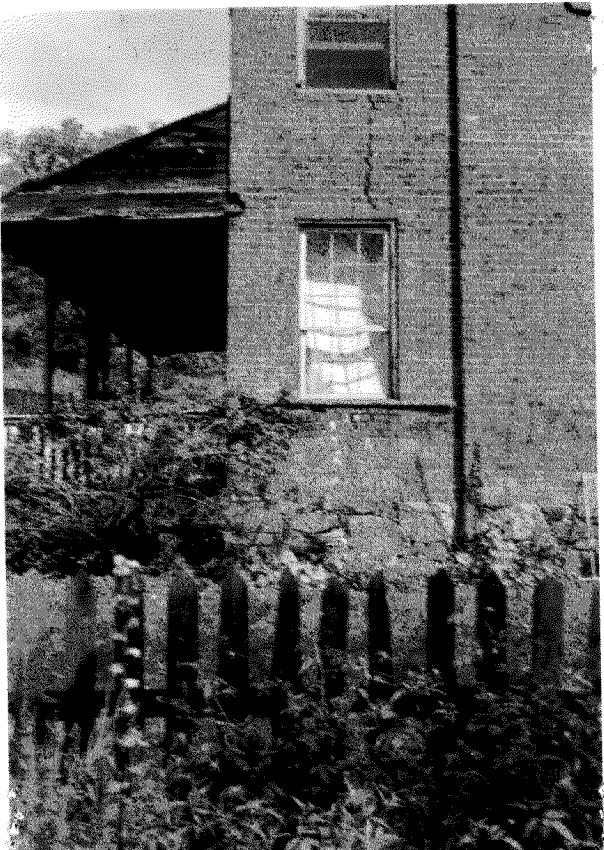
Old Tavern # 5:

This view shows the condition of the masonry of the west wall. The shifting movement of the porch in strong winds is responsible for many loose bricks in the wall. The porch should be stabilized until a decision is made in regards to the entire structure.

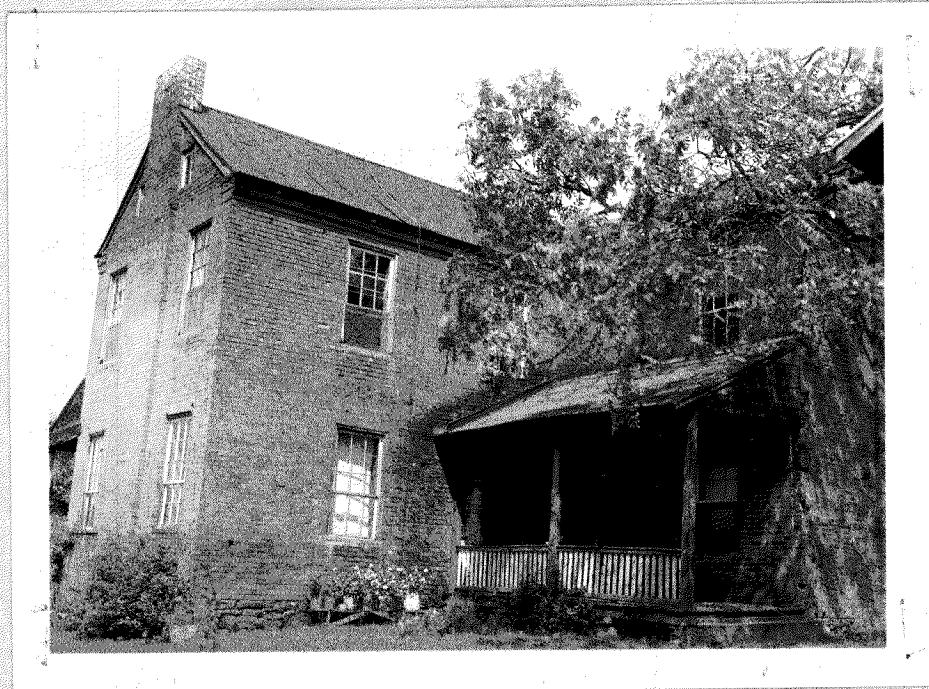
old tavern # 4;

This view shows the south side of the building, the disappearance of the mortar between the bricks are quite noticeable. Note the heavy brick fascia under the eaves.

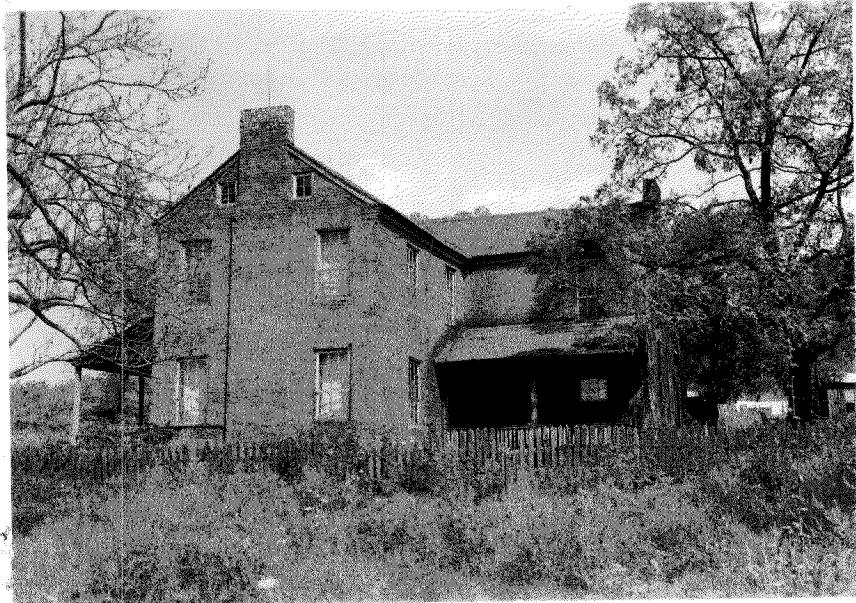
Old Tavern # 81

This view shows the west and south sides of the building. The camera was placed in center of the road constructed previously to route # 81. This road is the one suggested as an approach road to the tavern, and permits ample parking facilities.

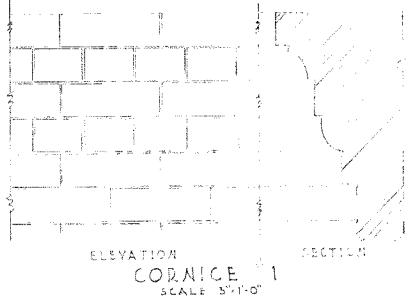
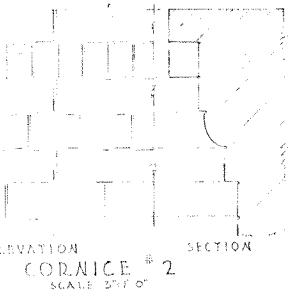
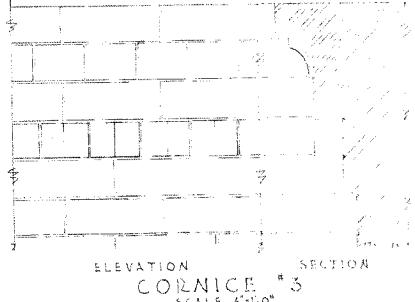
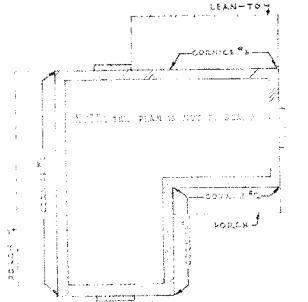
Building #1

This drawing illustrates the three different types of brick fascia laid under the eaves, of the old Tavern.
