historic structures report

mechanical/electrical rehabilitation

main building

STATUE OF LIBERTY ELLIS ISLAND

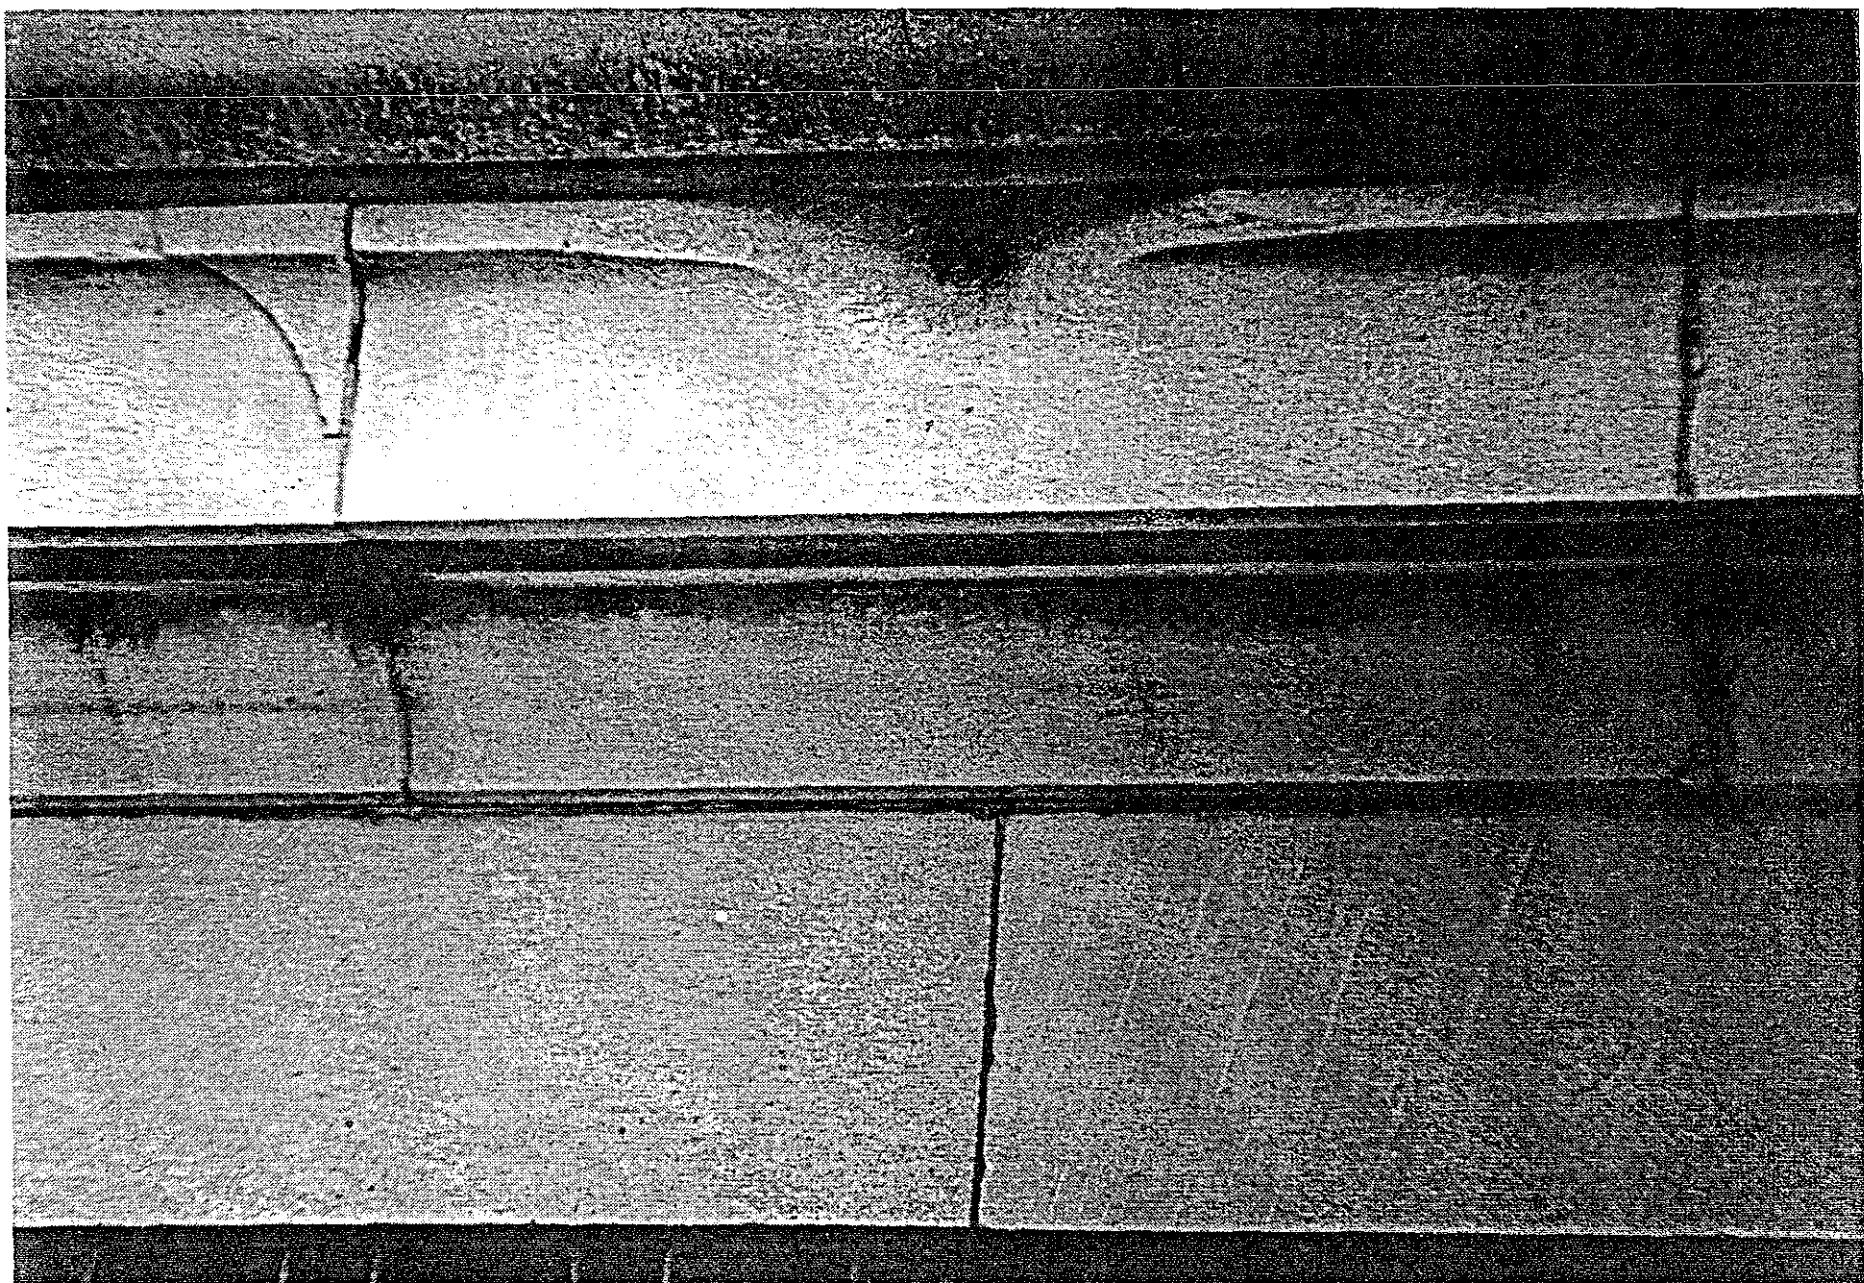
Spalling caused by grill anchors in window E105.

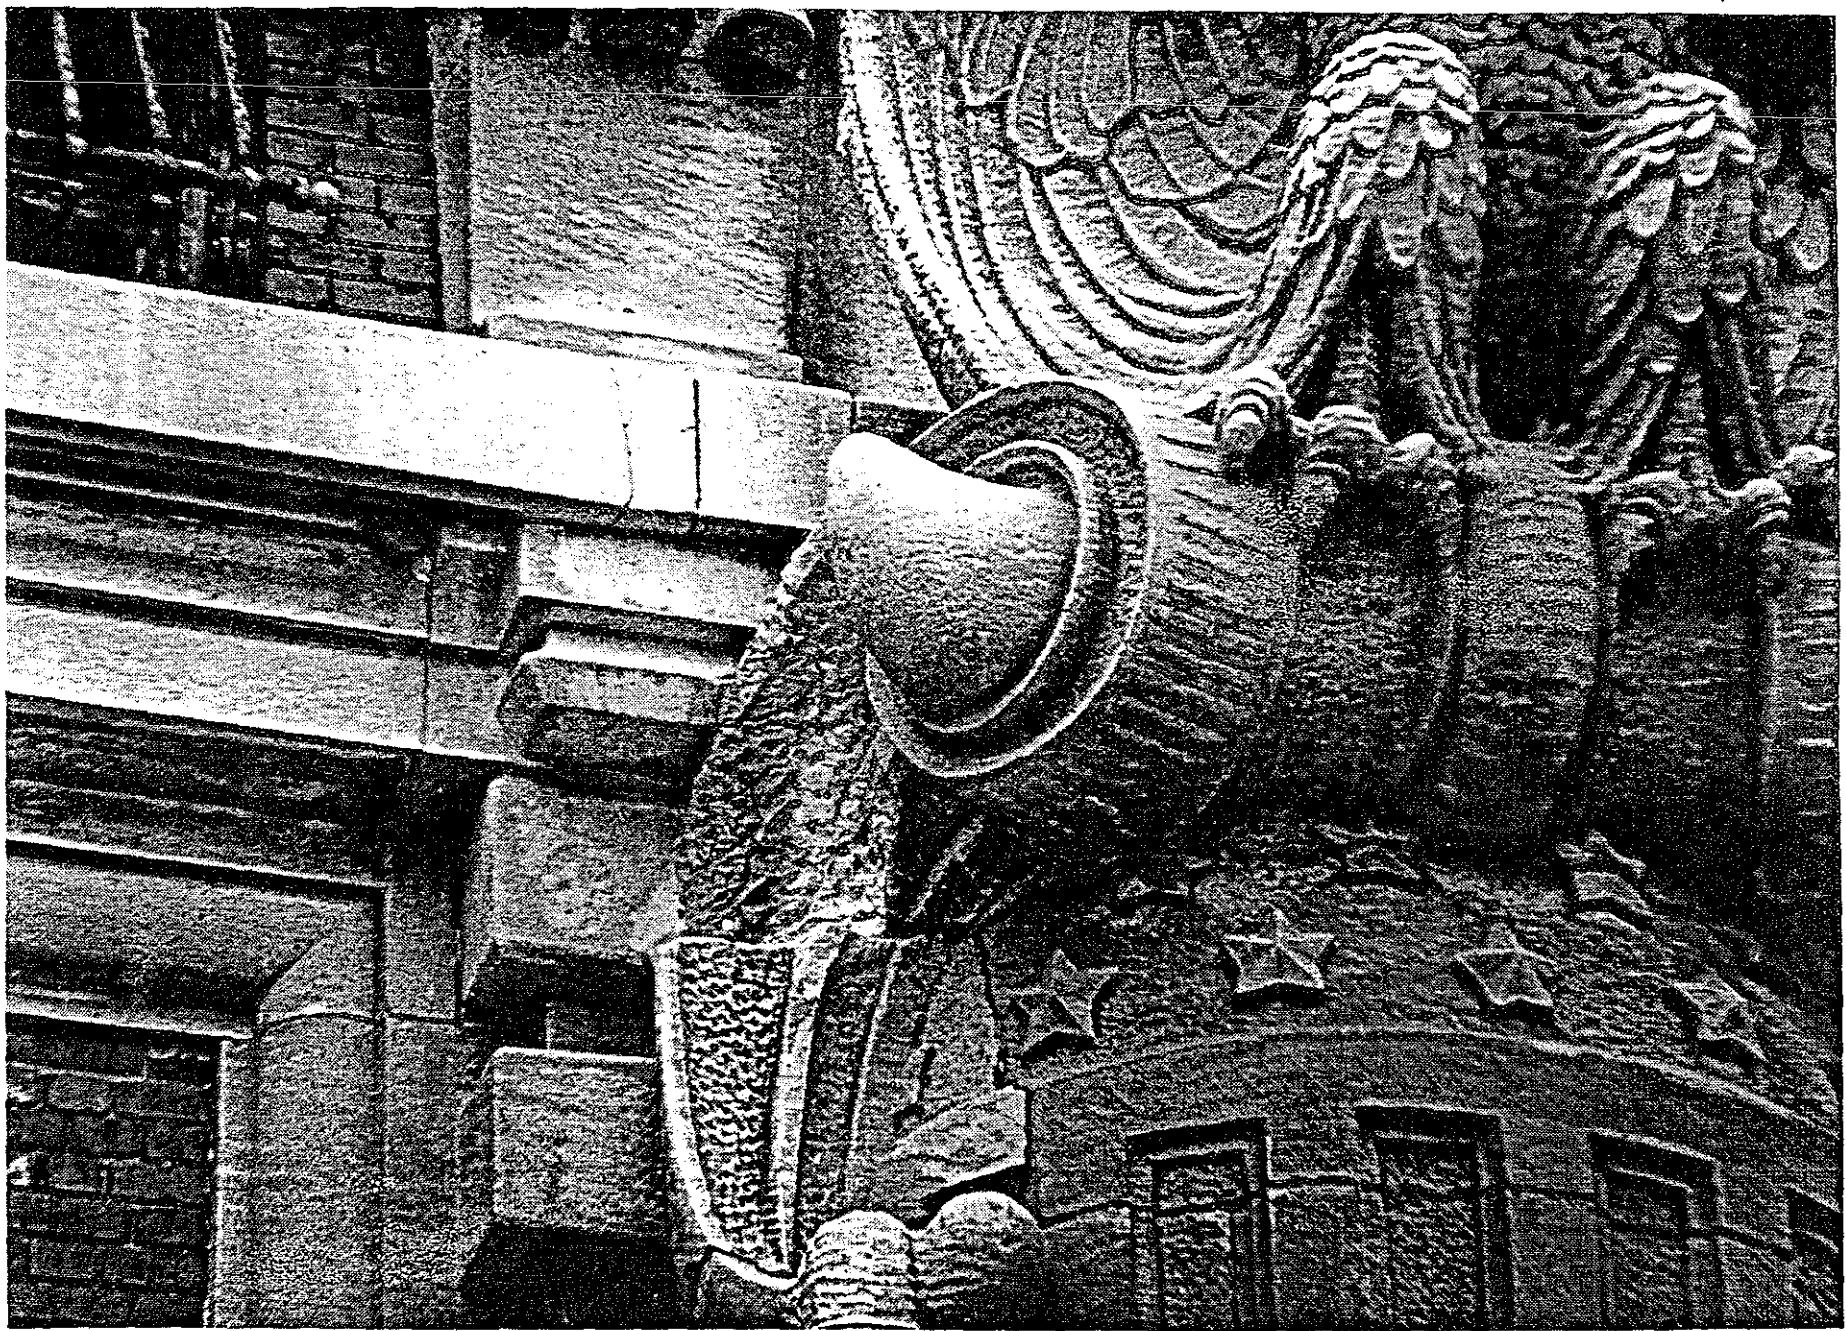
Figure 49. Spalling on top of scrolls which are part of the northwestern sculpture group.

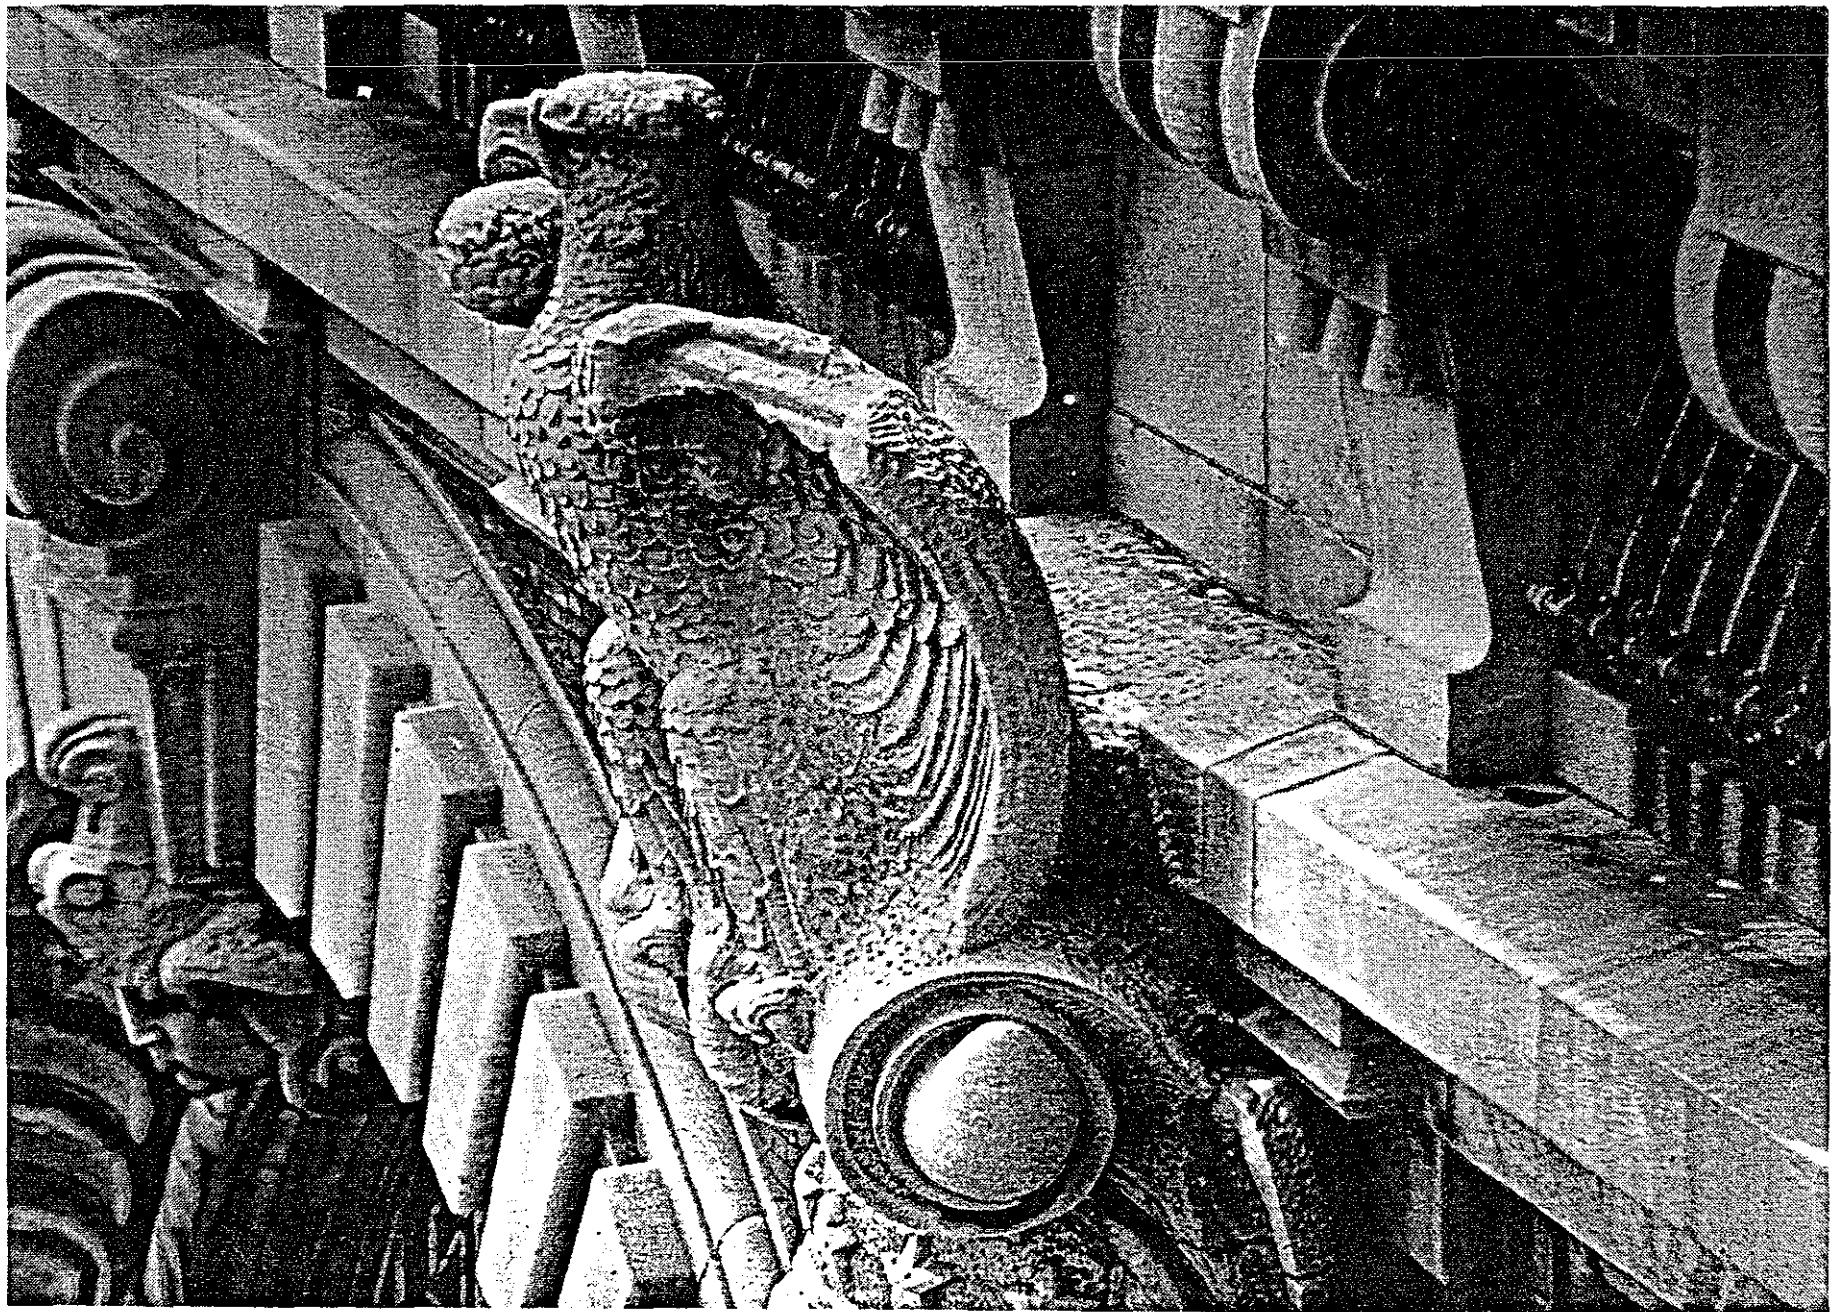
Figure 50. Damaged stone wing on the northwestern eagle.

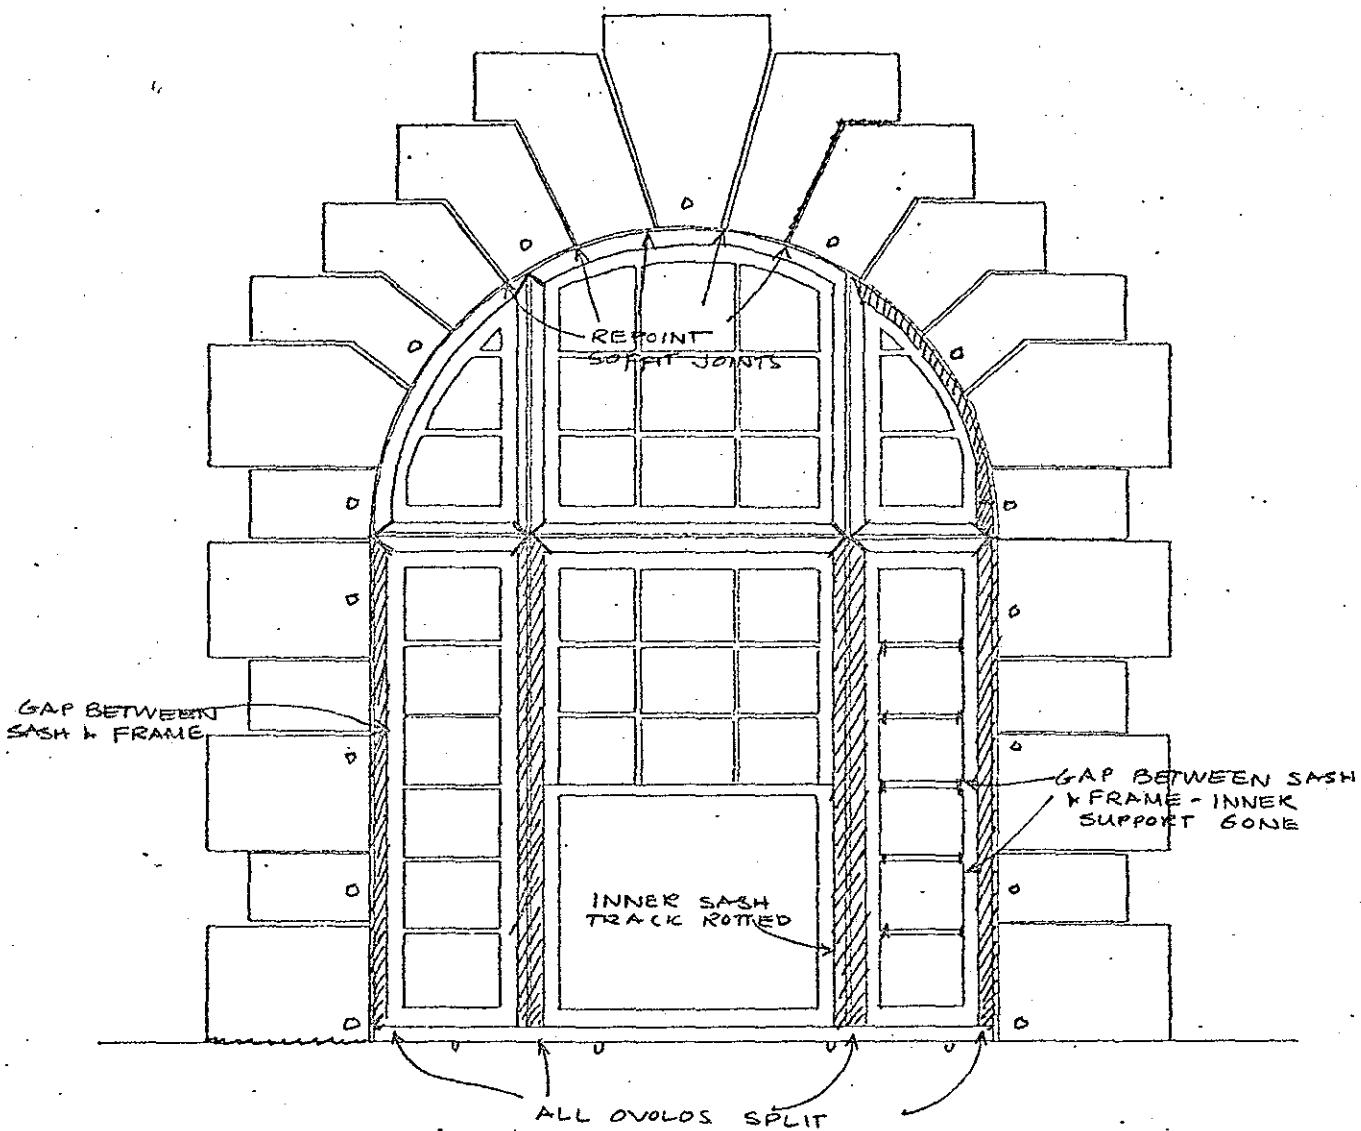
B1 FIRST FLOOR	NUMBER N101	CLASS 2
MCHANICAL AND ELECTRICAL REHABILITATION MAIN BUILDING ELLIS ISLAND Statue of Liberty National Monument, New York	BUILDING CONSERVATION TECHNOLOGY THE DEDENHARDT GROUP 19 West 44th Street, New York NY 10036

UPPER & LOWER SASH IN CENTRAL WINDOW JAMMED OPEN

GRILL REMOVED

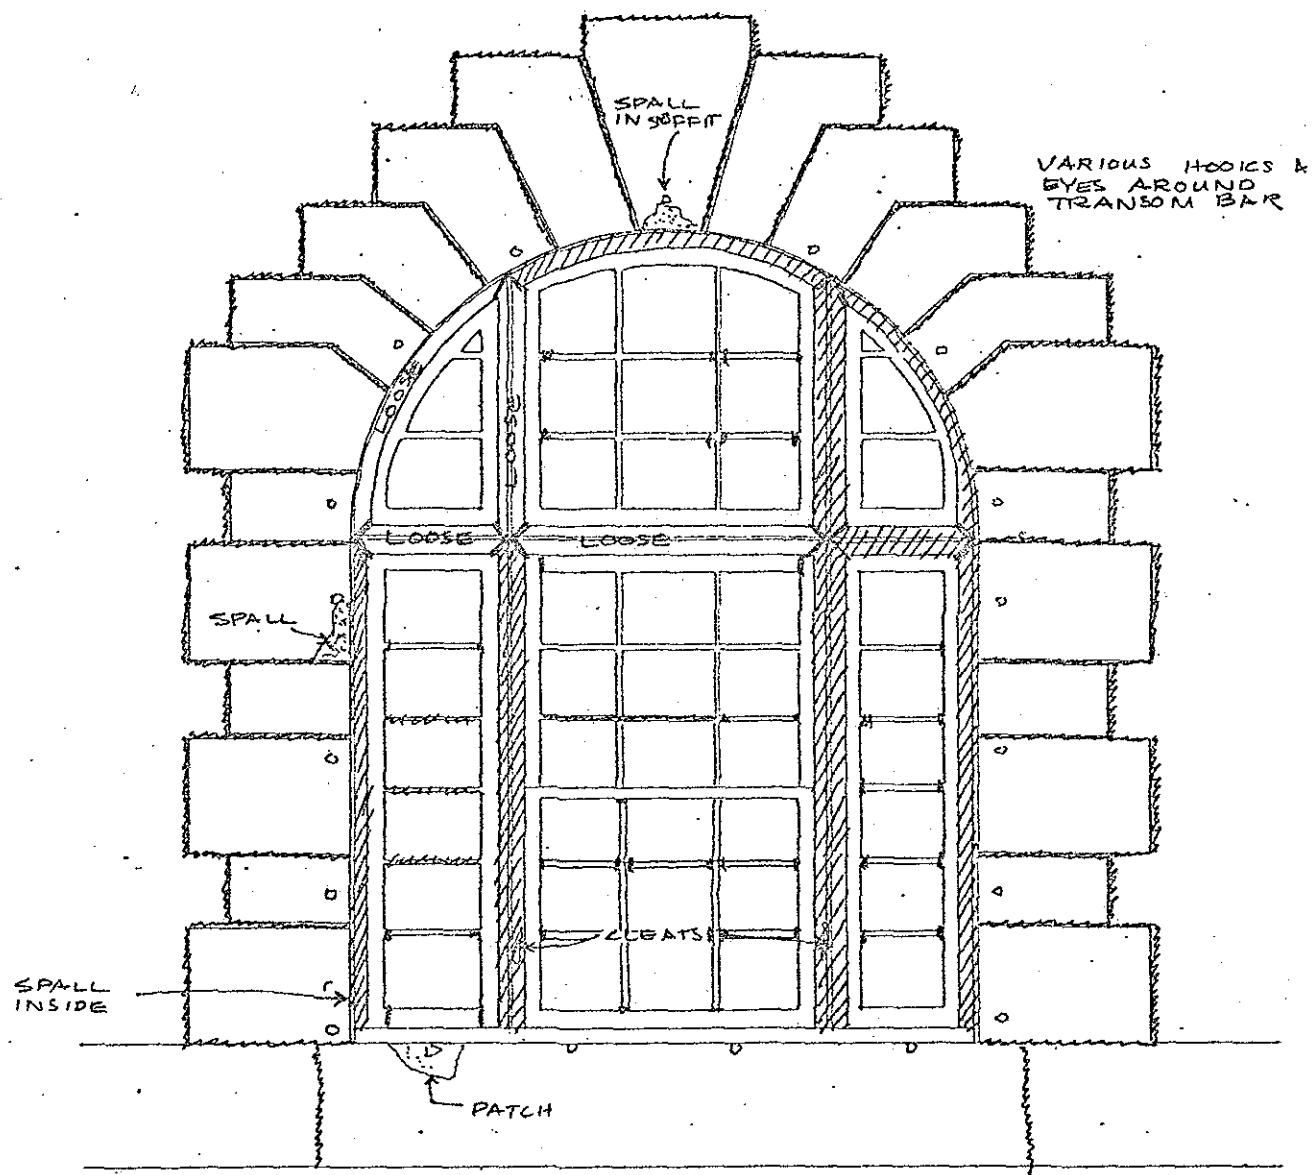
B1 FIRST FLOOR	NUMBER N 102	CLASS 2/3
MECHANICAL AND ELECTRICAL REHABILITATION MAIN BUILDING ELLIS ISLAND Statue of Liberty National Monument, New York	BUILDING CONSERVATION TECHNOLOGY THE BREWSTER GROUP

INTERIOR:
 -STOPs MISSING, ROTTED, LOOSE
 -STOOLS ROTTEN

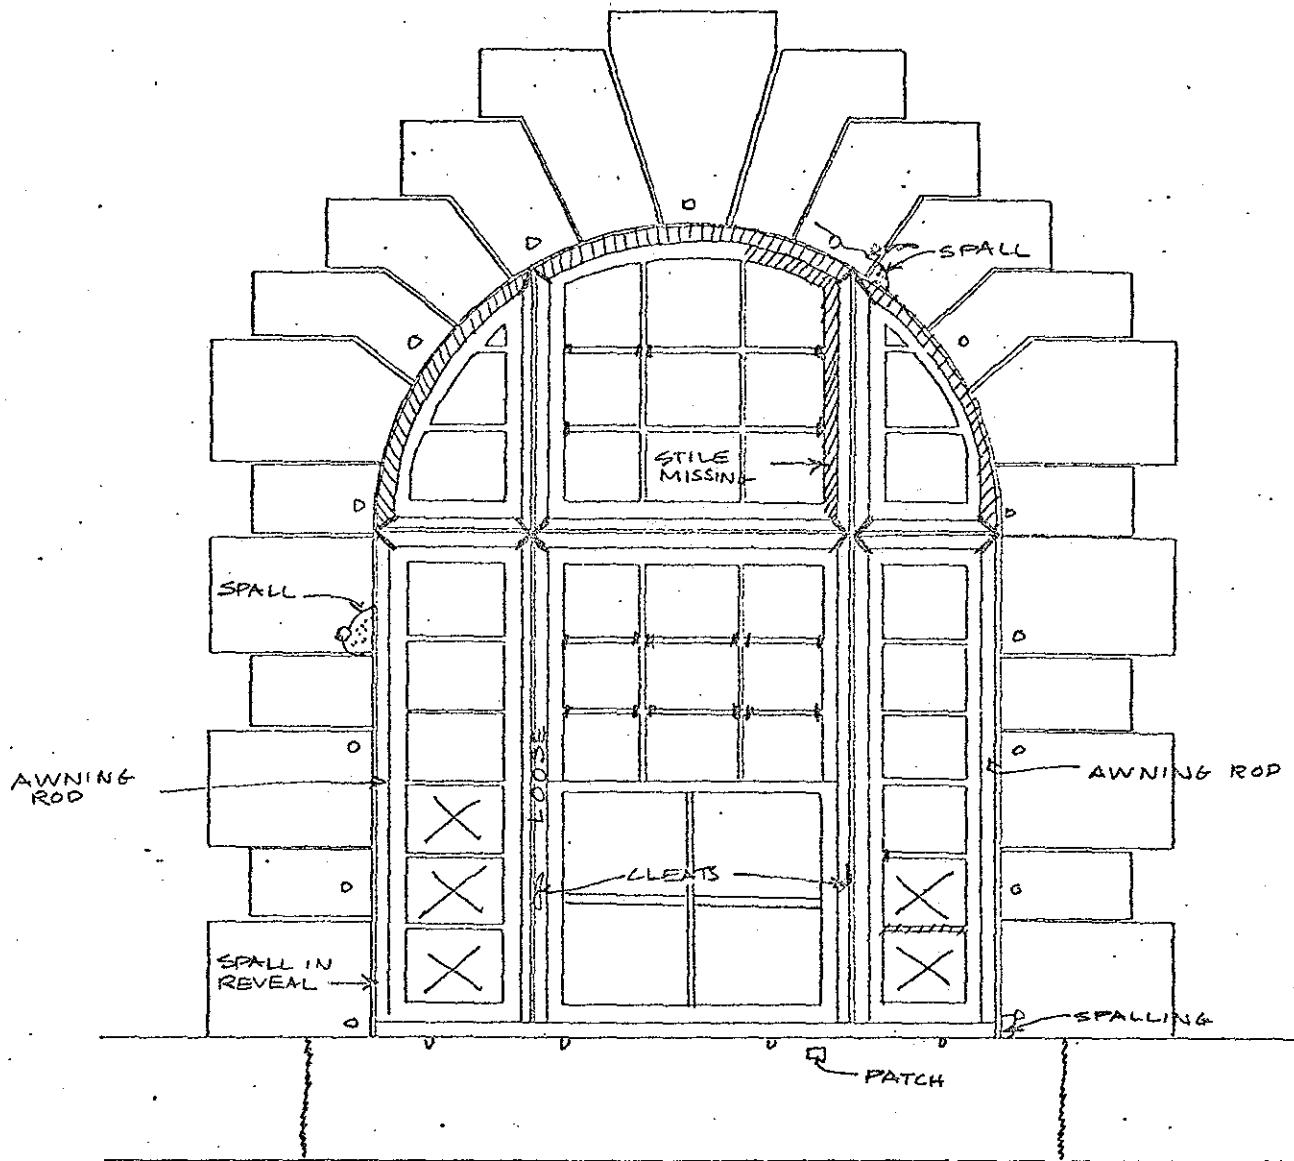
B1 FIRST FLOOR	NUMBER N 103	CLASS 3 wood
MECHANICAL AND ELECTRICAL REHABILITATION MAIN BUILDING ELLIS ISLAND Statue of Liberty National Monument, New York	BUILDING PRESERVATION TECHNOLOGY THE DEDONIOTZ GROUP	2 stone

INTERIOR: SASH STOPS ROTTED, LOOSE

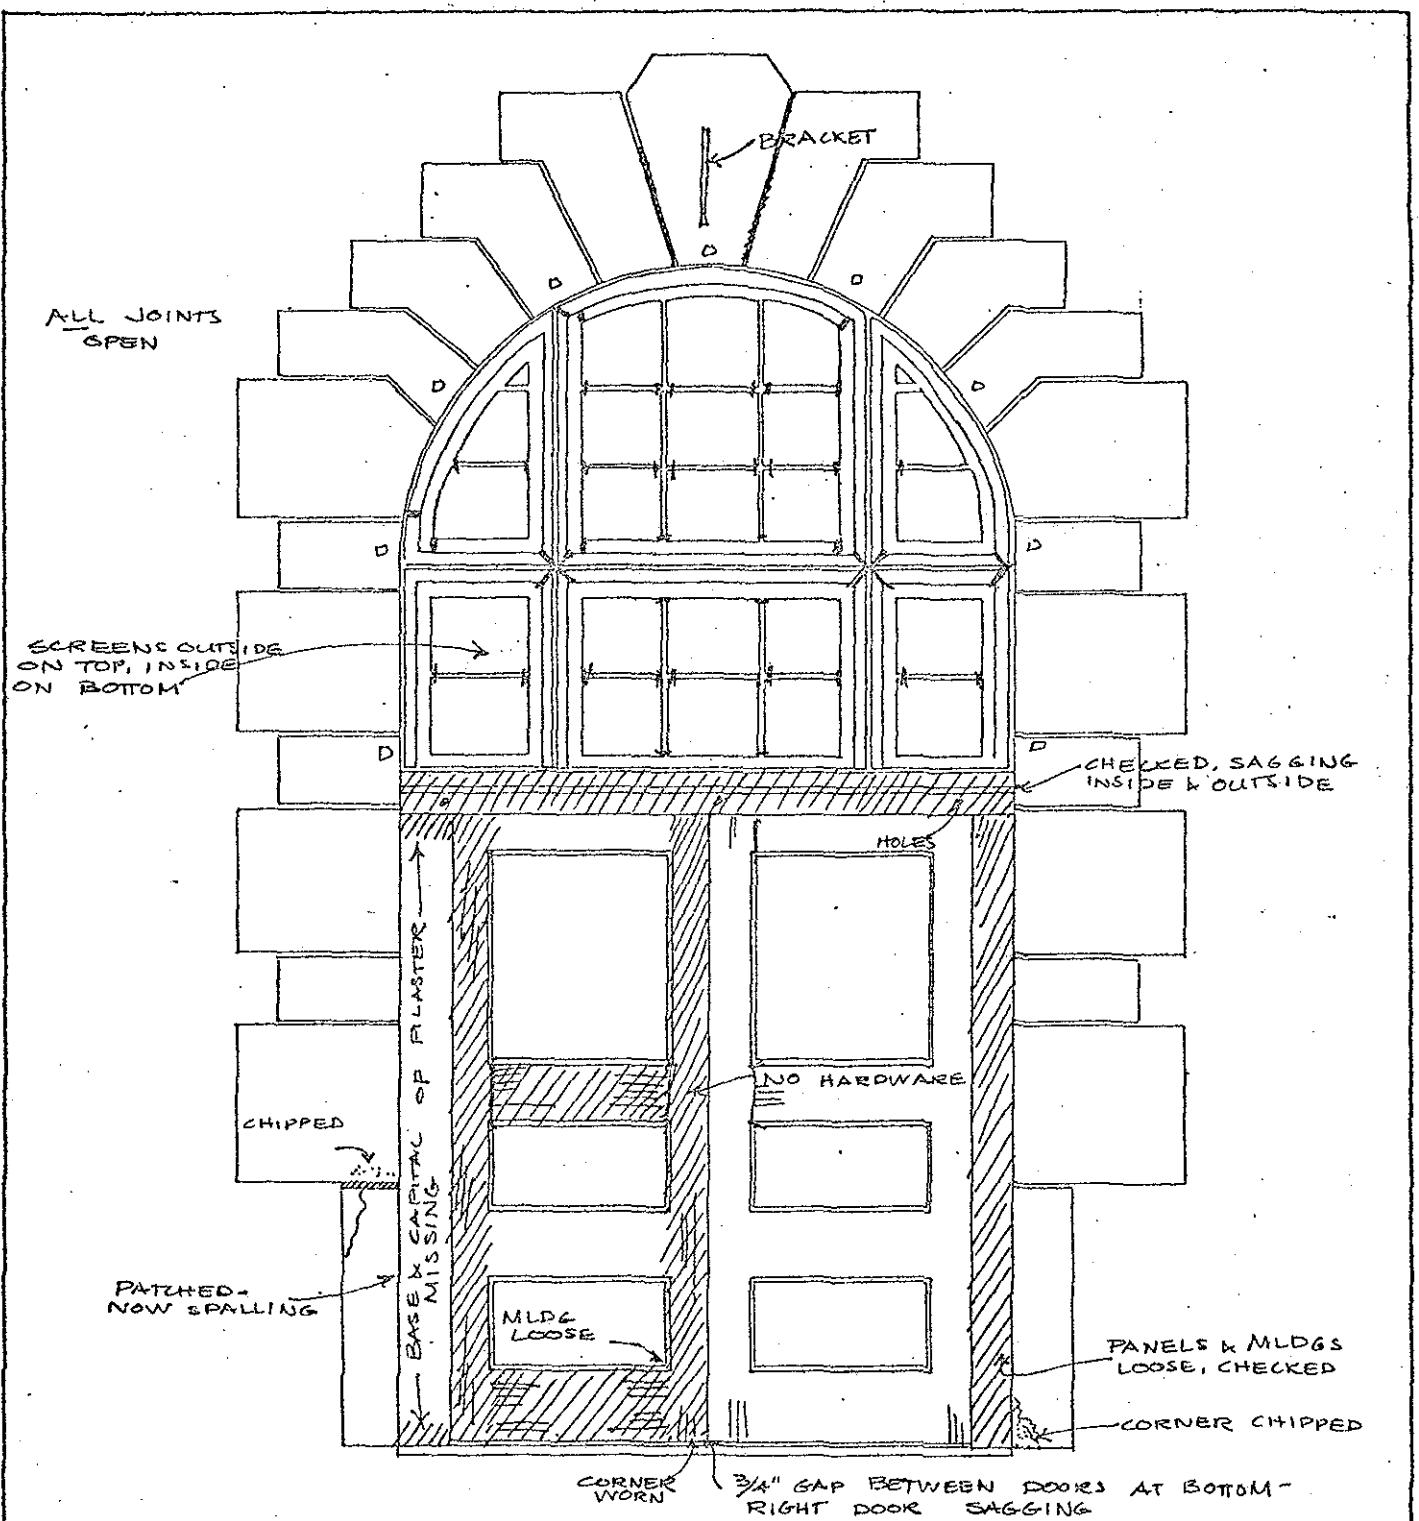
B1 FIRST FLOOR	NUMBER E 105	CLASS 2 wood, 2 stone
MECHANICAL AND ELECTRICAL REHABILITATION MAIN BUILDING ELLIS ISLAND Statue of Liberty National Monument, New York	BUILDING CONSERVATION TECHNOLOGY THE EISENBERG GROUP	19 West 44th Street, New York NY 10036

SCREEN DOORS. INSIDE
GRILLS OVER DOOR WINDOWS CORRODED
ARE DOORS ORIGINAL?

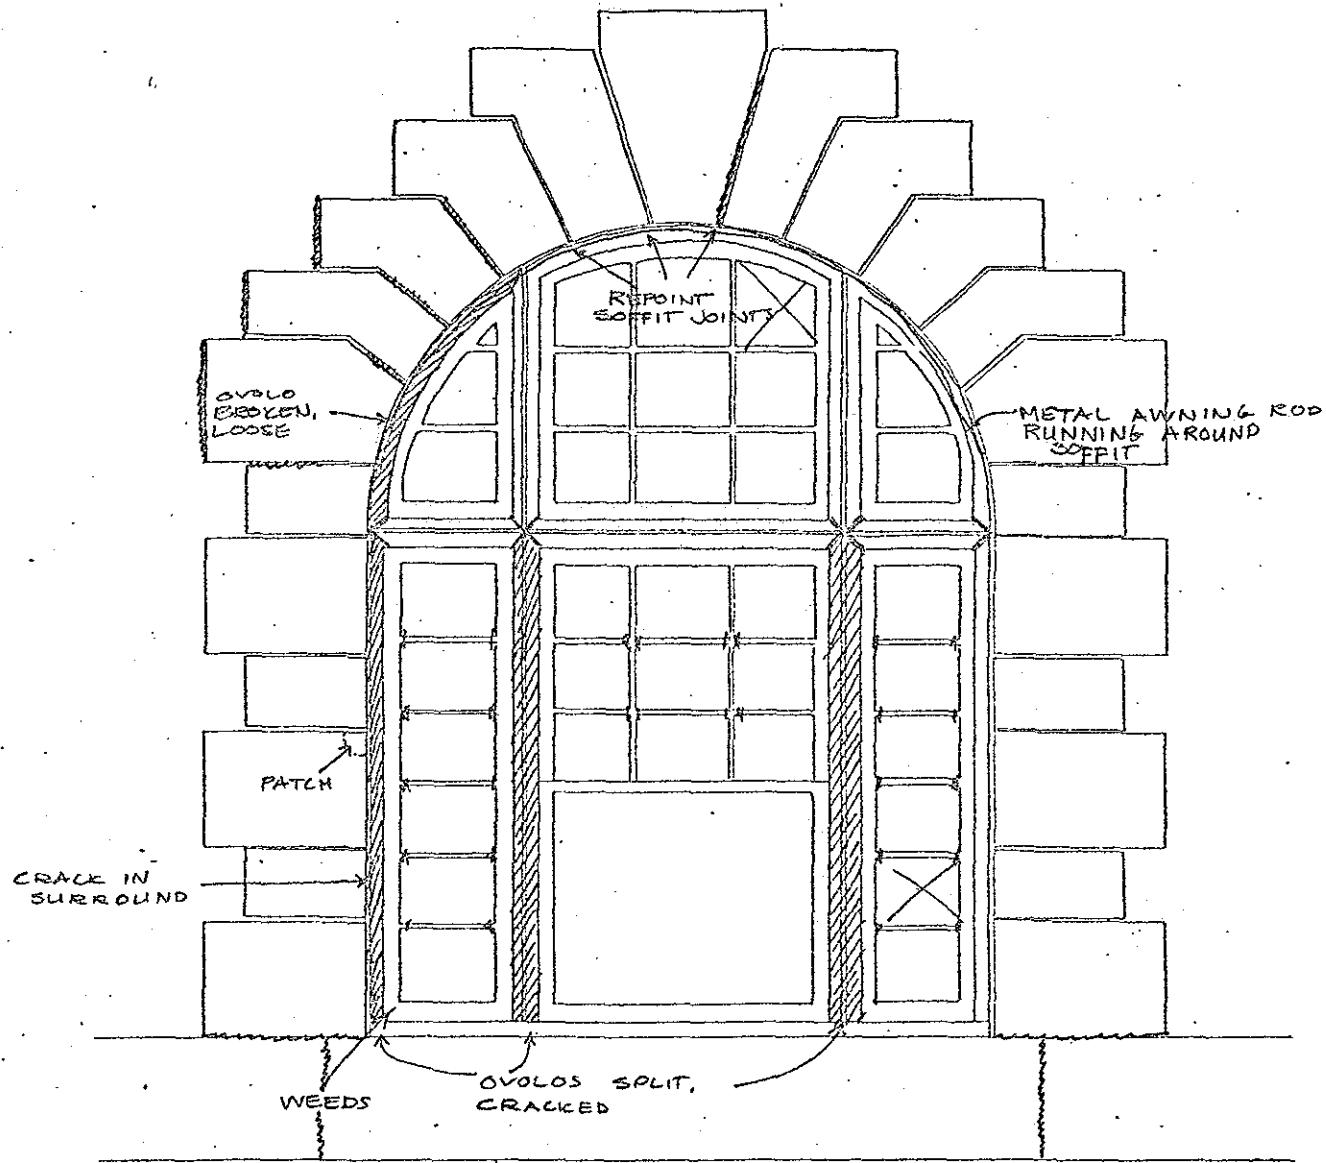
B1 FIRST FLOOR	NUMBER E108	CLASS 2
MECHANICAL AND ELECTRICAL REHABILITATION MAIN BUILDING ELLIS ISLAND Statue of Liberty National Monument, New York	BUILDING CONSERVATION TECHNOLOGY THE DOWD GROUP 19 West 44th Street, New York NY 10036

ALL JOINTS OPEN

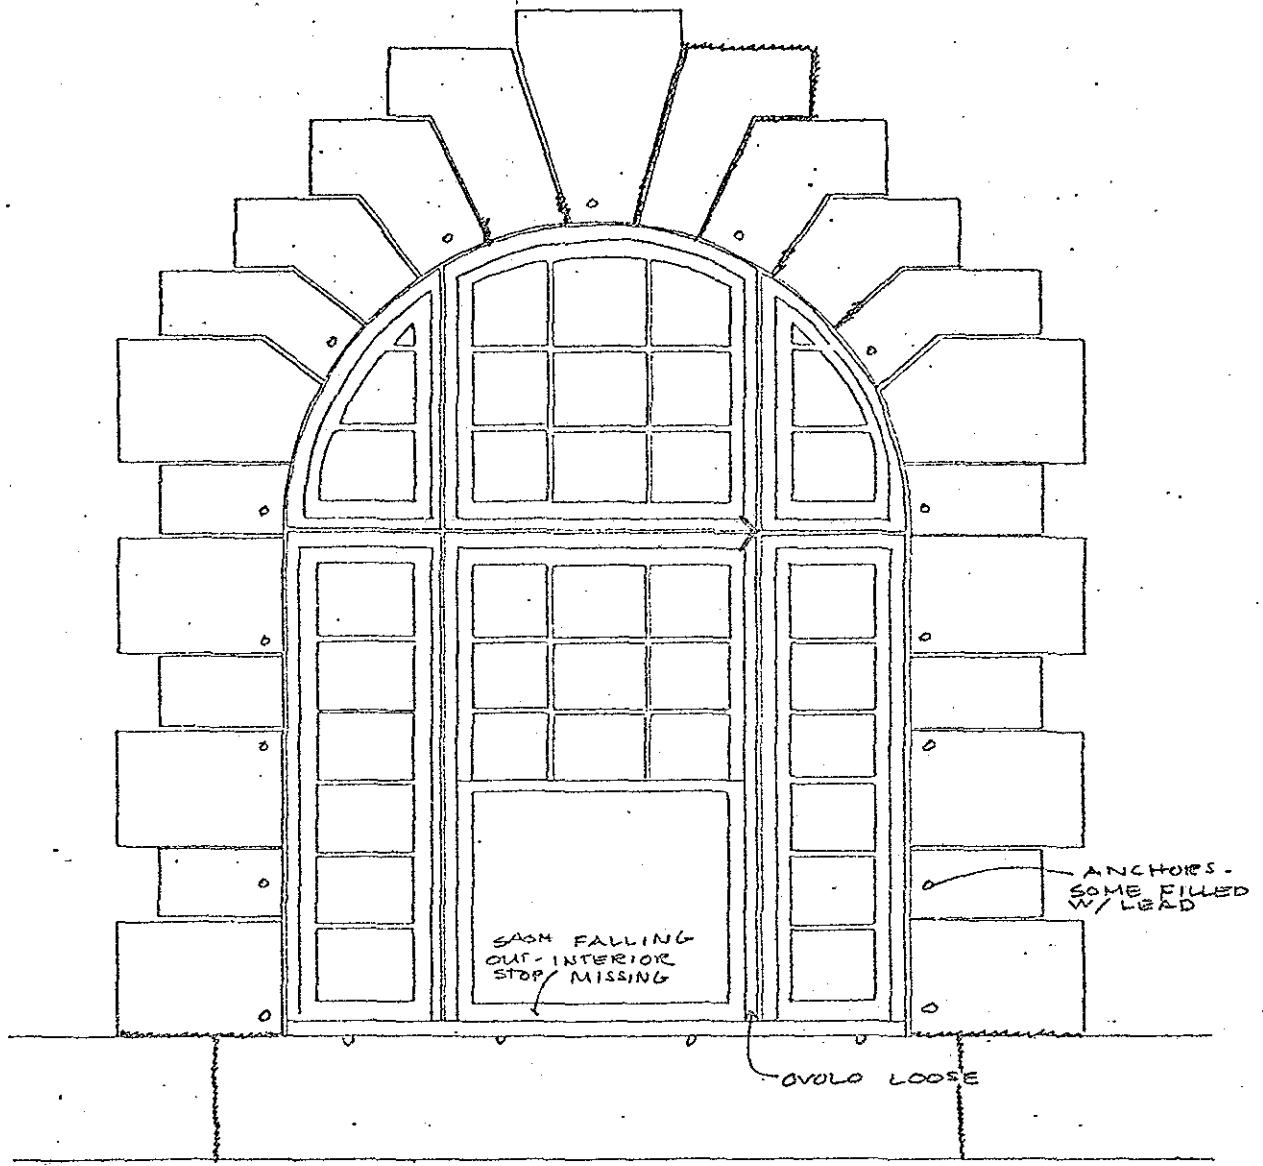
B2 FIRST FLOOR DOOR	NUMBER S103	CLASS 2
MECHANICAL AND ELECTRICAL REHABILITATION MAIN BUILDING ELLIS ISLAND Statue of Liberty National Monument, New York	BUILDING CONSERVATION TECHNOLOGY THE EHRENKRANTZ GROUP 19 West 44th Street, New York NY 10036

INTERIOR: SASH STOPS MISSING, ROTTEN, LOOSE
WINDOW SASH & TRANSOM INOPERABLE

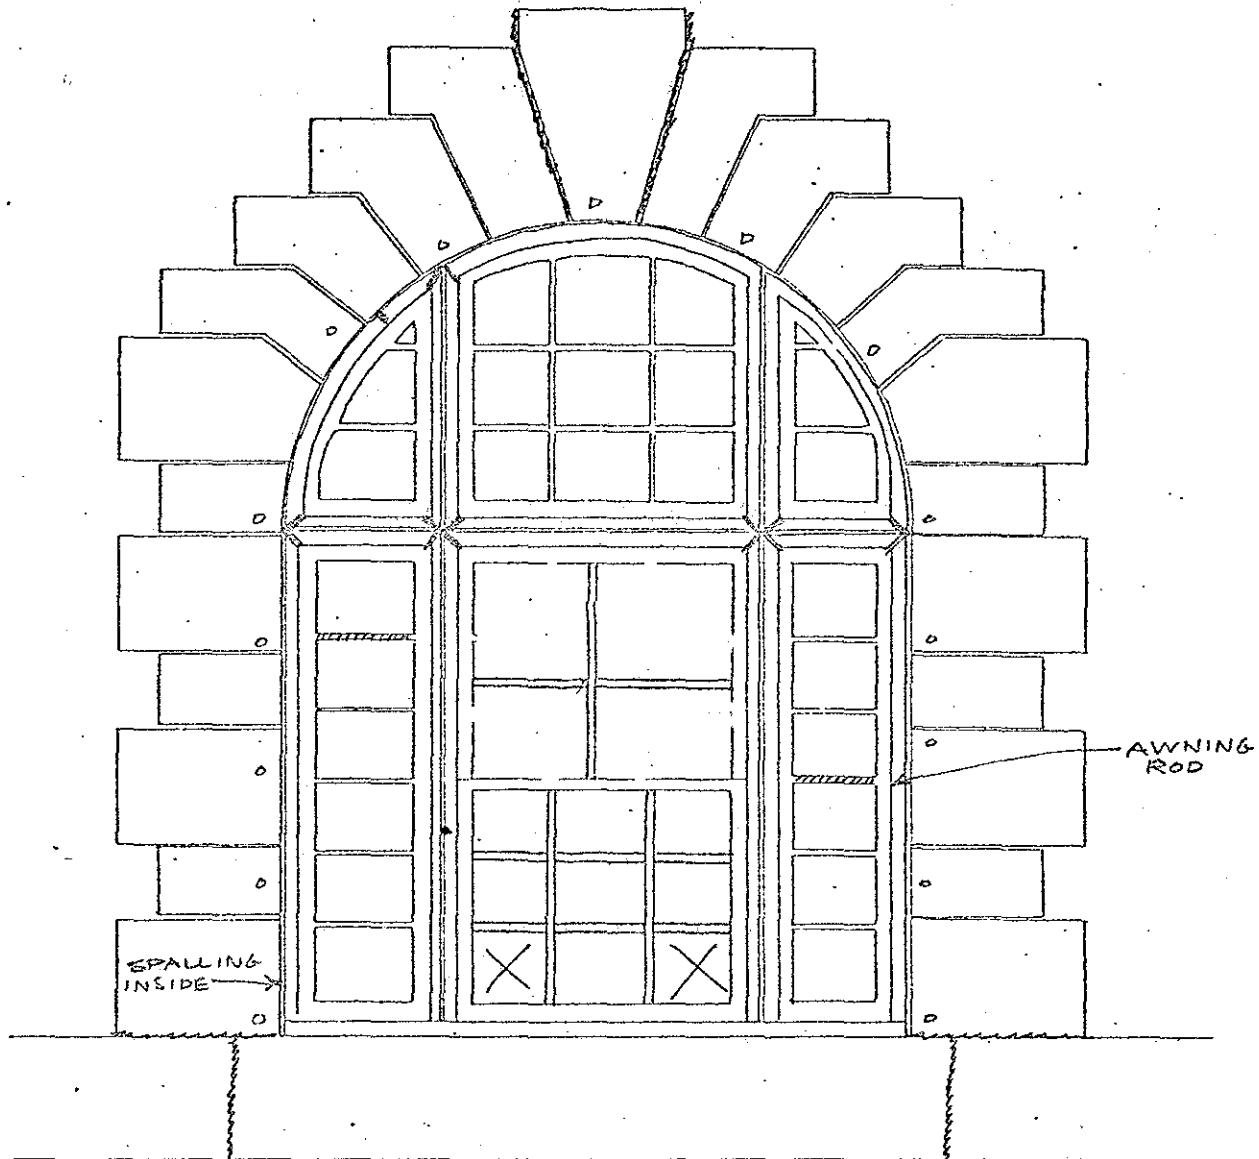
B1 FIRST FLOOR	NUMBER S105	CLASS 2
MECHANICAL AND ELECTRICAL REHABILITATION MAIN BUILDING ELLIS ISLAND Statue of Liberty National Monument, New York	BUILDING CONSERVATION TECHNOLOGY THE EBERGANTZ GROUP 19 West 44th Street, New York NY 10036

SCREEN OVER LOWER SASH - POOR CONDITION

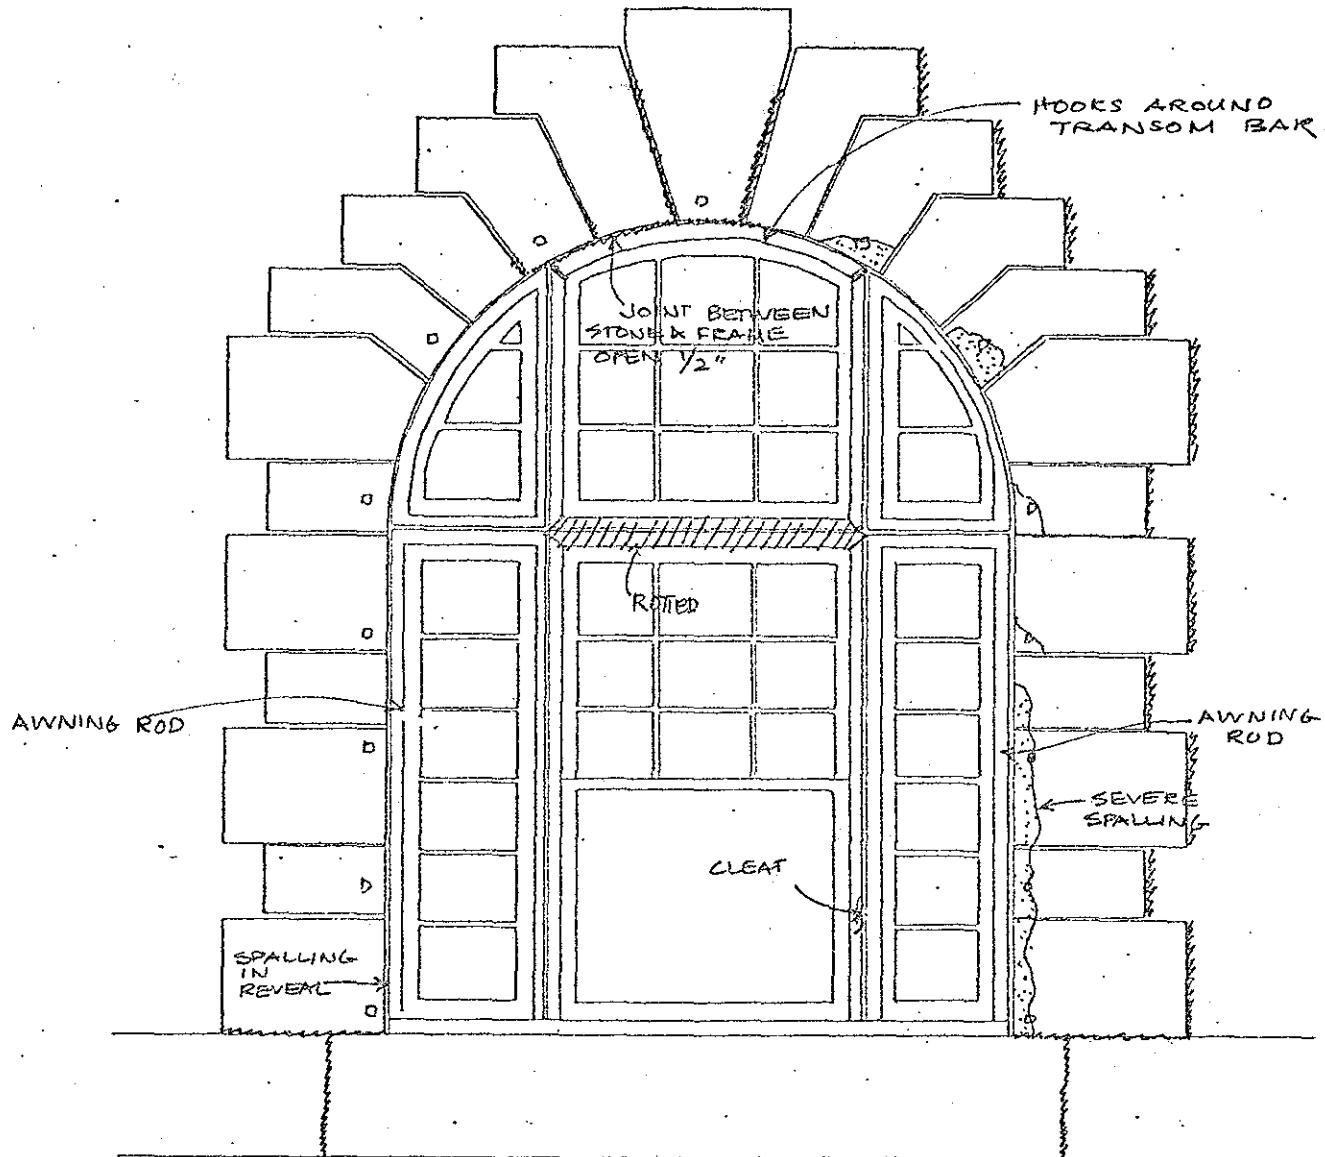
B1 FIRST FLOOR	NUMBER S 116	CLASS 2
MECHANICAL AND ELECTRICAL REHABILITATION MAIN BUILDING ELLIS ISLAND Statue of Liberty National Monument, New York	BUILDING CONSERVATION TECHNOLOGY THE DEDDANTZ GROUP

SCREEN OVER LOWER SASH - POOR CONDITION
GRILL REMOVED

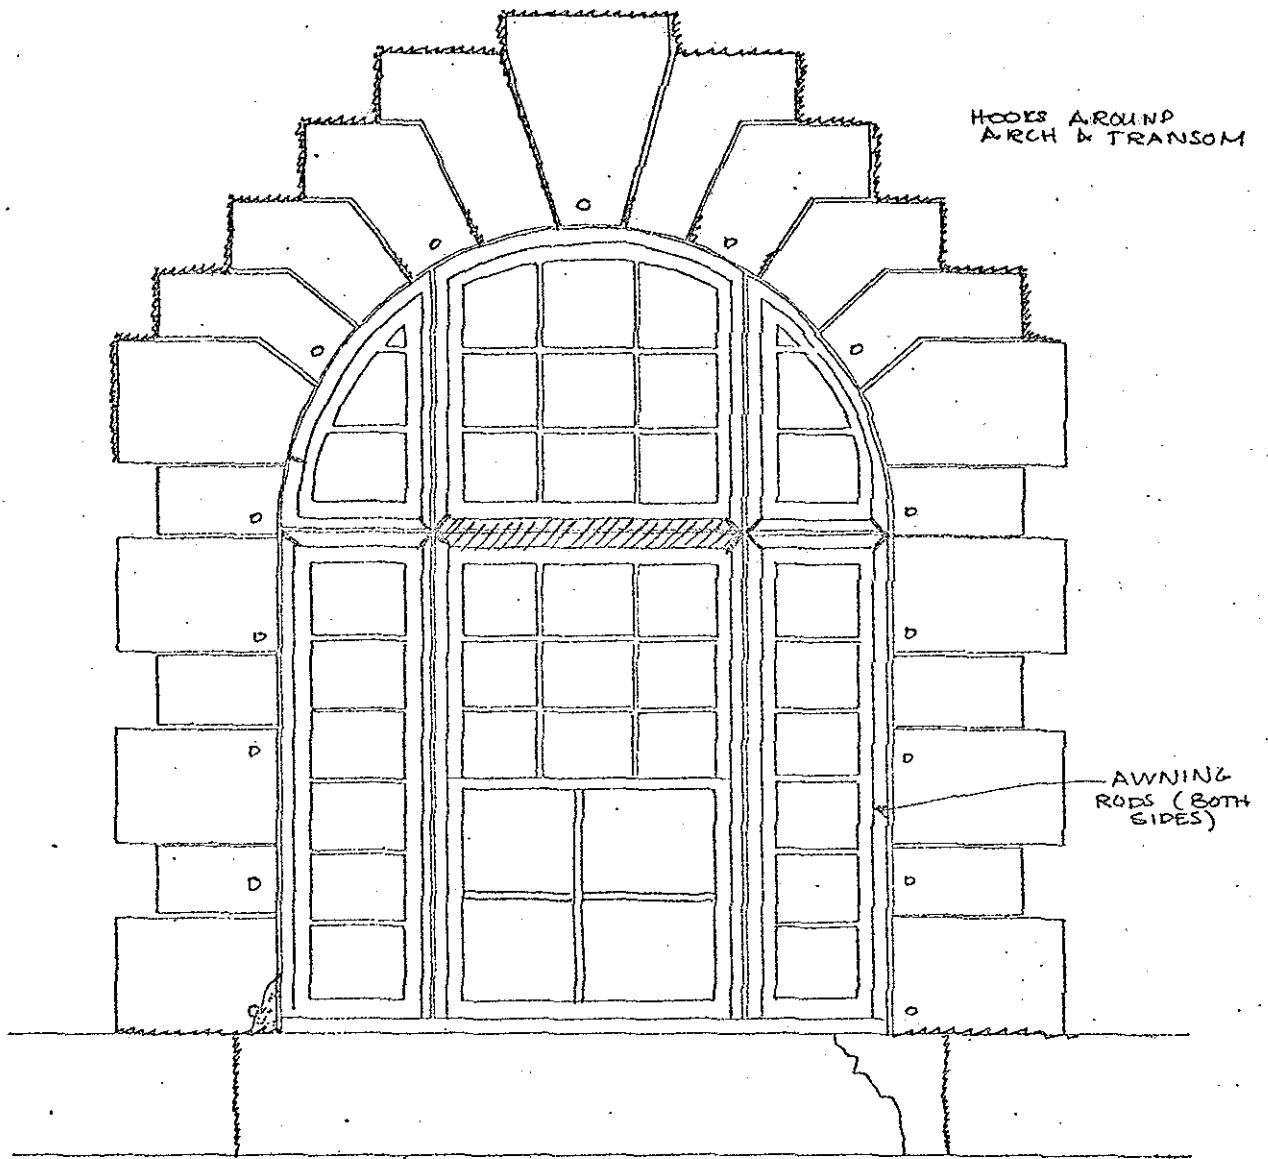
B1 FIRST FLOOR	NUMBER 5189	CLASS 21 wood
MECHANICAL AND ELECTRICAL REHABILITATION MAIN BUILDING ELLIS ISLAND Statue of Liberty National Monument, New York	BUILDING OBSERVATION METHODOLOGY THE BREWSTER GROUP 19 West 44th Street, New York NY 10036	2 Stone

SCREEN OVER LOWER SASH - POOR CONDITION
