historic structures report

mechanical/electrical rehabilitation

main building

STATUE OF LIBERTY ELLIS ISLAND

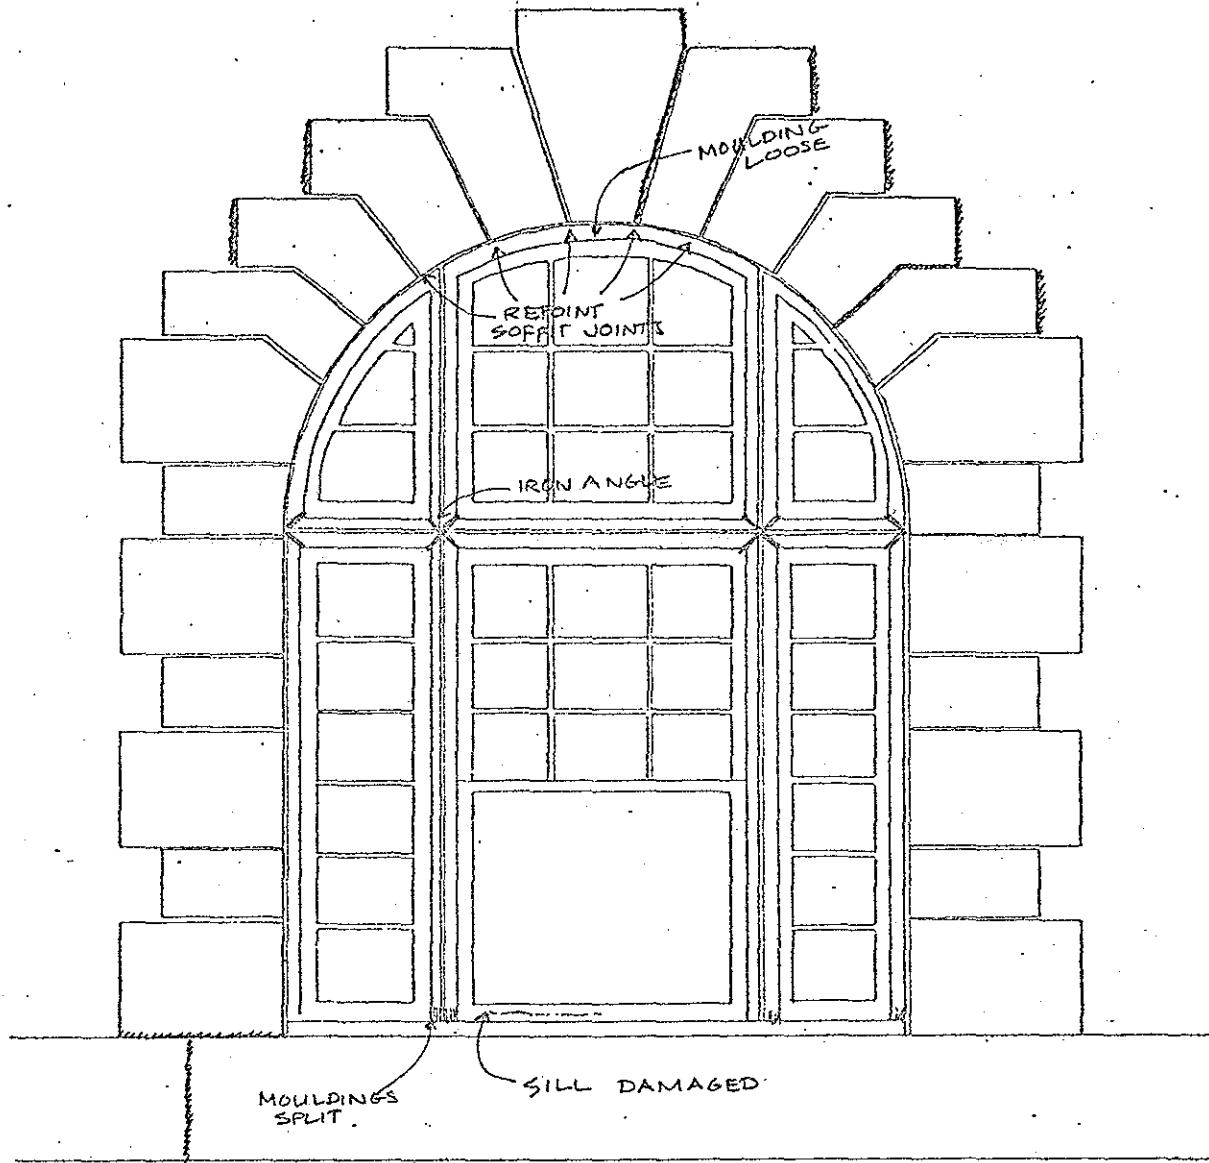
B1 FIRST FLOOR	NUMBER W102	CLASS I
MECHANICAL AND ELECTRICAL REHABILITATION MAIN BUILDING ELLIS ISLAND Statue of Liberty National Monument, New York	BUILDING CONSERVATION TECHNOLOGY THE DERNANTZ GROUP	19 West 44th Street, New York NY 10036

GRILL IN PLACE - RUSTED AT BOTTOM

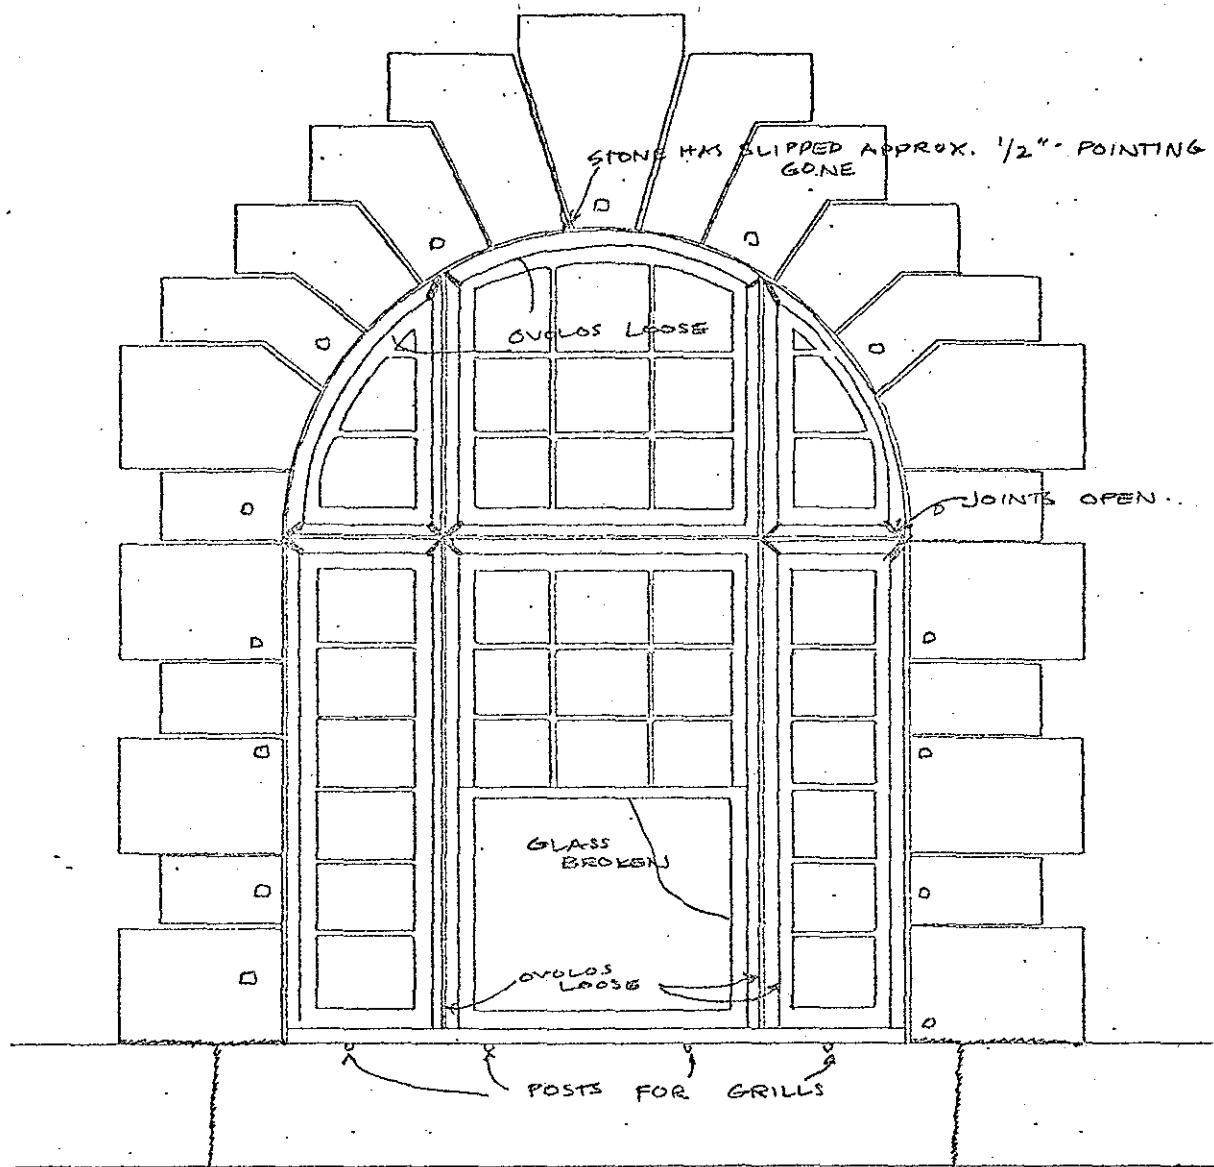
B1 FIRST FLOOR	NUMBER W104	CLASS I
MECHANICAL AND ELECTRICAL REHABILITATION MAIN BUILDING ELLIS ISLAND Statue of Liberty National Monument, New York	BUILDING CONSERVATION TECHNOLOGY THE EBENHACKER GROUP	19 West 44th Street, New York NY 10036

IRON CRAMPS IN SURROUND - RUSTING, HAVE BEEN COVERED
W/LEAD

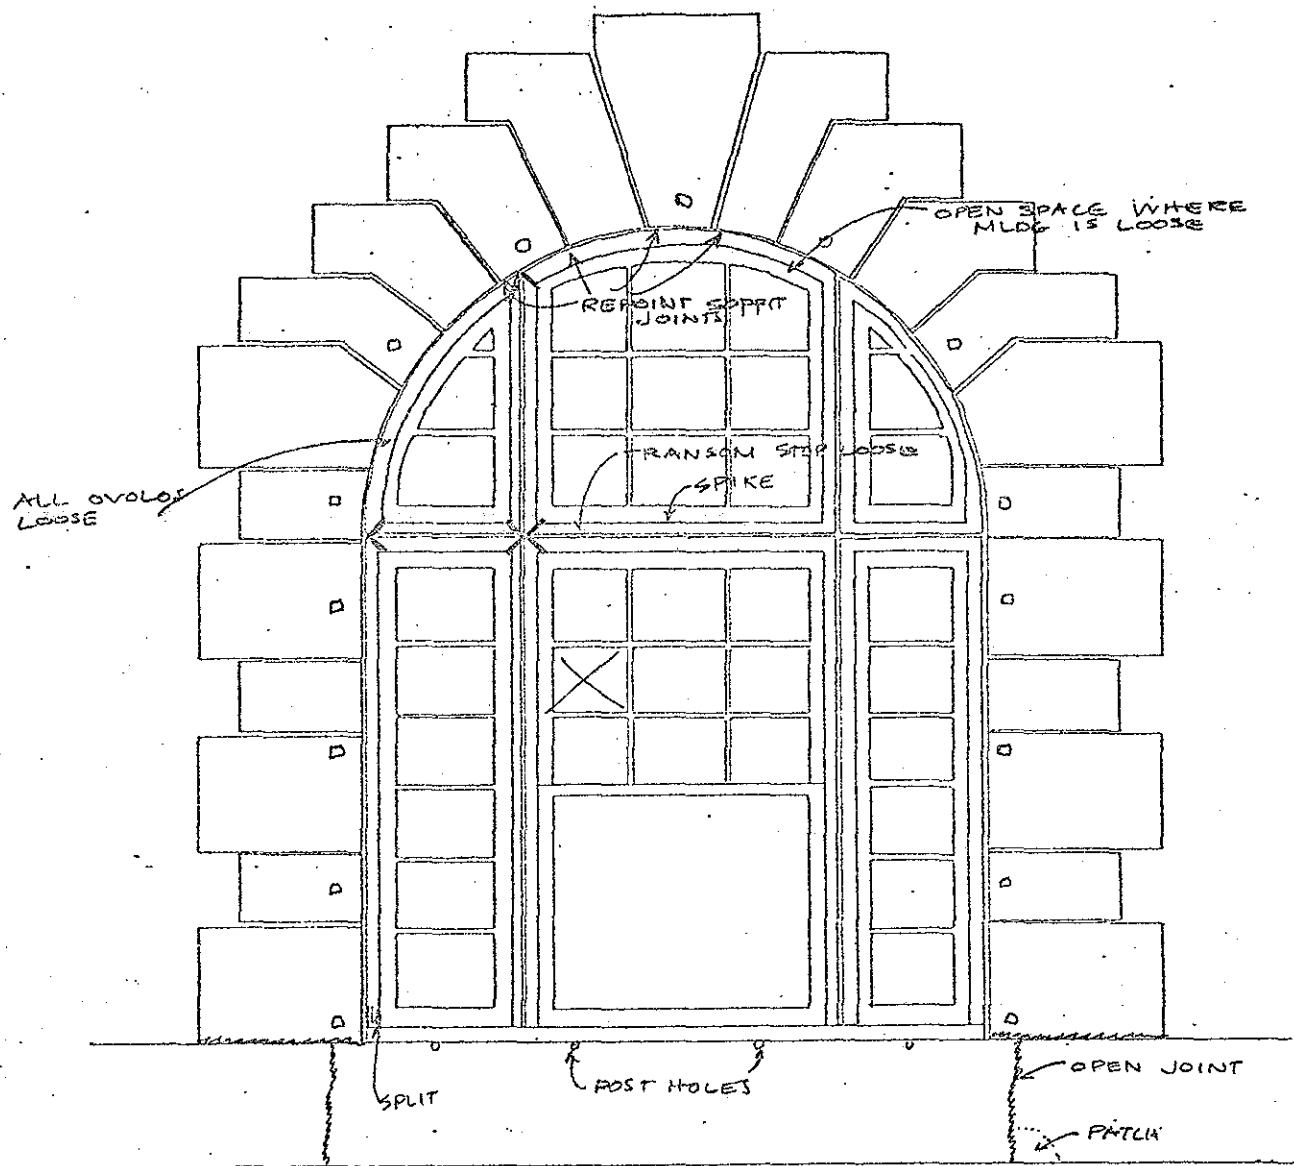
B1 FIRST FLOOR	NUMBER W105	CLASS 2
MECHANICAL AND ELECTRICAL REHABILITATION MAIN BUILDING ELLIS ISLAND Statue of Liberty National Monument, New York	BUILDING CONSERVATION TECHNOLOGY THE DEDDINGTON GROUP 19 West 44th Street, New York NY 10036

INTERIOR: STOOL AND ALL SASH STOPS ARE ROTTED, LOOSE -
REQUIRE REPLACEMENT; SASH PULLEYS, TRANSOM HINGES
INOPERABLE.

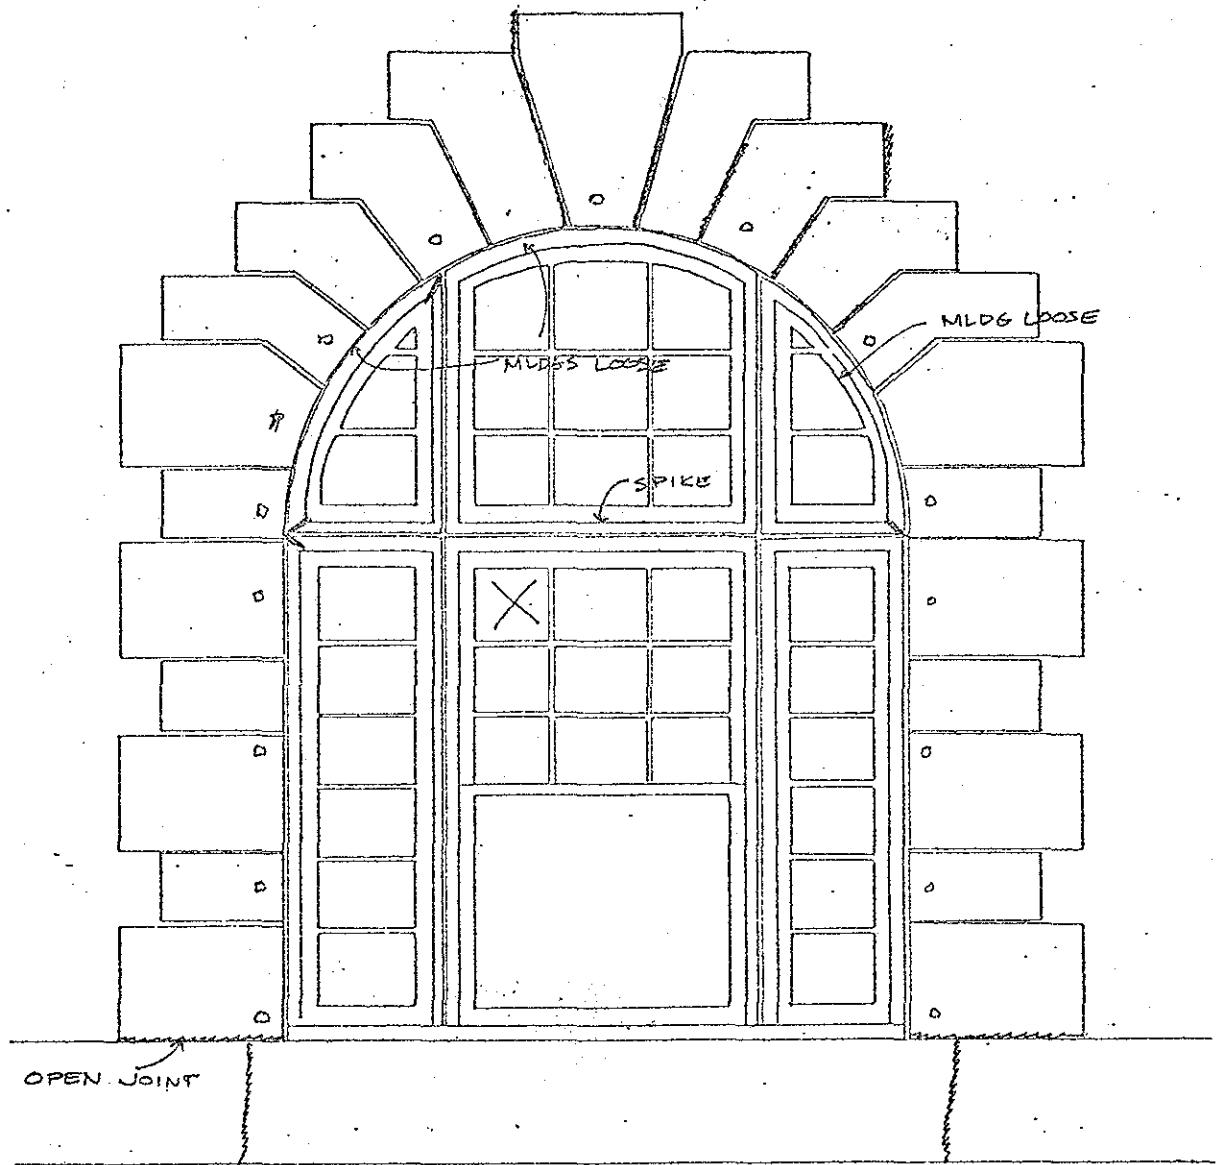
B1 FIRST FLOOR	NUMBER W 106	CLASS 2
MECHANICAL AND ELECTRICAL REHABILITATION MAIN BUILDING ELLIS ISLAND Statue of Liberty National Monument, New York	BUILDING CONSERVATION TECHNOLOGY THE BREWSTER GROUP 19 West 44th Street, New York NY 10036

INTERIOR: ALL SASH STOPS ROTTED, LOOSE
SASH PULLEY, TRANSOM HINGES & OPERATING
MECHANISM INOPERABLE

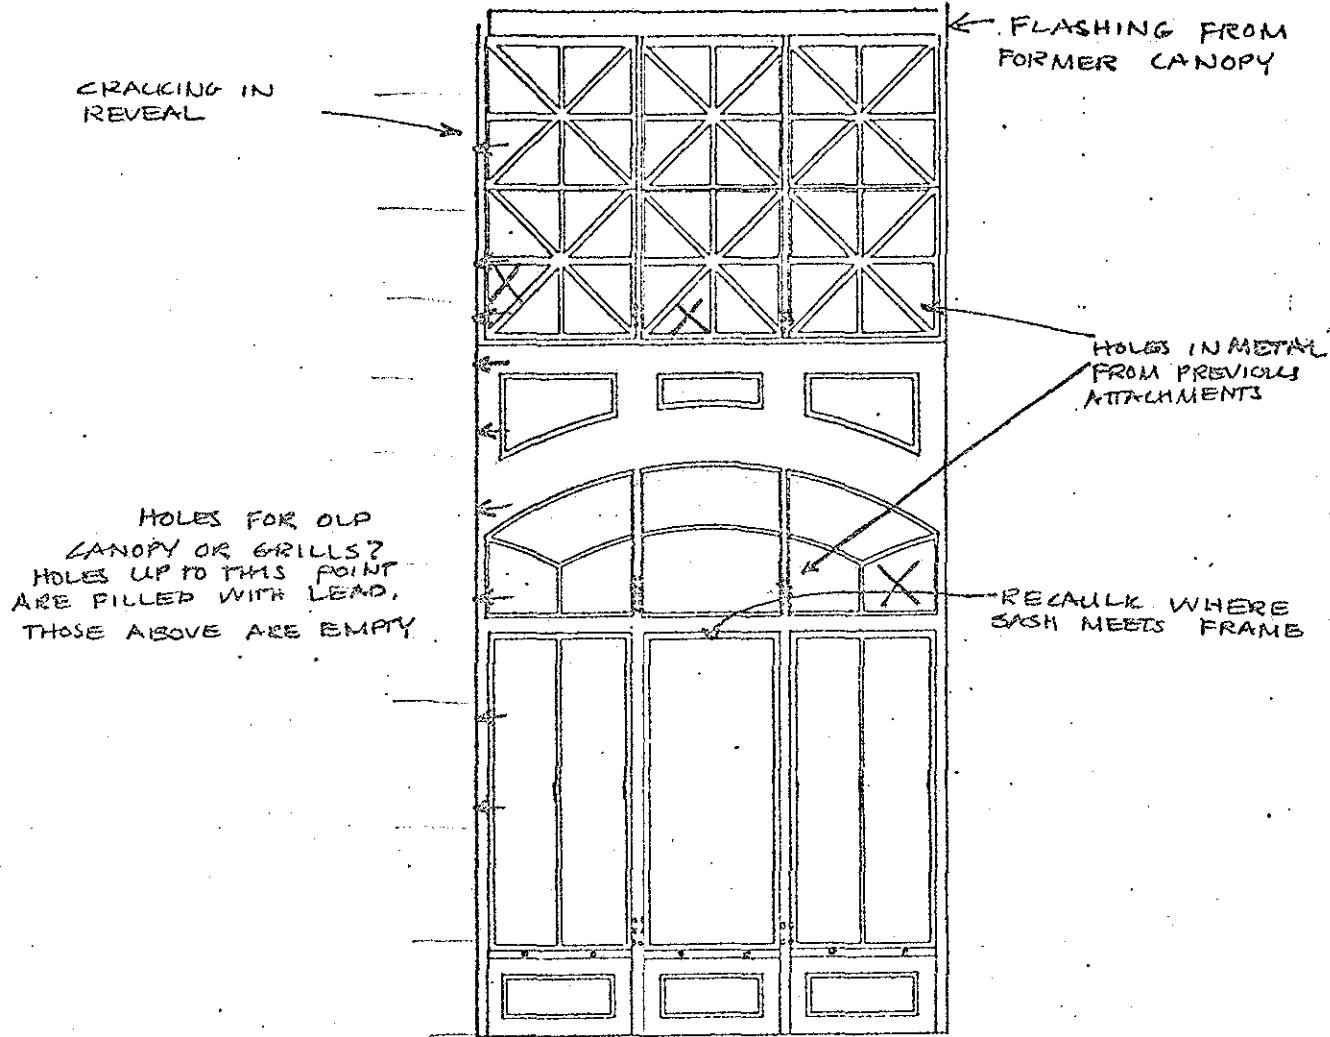
B1 FIRST FLOOR	NUMBER W.108	CLASS 2
MECHANICAL AND ELECTRICAL REHABILITATION MAIN BUILDING ELLIS ISLAND Statue of Liberty National Monument, New York	BUILDING CONSERVATION TECHNOLOGY THE DEGENKOLB GROUP 19 West 44th Street, New York NY 10036

SCREENS ON INTERIOR OF CASEMENT WINDOWS - POOR CONDITION - SIDE RAHS ROTTED, HARDWARE MISSING

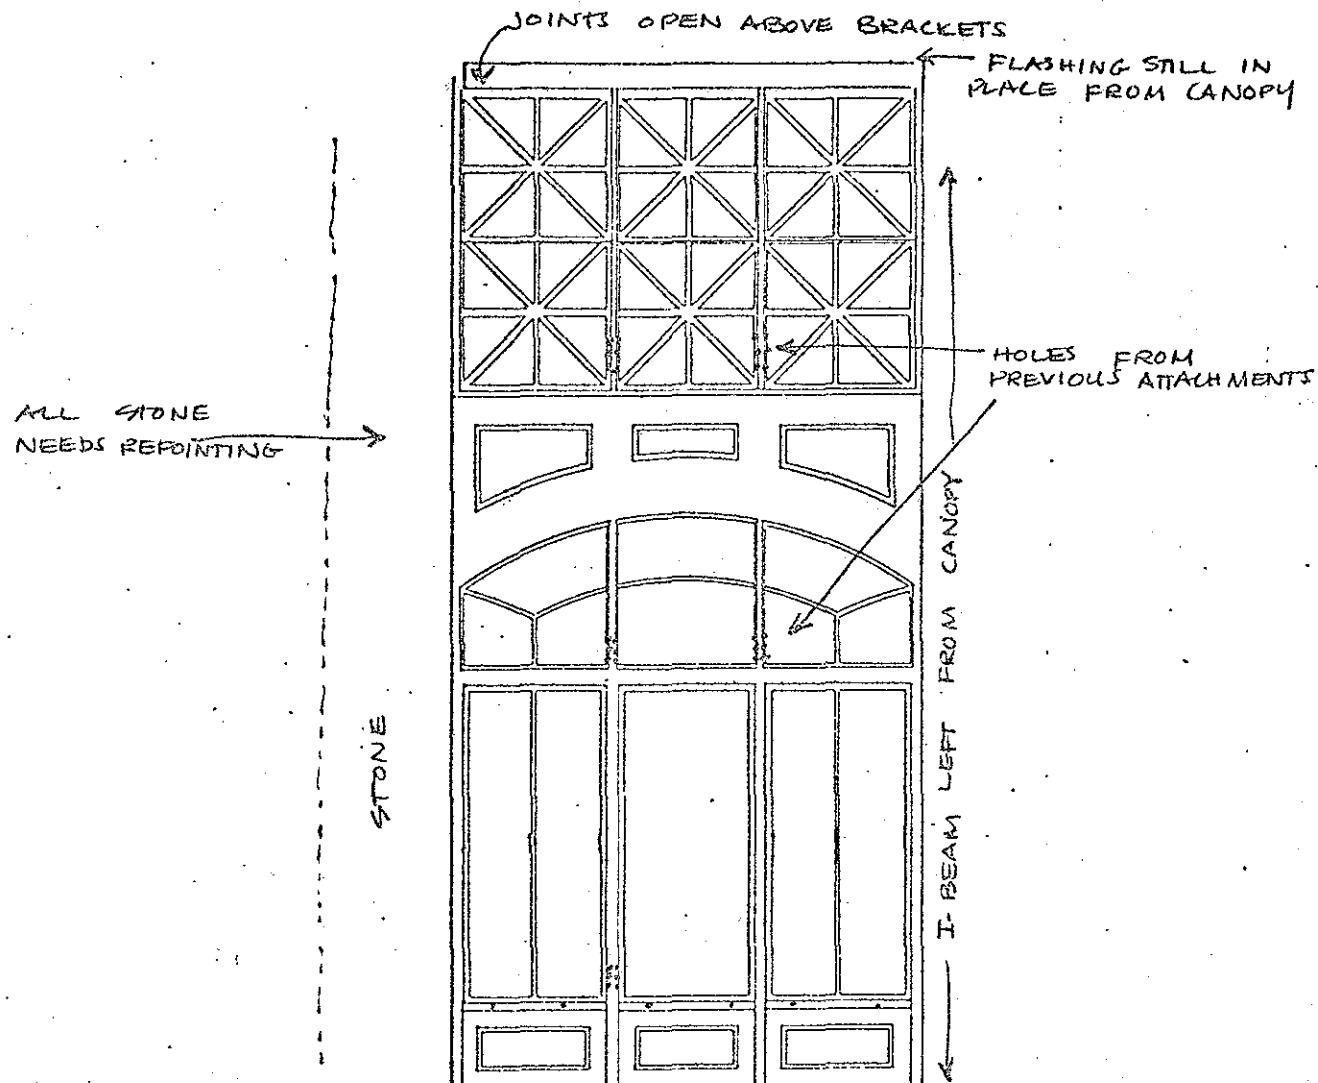
C1 MAIN ARCH, BOTTOM UNIT (4)	NUMBER S109	CLASS
MECHANICAL AND ELECTRICAL REHABILITATION MAIN BUILDING ELLIS ISLAND Statue of Liberty National Monument, New York	BUDGET ORGANIZATION TECHNOLOGY THE FIREBIRD GROUP 19 West 44th Street, New York NY 10036

METAL IN GOOD CONDITION - LIGHT SCALE IN SOME AREAS
WINDOW CASINGS BRONZE, ALL OTHER STEEL OR CAST IRON

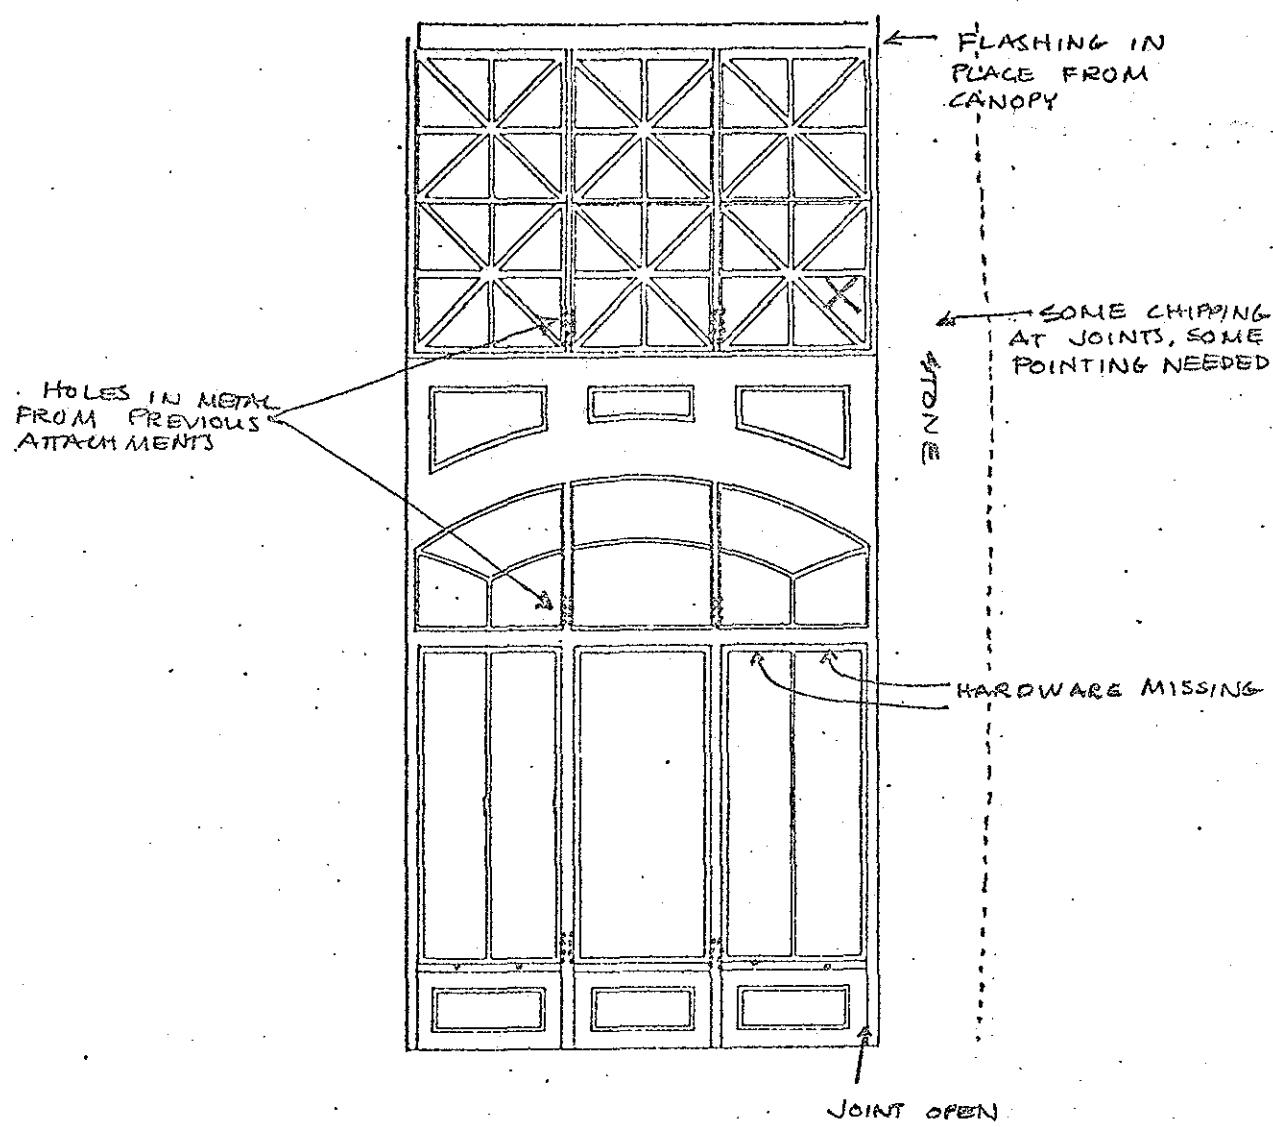
C1 MAIN ARCH, BOTTOM UNIT (4)	NUMBER S114	CLASS 1
MECHANICAL AND ELECTRICAL REHABILITATION MAIN BUILDING ELLIS ISLAND Statue of Liberty National Monument, New York	BUILDING OBSERVATION TOPOLOGY THE DREKONZ GROUP 19 West 44th Street, New York NY 10036

INTERIOR TRANSOM HARDWARE ALL IN PLACE - PAINTED,
CORRODED, UNOPERABLE

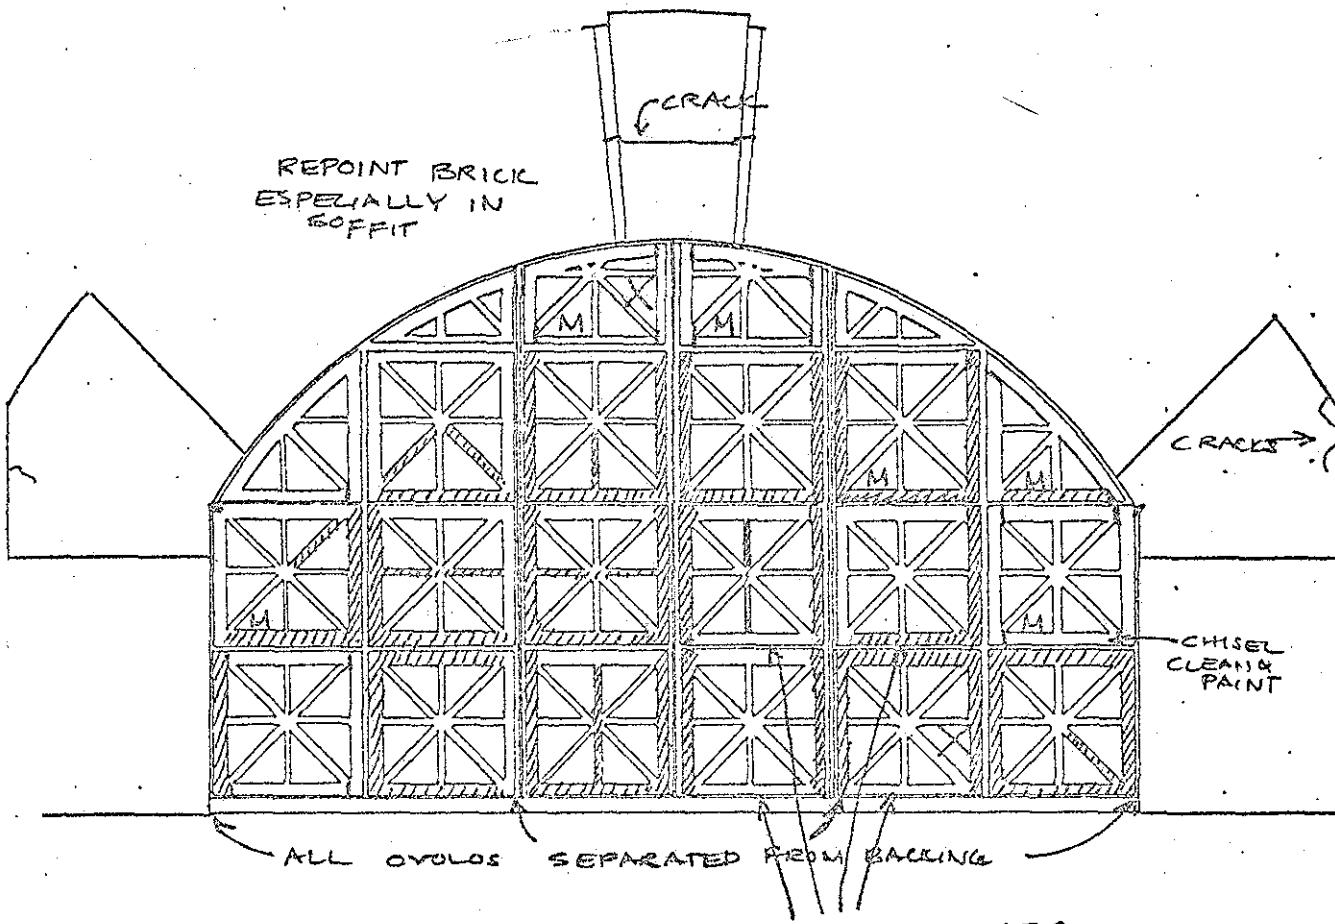
C3 ROOF LEVEL, SOUTH & NORTHERN ELEVATIONS (C)	NUMBER N 402	CLASS 3
MECHANICAL AND ELECTRICAL REHABILITATION MAIN BUILDING ELLIS ISLAND	BUDDE CONSTRUCTION INCORPORATED THE FRIEDMAN GROUP	19 West 44th Street, New York NY 10036

"M" INDICATES WINDOW WITH MOULDINGS INSTEAD OF PUTTY-
ALL ARE LOOSE

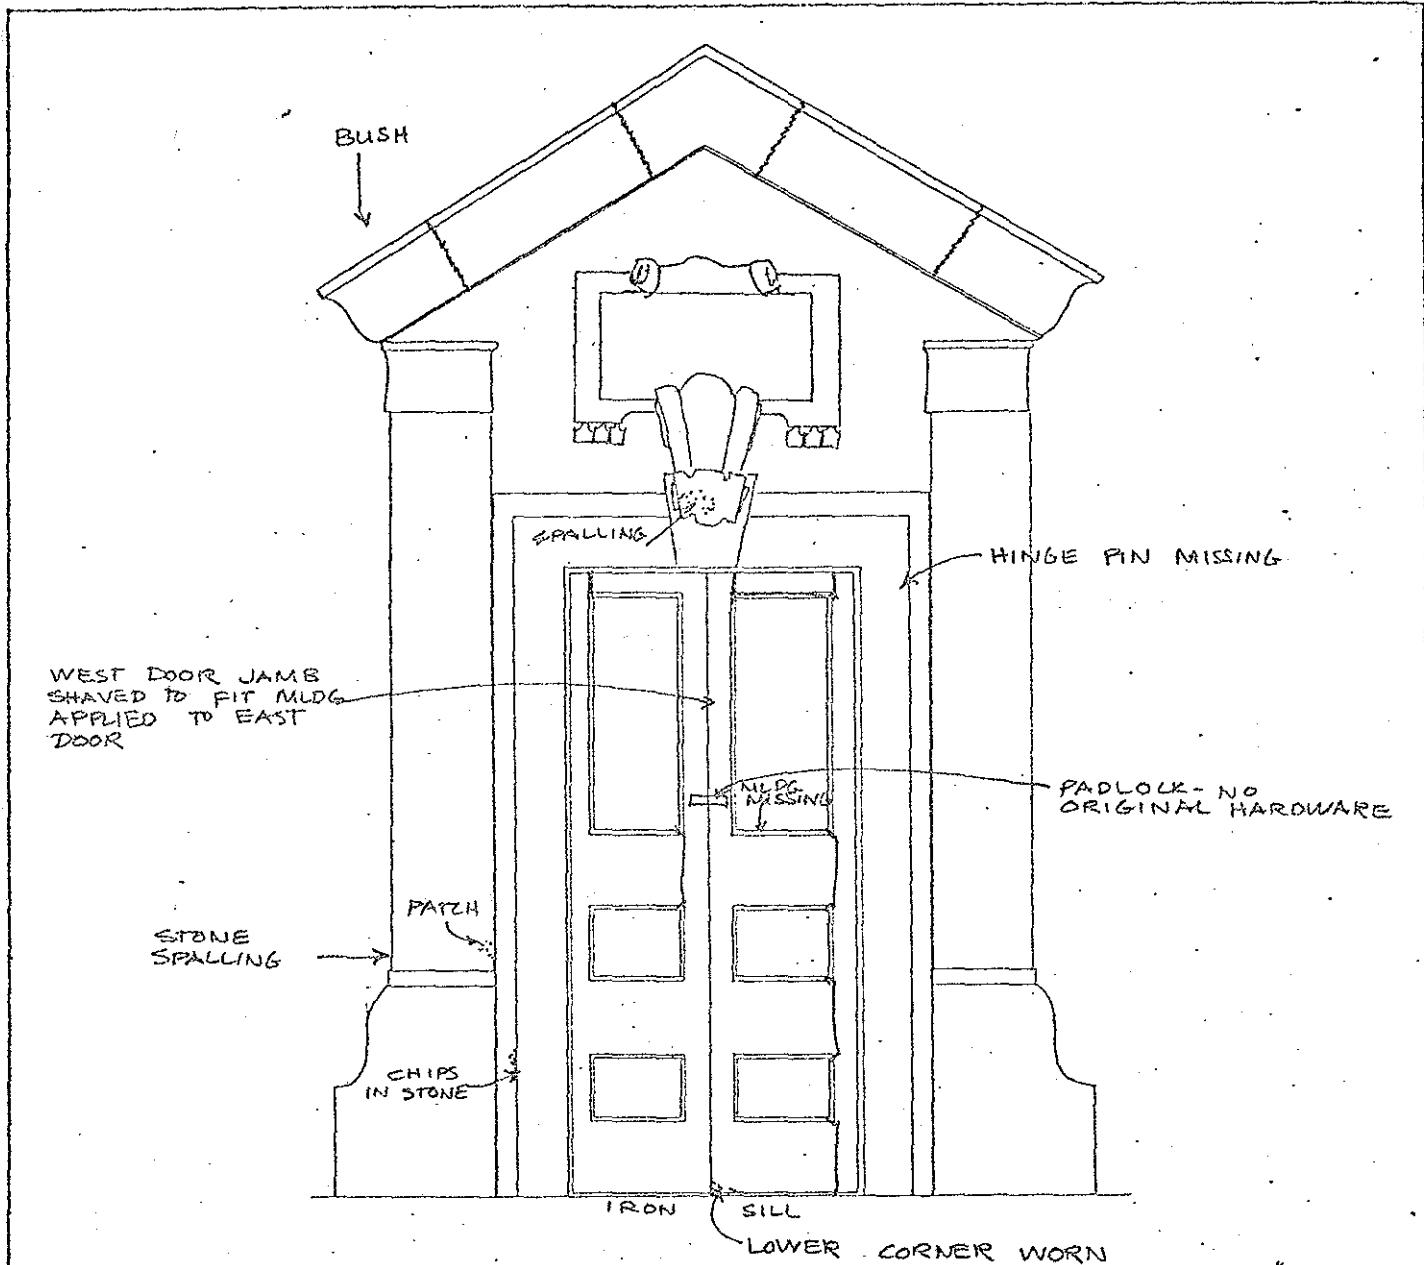
INTERIOR - DOOR CLOSER, WEST SIDE, RUSTED & NOT FUNCTIONAL -
DOOR WILL NOT CLOSE

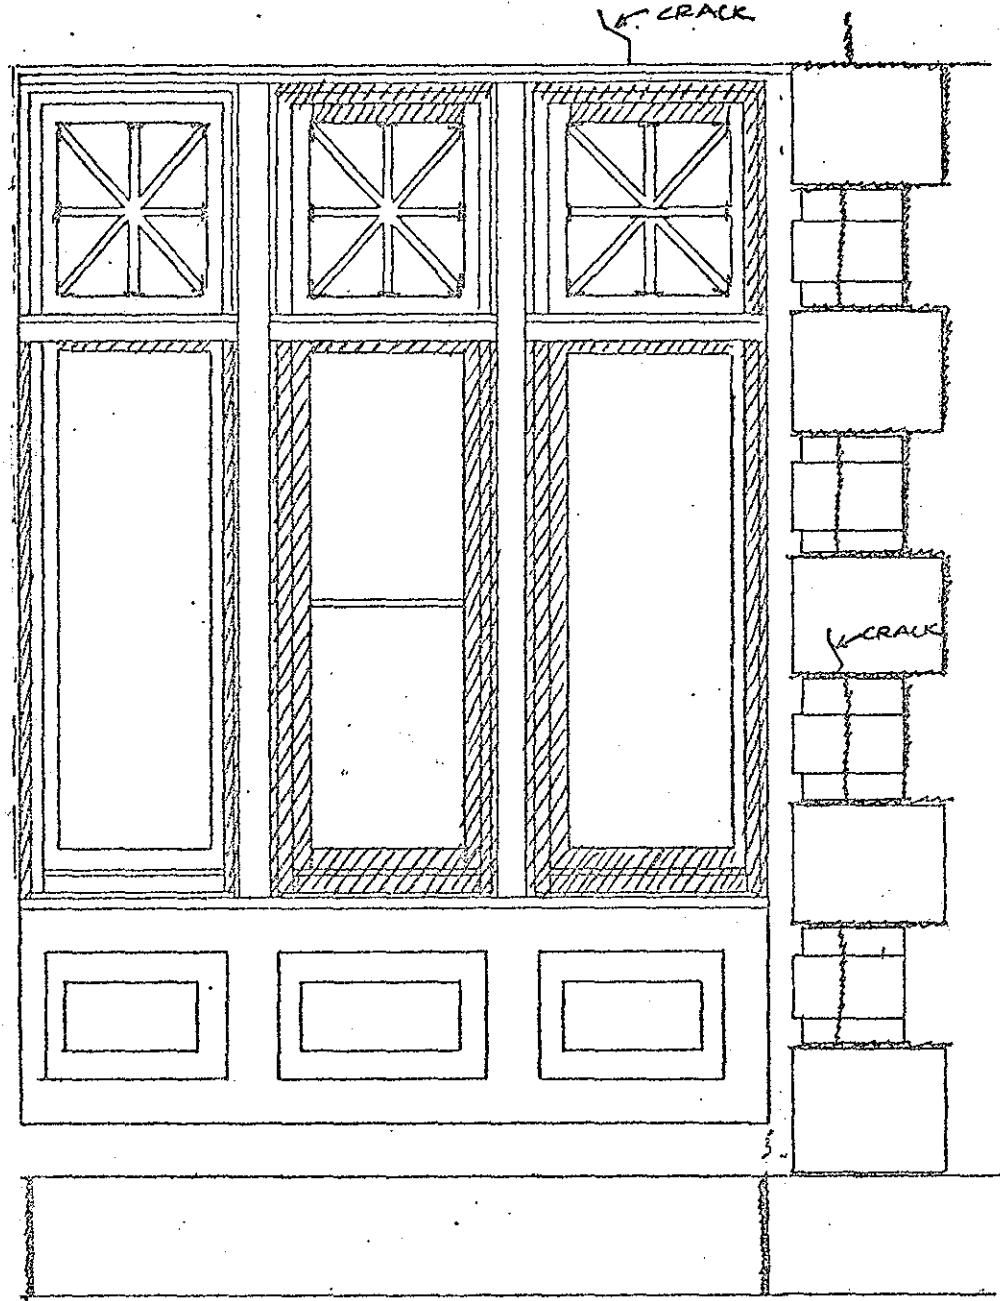
INTERIOR: SASH STOPS ROTTED & LOOSE
 SILLS & STOOLS ROTTED MISSING - REPLACE ALL INTERFRAMES
 GRILL OVER TRANSOM A SASH - CORRODED
 SCREENS OVER + LOWER SASH - FAIR CONDITION

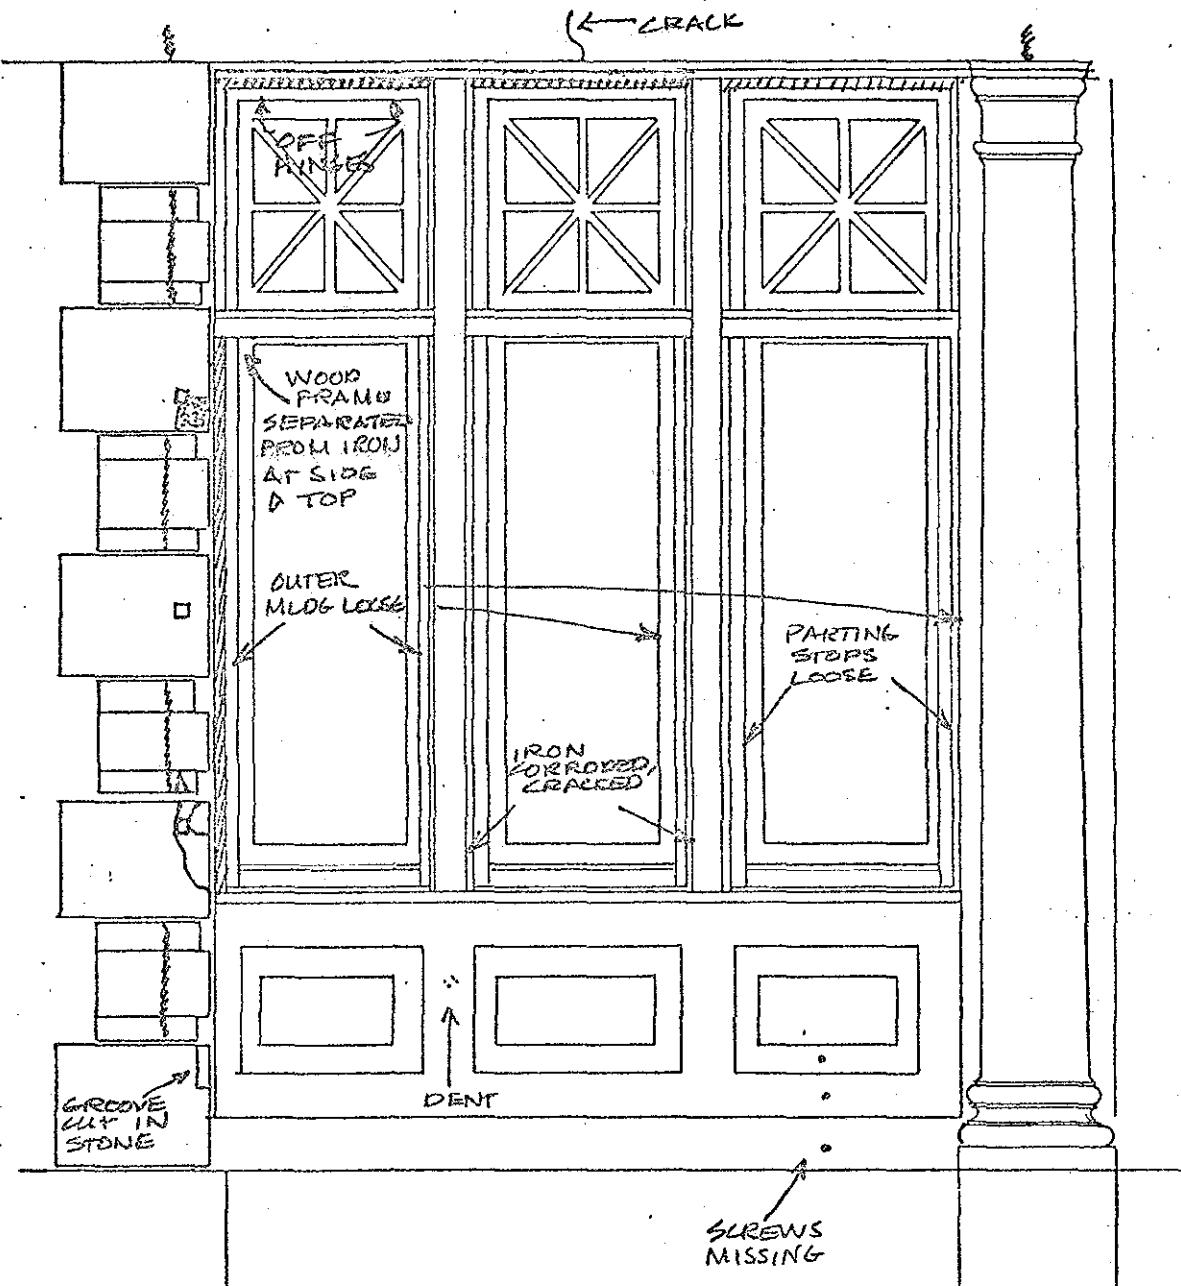
INTERIOR: • ALL FRAME COMPONENTS LOOSE ON CENTER & RIGHT WINDOWS
 • ALL FRAMING ON LEFT SIDE TORN AWAY, ROTTED
 • PANELS ABOVE TRANSOMS WARPED
 • SASH STUCK OPEN

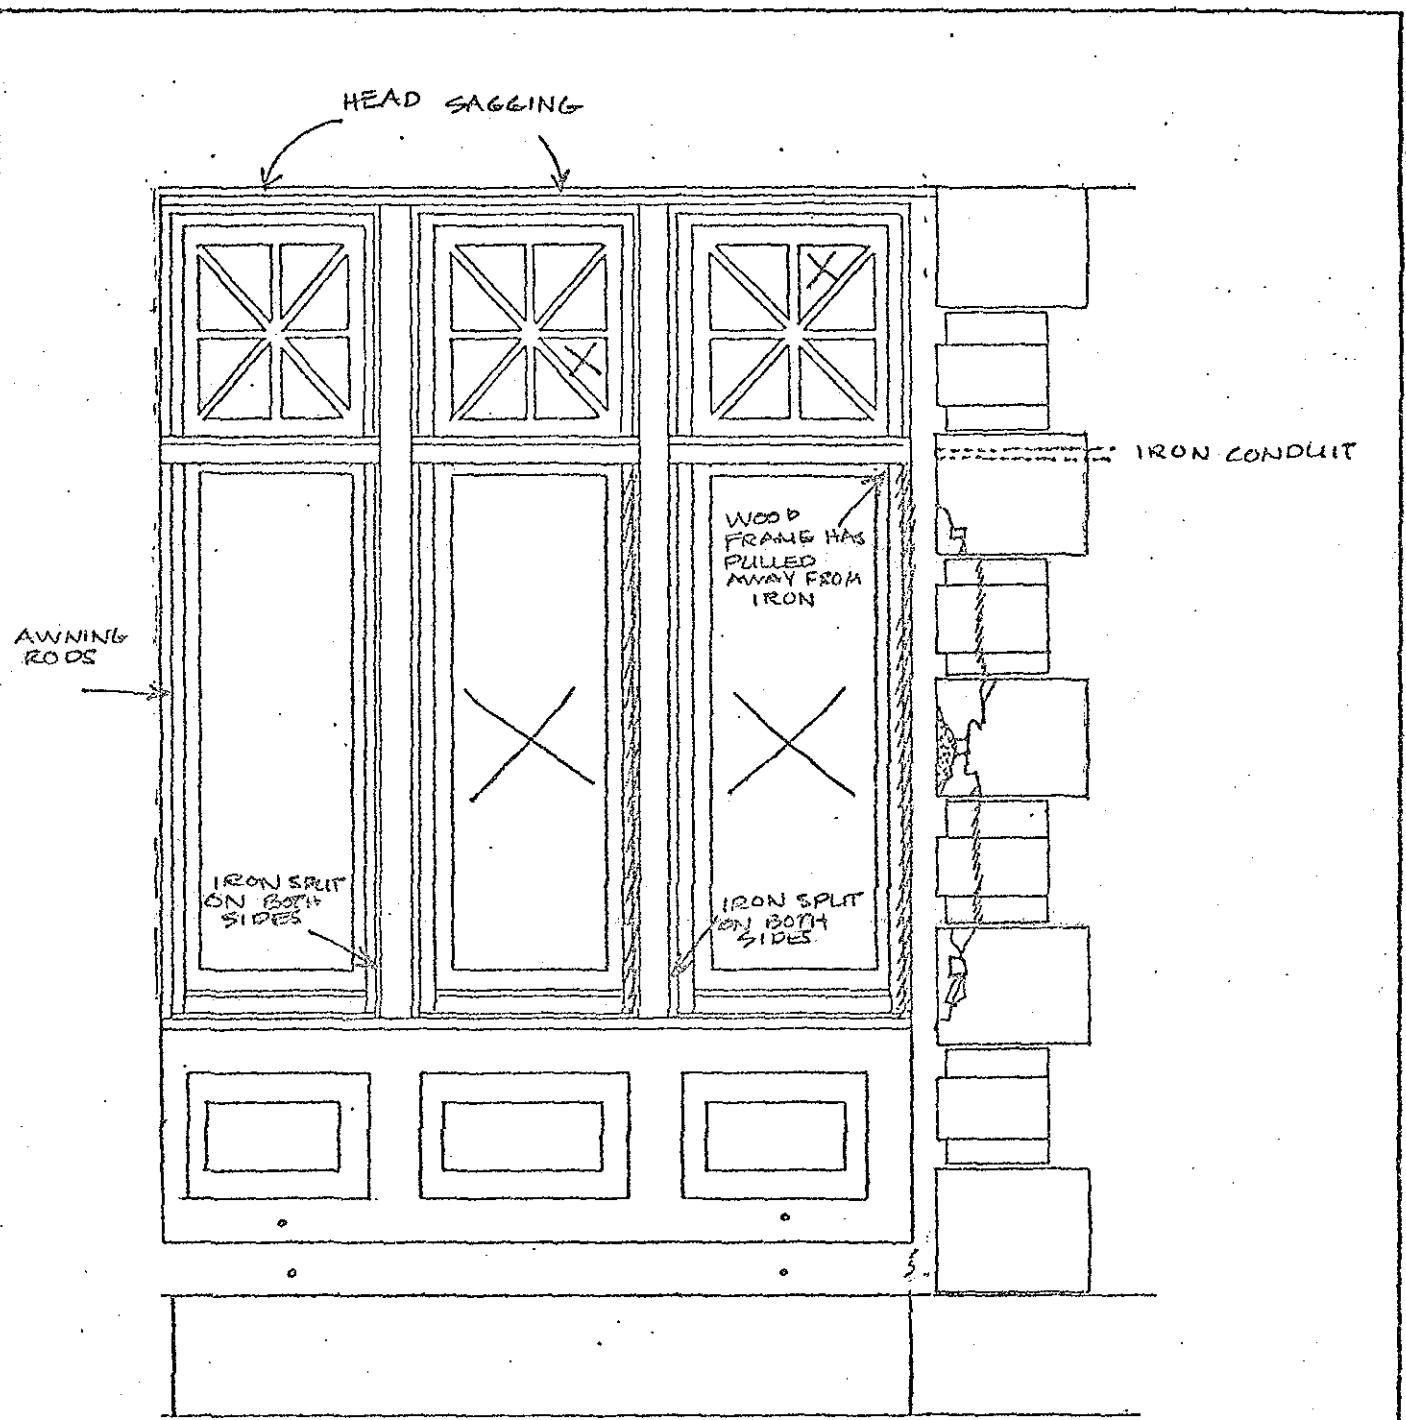
INTERIOR - FRAMING DESTROYED, CORNICE RIPPED AWAY OVER
WEST HALF OF WINDOW.
ALL INTERIOR PARTS LOOSE

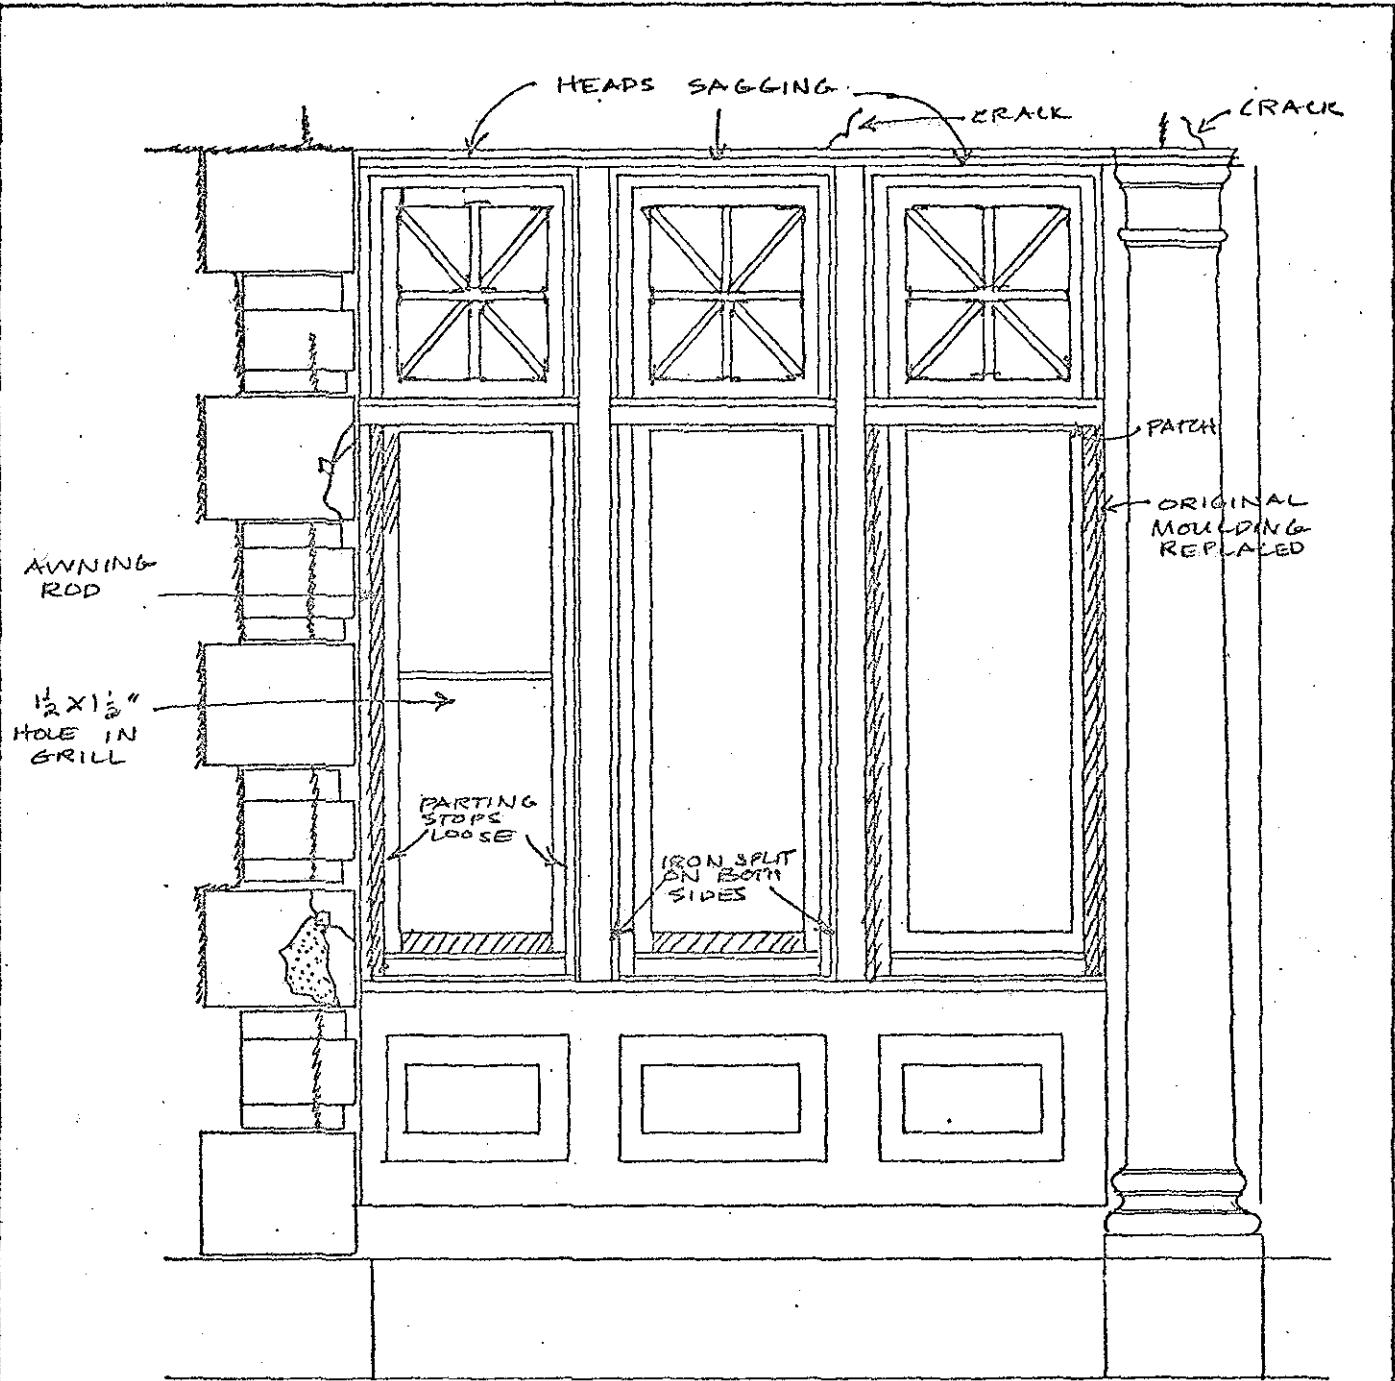
INTERIOR: - WALL SUPPORT DESTROYED - INTERIOR FRAME ROTTED

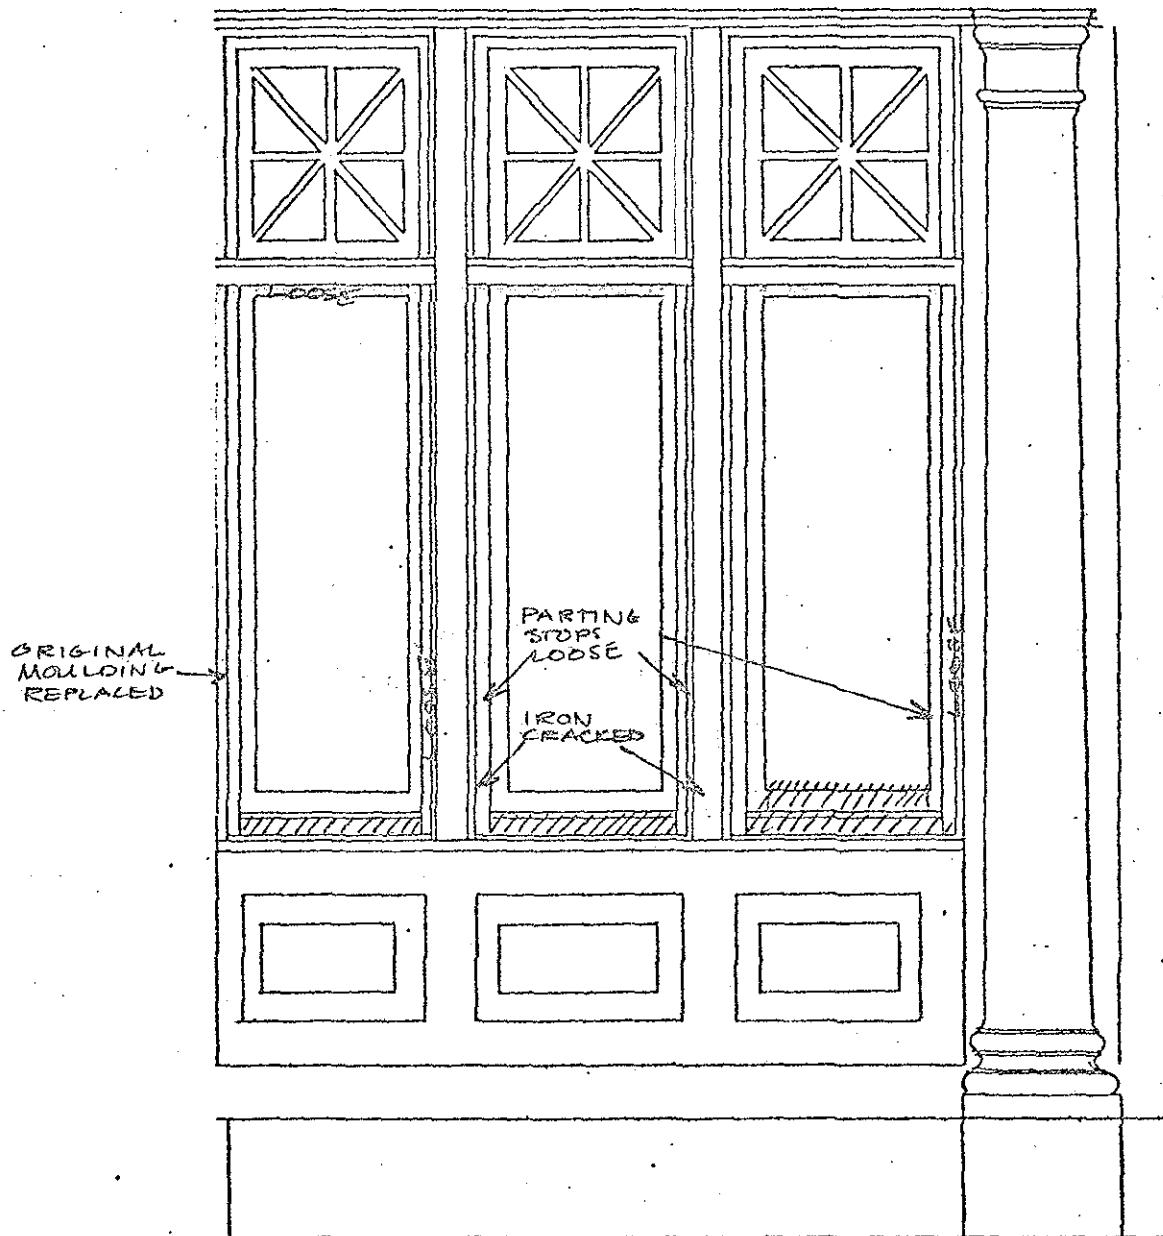
INTERIOR: - PANELS ABOVE TRANSOMS ALL BULGE
 - TRANSOM OF RIGHT (WEST) WINDOW CRACKED
 - MLDGS AROUND LOWER SASH, CENTER WINDOW LOOSE
 GRILLS OVER TRANSOM & LOWER SASH
 SCREENS OVER LOWER SASH. GENERALLY POOR CONDITION.
 FRAME SPLIT, MLDGS WARPED & LOOSE
