historic structures report

mechanical/electrical rehabilitation

main building

STATUE OF LIBERTY ELLIS ISLAND

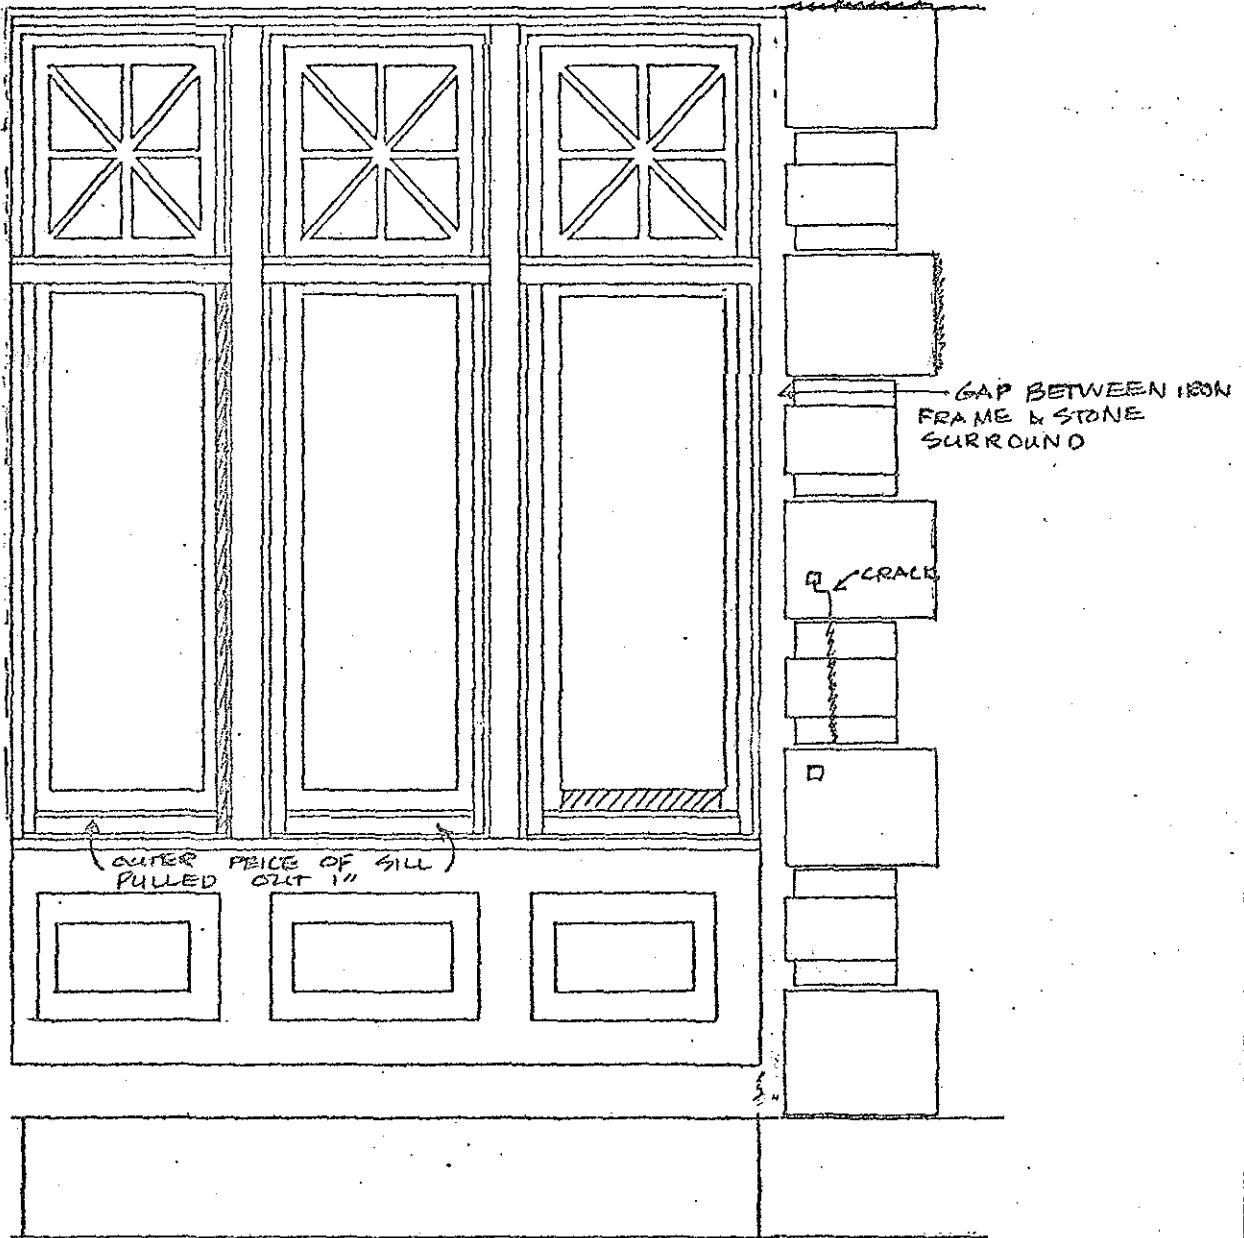
INTERIOR: • PANELS ABOVE TRANSOMS BOWED
• ALL SASH STUCK OPEN

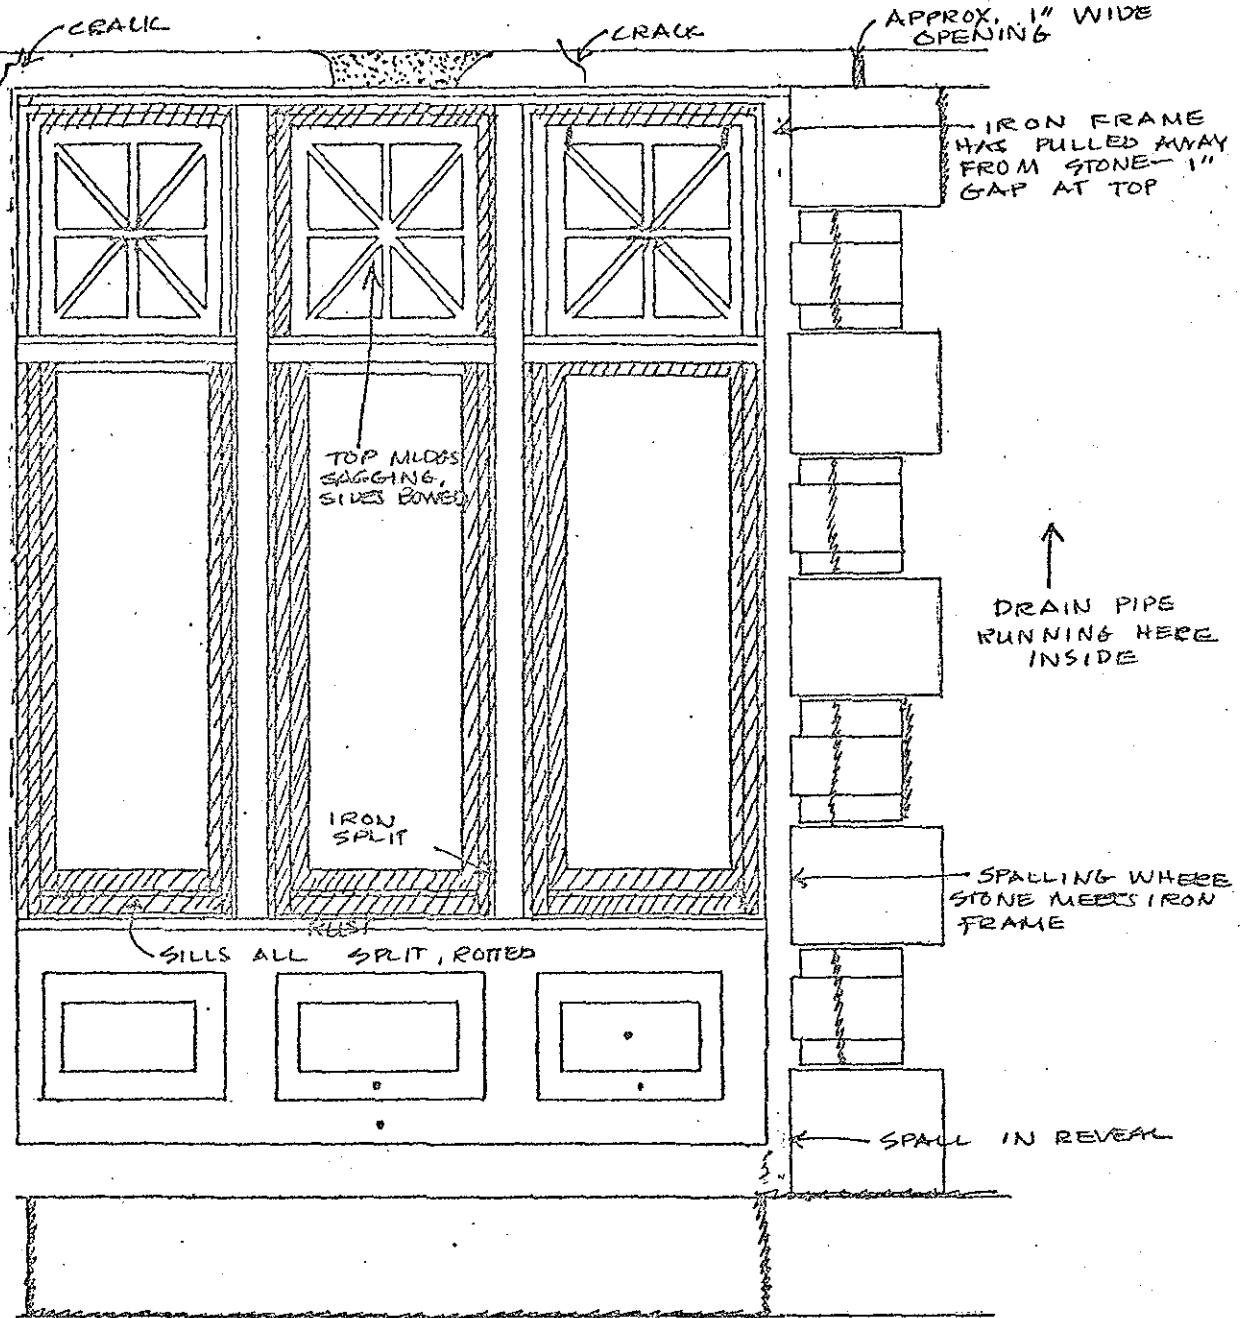
INTERIOR: • INTERIOR HAS FALLEN IN - ENTIRE FRAME IS ROTTED

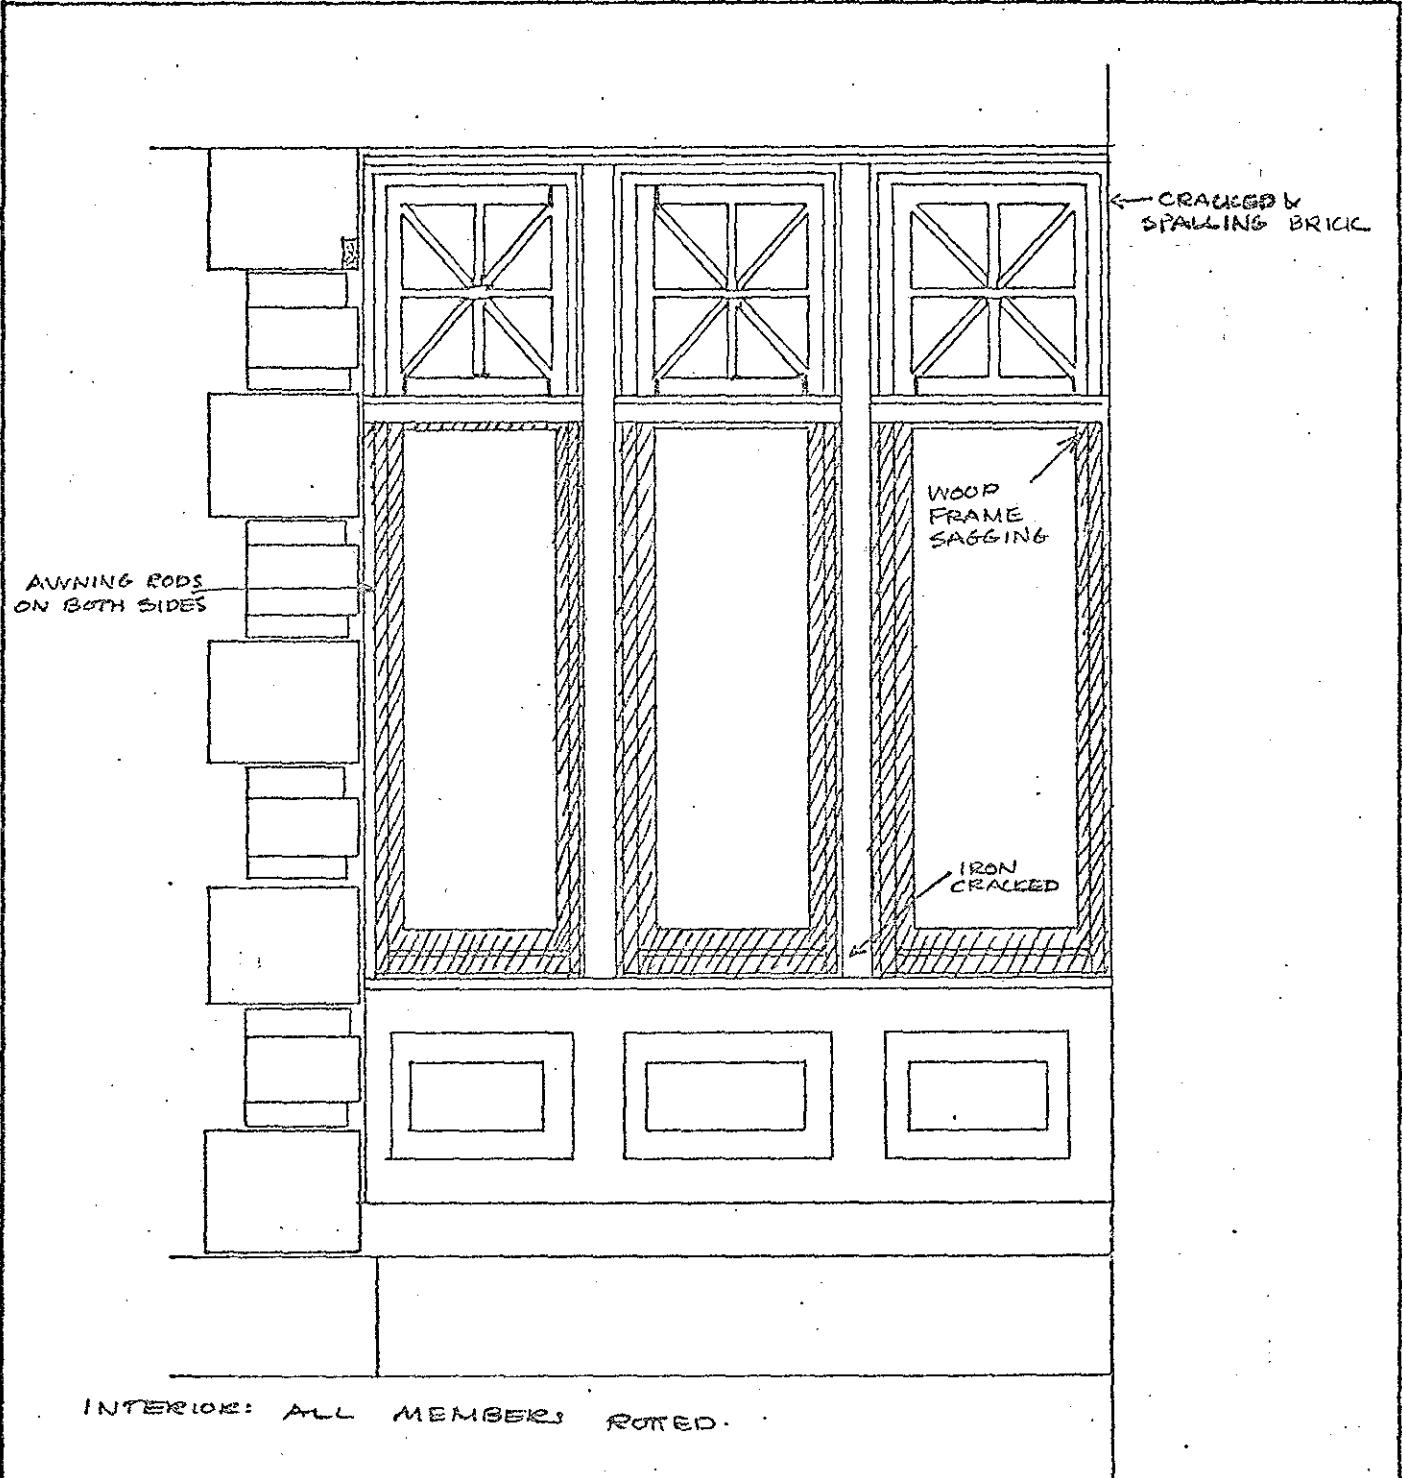
GRILL OVER UPPER & LOWER SASH - HEAVILY CORRODED ON
LOWER PORTION
NO SCREENS

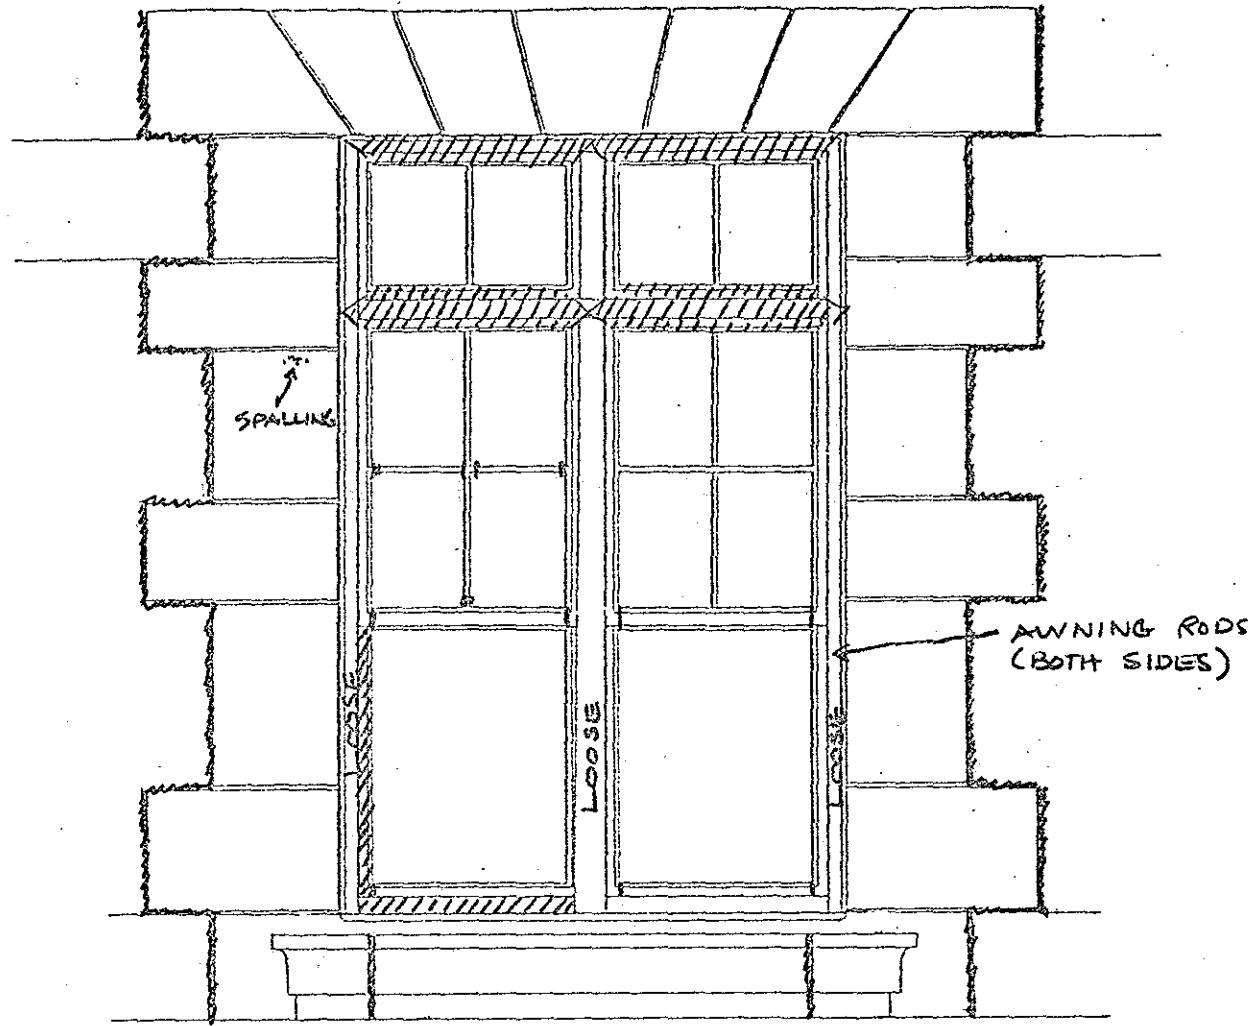
- INTERIOR:
- FRAME HAS FALLEN IN ON WEST (RIGHT) SIDE
 - JAMBS SPLIT AT CORNERS
 - TRANSOM & CENTER JAMB LOOSE
 - ALL FRAMING ROTTED

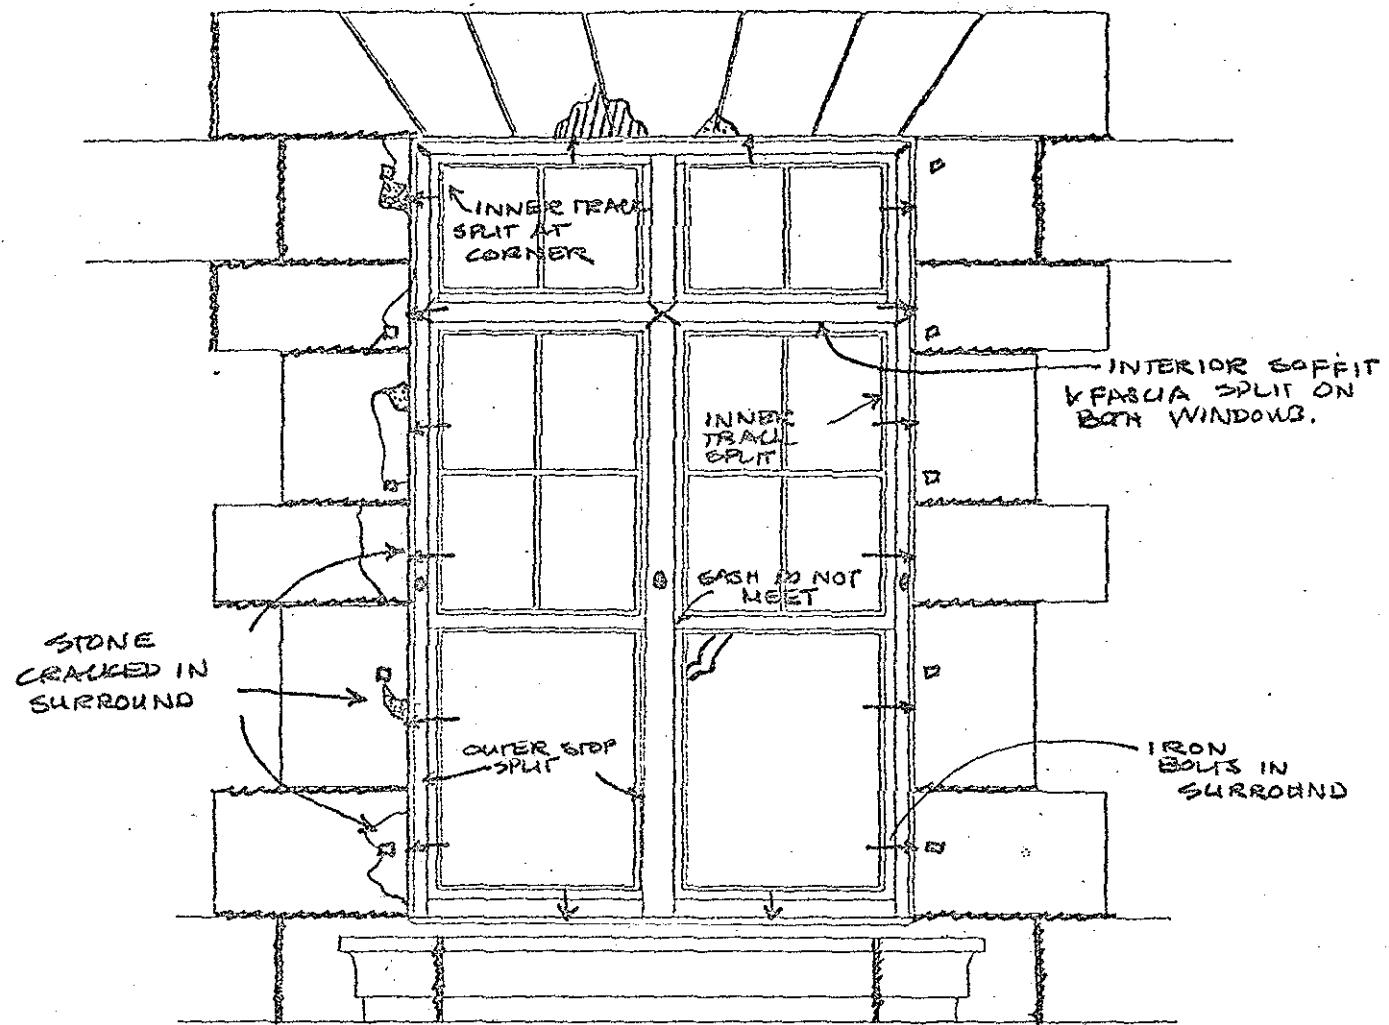
INTERIOR WOOD DAMP. MOULDINGS LOOSE ; WINDOWS
WILL NOT OPEN - UNABLE TO CHECK EXTERIOR TRIM

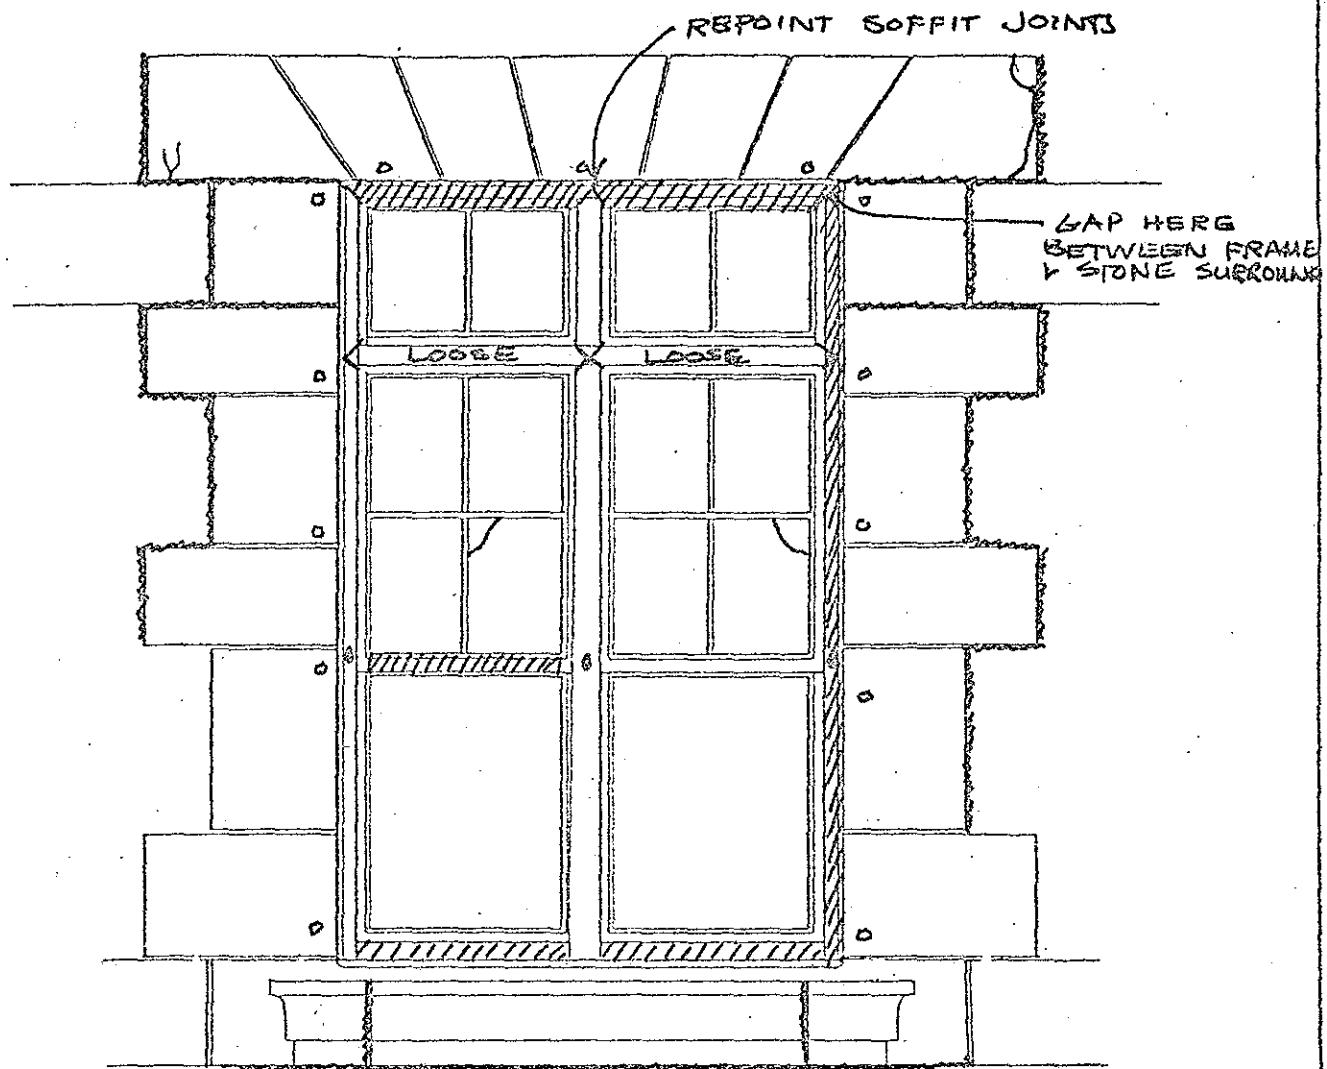
- INTERIOR:
- HEAD & TRANSOM SPLIT & WARPED
 - SOFFIT OF HEAD HAS PALLEN OFF
 - JAMB'S ON BOTH SIDES OF WEST (LEFT) WINDOW LOOSE
 - EAST (RIGHT) JAMB ROTTED
 - SASH APPEARS O.K.

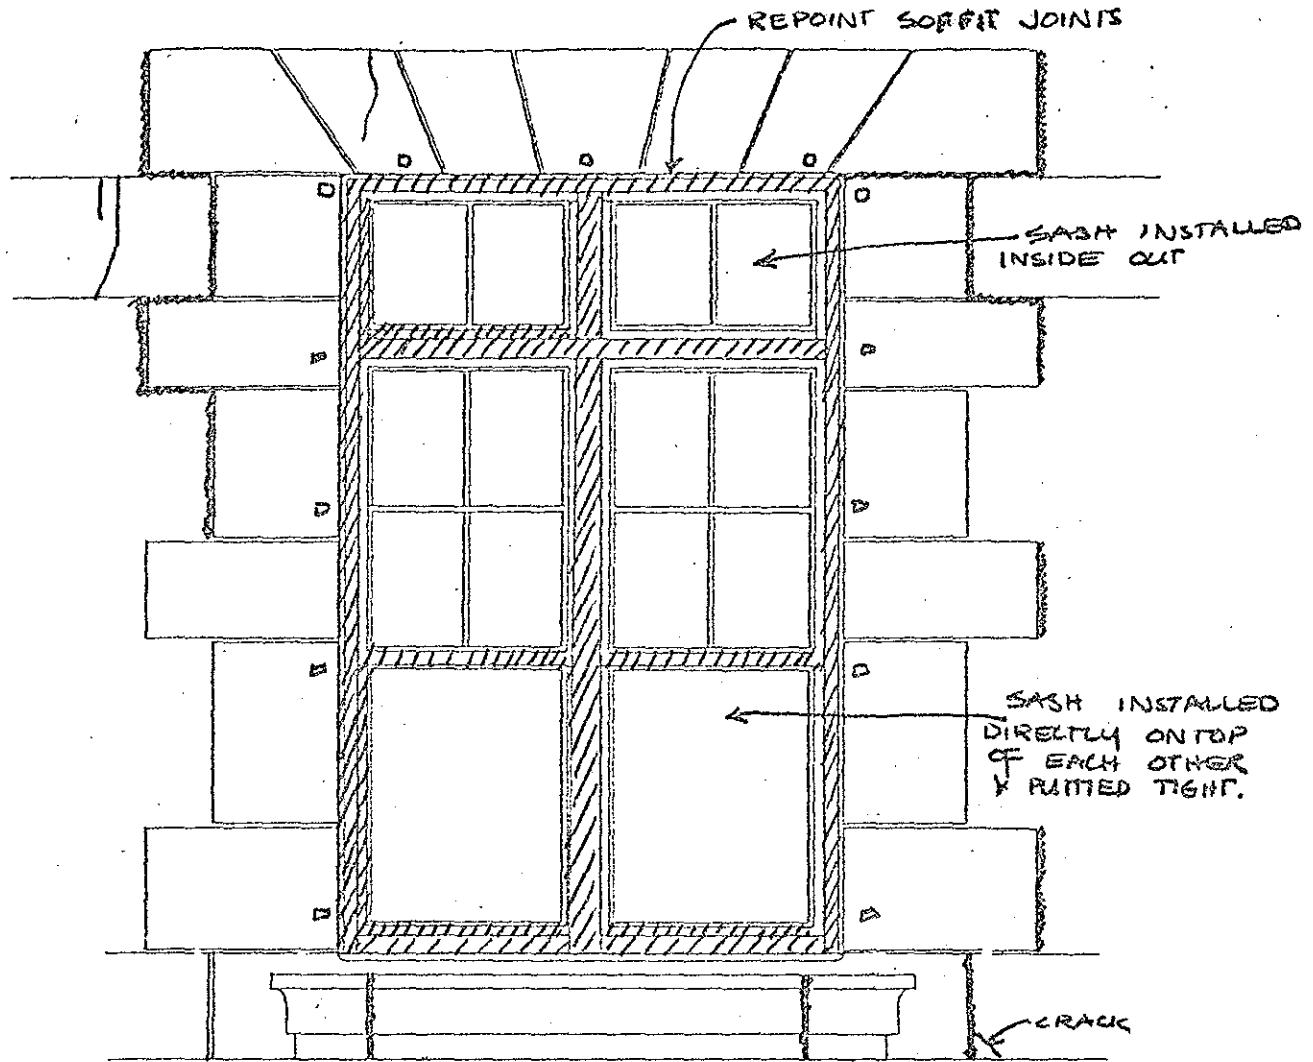
ALL OUTER MOULDINGS AND FRAMEWORK HAVE
BEEN REPLACED WITH MAKE-SHIFT FRAMES.

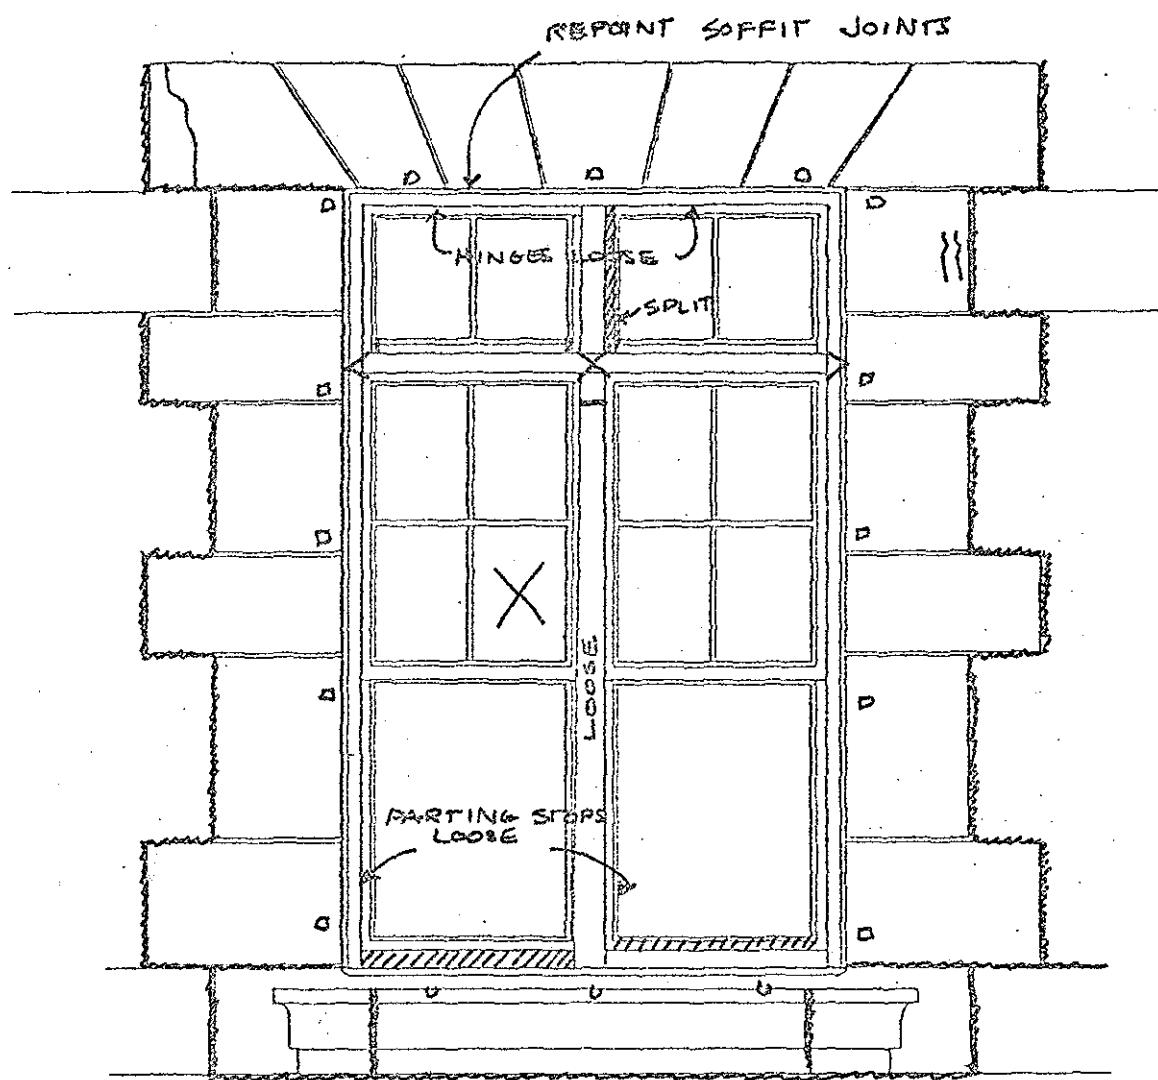
INTERIOR: • ALL MLDGS FRAMING OPENINGS MISSING, LOOSE AND /OR WARPED.

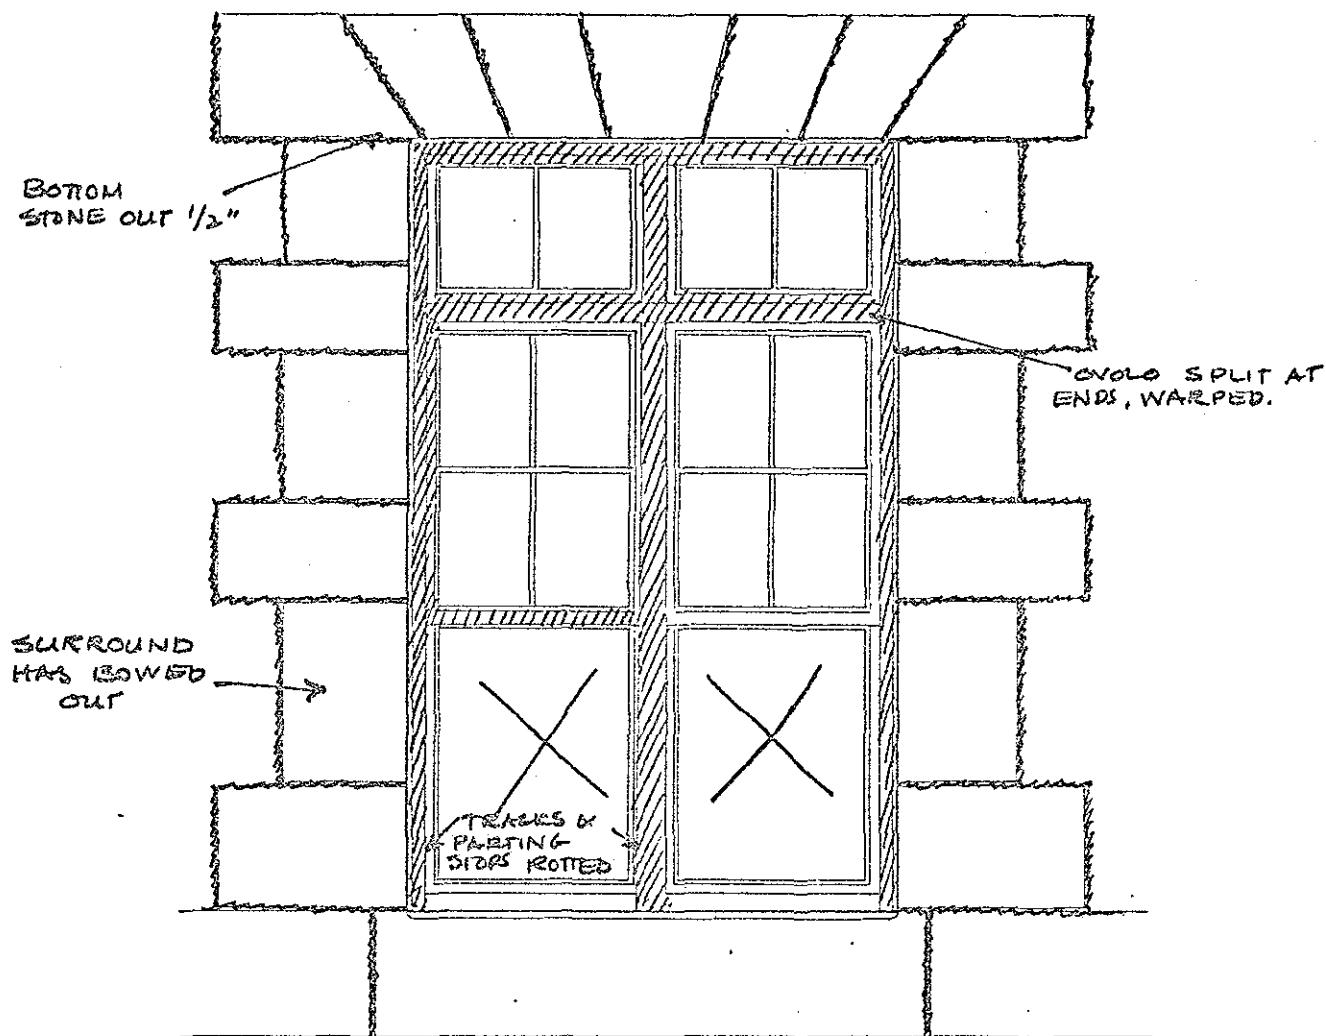
INTERIOR: ALL FRAMING ROTTED
