Subject: Metallurgical Study of the Statue of Liberty

Report A.L.#995

Examination of Parts from the Statue of Liberty by
Winterthur Museum's Energy Dispersive X-Ray Fluorescence Analyzer (XRF).

The National Park Service requested Winterthur to determine if an analytical study of the corrosion layer and the structure of the Statue of Liberty could reveal causes of the severe corrosion and make suggestions to stabilize the system to avoid catastrophic destruction.

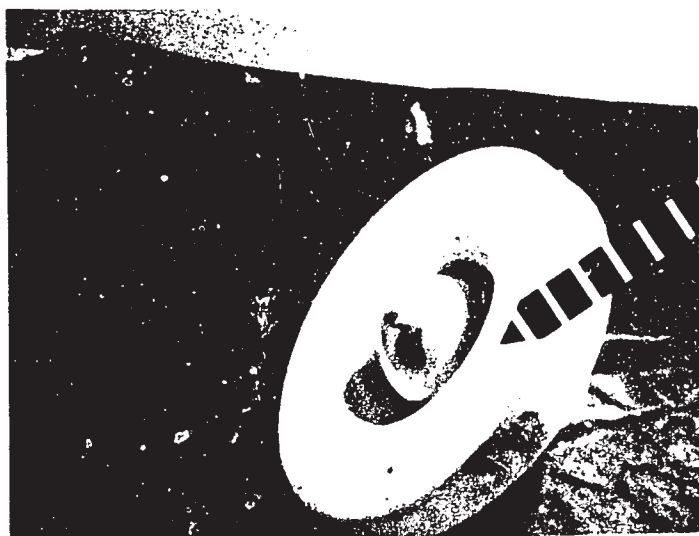
#B1893 - Face of Cylinder
#B1894 - Soldered Joint

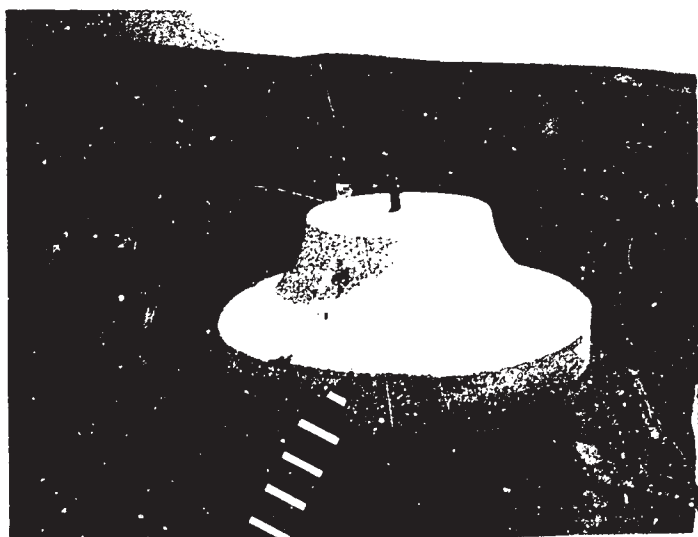
#B1894 - Soldered Area

1. Antimony - Antimony found in the range of .02 - .035% is probably an impurity in the copper that could not be removed by the refining process then in use. B1894 is a measurement made at a soldered area showing 44% lead which frequently contains antimony, especially if the lead was reclaimed, since antimony is used to harden or strengthen lead structures.

found except at the soldered part B1894. Mercury on the solder was obscured by the contiguous element lead which appeared to be 44% in the solder.

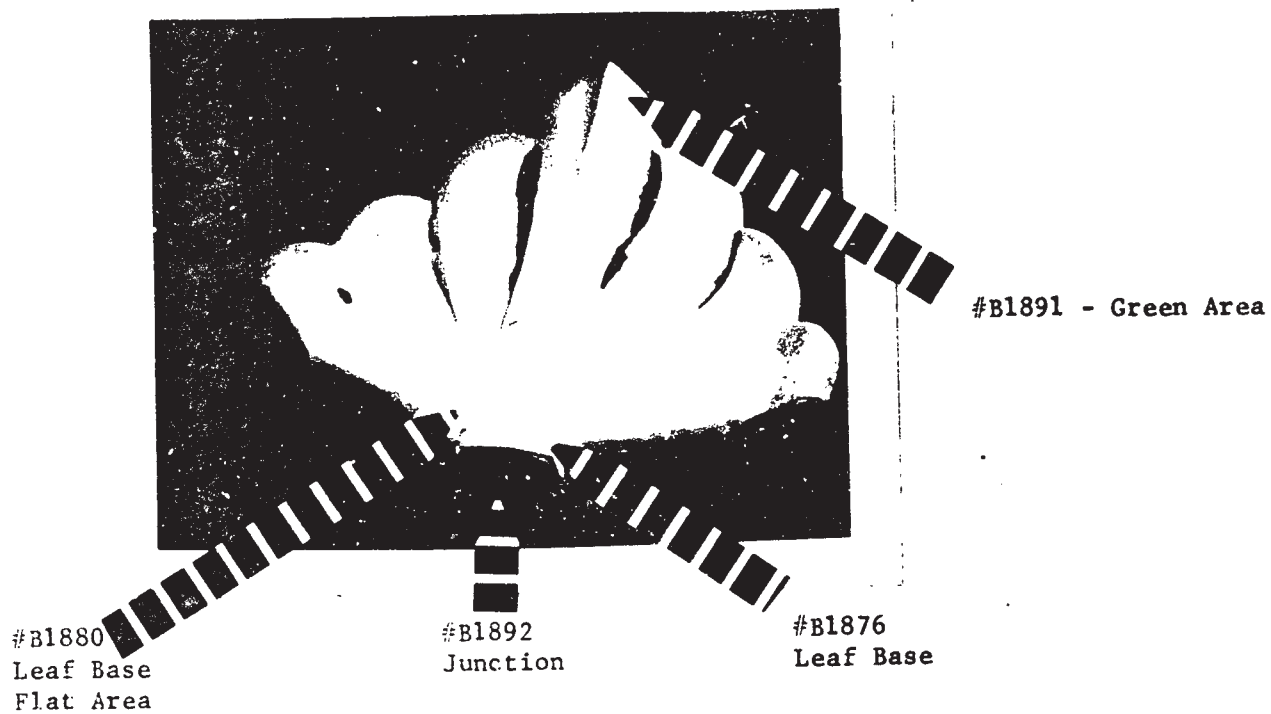
Table 2 Measurement Locations

7. Gold - None found.
 8. Iron - The iron content of the copper varies from about 0.3 to 0.5%, generally. B1892 shows about 2% iron on the gusset insert of the anthemium where it had been riveted or bolted to another part of the Statue.
No iron was detected in the B1878 scraping which is strange and should be rechecked. This might be an error due to the very small sample (25 mg.) employed.
