CANYON VILLAGE FACILITIES

YELLOWSTONE PARK COMPANY

Prepared by
ORR PICKERING & ASSOCIATES
Architects and Engineers
Billings, Montana

November 1963

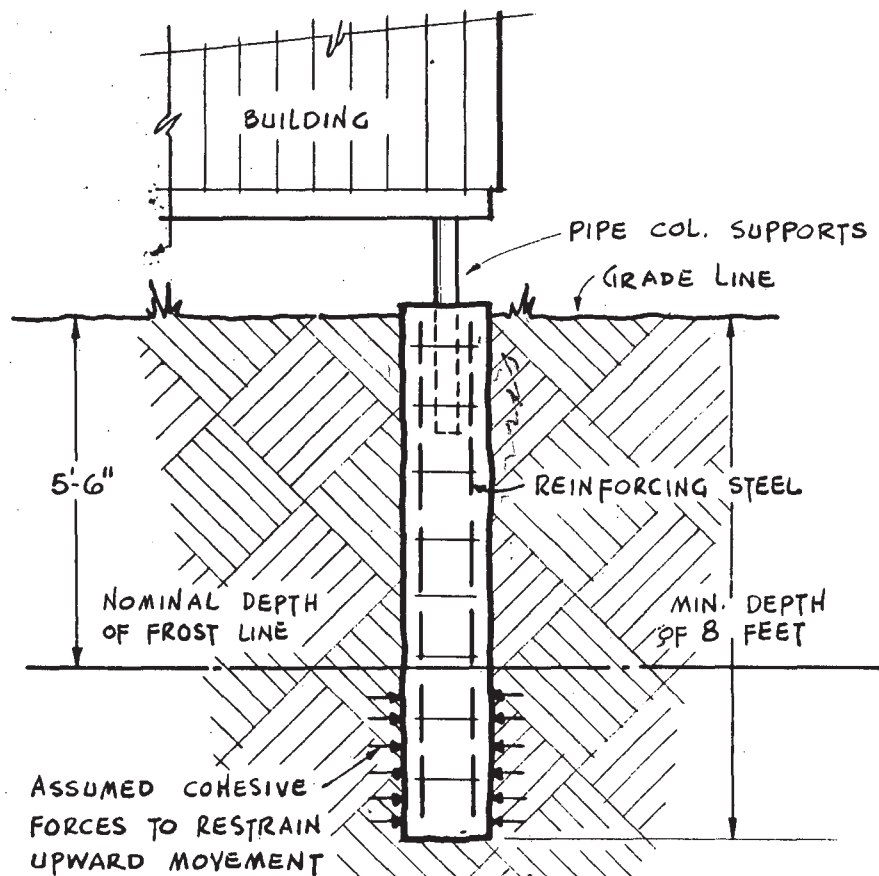
"AS DESIGNED"

The design of the cabin footings, in lieu of eliminating the frost grip, was based on the premise that if the footings were extended deep enough below frost line (or into the bedrock as the case might be) the bond developed by skin friction on the surface below the frost line (or the bond with bedrock) together with the dead weight of the loaded pier would be sufficient to offset the lifting action of the heaving material above.

Regretably, the footings as built were obviously not deep enough to withstand the forces acting around them. These forces were further intensified by the presence of excess water. Compounding the situation was the fact that many piers were poured with an "over-run" of concrete at the top forming a "mush-room head". This gives uplifting forces a tremendous purchase on the pier in addition to the grip on the sides.

The sketch on the following page illustrates the "designed" and some "as-built" footings. This information is based on excavations made to investigate the footings and is well documented by photographs in the YP Co. files.

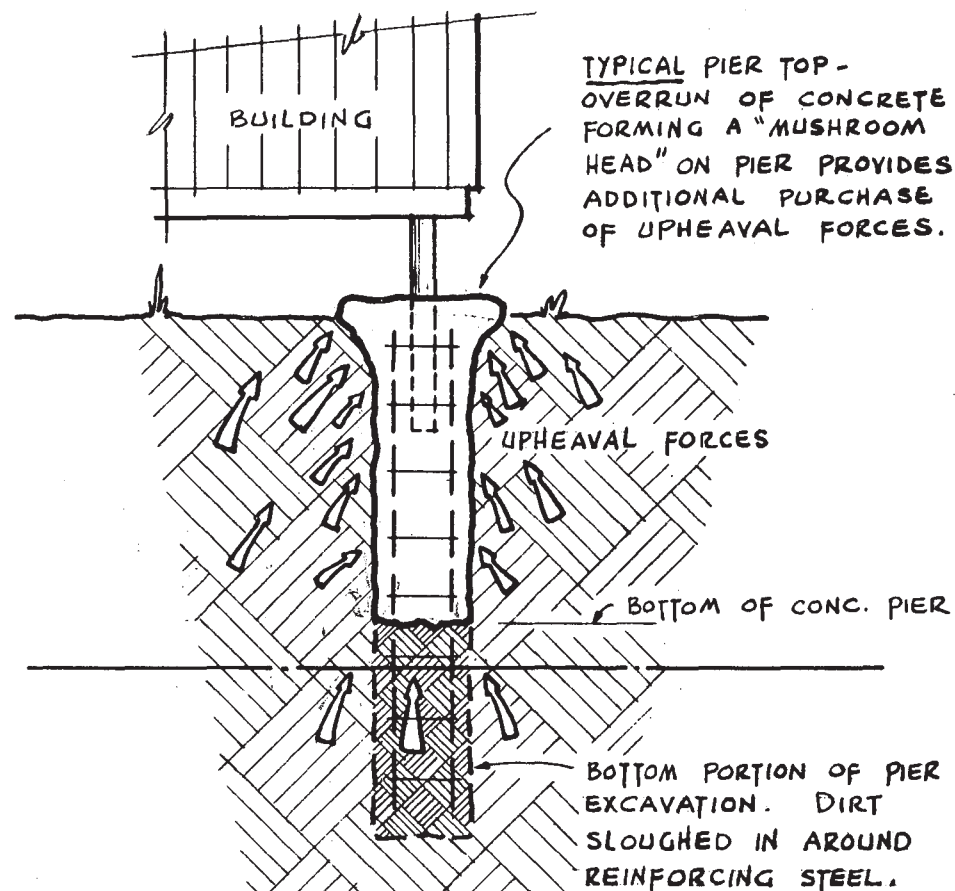
"AS BUILT"

IN SOME CASES EXPOSED TO VIEW BY EXCAVATION

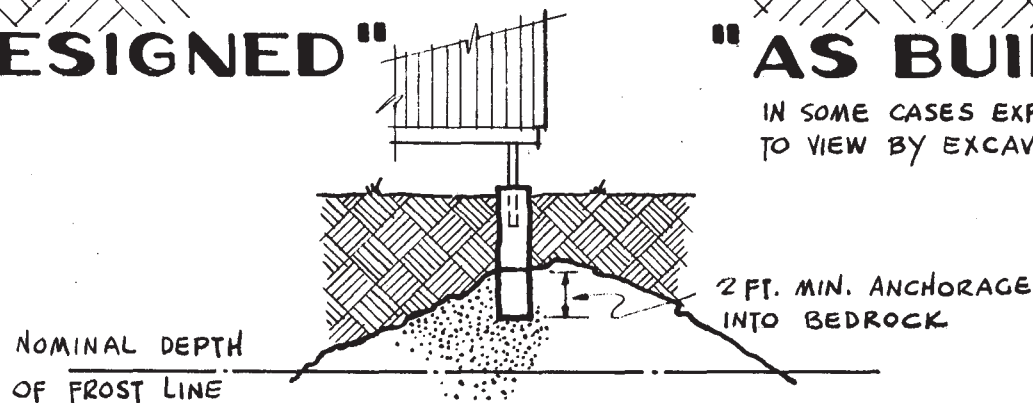
ALTERNATE DESIGN FOR CASES WHERE BEDROCK WAS FOUND ABOVE MIN. DEPTH

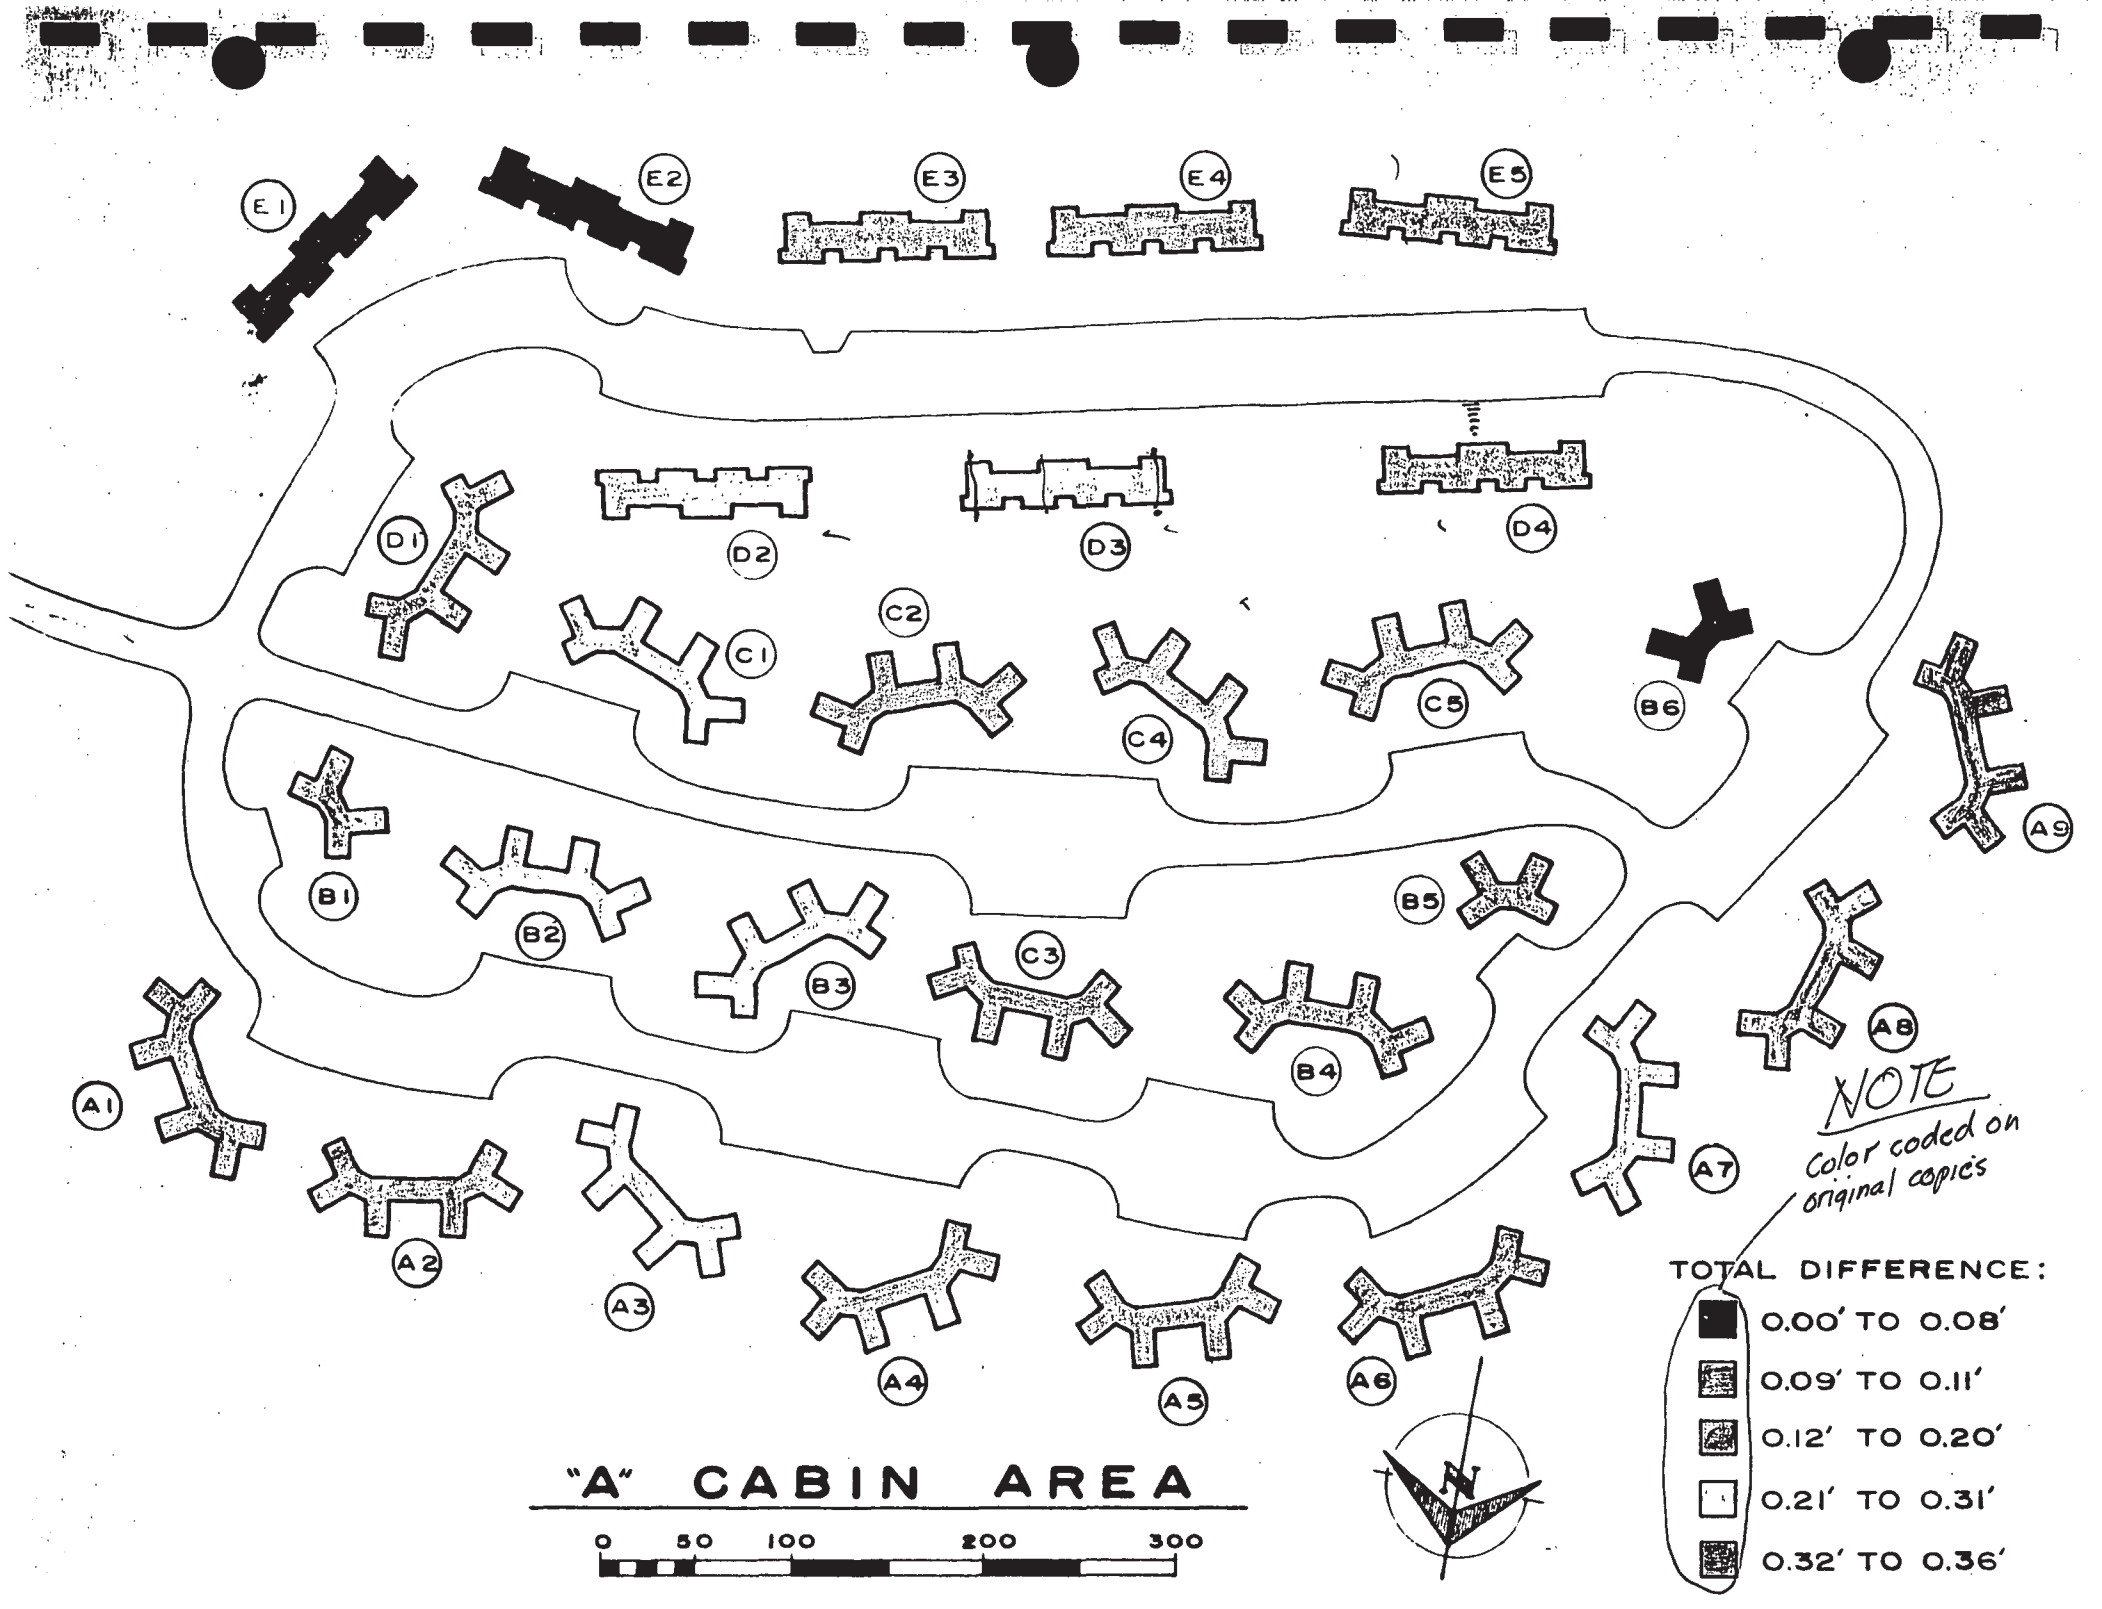
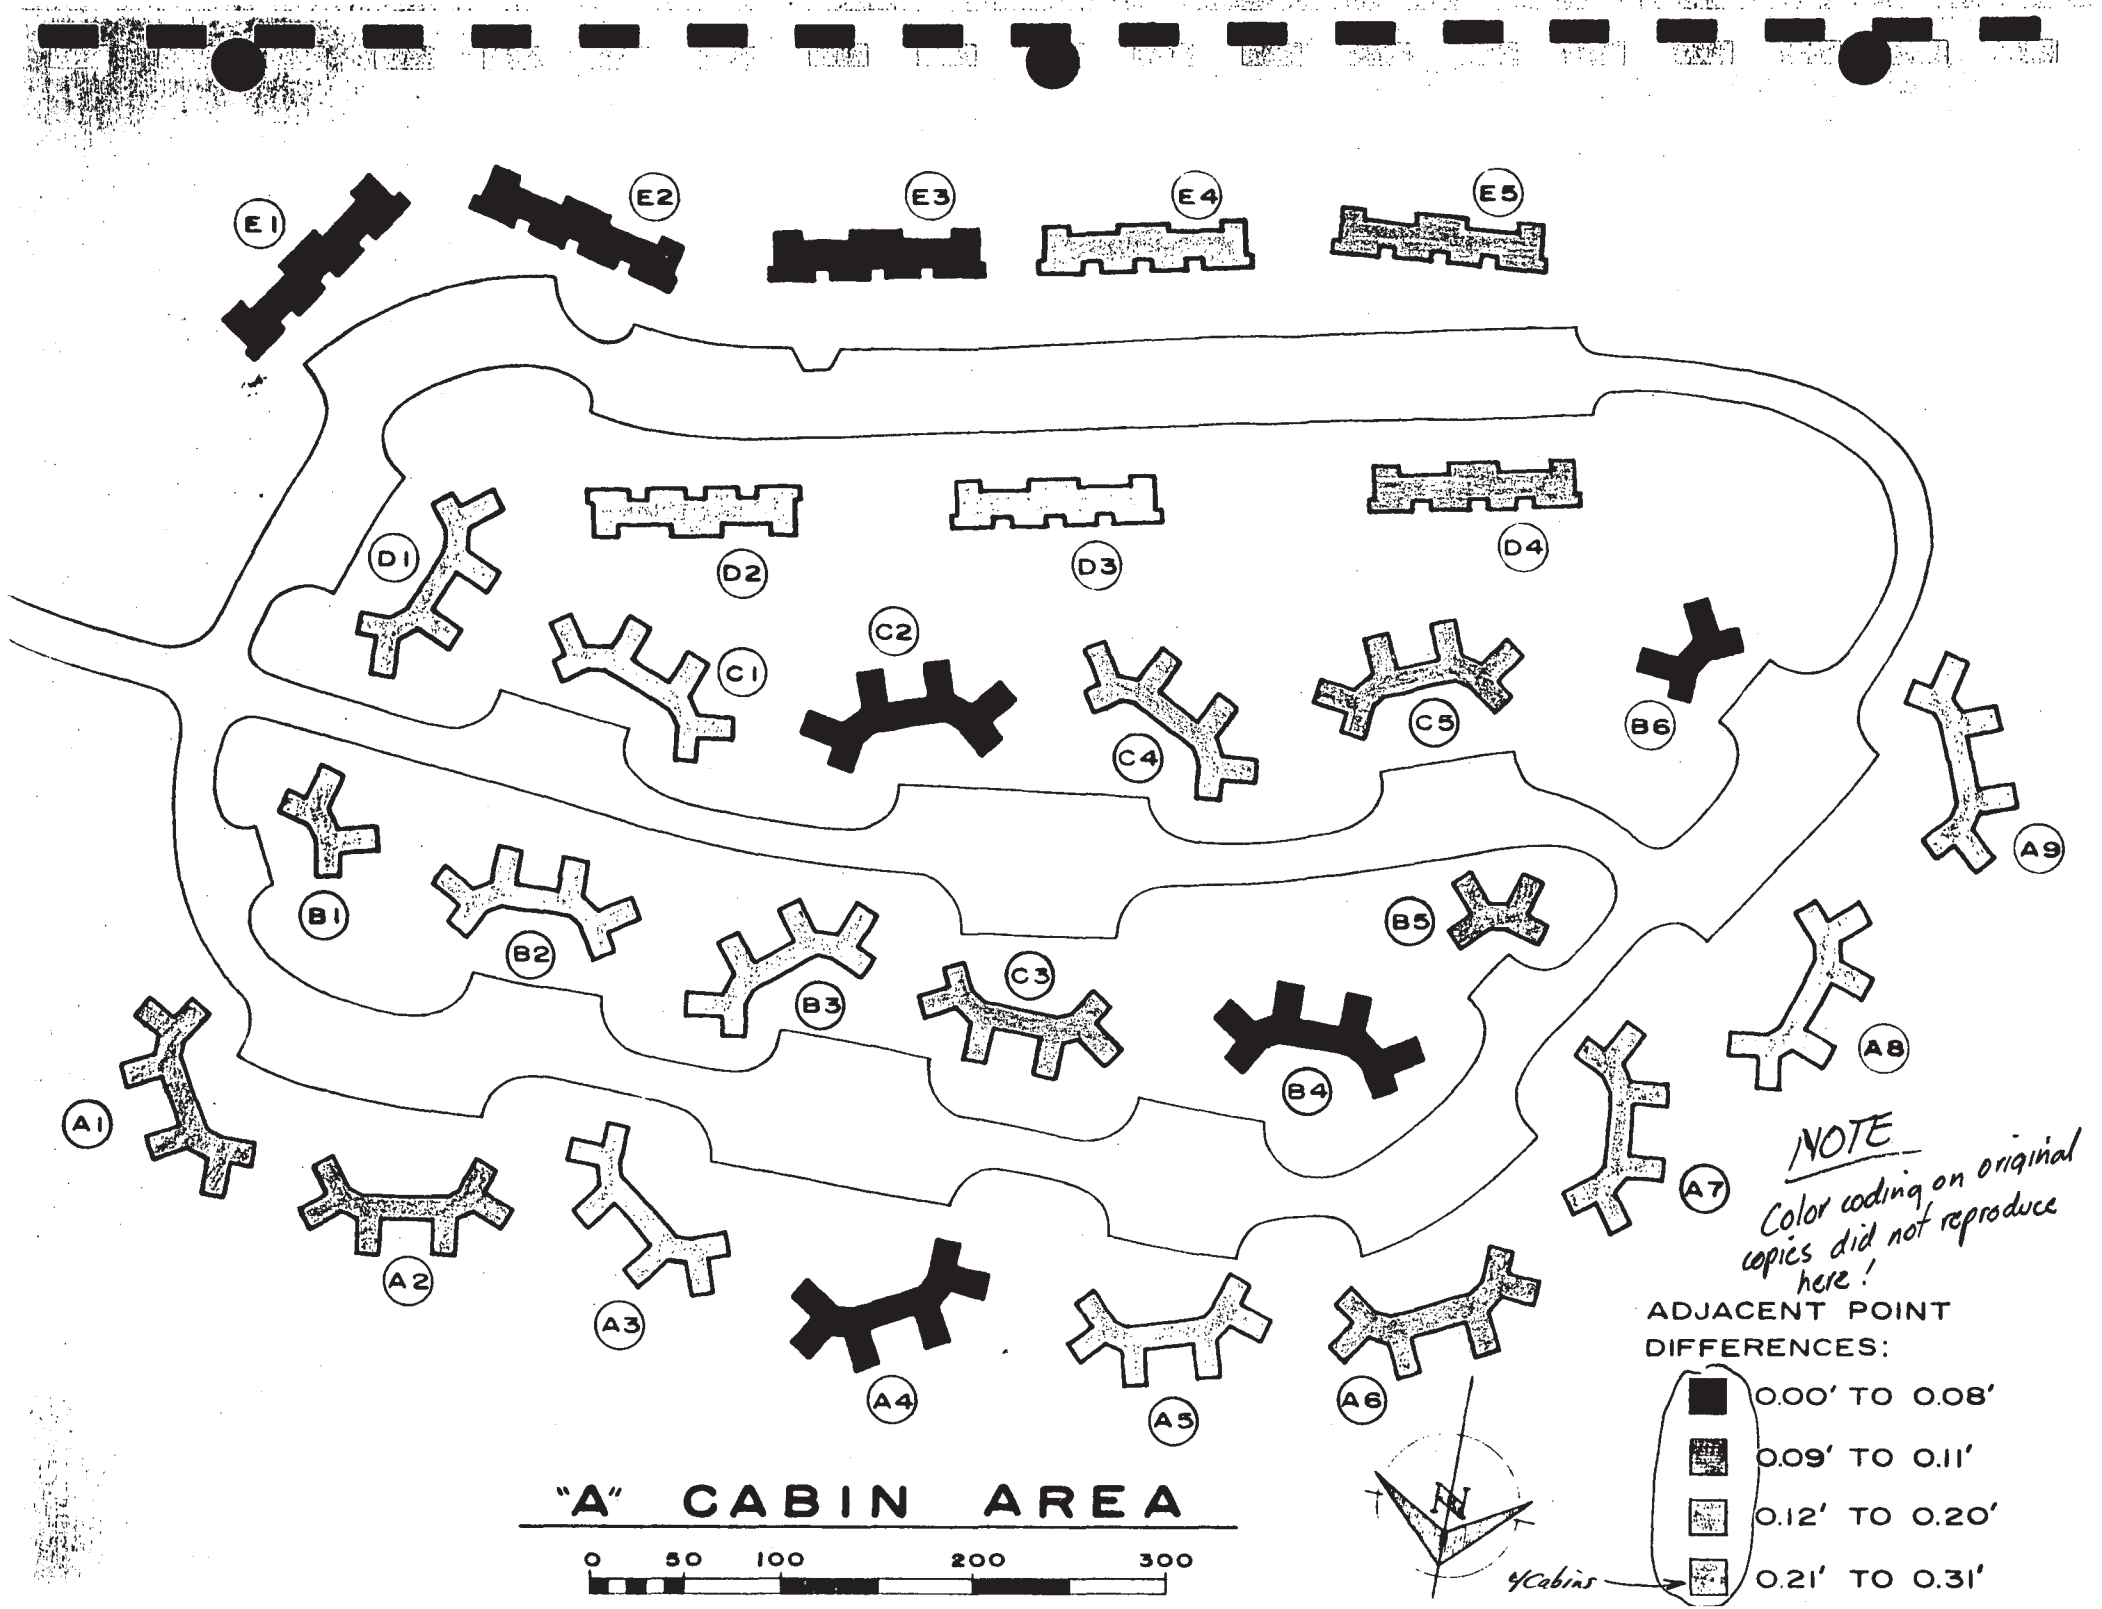
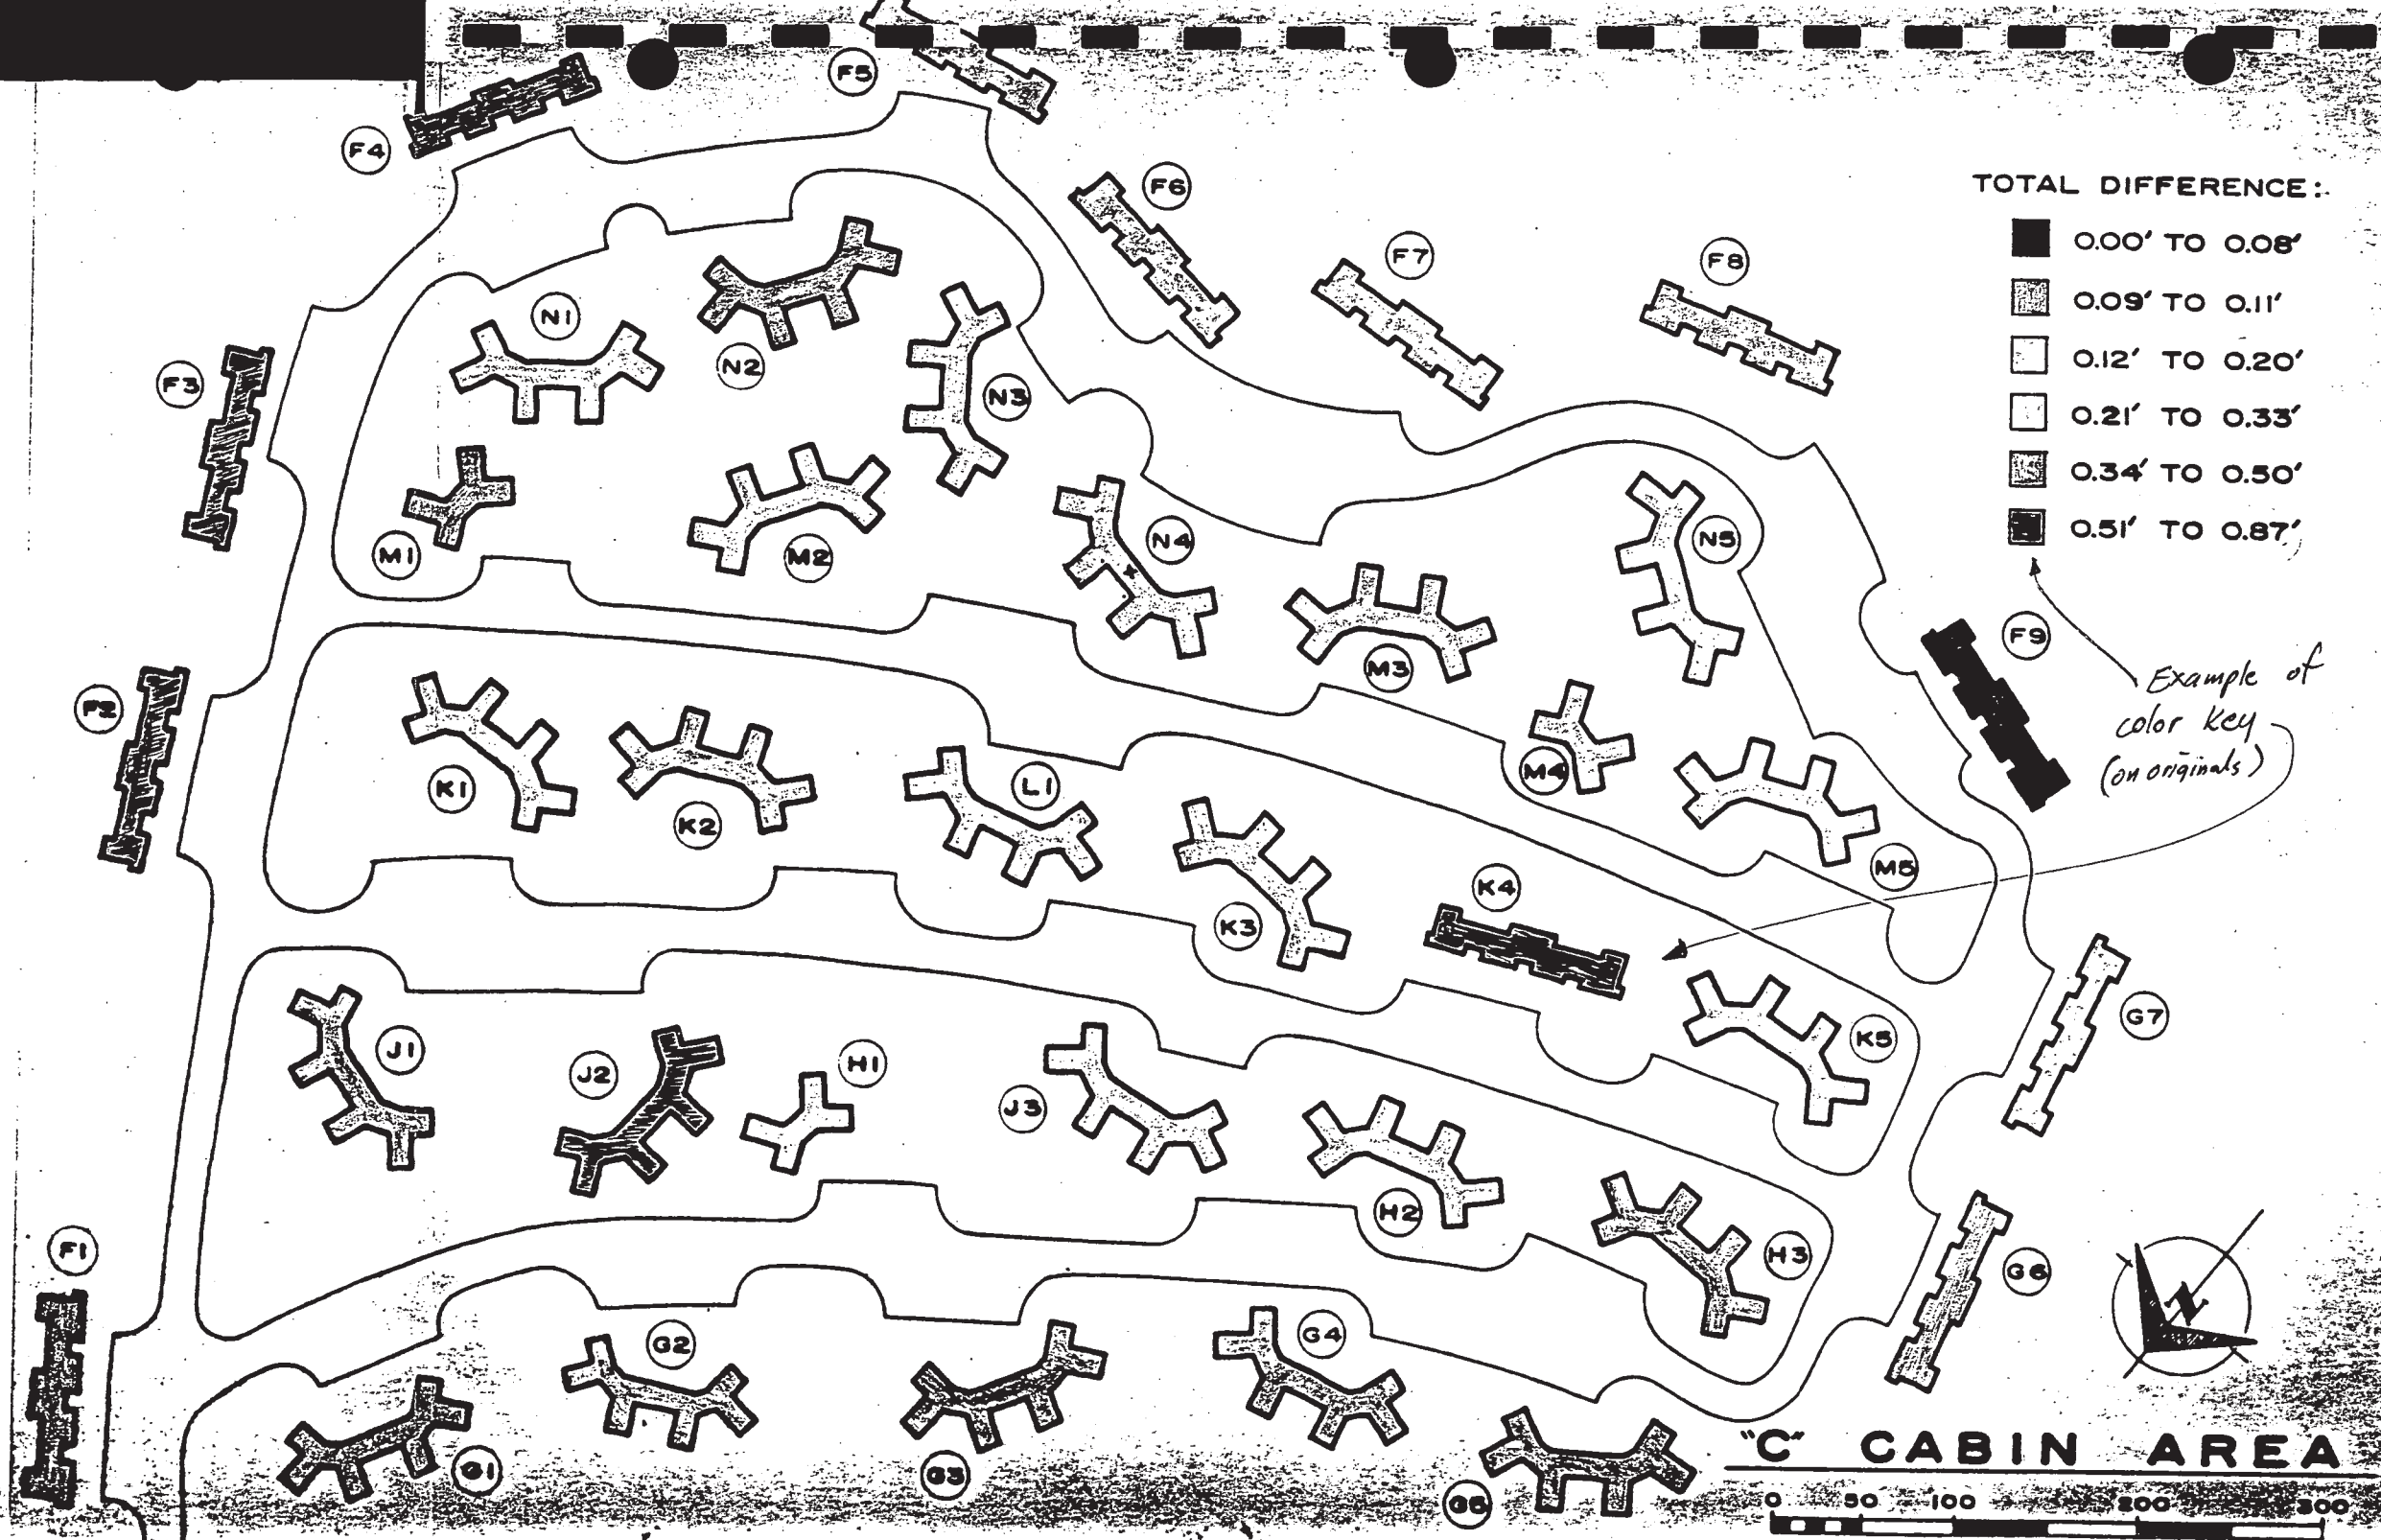
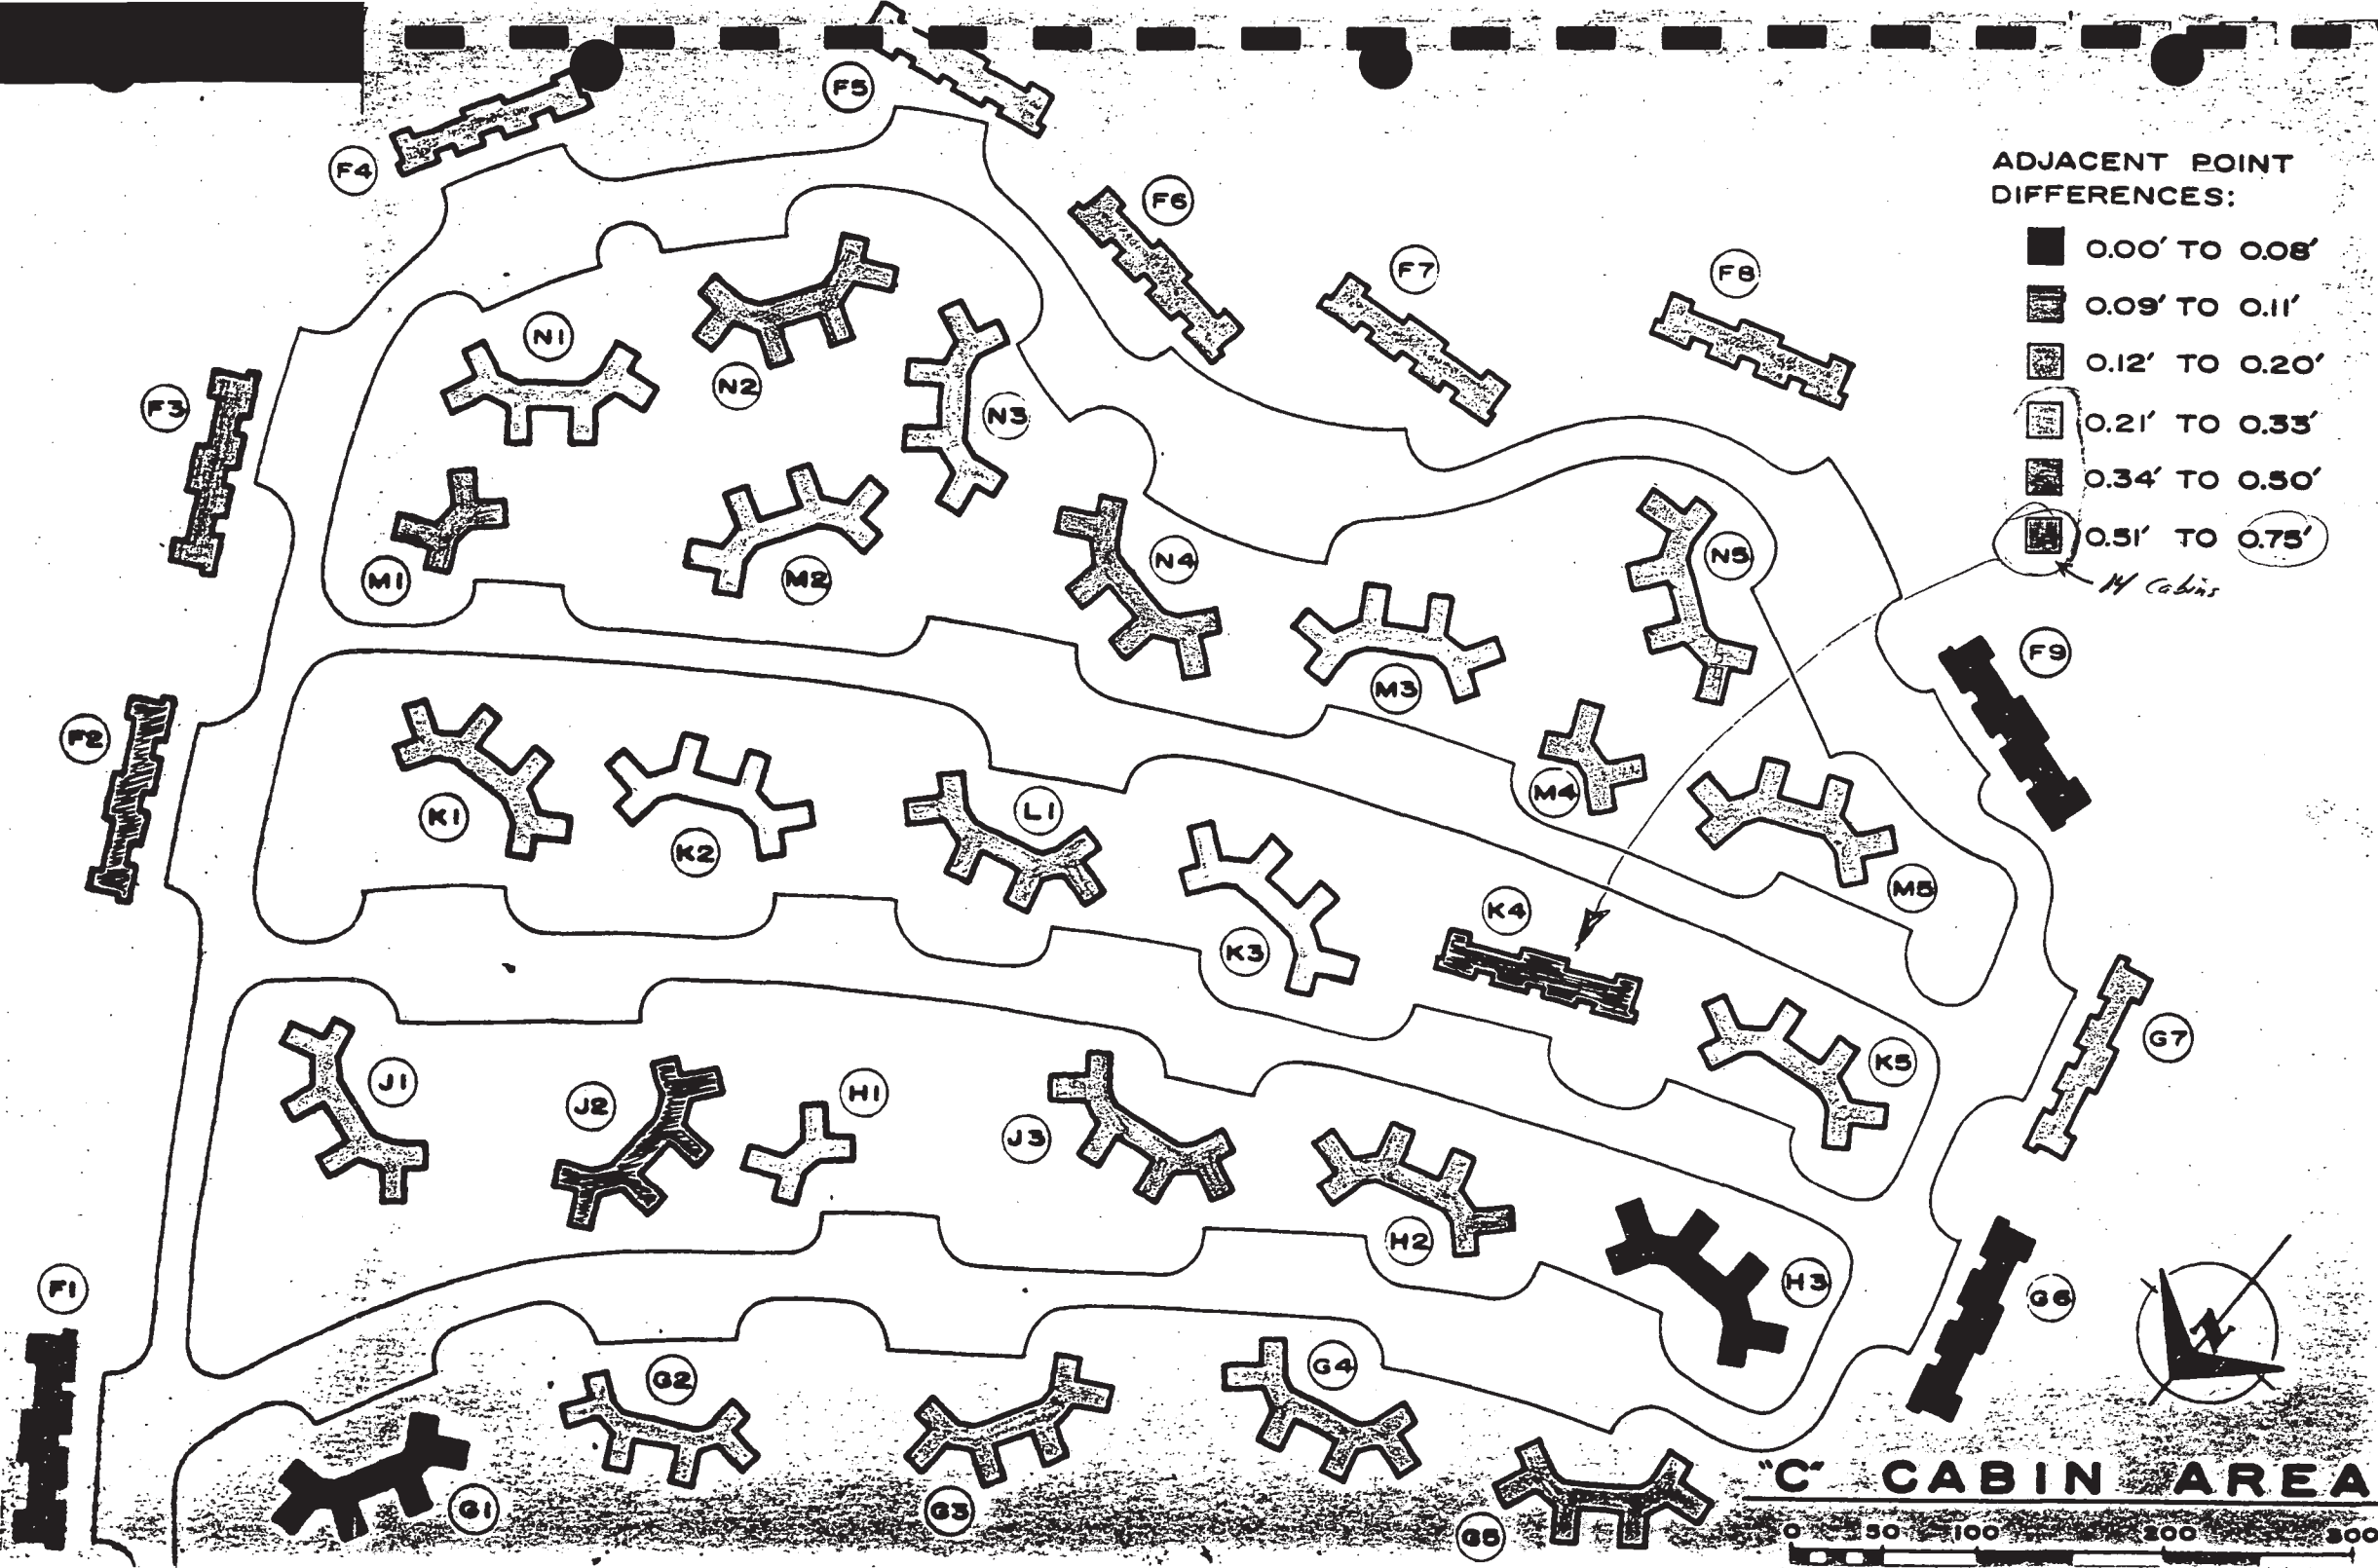
"C" CABIN AREA

Drawings on the preceding pages show a plotting of the ranges in movement for each cabin in two different manners. For instance, one of the "A" area site drawings shows the maximum difference in total readings of high and low points wherever found, on any cabin expressed as being within a given range which is designated by a color. The other "A" area site plan shows similarly the maximum difference between any two adjacent points.

Differences in total readings give an idea of general movement of the cabin as a whole whereas differences between adjacent points show severity of localized movement and is an indication of trouble or "distress" in cabin structure.

It might be reasonably assumed that differences between adjacent points of 0.2 foot (2.4 inches) is within a tolerable limit. With this assumption it can be stated that four out of 29 cabins in the "A" area and fourteen out of 38 cabins in the "C" area show excessive movement as of now.* This amounts to 14% of "A" area cabins and 37% of the "C" area cabins which have been damaged.
