CANYON VILLAGE FACILITIES

YELLOWSTONE PARK COMPANY

Prepared by
ORR PICKERING & ASSOCIATES
Architects and Engineers
Billings, Montana

November 1963

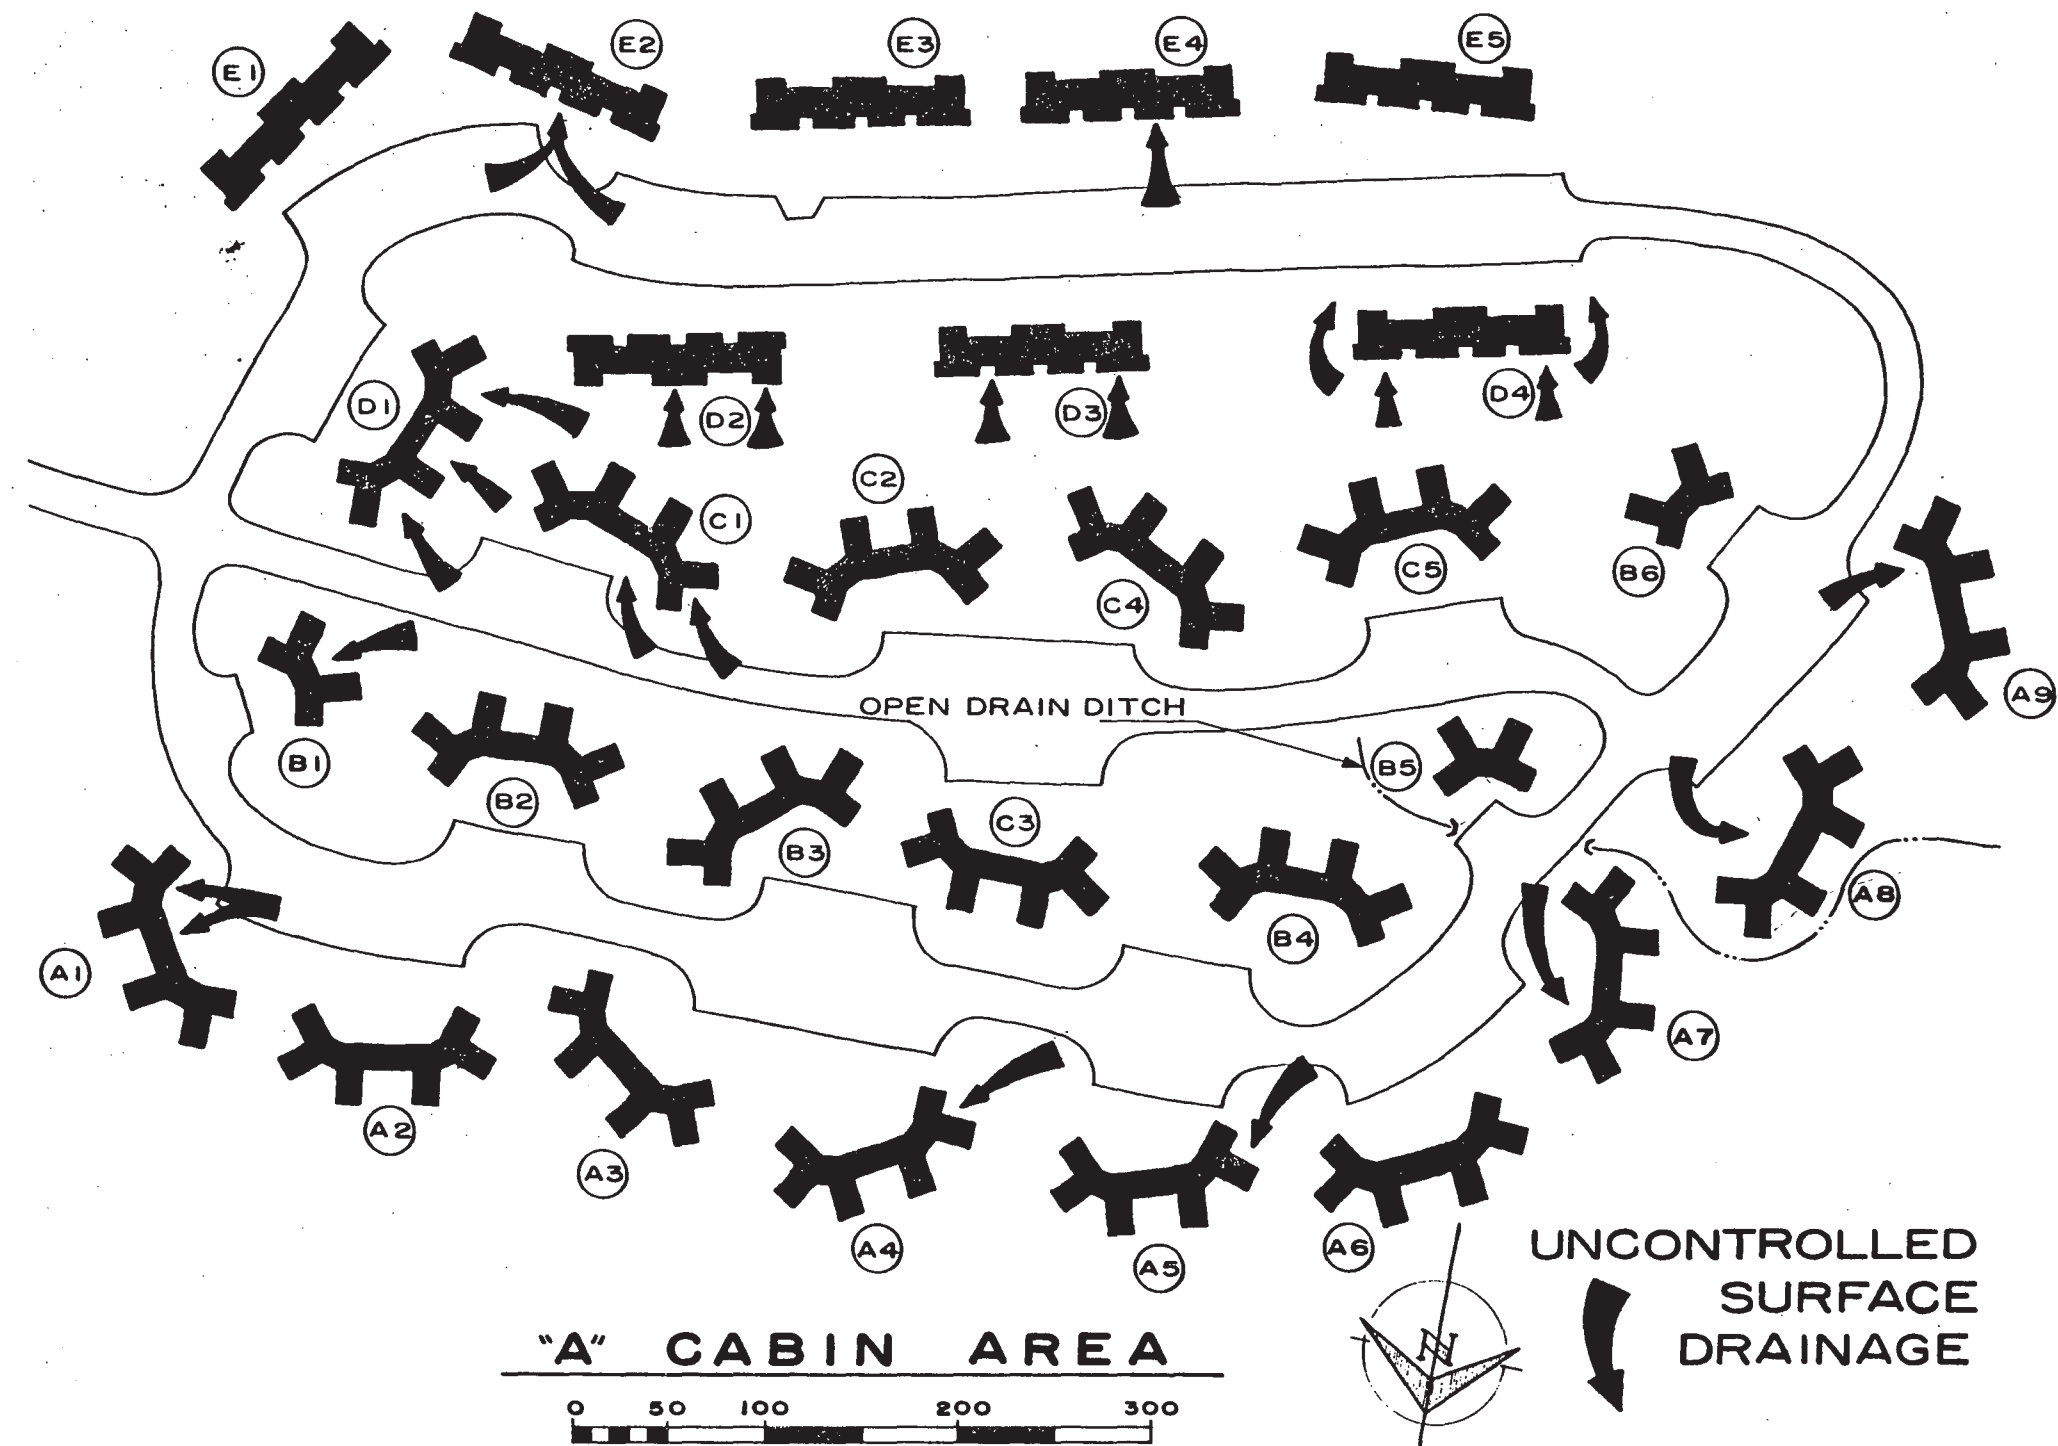
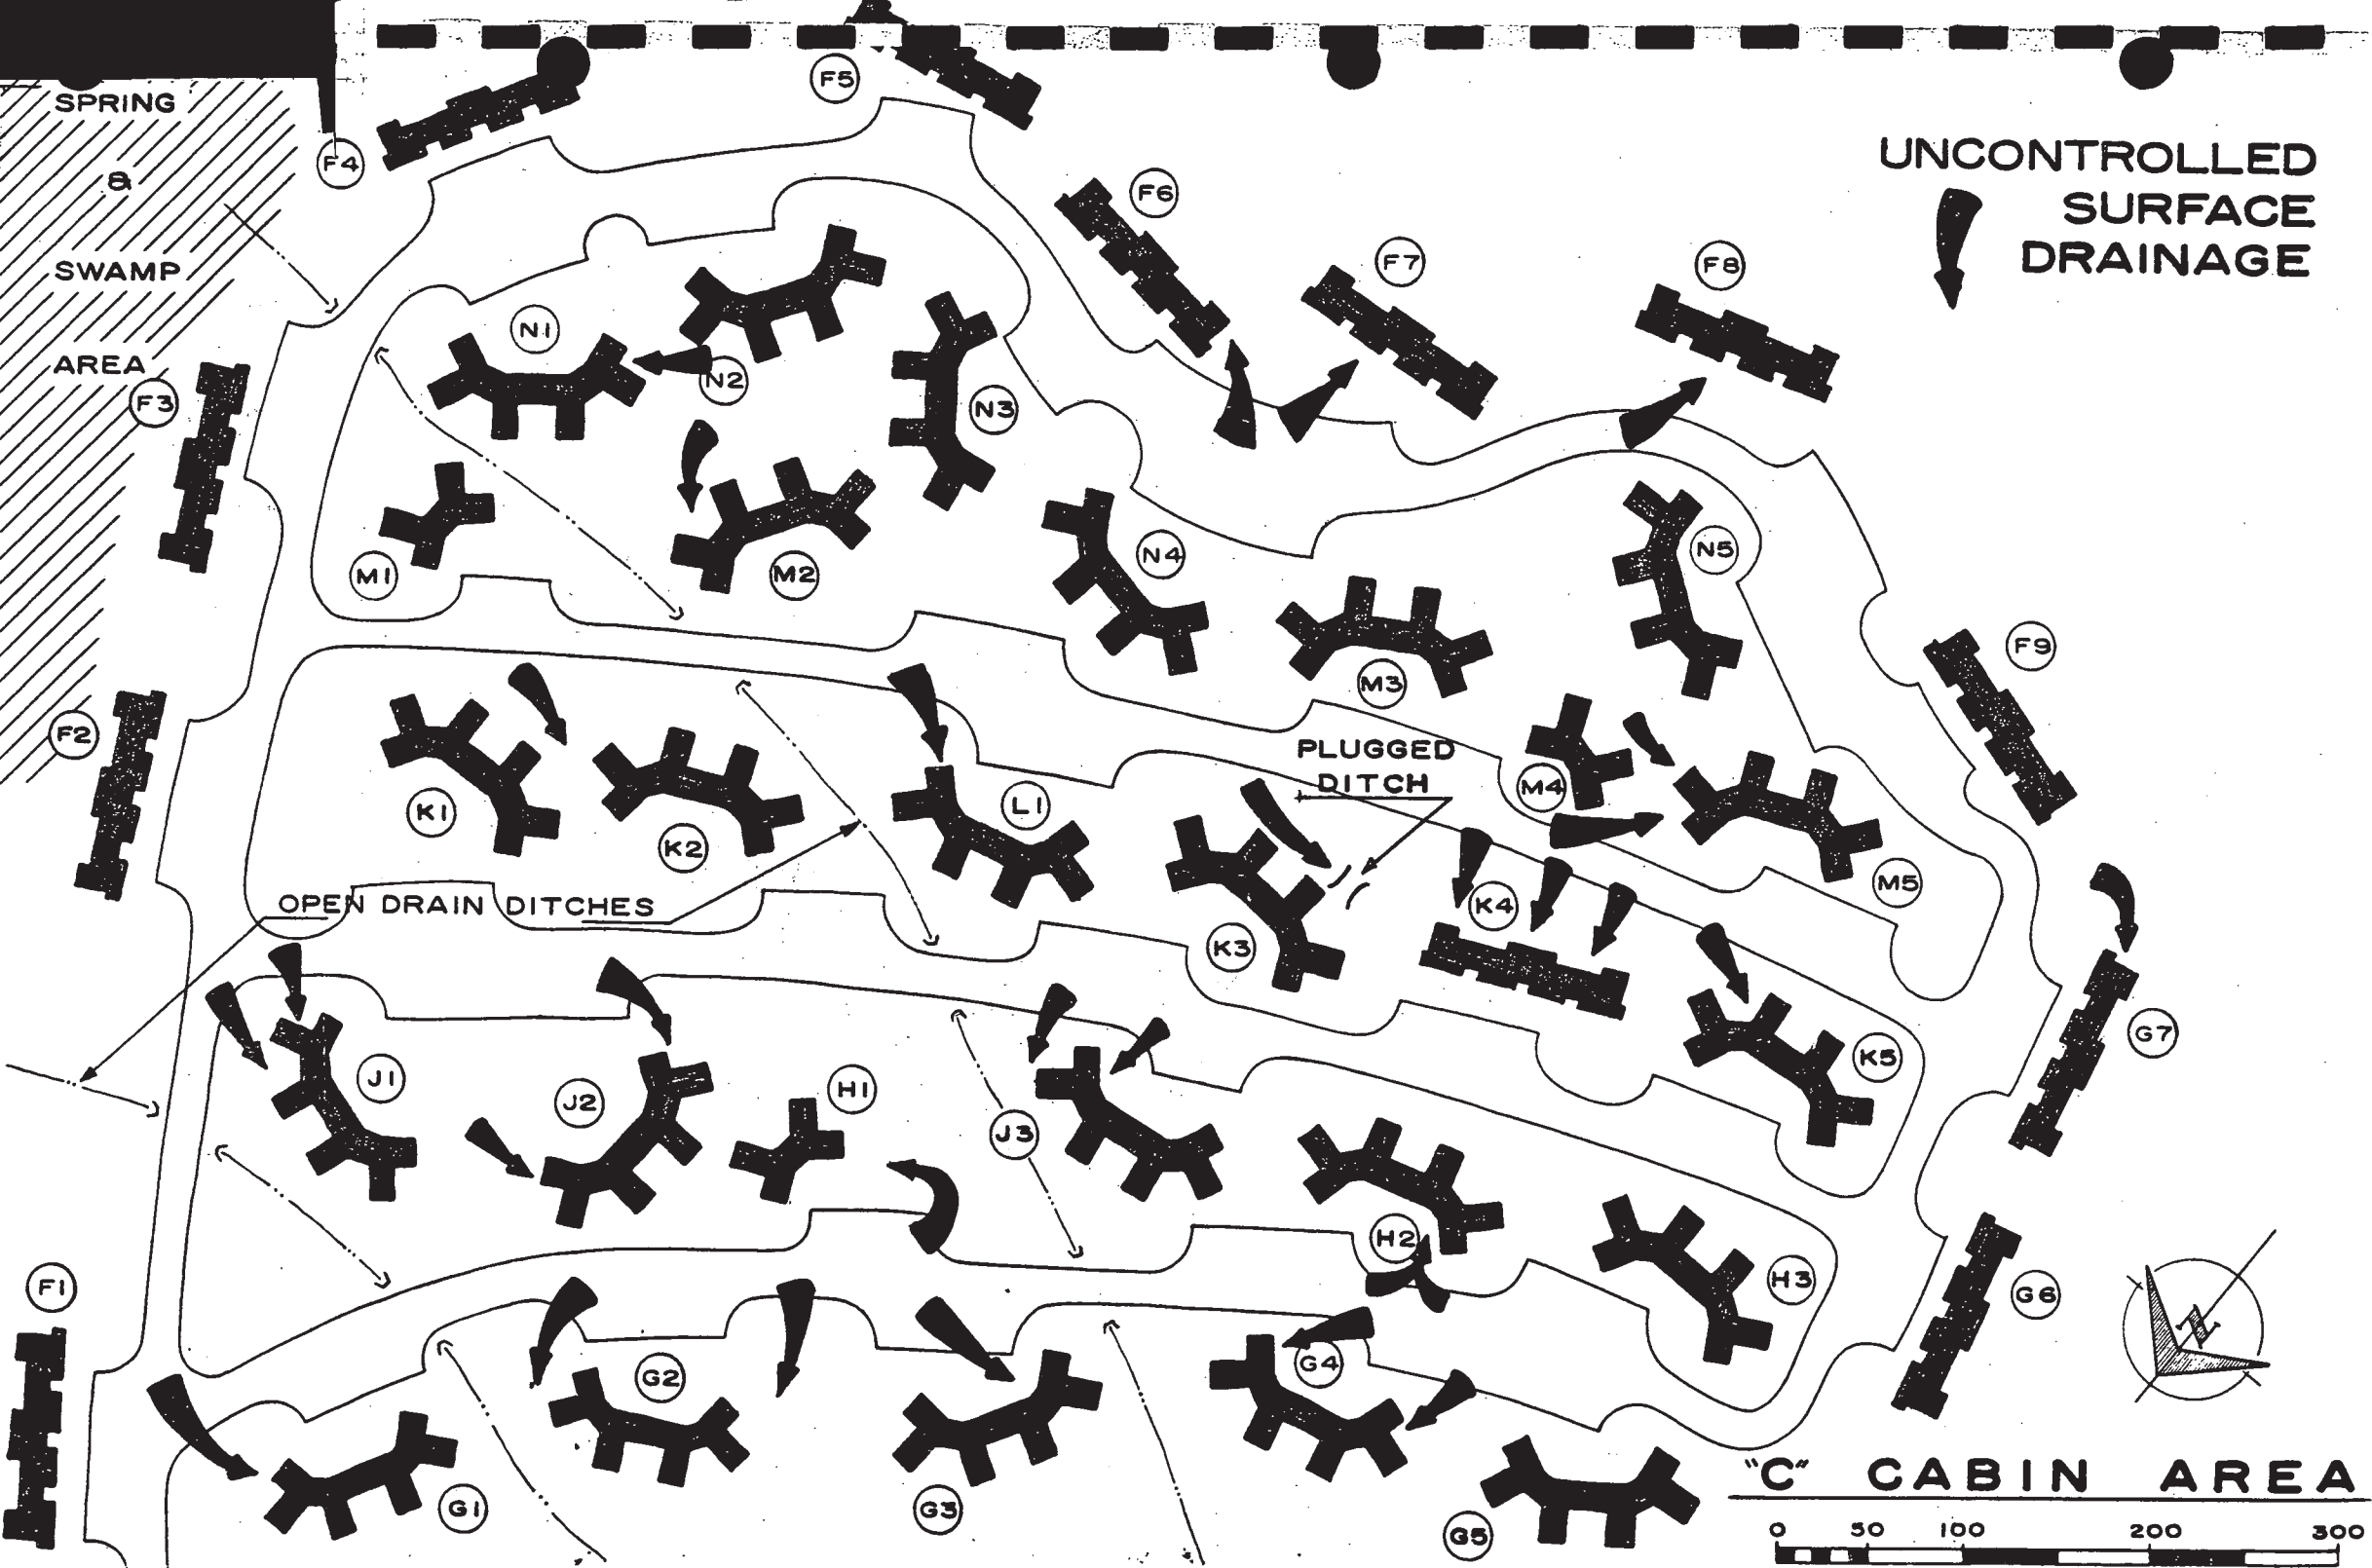
Review of the two drainage charts on the preceding pages will show direct correlation between cabin movement and either uncontrolled surface drainage or subsurface drainage. This explains the reason why most movement and damage has occurred in the "C" area.

Physical measurements on the site and complex analyses are not necessary to demonstrate that excess ground water is present and is one of the prime causes of frost upheaval.

Whatever subsurface drainage piping there may be is quite apparently undersized, plugged, improperly installed or otherwise ineffective; if it was, in fact, all installed in the first place. Standing water over our shoetops (in a dry August) within 20 feet of cabins at the East end of "C" area is mute testimony regarding the underground perforated metal pipe shown on the drawings at that location.

- a. Evaluation of present underground drainage pipe system. Replacement and additions as necessary.
- b. Study of present open ditches. Need for lining of ditches is anticipated.
- c. Complete storm drainage system including curbs and gutters, catch basins, etc.
