# **Coastal Hazards & Sea-Level Rise Asset Vulnerability Assessment for Assateague Island National Seashore**

Summary of Results

NPS 622/188380, May 2023

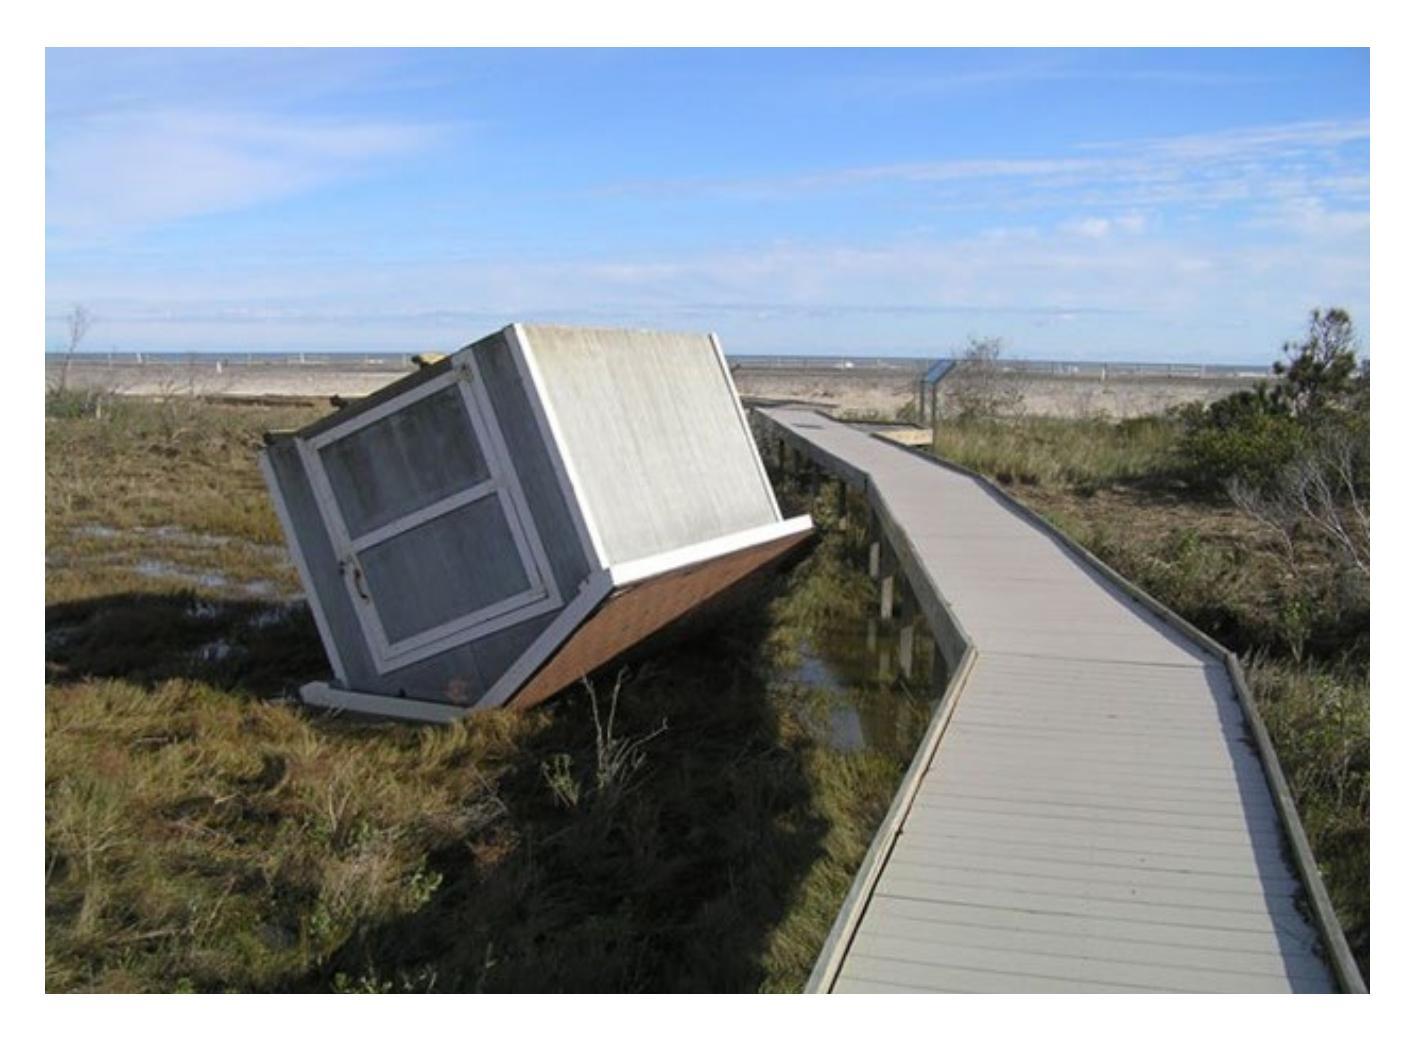
**ON THE COVER** Bike Shed against a boardwalk after Hurricane Sandy at Assateague Island National Seashore Photo credit: NPS

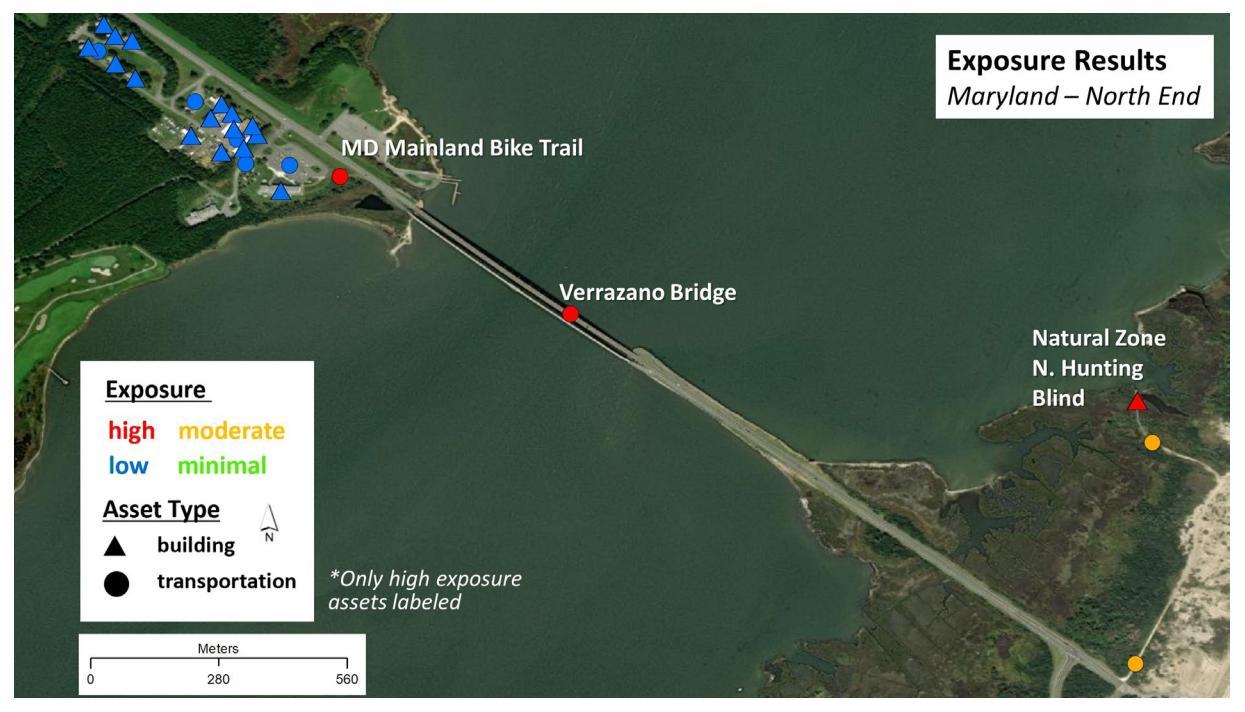
**Figure 1**. ASIS exposure results for the Maryland North End area. Only high exposure assets are labeled. Background map is ESRI streaming imagery.

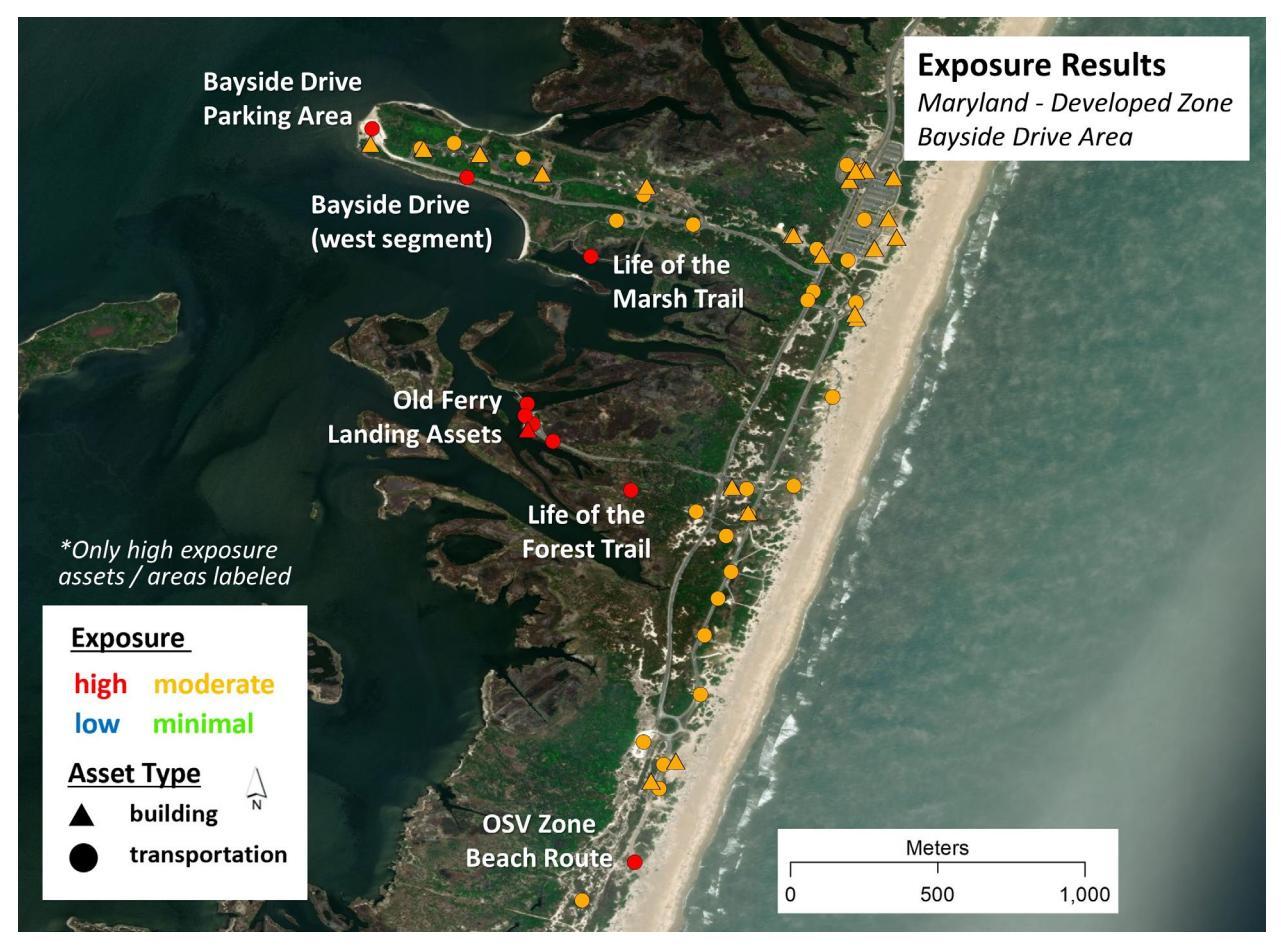
**Figure 2.** ASIS exposure results for the Maryland Developed Zone and Bayside Drive area. Only high exposure assets and areas are labeled. Background map is ESRI streaming imagery.

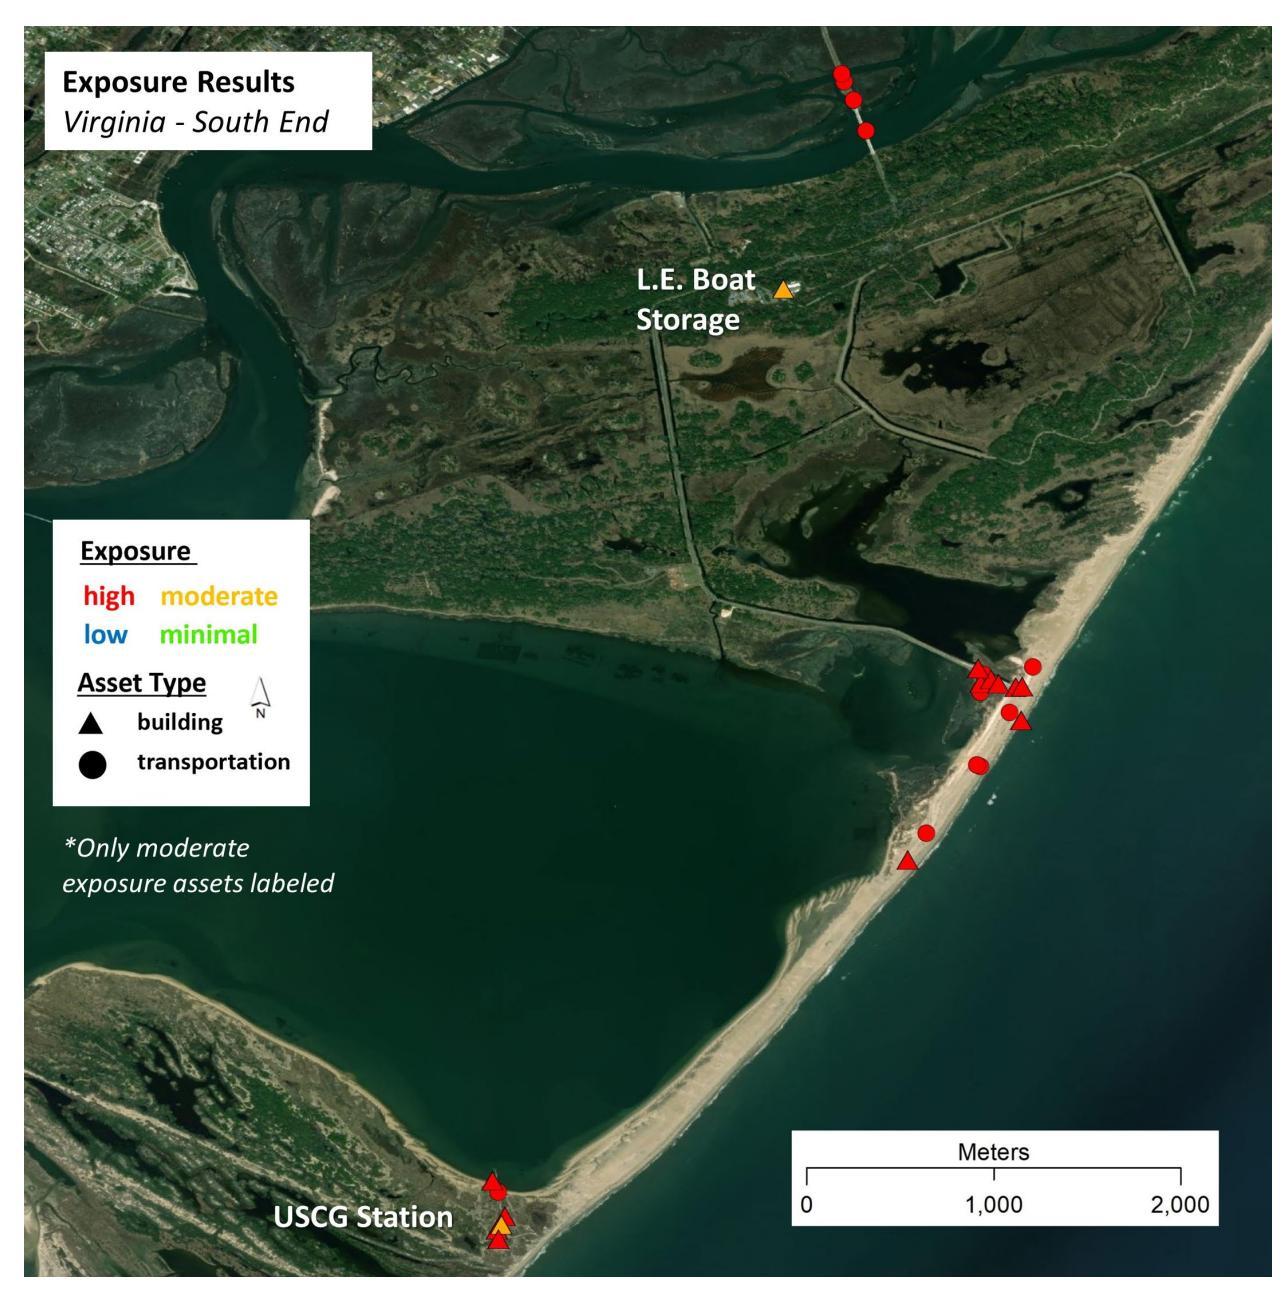
**Figure 3.** ASIS exposure results for the Virginia South End area. Only moderate exposure assets are labeled. Background map is ESRI streaming imagery.

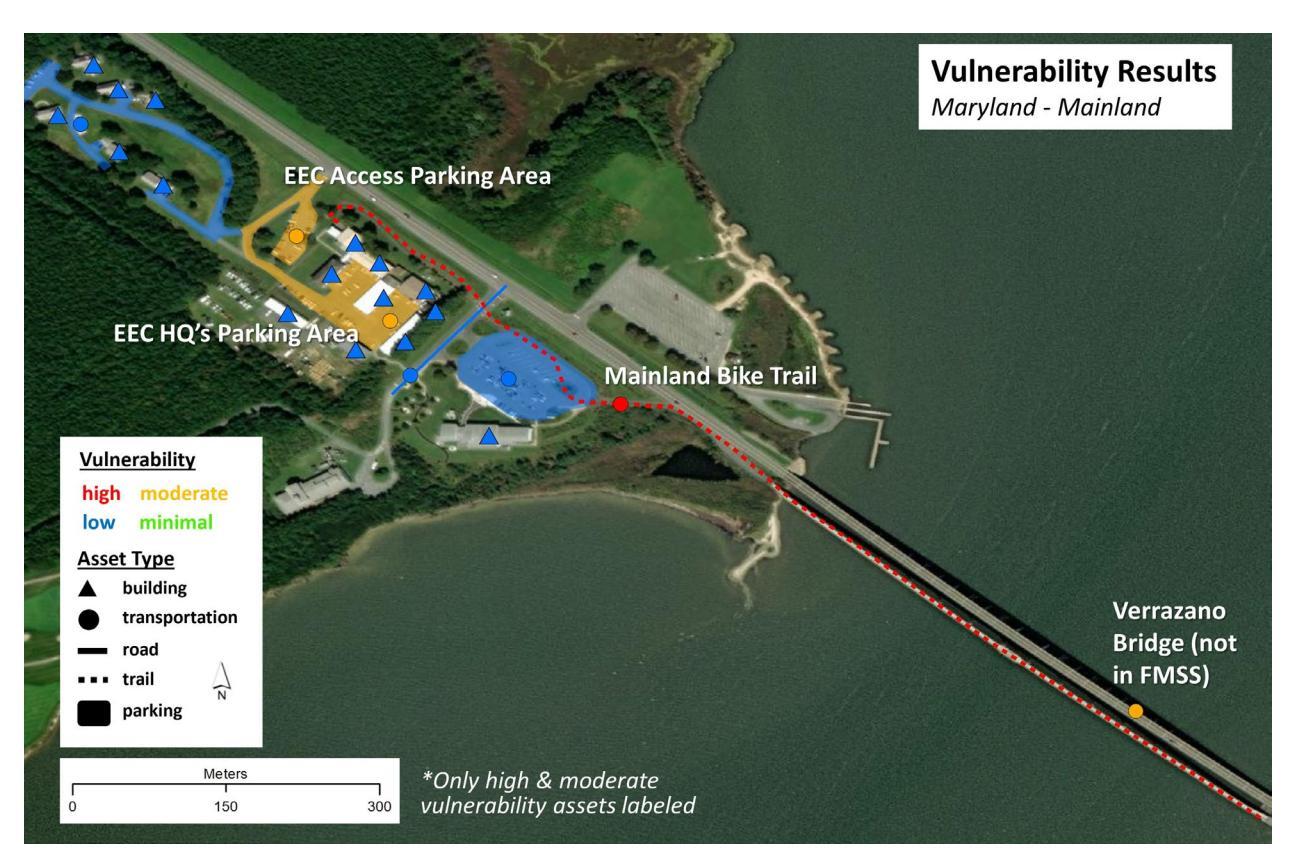
**Figure 4**. ASIS vulnerability results for the Maryland Mainland area. Only high and moderate vulnerability assets are labeled. Background map is ESRI streaming imagery.

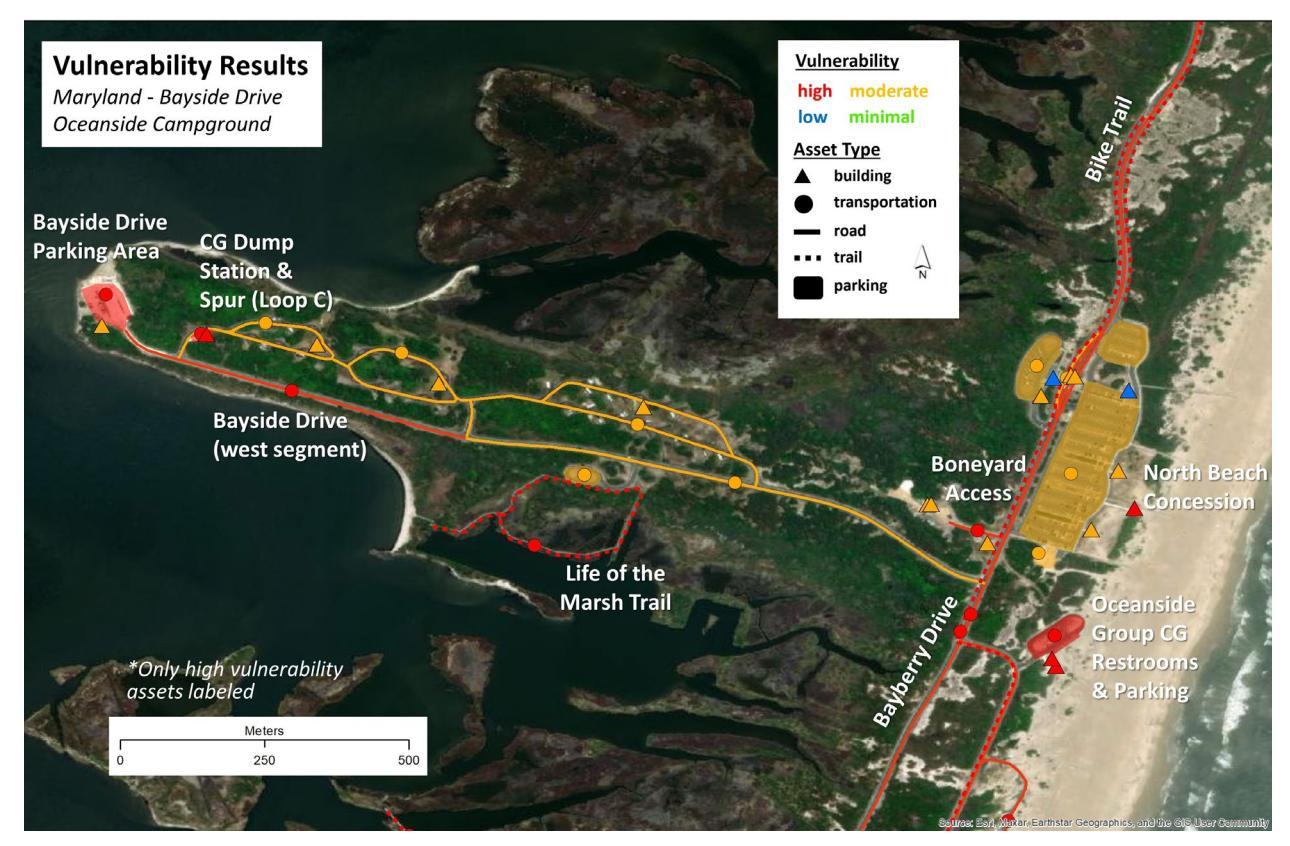
**Figure 5**. ASIS vulnerability results for the Maryland Bayside Drive and Oceanside Campground areas. Only high vulnerability assets are labeled. Background map is ESRI streaming imagery.

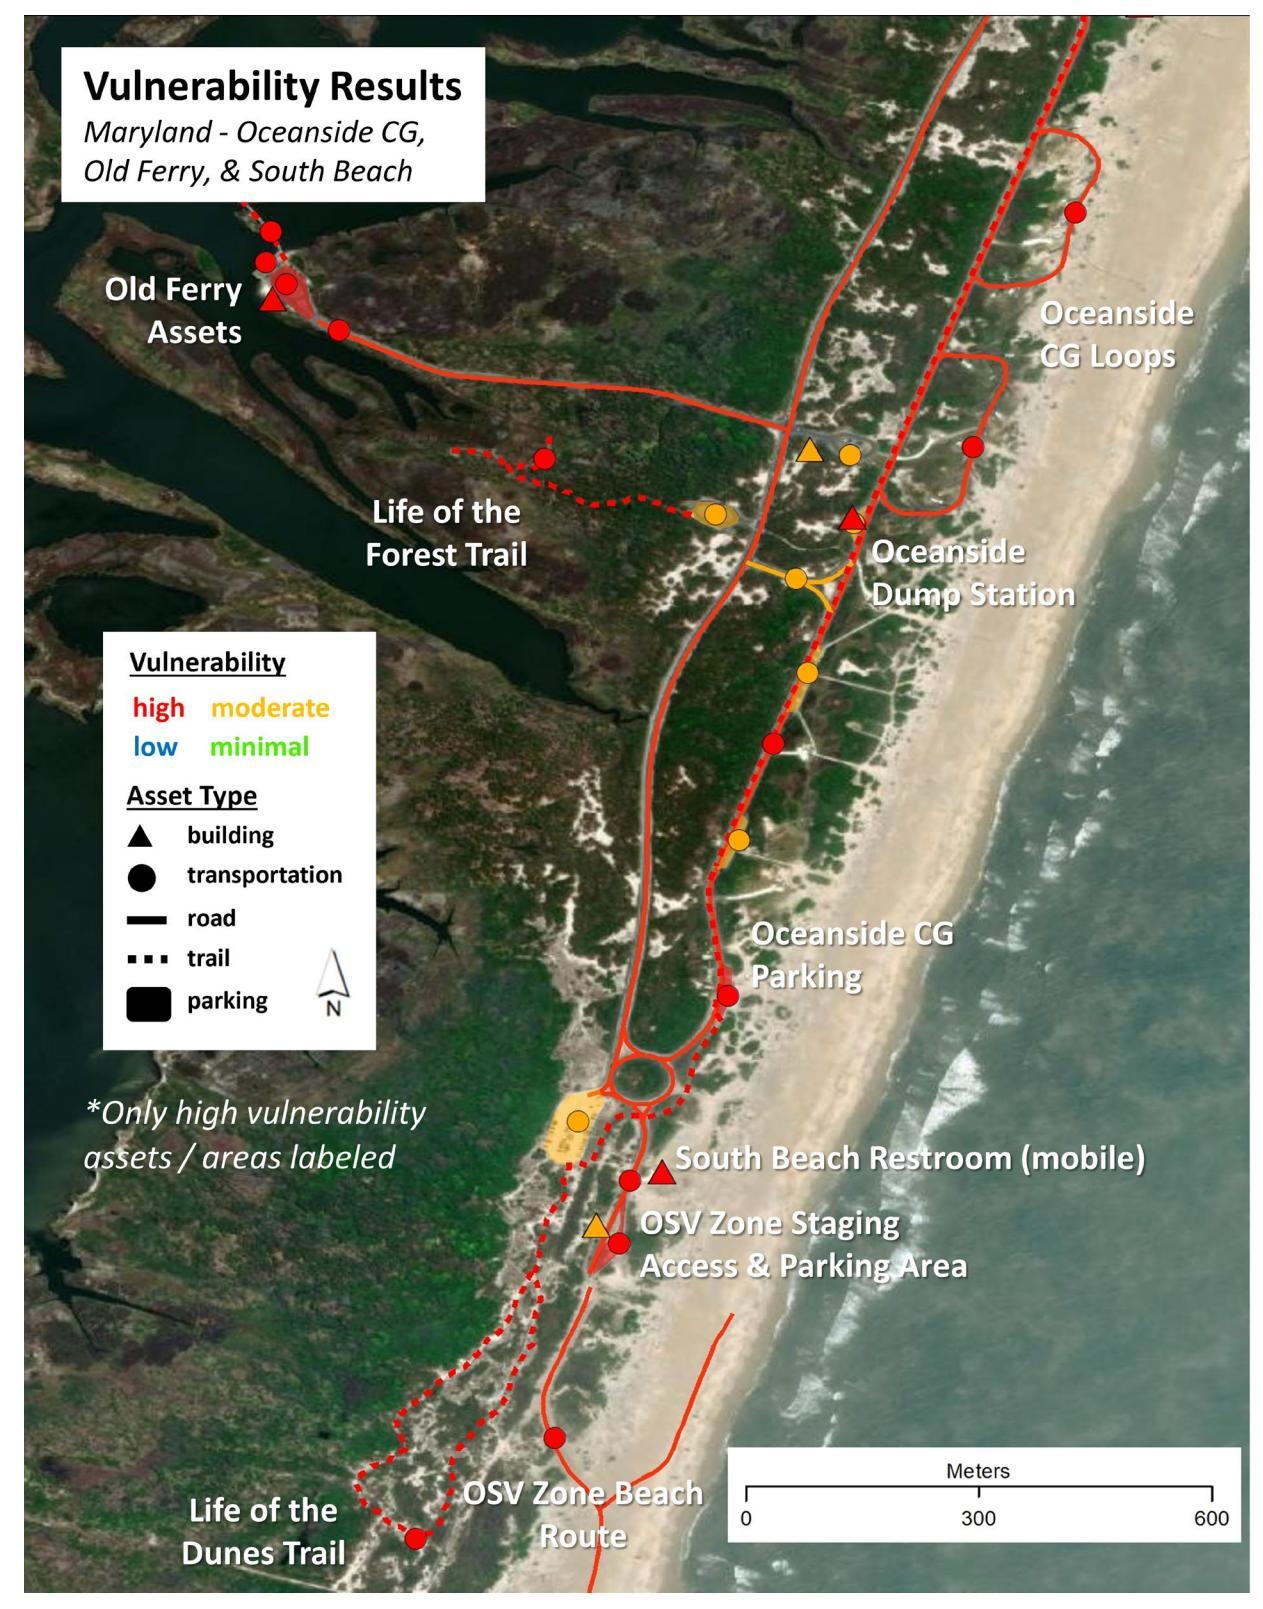
**Figure 6**. ASIS vulnerability results for the Maryland Oceanside Campground, Old Ferry, and South Beach areas. Only high vulnerability assets and areas are labeled. Background map is ESRI streaming imagery.

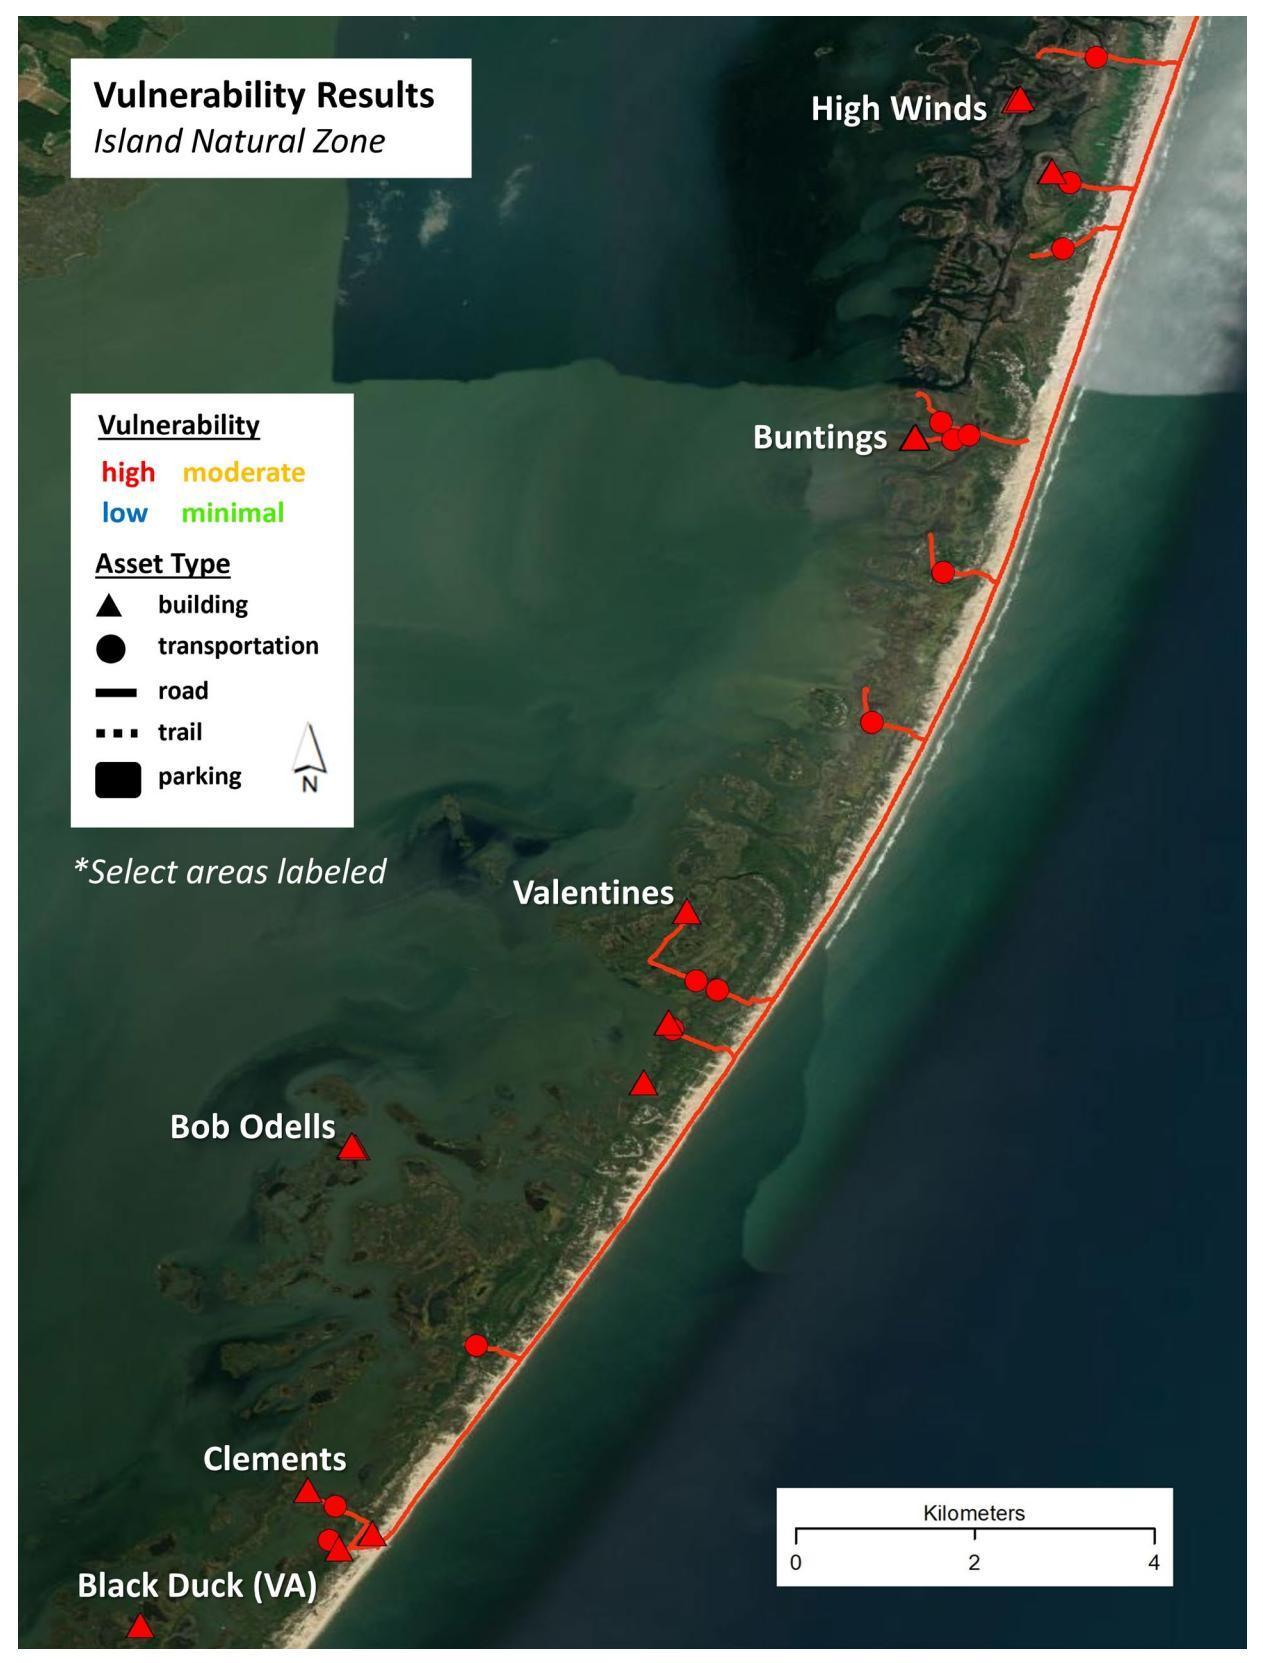
**Figure 7**. ASIS vulnerability results for the Natural Zone area (both Maryland and Virginia). Only select areas are labeled. Background map is ESRI streaming imagery.

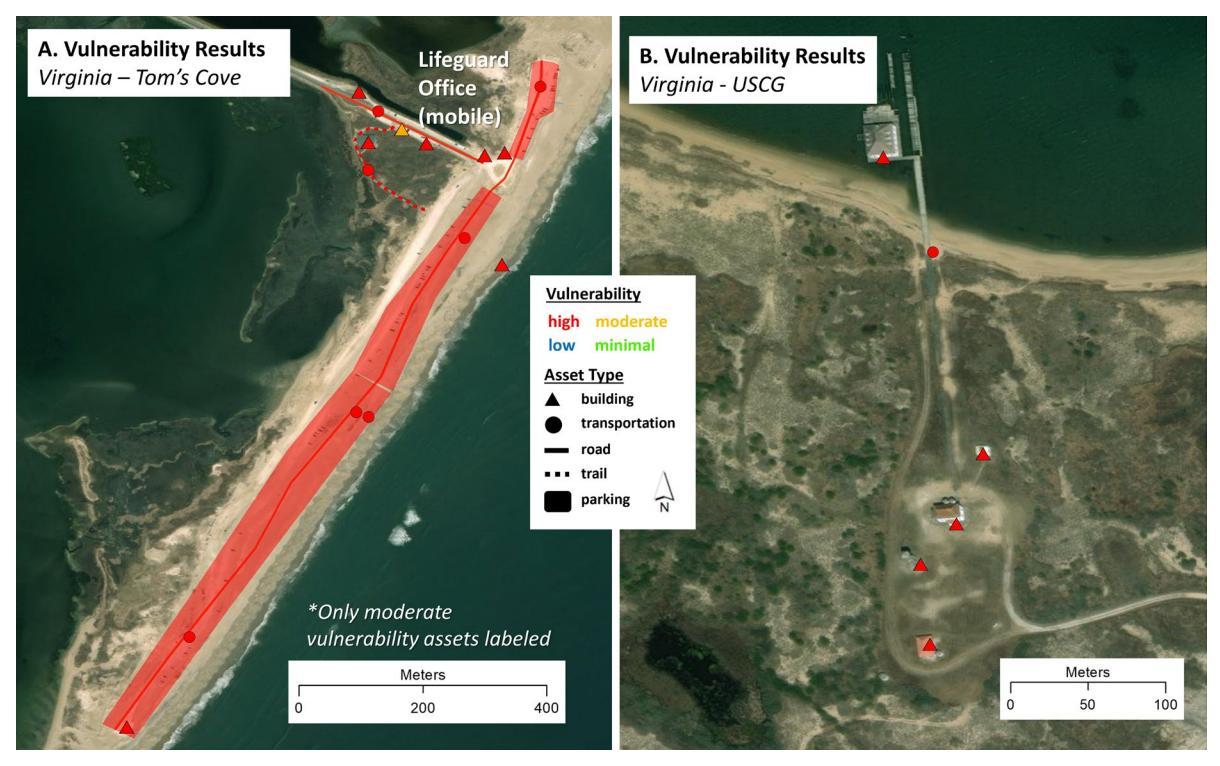
**Figure 8.** ASIS vulnerability results for the A) Toms Cove and B) USCG areas in Virginia. Only moderate vulnerability assets are labeled. Background maps are ESRI streaming imagery.

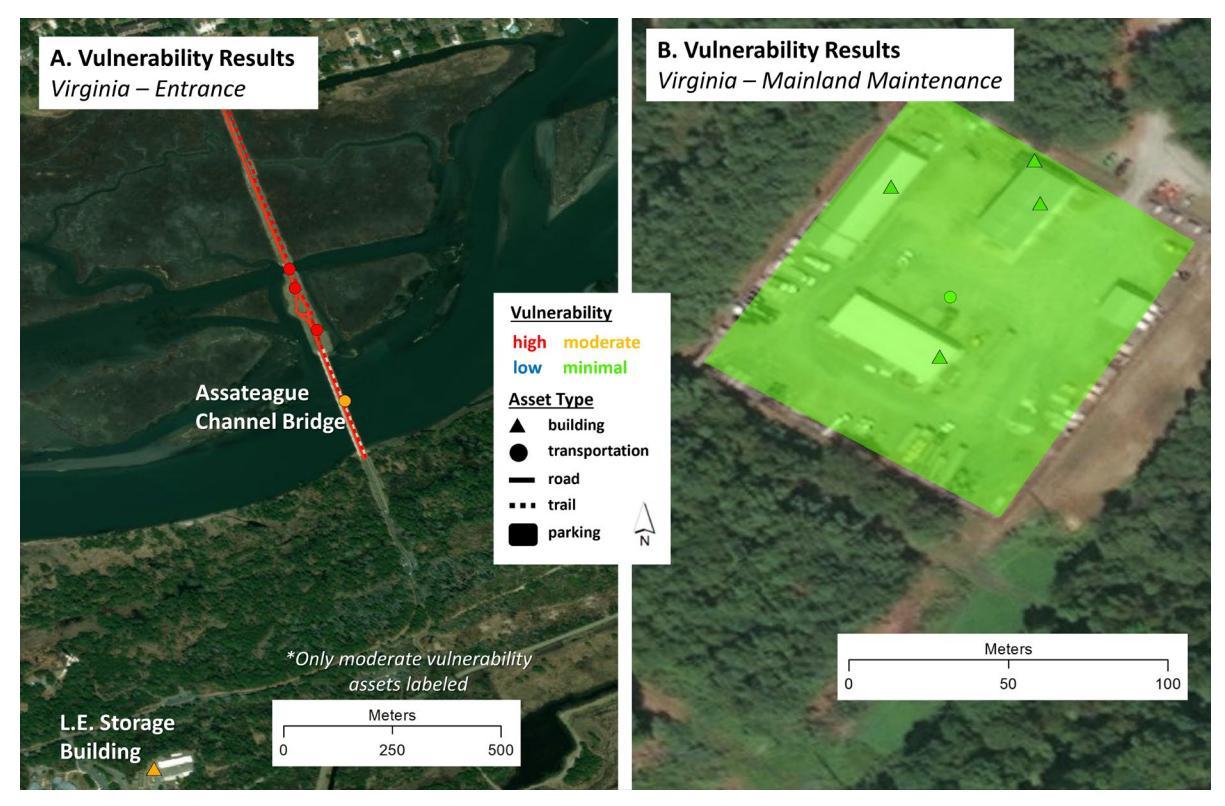
**Figure 9.** ASIS vulnerability results for the A) Entrance and B) Mainland Maintenance areas in Virginia. Only moderate vulnerability assets are labeled. Background maps are ESRI streaming imagery.
