Coastal Hazards & Sea-Level Rise Asset Vulnerability Assessment for Cumberland Island National Seashore

Summary of Results

NPS 640/186744, November 2022

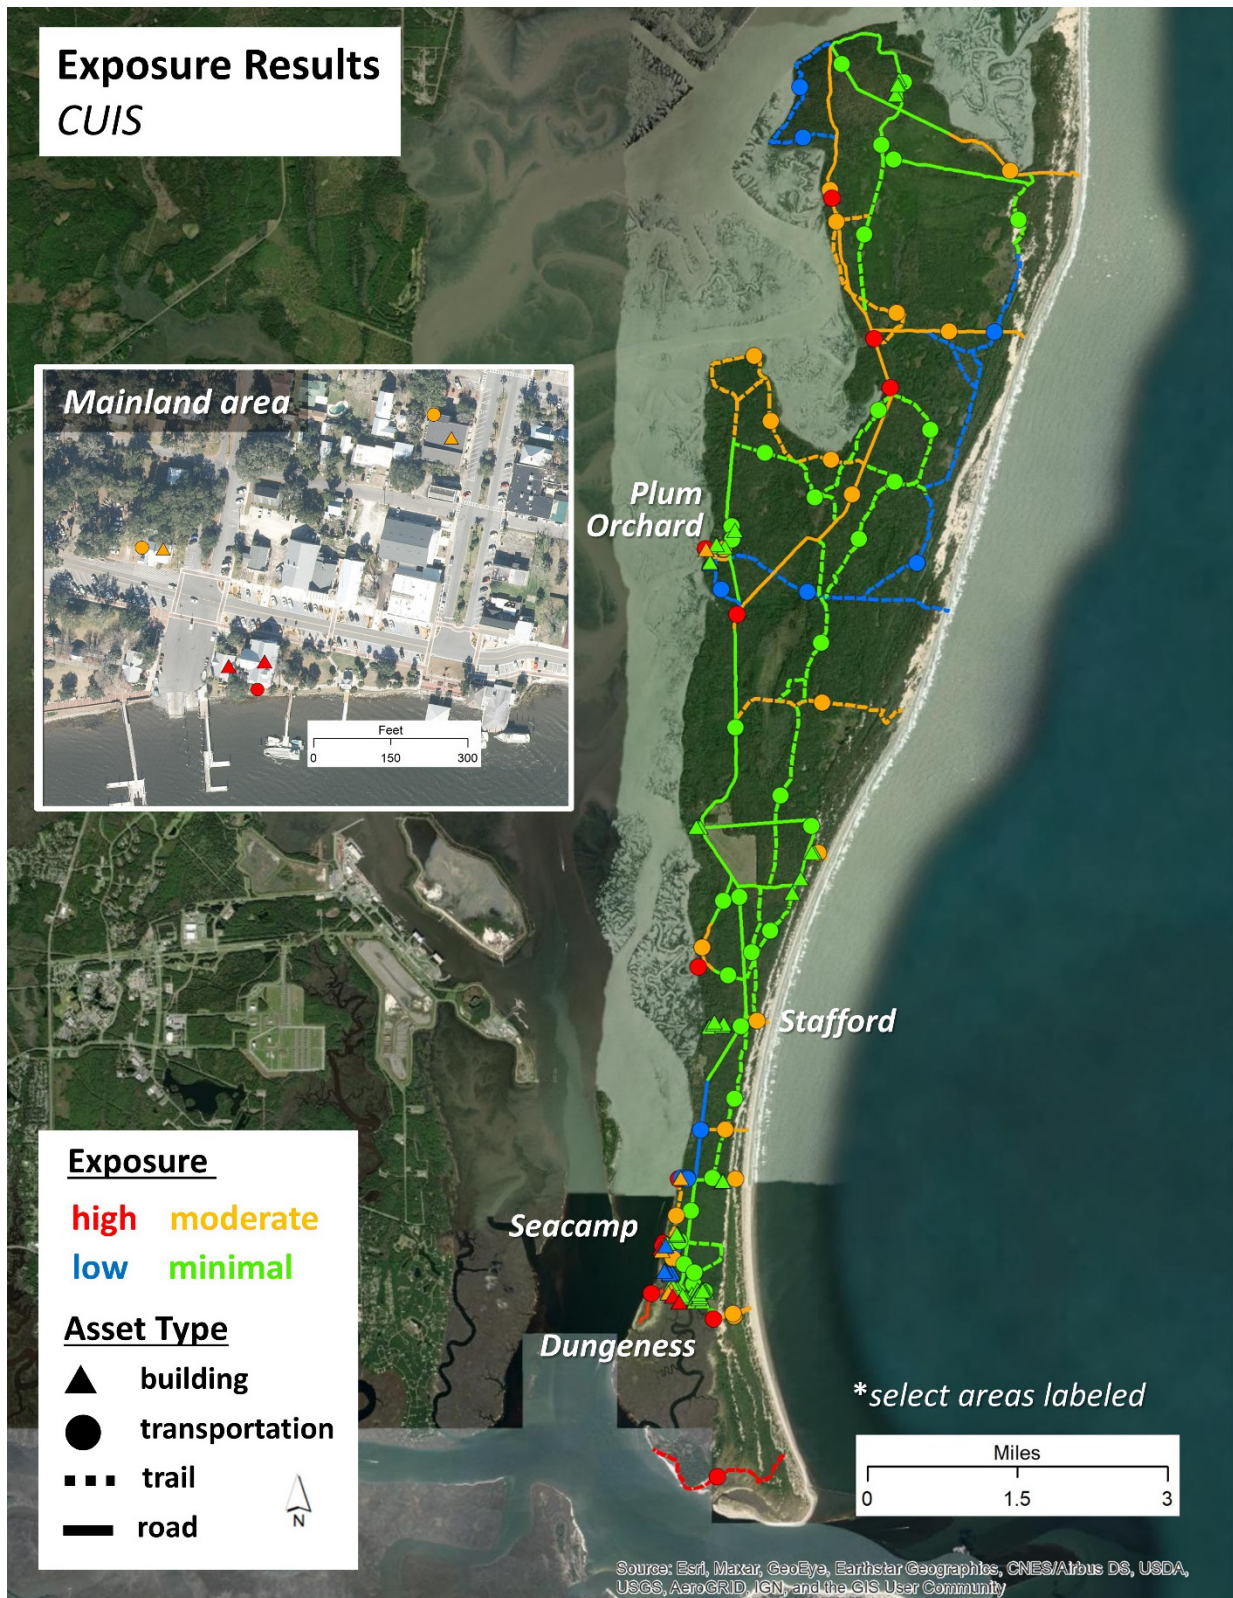
One-third (33%) of assets analyzed at CUIS have either high or moderate exposure to the evaluated coastal hazards (Table 2, and Figure 1). Most of the high exposure assets are transportation related (roads, bridges, trails, and shorelines/seawalls), as only five buildings have high exposure. Eleven assets (three buildings and eight transportation) at CUIS are within all evaluated exposure zones, including the Waterwheel House Ruin, Boat House, Garden Point Road, and Marsh Boardwalk at Dungeness. Only 11% of assets have low exposure and over half (56%) have minimal exposure. Although CUIS is a barrier island, it has significant elevation and width in many locations, leading to lower exposure overall of many assets.

Figure 1. CUIS exposure results summary. Only select areas are labeled. Background map is ESRI streaming imagery.

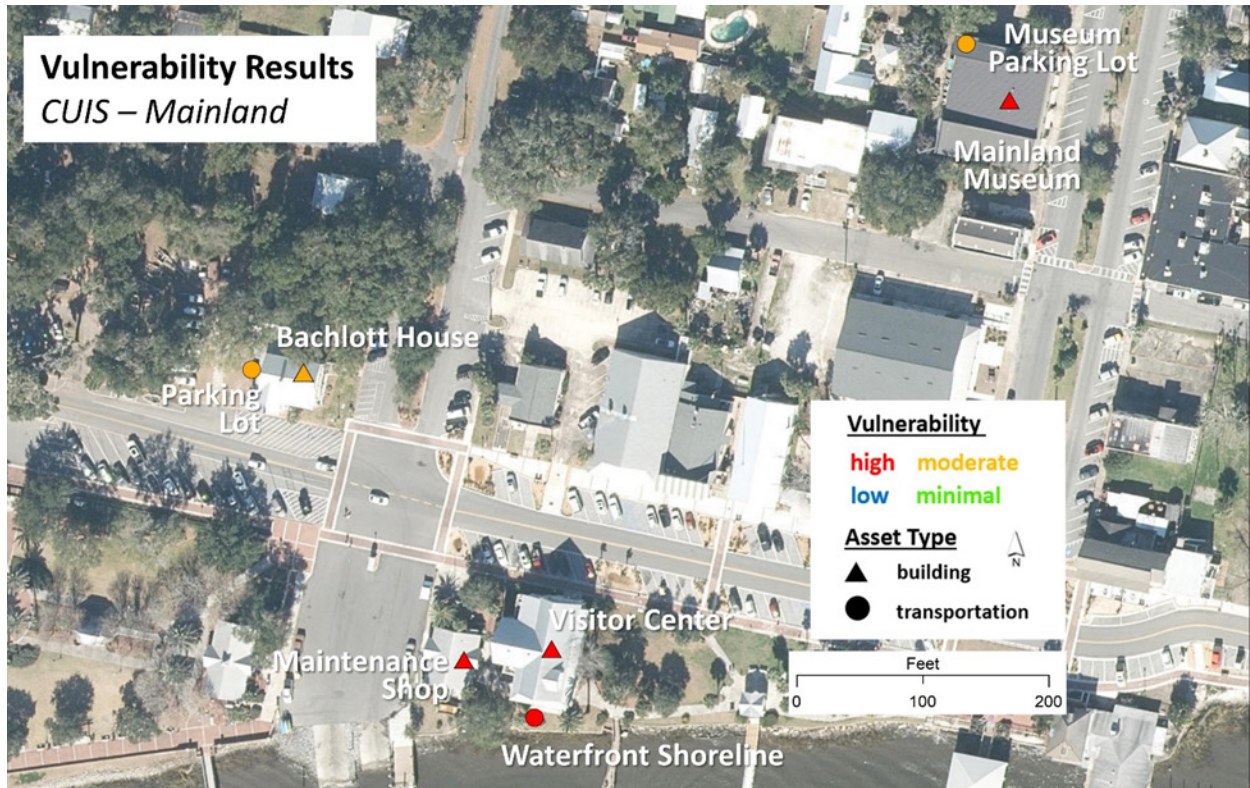
Figure 2. CUIS vulnerability results summary for the Mainland area. Only select assets are labeled. Background is ESRI streaming imagery.

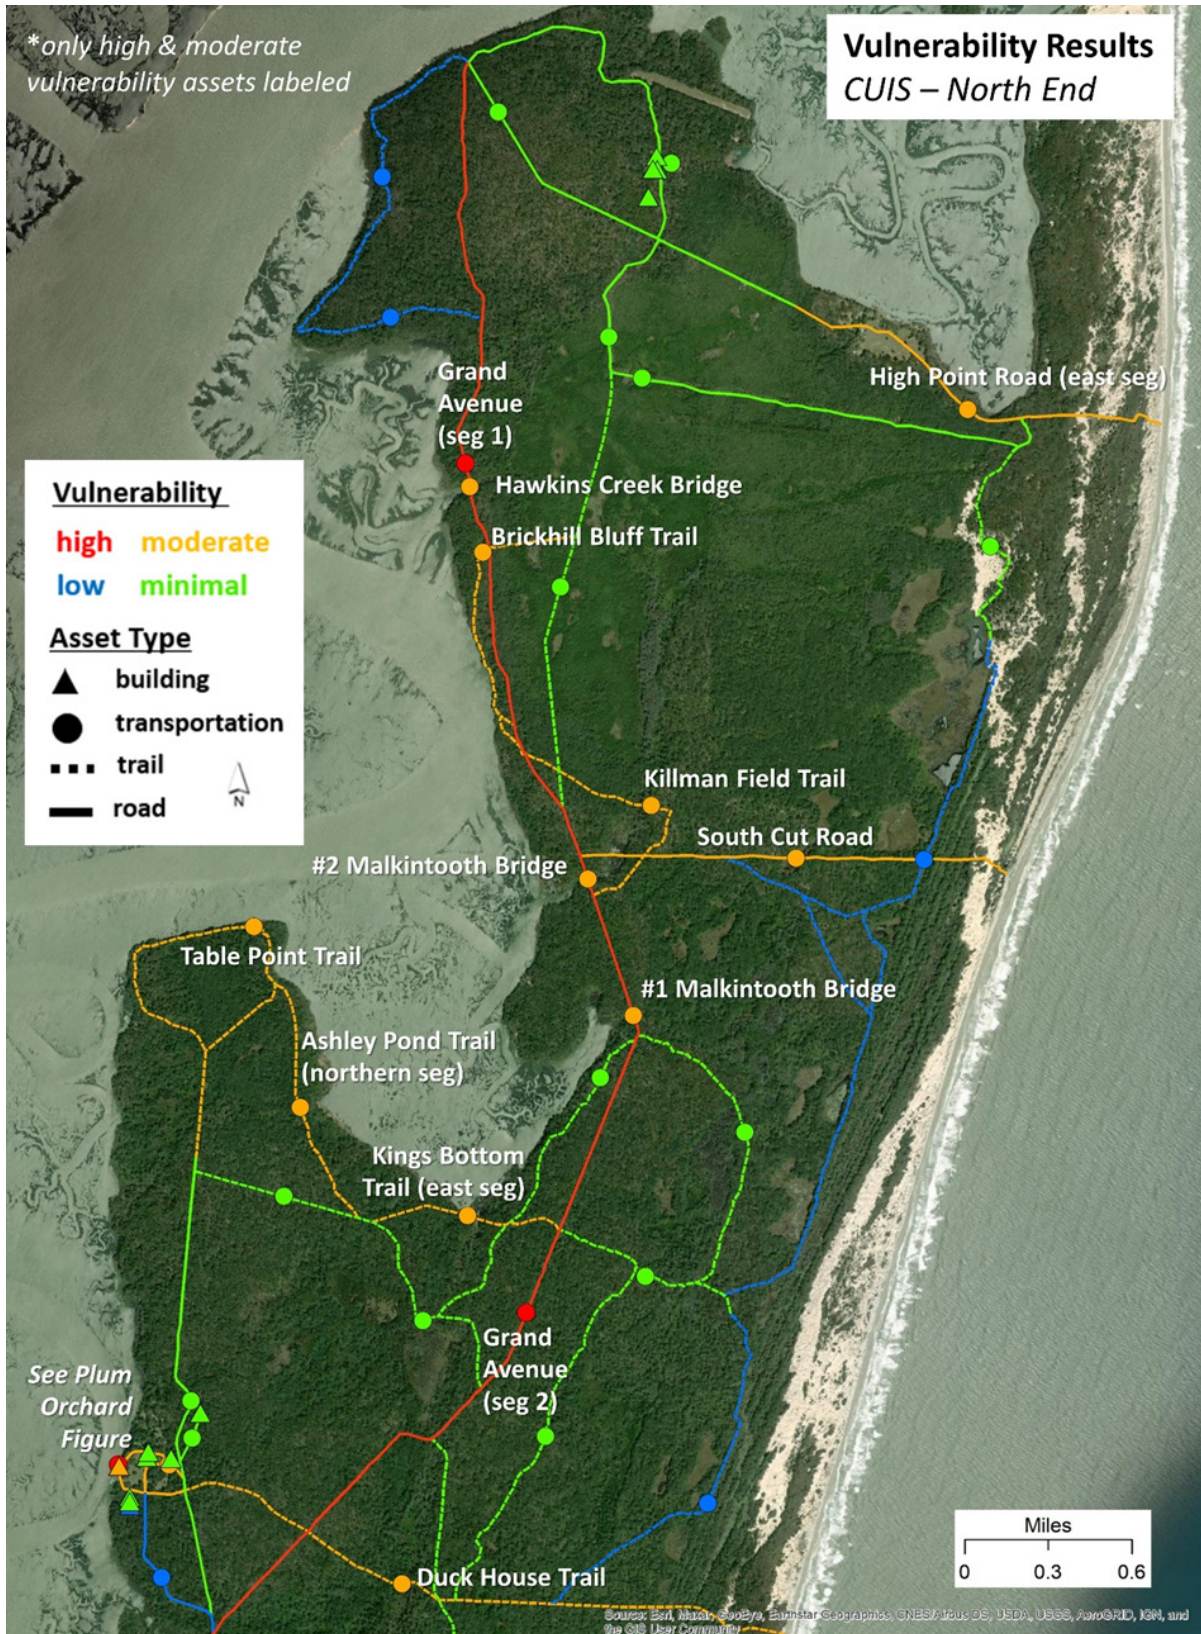
Figure 3. CUIS vulnerability results summary for the north portion of the island. Only select assets are labeled. Background is ESRI streaming imagery.

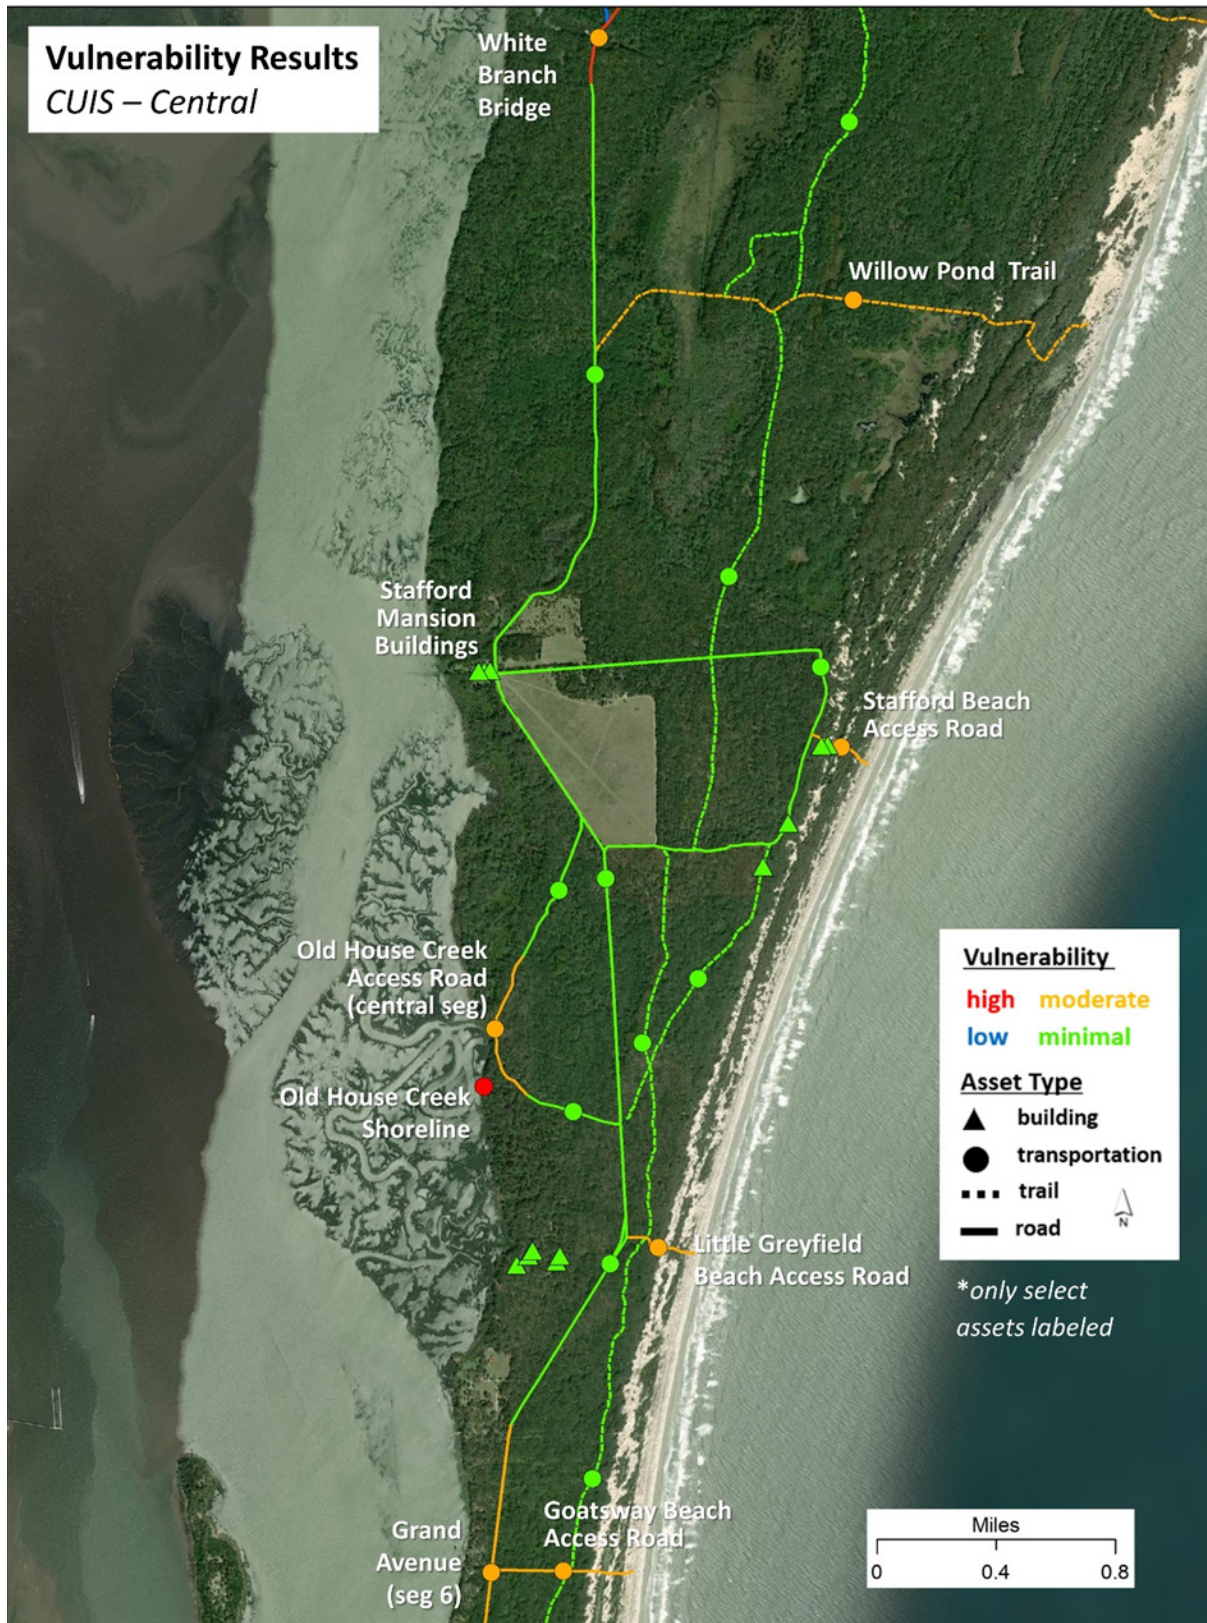
Figure 4. CUIS vulnerability results summary for the central portion of the island. Only select assets are labeled. Background is ESRI streaming imagery.

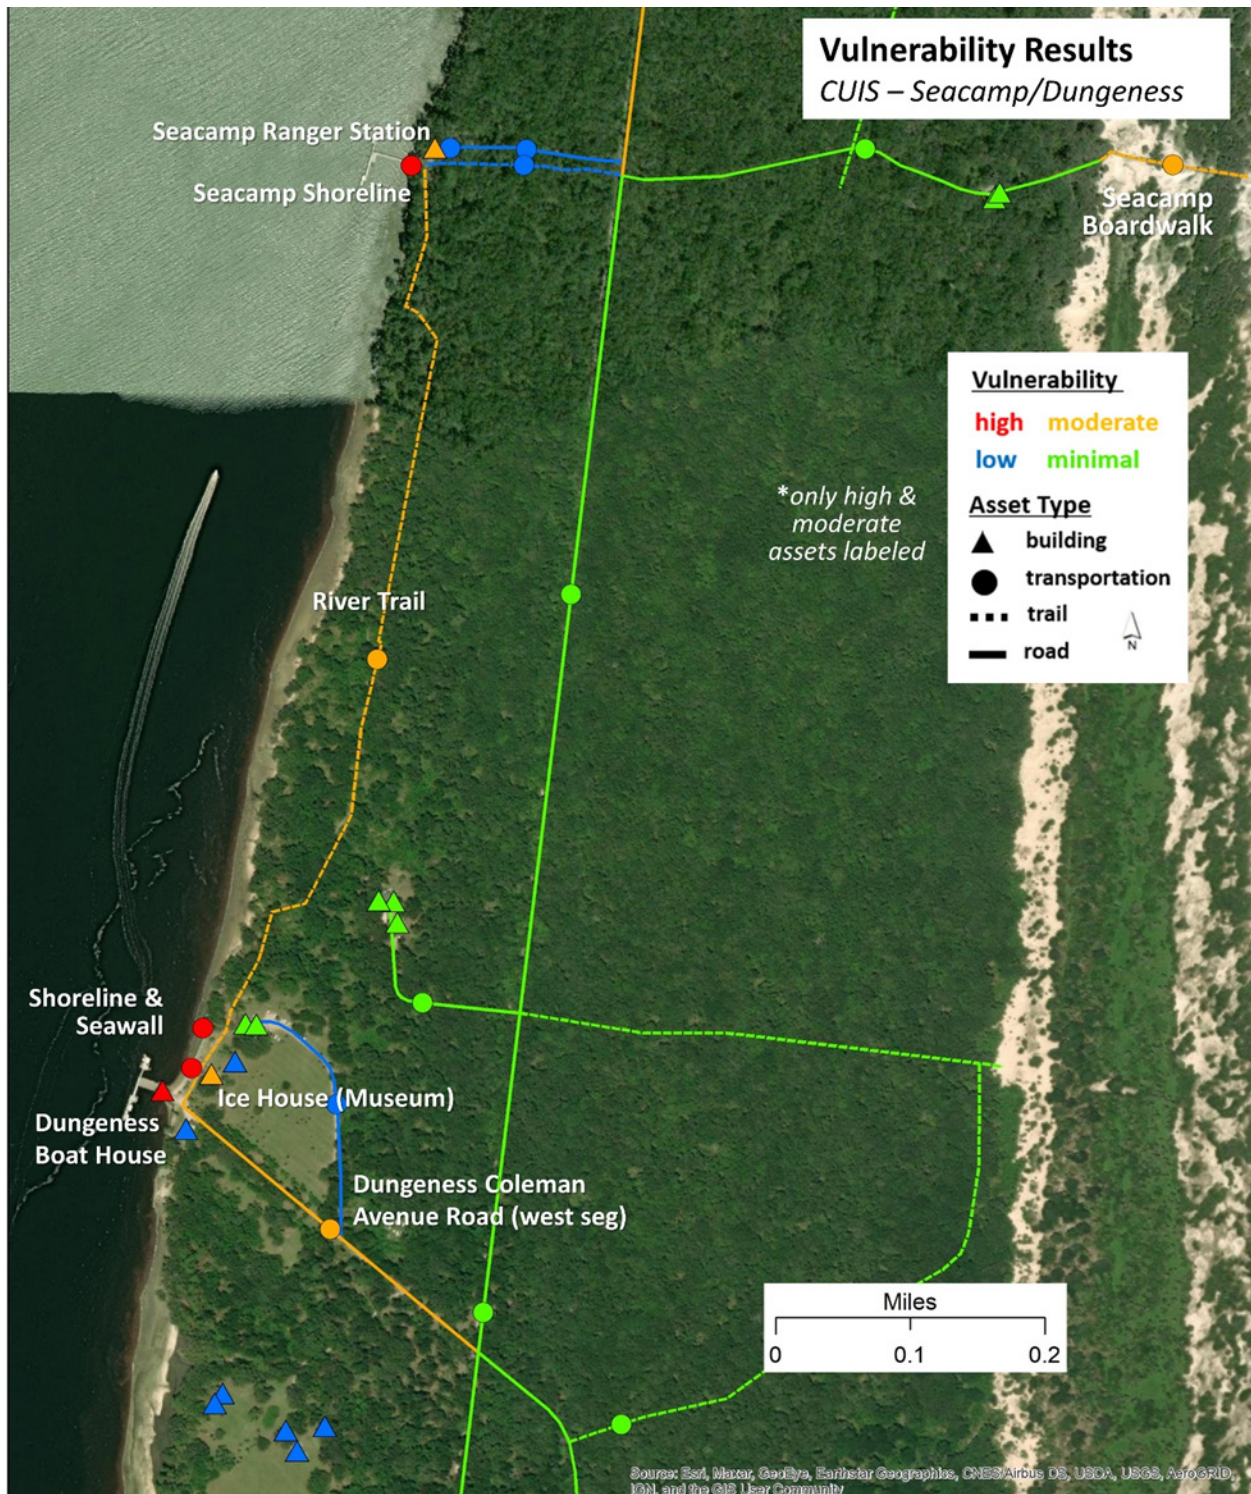
Figure 5. CUIS vulnerability results summary for the Seacamp/Dungeness area. Only select assets are labeled. Background is ESRI streaming imagery.

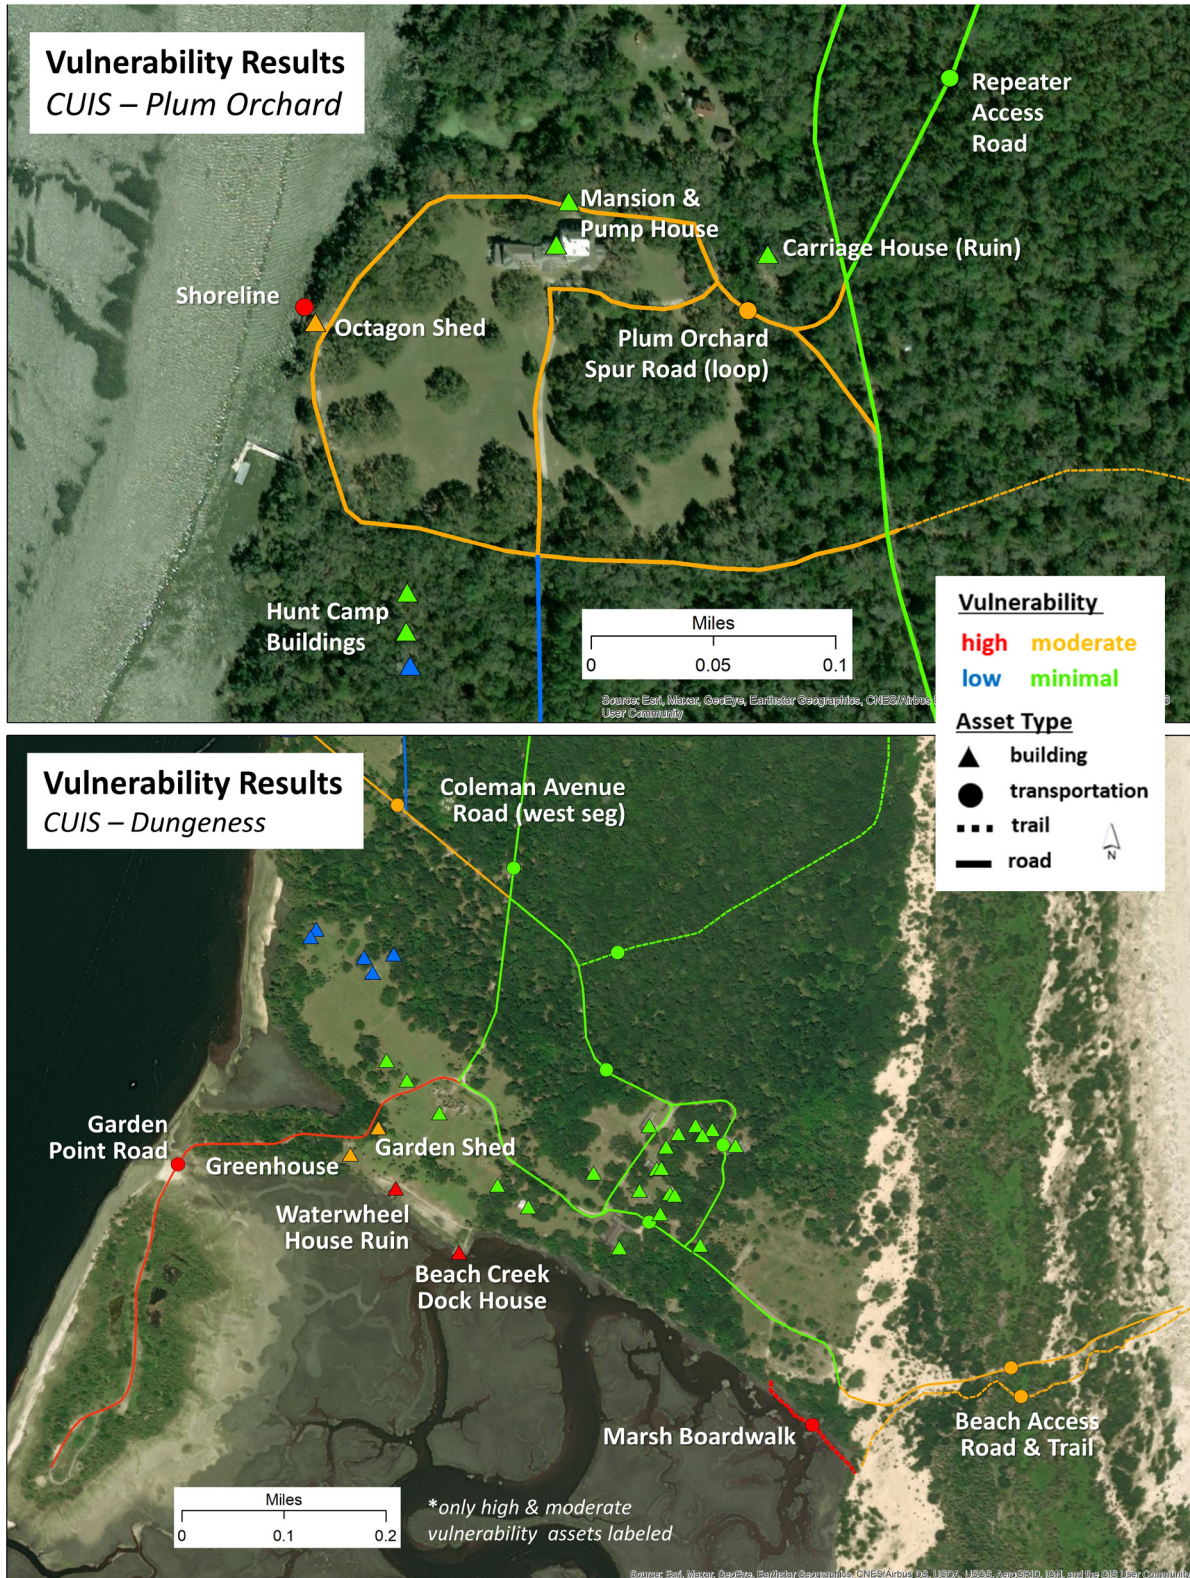
Figure 6. CUIS vulnerability results summary for the Plum Orchard and Dungeness areas. Only select assets are labeled. Background is ESRI streaming imagery.
