Coastal Hazards & Sea-Level Rise Asset Vulnerability Assessment for Everglades National Park

Summary of Results

NPS 160/186783, November 2022

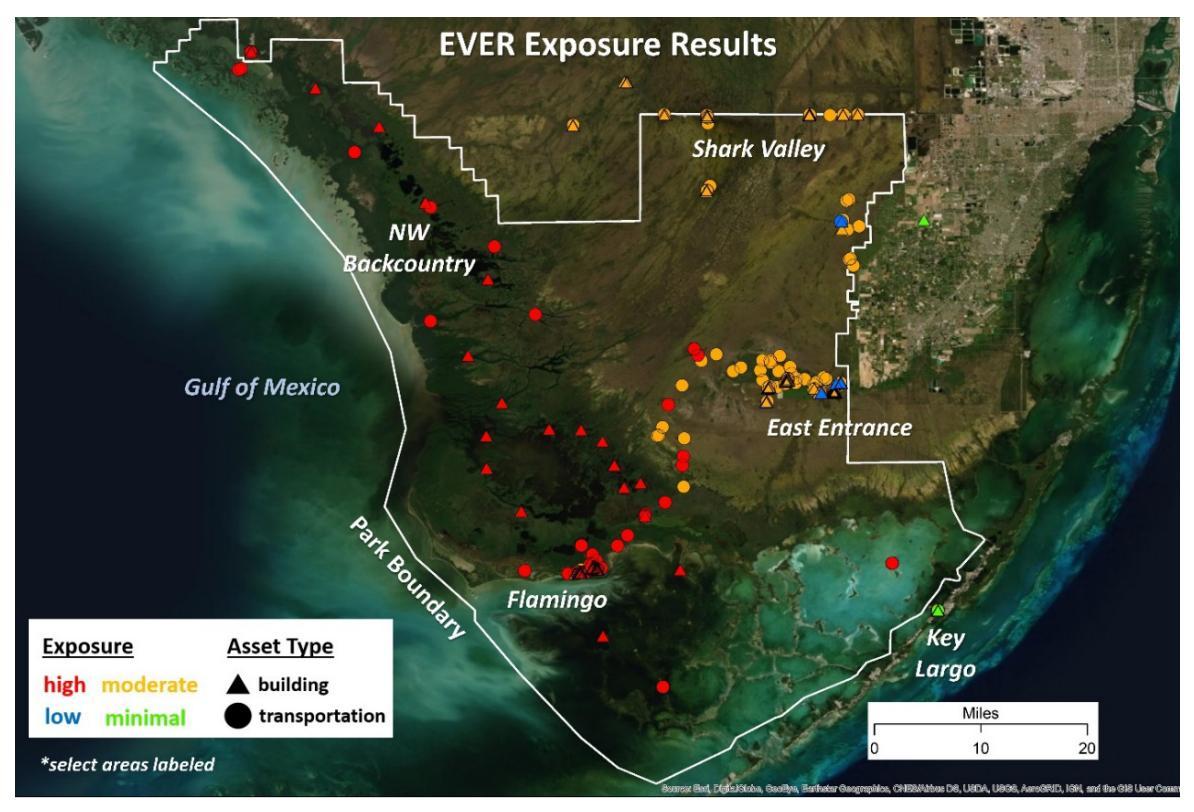
Over 95% of assets evaluated at EVER have either high or moderate exposure to coastal hazards and SLR (Table 2, and Figure 1). Over one-third of all assets have high exposure, while nearly two-thirds have moderate exposure. These results are primarily a factor of the park's high exposure to coastal flooding, as indicated by the widespread FEMA VE and AE flood zones (1% annual chance flood, \pm wave velocity), as well as the modeled Category 3 storm surge inundation extent across EVER.

Most high exposure assets are in the northwestern and southwestern areas of the park (e.g., Northwest Backcountry and Flamingo), where elevations are commonly less than 5 feet above sea level and much of the land area is comprised of mangrove swamps. Twenty-eight assets (10 buildings and 18 transportation) at EVER are within all evaluated exposure zones (scored the highest possible raw score), including the Flamingo Ranger Station, Guy Bradley Visitor Center, Whitewater Bay Marina, Florida Bay Marina, Flamingo VC Waterfront, and Everglades City Waterfront. Only 10 assets at EVER have low exposure, and 8 have minimal exposure. Most of these lower exposure assets are located near the park's eastern entrance and in the Key Largo area.

Figure 1. EVER exposure results summary. Only select areas are labeled. Background map is ESRI streaming imagery.

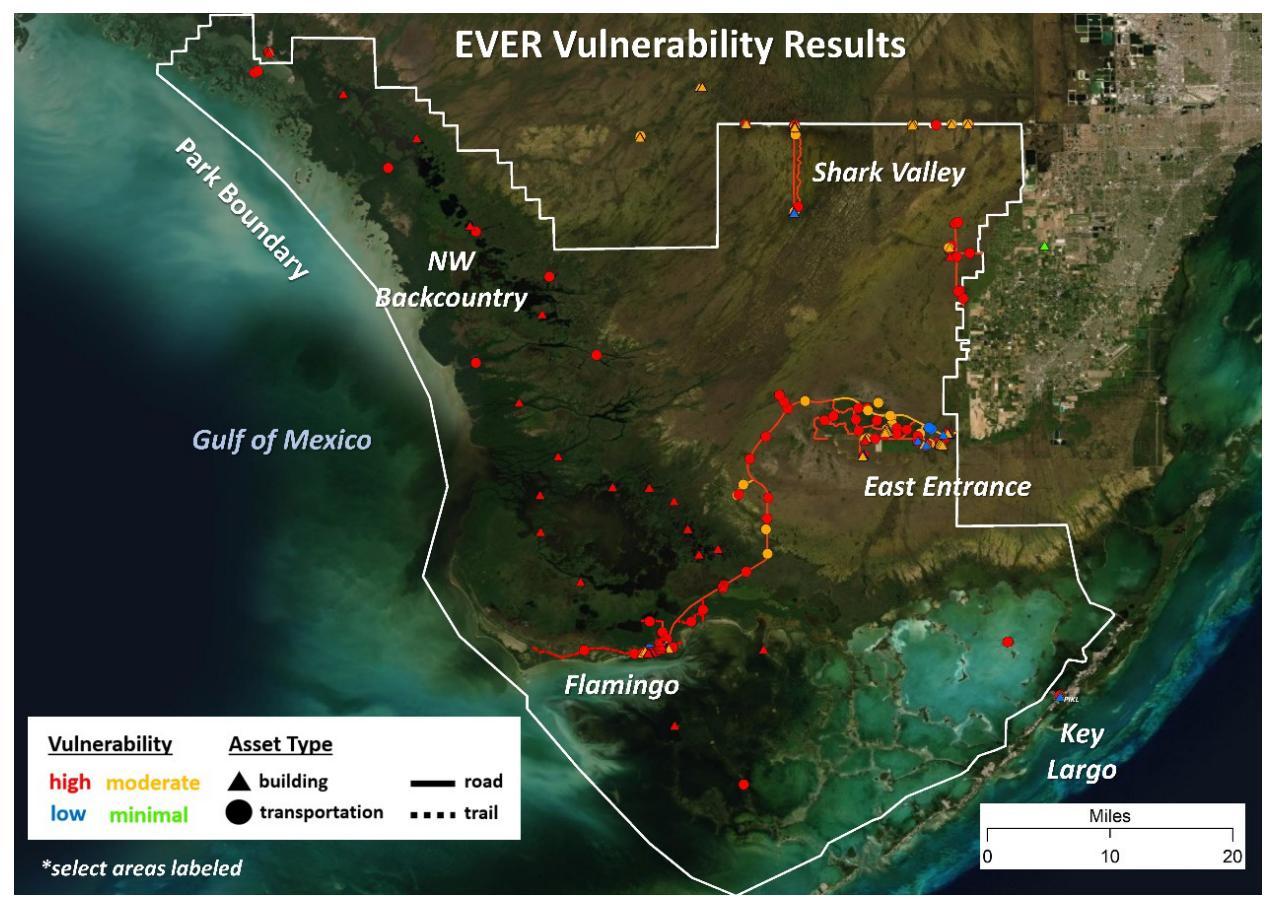
Over 90% of assets evaluated at EVER have high or moderate vulnerability to coastal hazards and SLR, and only a few assets have low or minimal vulnerability (Table 4, and Figures 2-4). Almost two-thirds of EVER assets have high vulnerability, while approximately one-third have moderate vulnerability. Reflecting their high exposure, a large portion of the high vulnerability assets are in the Flamingo and Northwest Backcountry areas of the park. However, high vulnerability assets are also distributed throughout all other areas of EVER.

Figure 2. EVER vulnerability results summary. Only select areas are labeled. Background is ESRI streaming imagery.

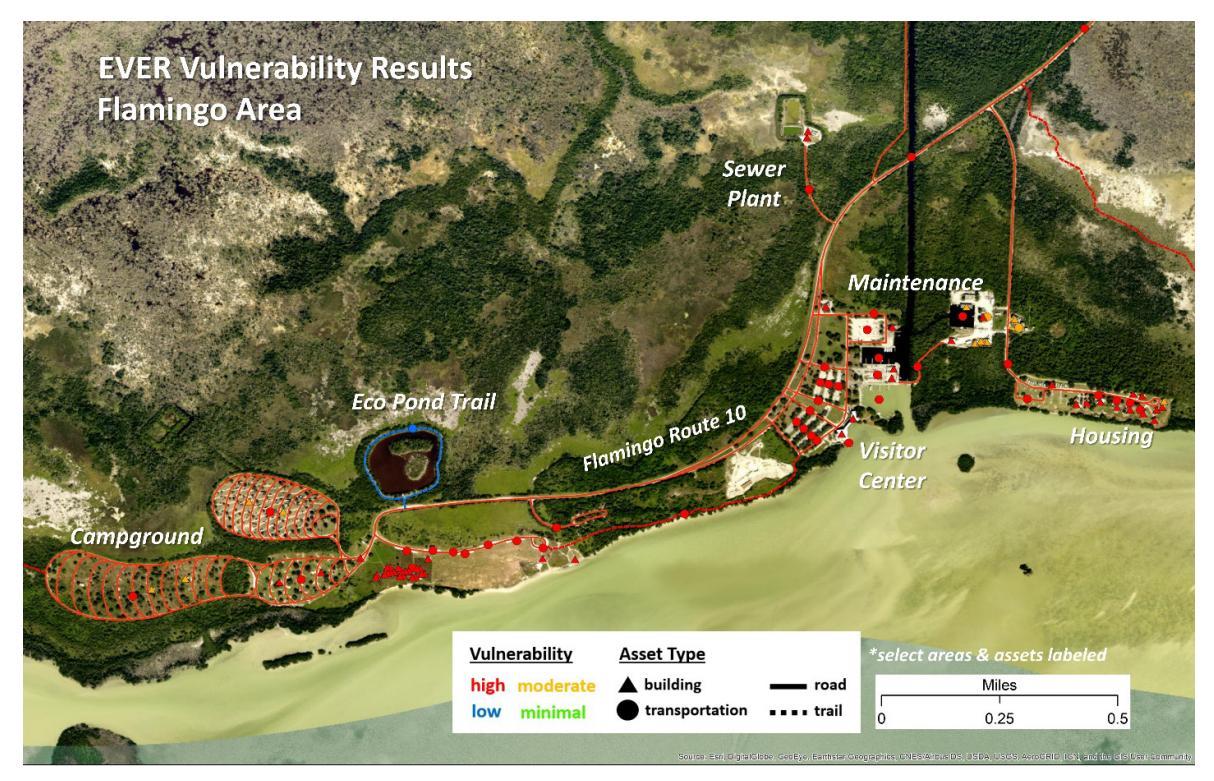
Figure 3. EVER vulnerability results summary for the Flamingo area. Only select areas and assets are labeled. Background is ESRI streaming imagery.

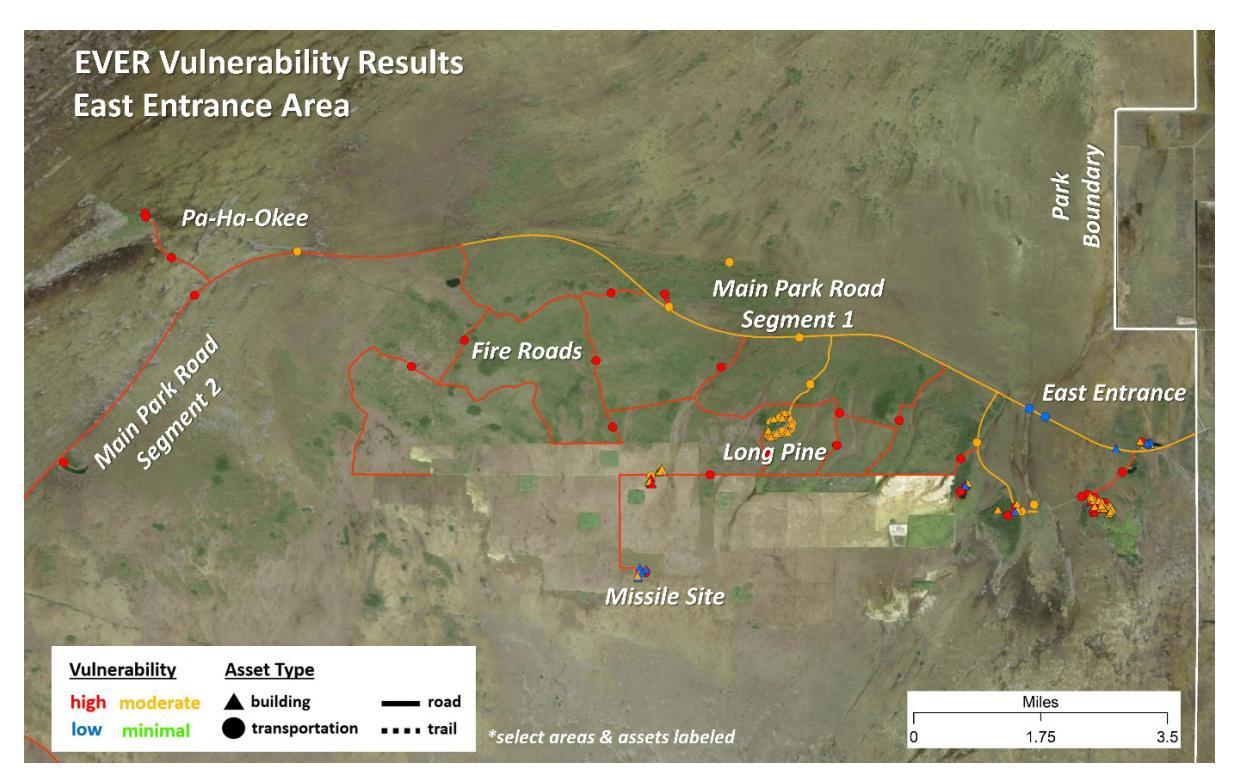
Figure 4. EVER vulnerability results summary for the East Entrance area. Only select areas and assets are labeled. Background is ESRI streaming imagery.

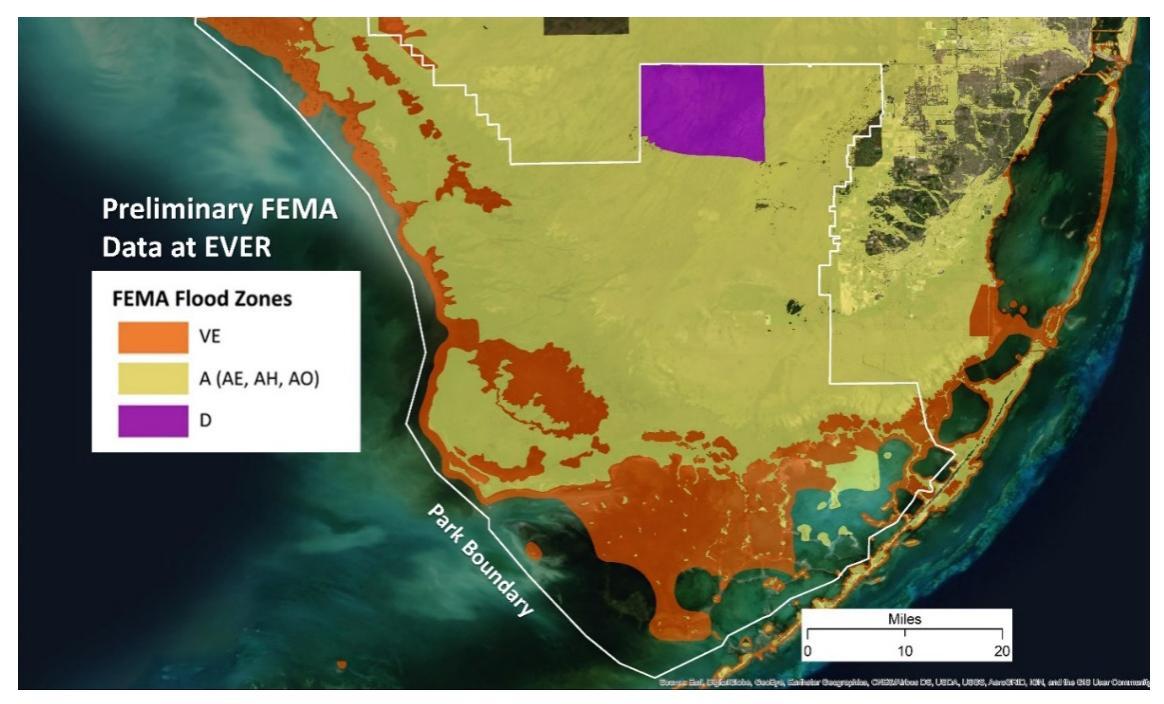
FEMA data: We used the preliminary FEMA data for both Miami-Dade (2021) and Monroe (2019) counties to evaluate exposure to flooding (FEMA 2019; 2021). A small portion of the park near Shark Valley is mapped as FEMA D zone (possible but undetermined flood hazards; Figure 5). We interpreted assets in this area to be within the FEMA A zone, based on adjacent FEMA mapping, historical flooding information, and park geomorphology.

Figure 5. Preliminary FEMA data in the EVER area of south Florida. Note the presence of the D zone (purple shade) in the northeastern portion of the park. Background is ESRI streaming imagery.
