# Coastal Hazards & Sea-Level Rise Asset Vulnerability Assessment for Independence National Historical Park, Edgar Allen Poe National Historic Site, Thaddeus Kosciuszko National Memorial, and Gloria Dei Church National Historic Site

Summary of Results

NPS 391/188379, NPS 478/188379, NPS 455/188379, NPS 004/188379, May 2023

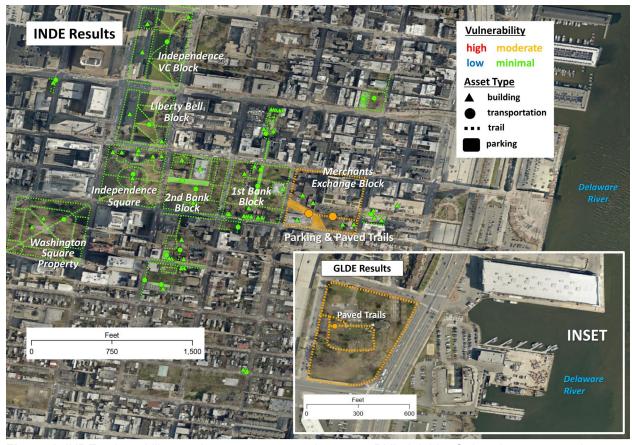
Most assets (97%) evaluated at INDE-EDAL-THKO-GLDE have minimal vulnerability to the assessed coastal hazards and SLR (Table 4). Three assets have moderate vulnerability: Paved Trails and Dock Street Parking in the Merchants Exchange Block of INDE, and Paved Trails at GLDE (Table 4, and Figure 1). Both moderate vulnerability assets at INDE have a high asset priority index (API  $\geq$  80, as reported in FMSS).

**Figure 1.** INDE vulnerability results summary, near downtown Philadelphia. Only select areas and moderate vulnerability assets are labeled. Inset shows GLDE vulnerability results. Background is ESRI streaming imagery.
