# TRAFFIC SAFETY STUDY

# **ROCK CREEK PARK**

# Traffic Safety Study Rock Creek Park, Washington, D.C.

### United States Department of the Interior National Park Service Denver Service Center

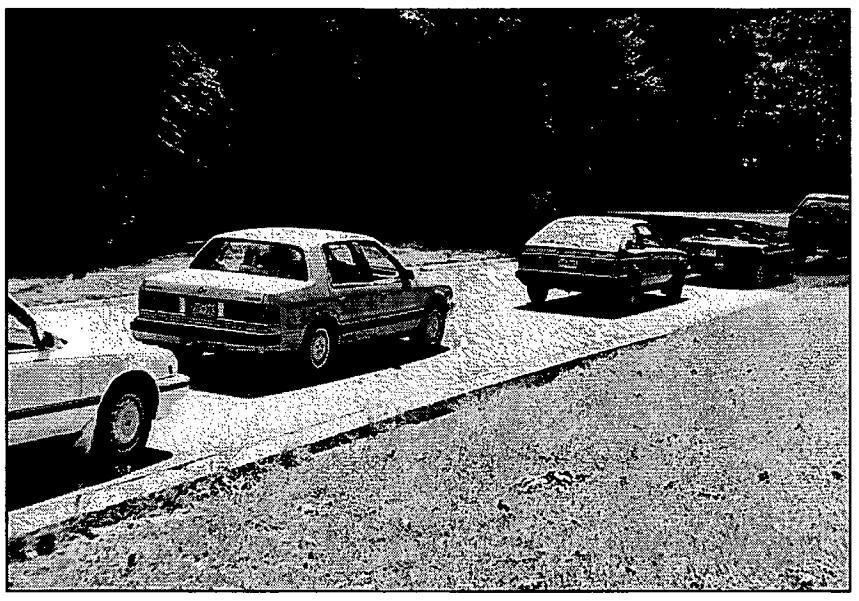
Notice that the elevation of the shoulder area behind the curb on this section of Beach Drive is 4-6-inches lower than the adjacent curb. This condition can compound the severity of a run-off-the-road accident due to the grade change.

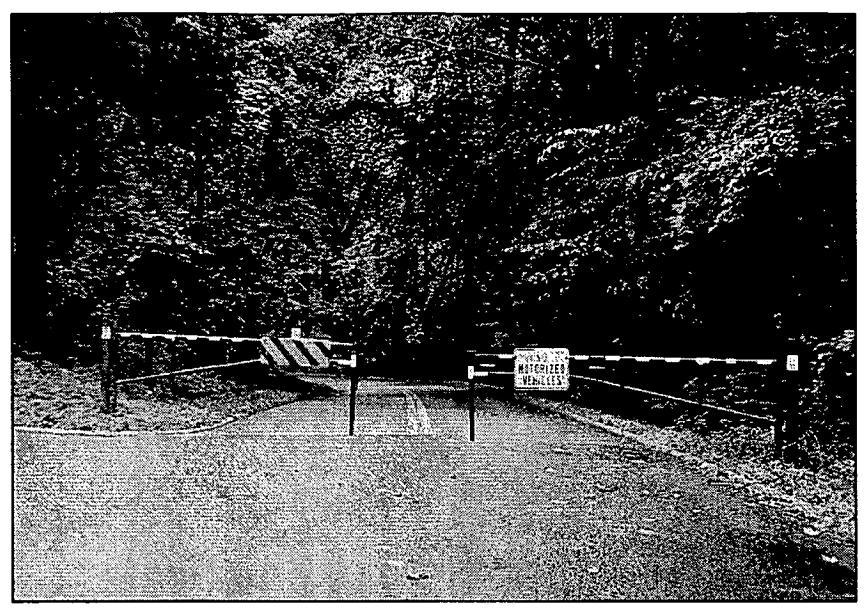
The Park uses gates like this one for temporary road closures. The supports and gate structure are well designed and appropriate for the conditions. The object marker signs on the gates should be red and white striped instead of yellow and black. Two of these object marker signs should be presented.

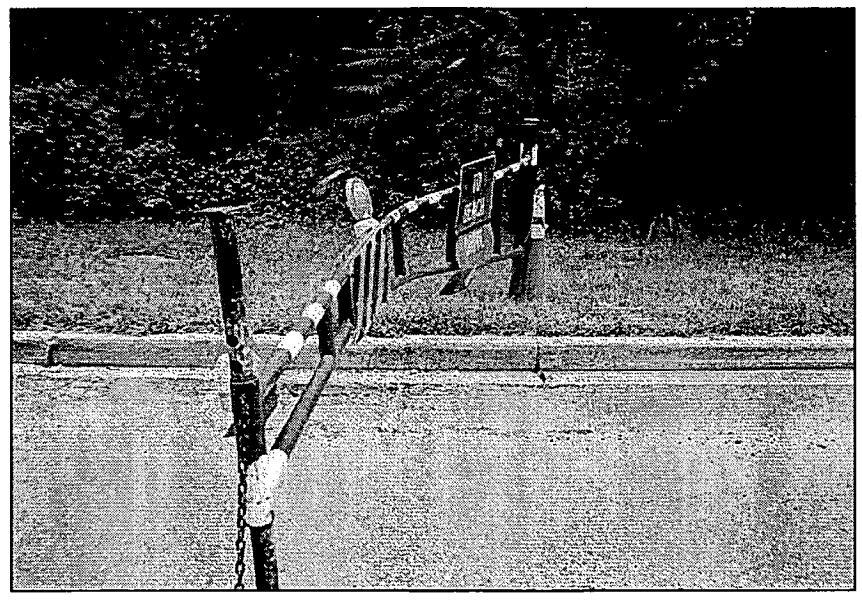
This gate shows evidence of repeated vehicle impacts. The signing on the gate is non-standard and there is inadequate advance warning signing identifying the road closure.

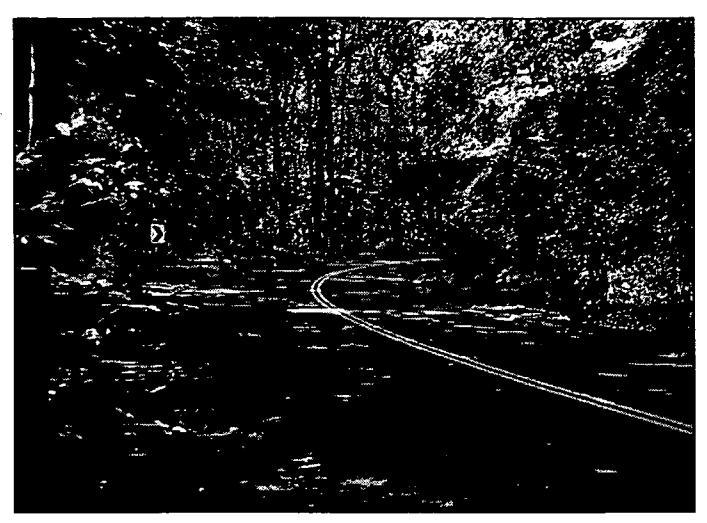
The three chevron signs tend to blend into the vegetation behind the signs. It is recommended that additional chevrons be added at this site so that 3 signs can be seen on both approaches to the curve. All of the chevrons should be oversized for better visibility.

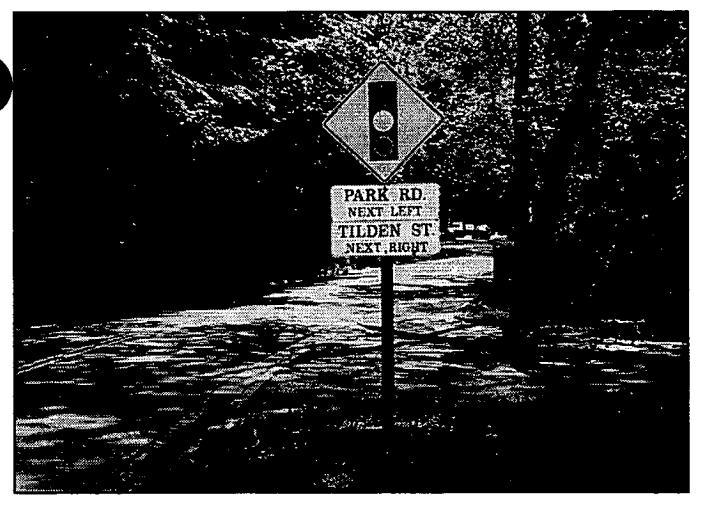
Signal ahead warning signs are located on both the north and south approaches to the intersection. The access into the picnic area shown in this photo is recommended to be closed because it is located so close to the intersection.

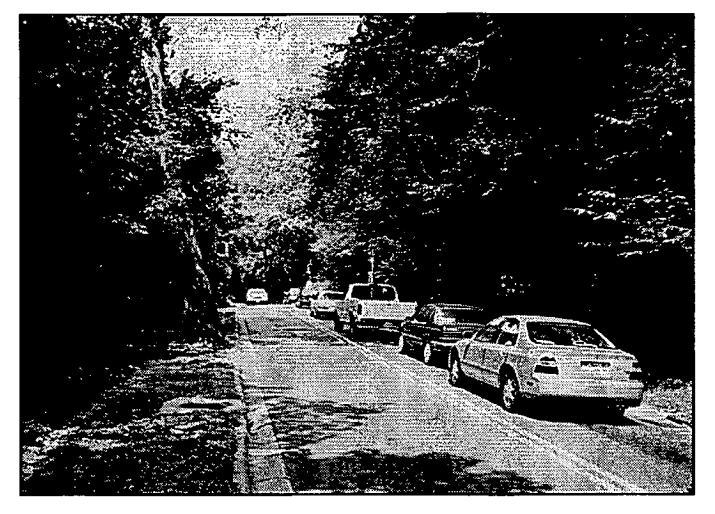
The traffic signal creates long traffic queues that extend south around the curve located south of the intersection. Notice the tree located just outside the curbline on the left in the photo. The tree shows evidence of repeated vehicle impacts.

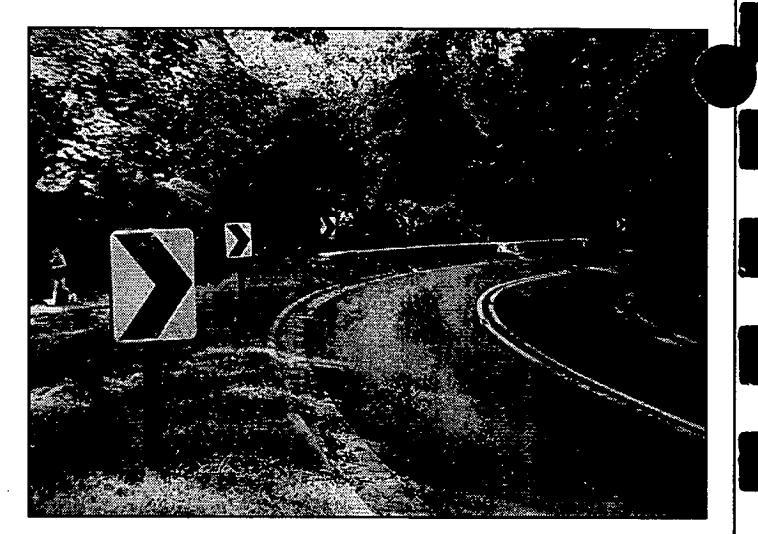
Five chevron warning signs are used to delineate the curve. Notice the large gap between the 4th and 5th sign in the series. This gap should be filled with an additional chevron sign. Additional chevrons are recommended at both ends of the existing series of signs.

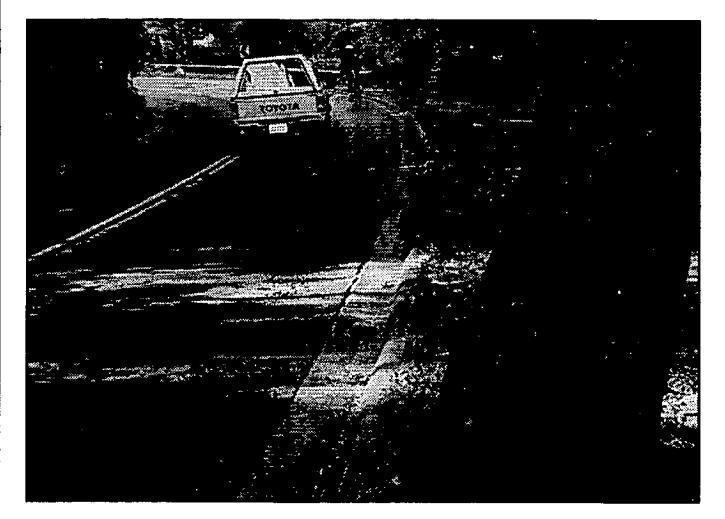
Although there is a paved path adjacent to this site bicyclists still use the roadway causing vehicles to hug the centerline through this curve.

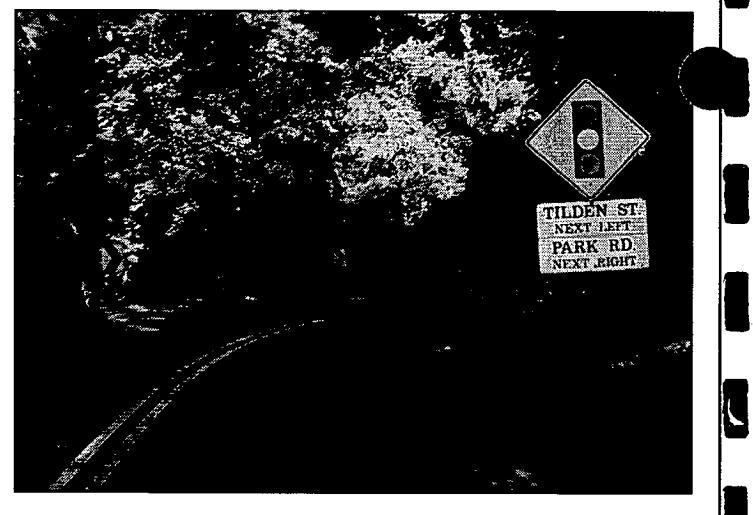
This signal ahead warning sign alerts drivers of the condition around the curve. Traffic often backs up down to and around this curve. Rear end accidents or near accidents occur at the location partially due to the limited sight distance in this curve.

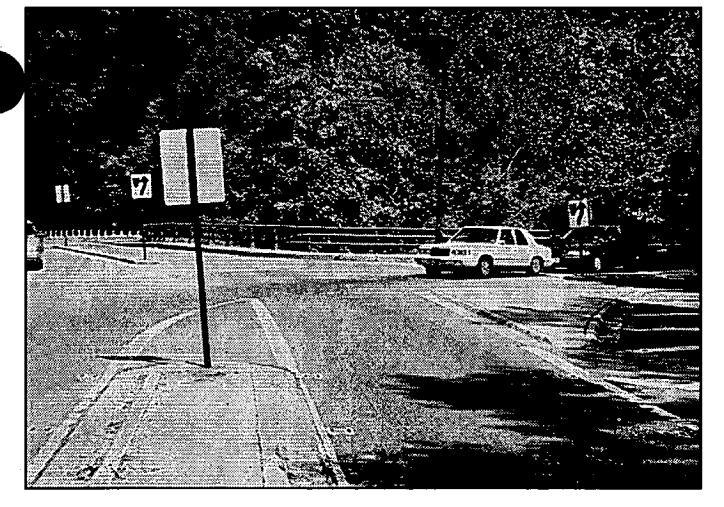
Notice how the drivers must move forward one vehicle length to see to the north, due to the visual obstruction caused by the bridge rail.

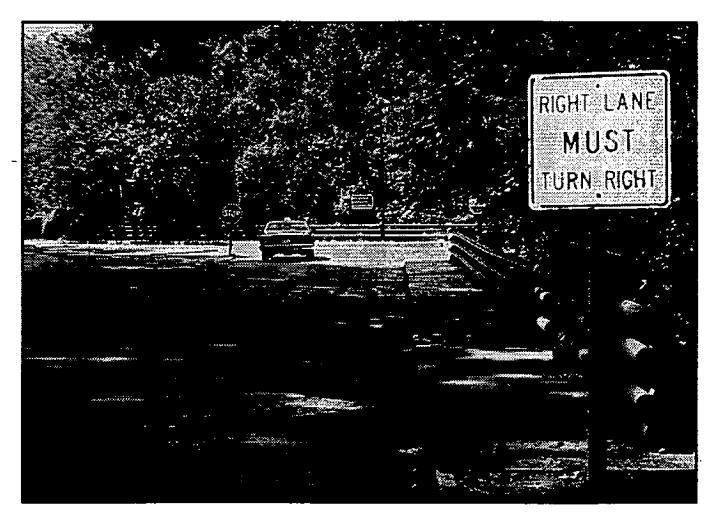
The intersection is visible on the east approach. Although it is hard to see in this photo, the pavement marking on this approach have been worn to the point that they are no longer effective.

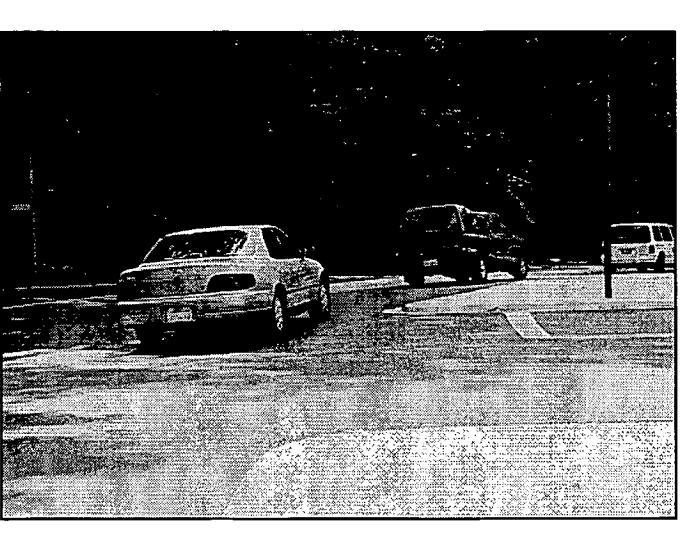
The newly constructed raised channelization median on the southwest side of the intersection protrudes out into the traffic lane causing traffic to turn hard at this point in the intersection. Vehicles were observed driving over the end of this median. Screeching tires are often heard when vehicles pass this point in the road.

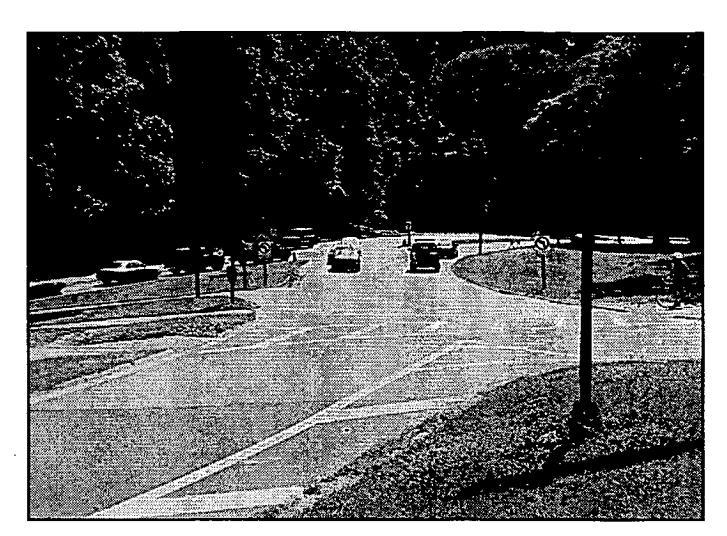
A pedestrian crosswalk is located across the parkway between the Beach and Cathedral intersections. Vehicles stopping abruptly at this crosswalk cause rear-end accidents.

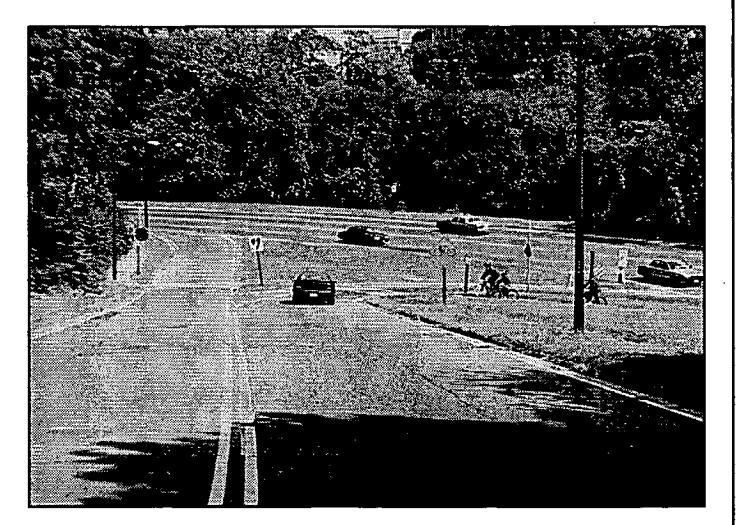
The pedestrian crossing at the bottom of the access ramp causes conflicts and near rear-end accidents. This crossing is heavily used. Drivers exiting the Parkway have very little visual advance notice of the crossing due to limited sight distance caused by vegetation growing on the inside of the curve.
