EARLY NINETEENTH CENTURY IRON FURNACES
A COMPARATIVE STUDY

Walter E. Hugins
Historian

Hopewell Village National Historic Site

January 7, 1954

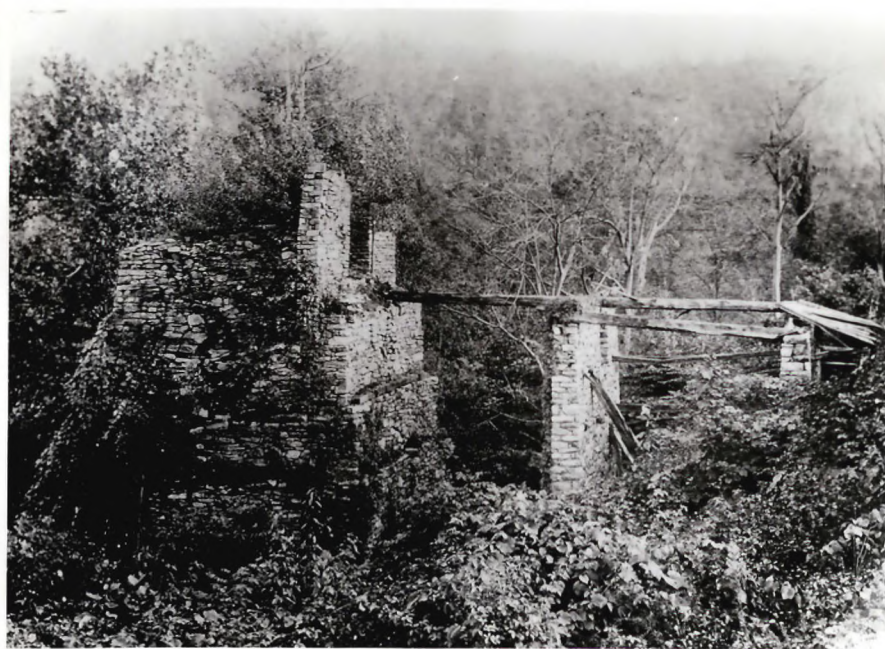
1. Photo No. 122-4

Sally Ann Furnace

This picture, taken ca. 1920, shows the ruins of the Furnace and the Bridge House walls. Note that the Bridge House floor had no appreciable upward slope.

Six Pennsylvania furnaces are shown, all roughly contemporary with Hopewell Furnace during the period in question. Sally Ann Furnace (Photo 1) was built in northern Berks County about 1791, and operated until 1869; it was rebuilt in part in 1879 and abandoned in 1881 after a fire. Windsor Furnace (Photo 2) was also located in northern Berks County and was built in 1768; it was abandoned about 1850 until rebuilt after the Civil War, and finally went out of blast in 1882. Curtin or Eagle Furnace (Photo 3) was built in Centre County about 1817 and operated until 1915; during its later history

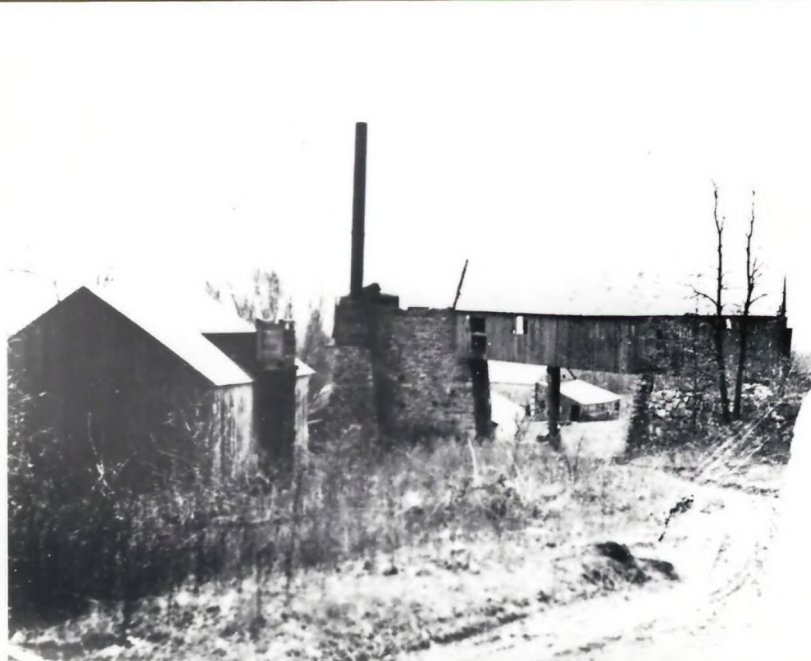
2. Photo No. 122-7

Windsor Furnace

This picture, probably taken in 1894, shows a long Bridge House with a marked upward slope. The Bridge House is apparently supported on masonry walls.

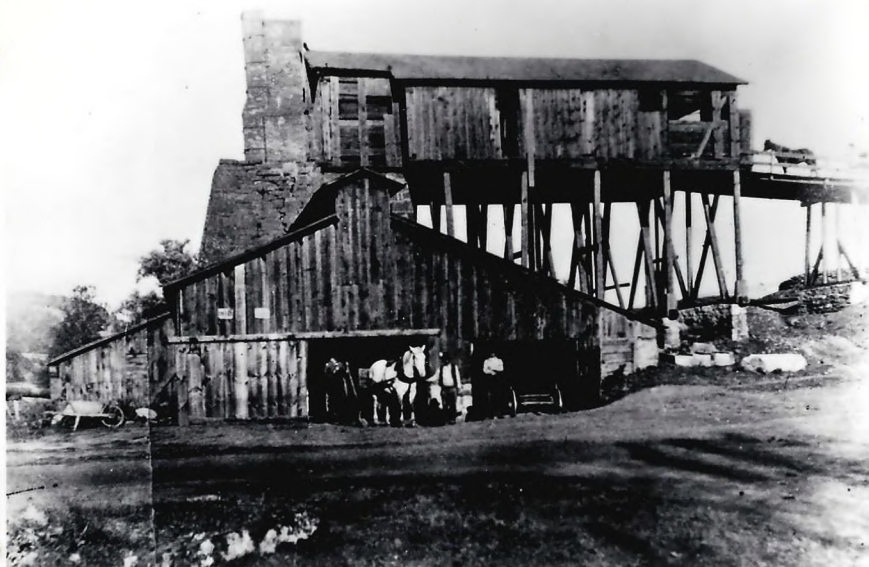
3. Photo No. 122-11

Curtin or Eagle Furnace

This picture, taken ca. 1915 just before the Furnace went out of blast permanently, shows a Bridge House supported on wooden pilings. The Bridge House floor appears to be fairly level, but note the slope of the approach ramp. Note also that ore and fuel carts are horse-drawn.

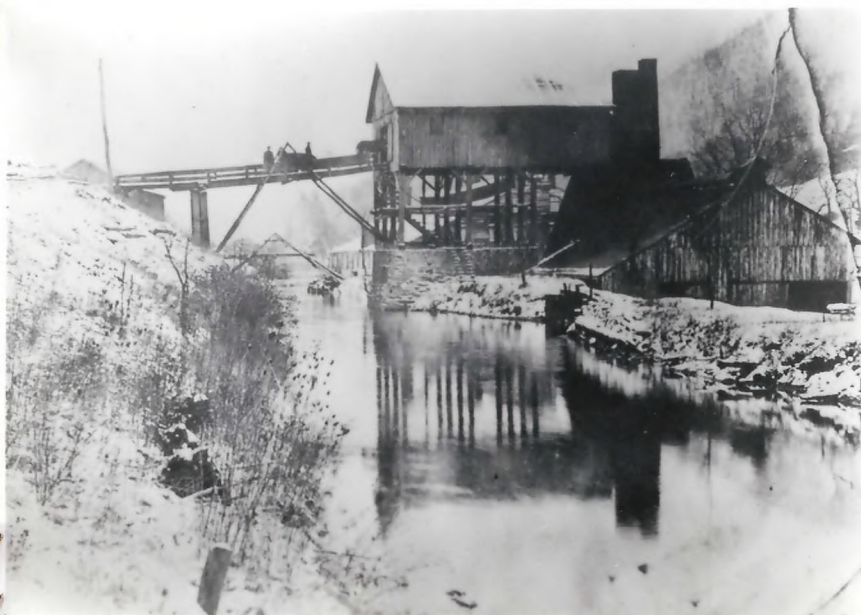
4. Photo No. 122-12

Hecla Furnace

Taken ca. 1920, this picture shows another Furnace Bridge House supported on wooden piles instead of masonry walls. This is similar to Photo No. 3 in the slope of the ramp, the level Bridge House, and the horse-drawn vehicles.

it was a hot-blast furnace. Hecla Furnace (Photo 4), also in Centre County, was built in 1820, rebuilt and modernized in 1864, and operated until 1921. Joama Furnace (Photos 5 and 6), in Berks County about 5 miles southwest of Hopewell, was built in 1792, rebuilt for steam power in 1847, and operated until about 1890. White-Deer Furnace (Photos 7 and 8) was built in Union County in 1846 and abandoned in the late 19th century.

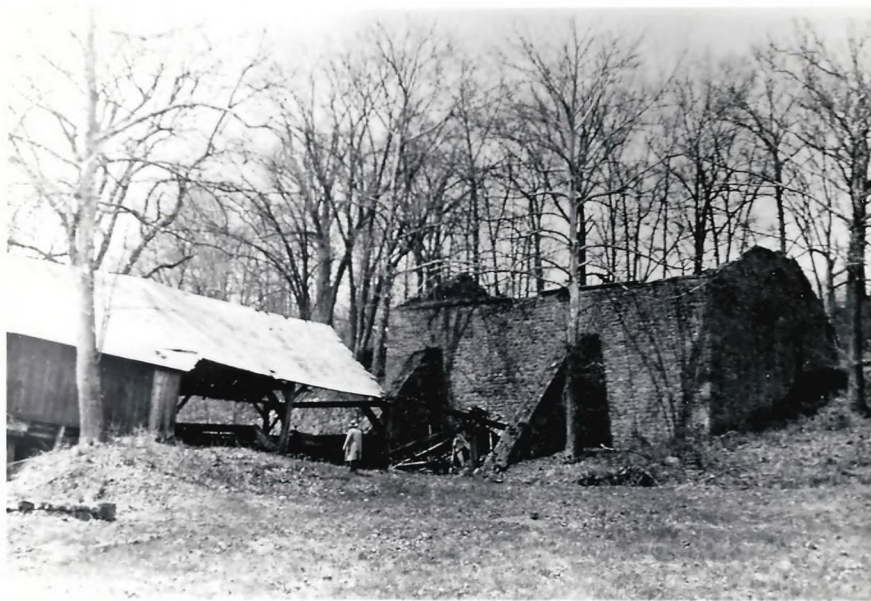
5. Photo No. 99-16

Joanna Furnace

This photo (ca. 1920) shows the ruins of the Coal House and the beginning of the ramp and Bridge House. Apparently, the slope of the ramp and Bridge House was appreciable.

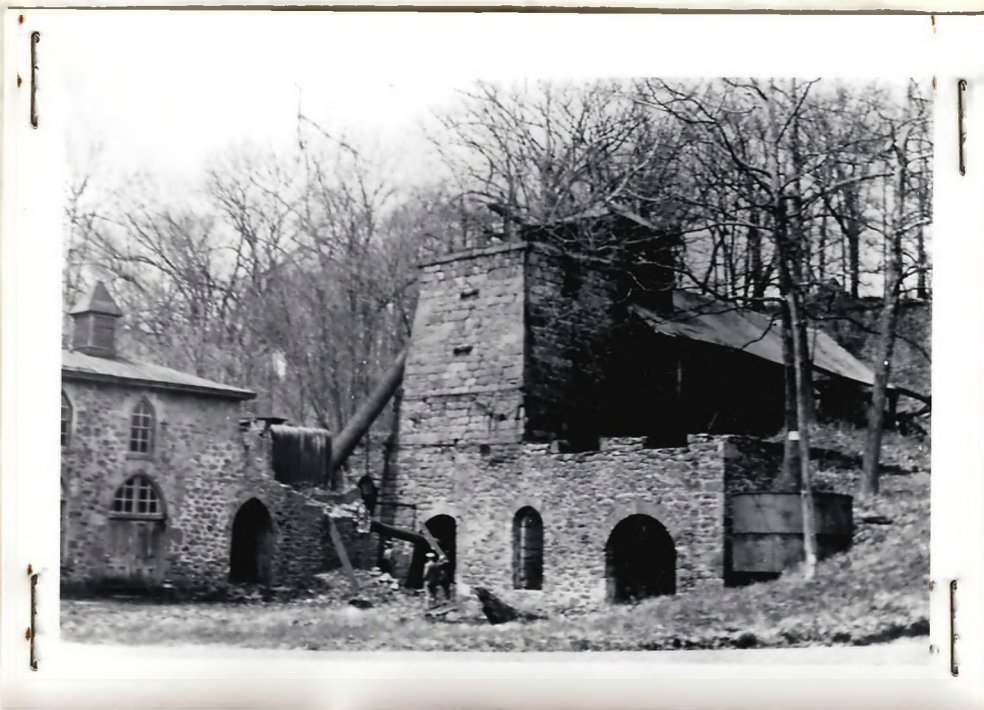
6. Photo No. 99-17

Joanna Furnace

Another view, showing the Furnace stack and part of the Bridge House in the background.

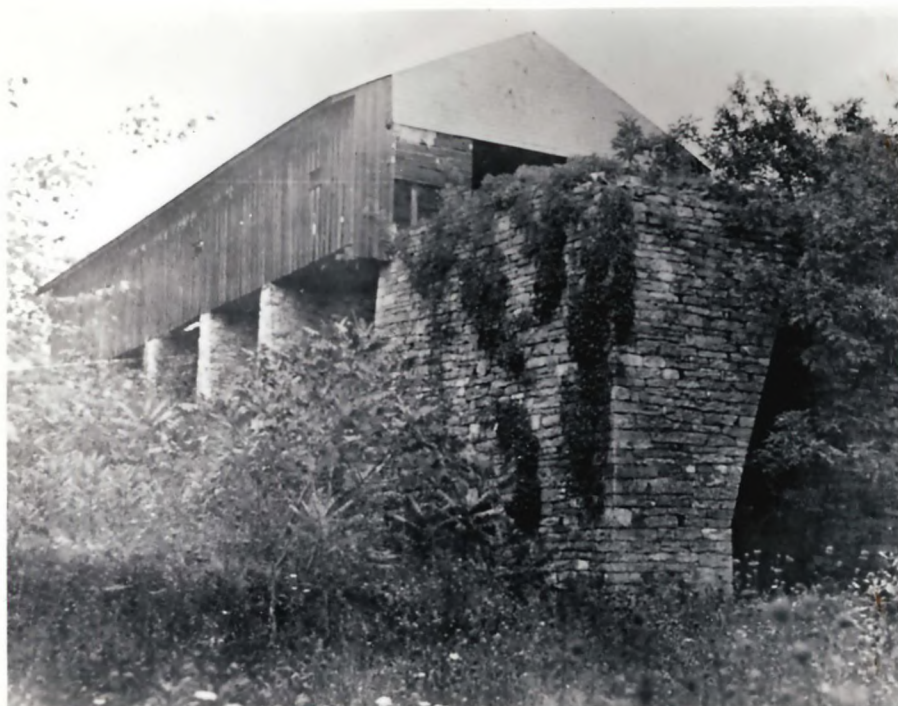
7. Photo No. 122-14

White Deer Furnace

This picture, dated about 1932, shows the ruins of the Furnace and the fairly well-preserved Bridge House. This appears to be level, supported on three or four masonry walls.

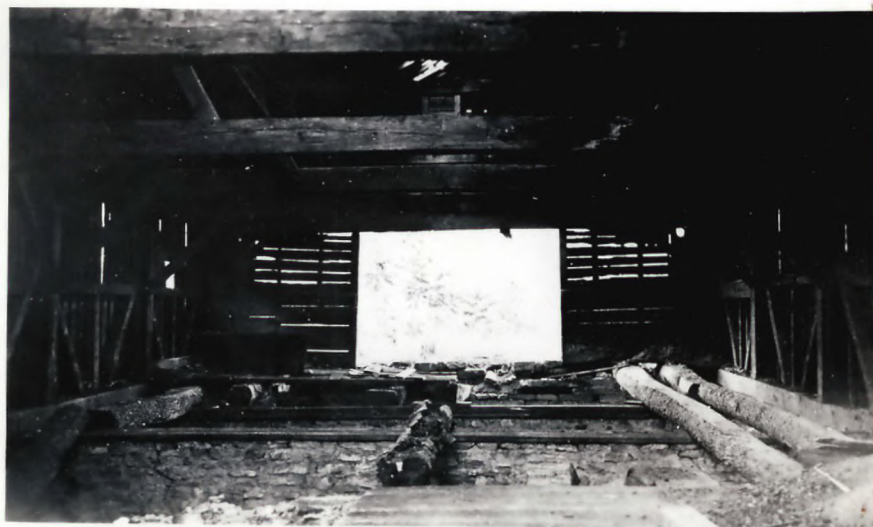
8. Photo No. 122-16

White Deer Furnace

An interior view of the Bridge House, looking towards the tunnel head of the Furnace. Here again, the Bridge House seems level. Note the floor joists and the interior framing, especially the knee braces. This is probably similar to the construction of the Hopewell Furnace Bridge House.
