HISTORIC STRUCTURES REPORT

PART III

WEST HEADRACE FLUME

Hopewell Village National Historic Site

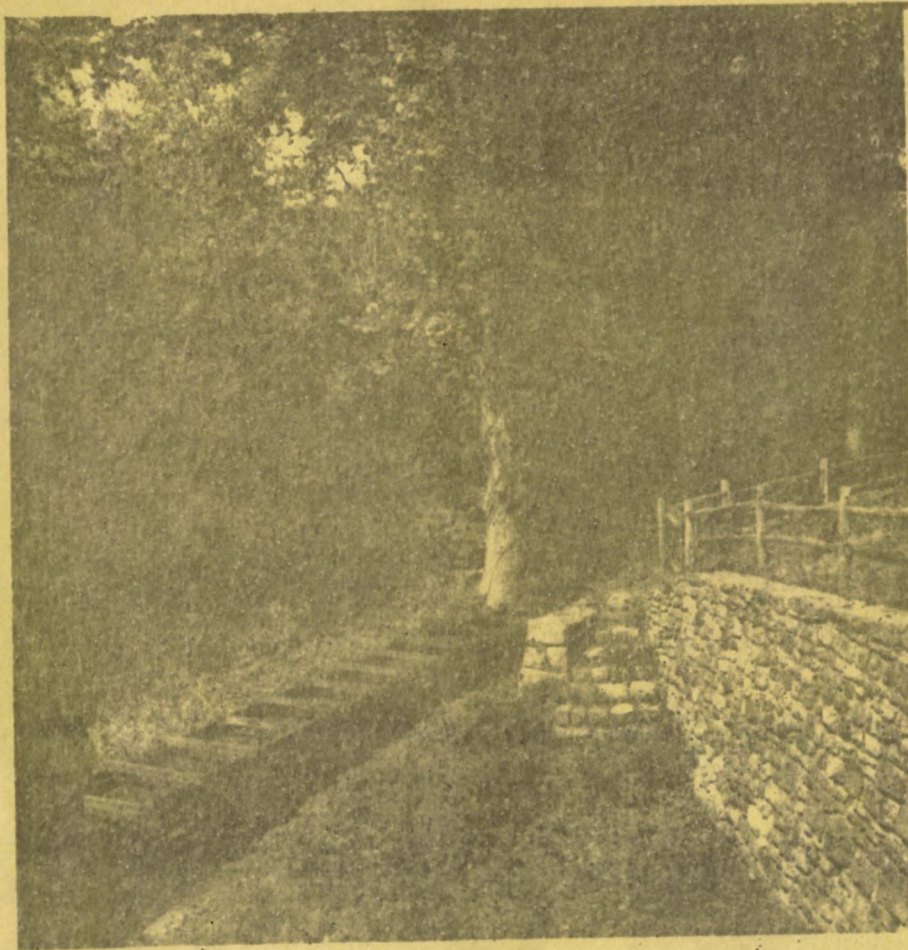
View of the flume from the connecting shed on top of the furnace bank.

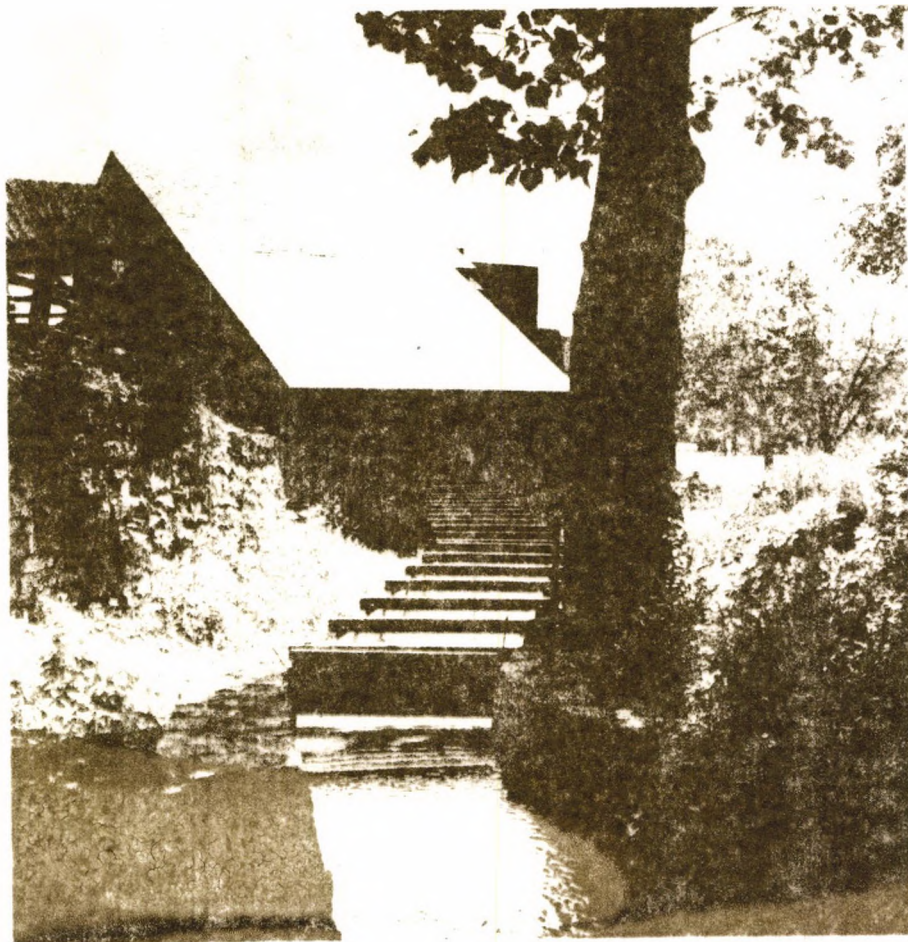
View looking up the fluse from where it enters the West Courtyard
and the Theal House and Bridgman House are in the background.

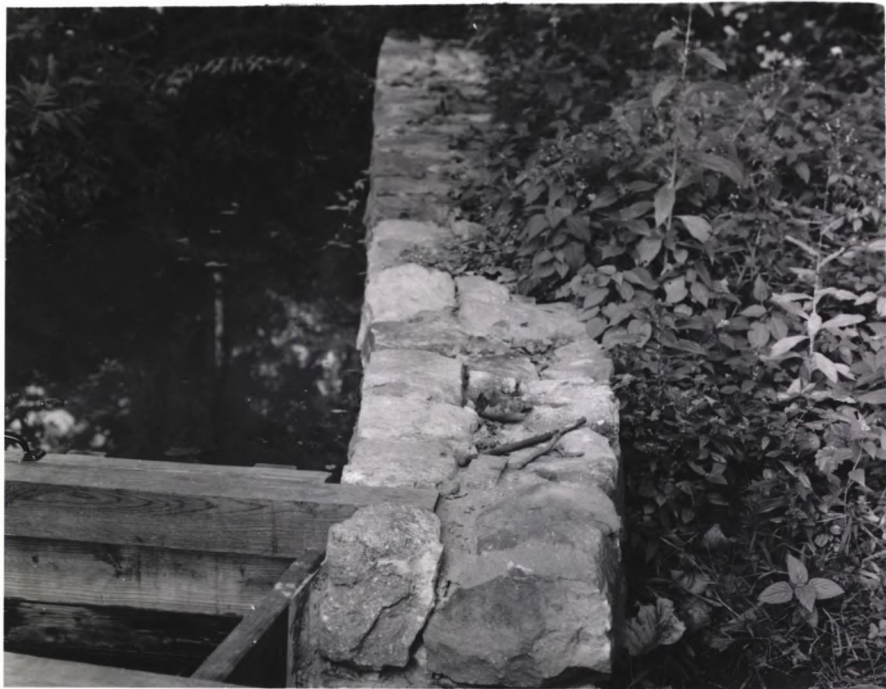
Resetting of Headrace Wall at the gate where
water enters the West Headrace Flume.

Foreman Charles Seidel, former Building Restoration Specialist, and his crew began construction of the new flume on April 27. The existing piers were used without any modification, however, some masonry work was necessary at the water cutoff where the race entered the forebay. Work was completed on May 14.

No extensive changes were made here but a small realignment of the stone wall was required to widen the opening to four feet.

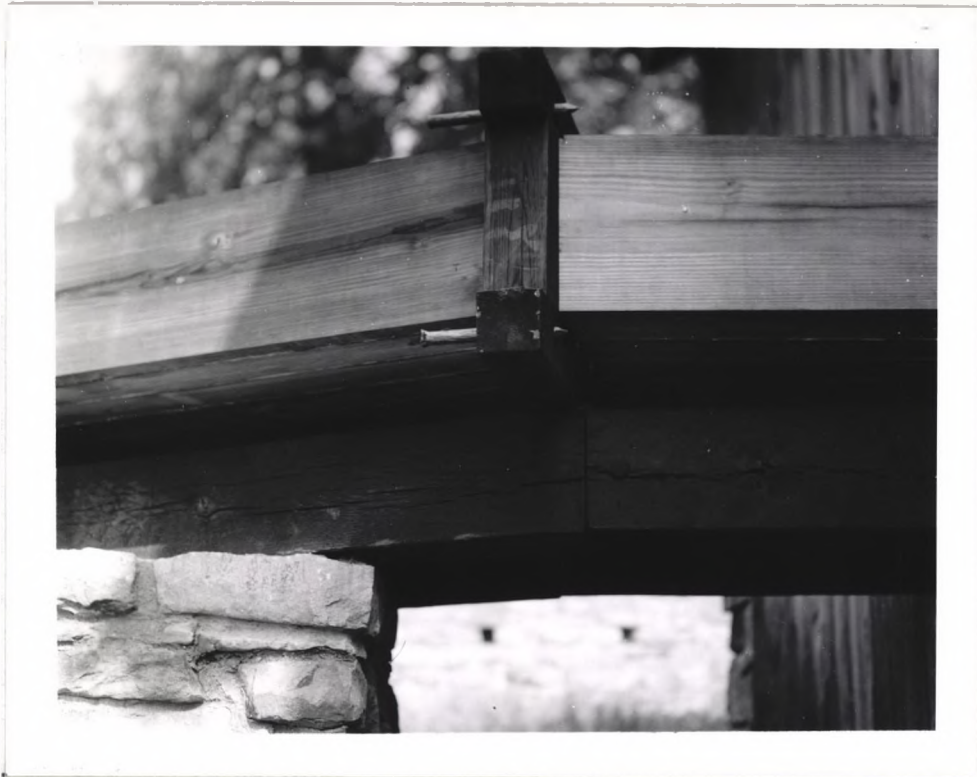
View of Forebay Pier #2 where flume enters wheelhouse on the right. Note that pegs have not been sawed off awaiting final curing of the oak timbers.

Four by four oak timbers were used for the bunks of the flume. This material was purchased from a local saw mill and was given a soaking treatment in creosote solution for several days. The oak bunks or yokes were mortised and tenoned by the Hopewell maintenance crew in March 1964. Supporting 8" x 8" timbers were given several brush applications of creosote.

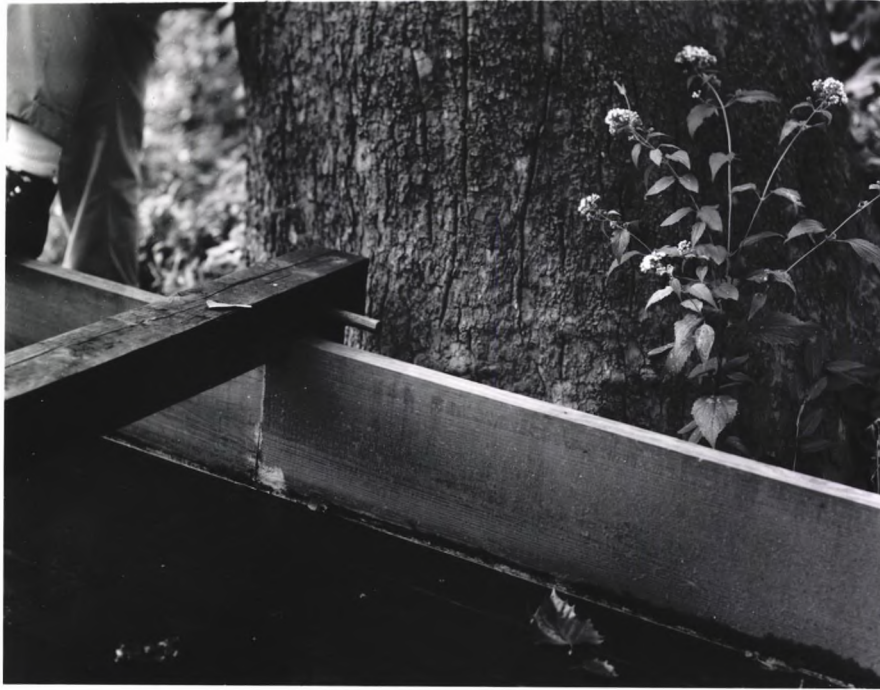
Four foot wide restored flume clears large Sycamore tree by a few inches. This tree did not interfere with the laying out of the flume but it came quite close.

A large sycamore tree was thus cleared by a few inches. It appears that when a portion of the retaining wall was rebuilt in 1951 it followed a gentle curve. The restored wall straightened out this curve.
