THE MARTIN LUTHER KING, JR. NATIONAL HISTORIC SITE

Historic Finishes Analysis 493A, B, C Auburn Avenue Atlanta, Georgia

Project Architect: JOSEPH K. OPPERMANN-ARCHITECT, P.A.

Prepared by: George Fore, Architectural Conservator

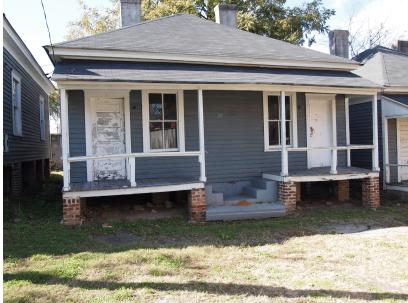
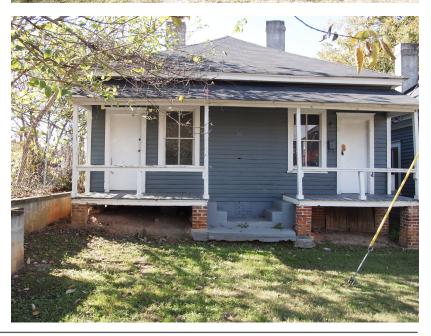
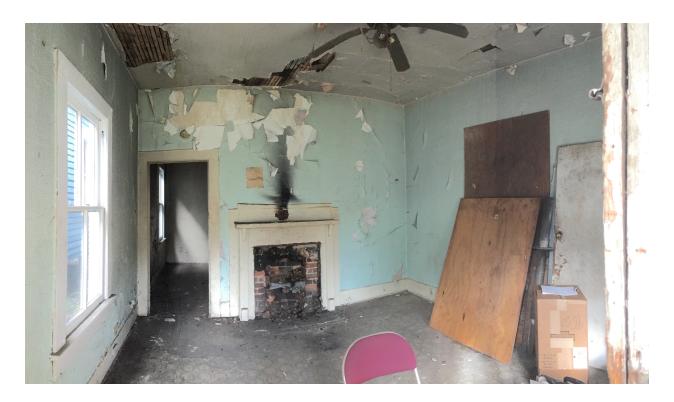
East elevations of 493 Auburn Avenue, units 1 & 2, top, units 3 & 4, center, and units 5 & 6. Unit numbers were assigned by the Post Office, and remain in place above each unit's east door. Designations "A, B and C" were assigned in the late 20th century, but no evidence of the letter system survives on the units.

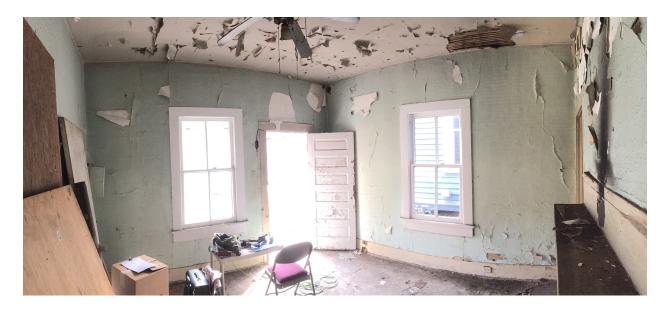
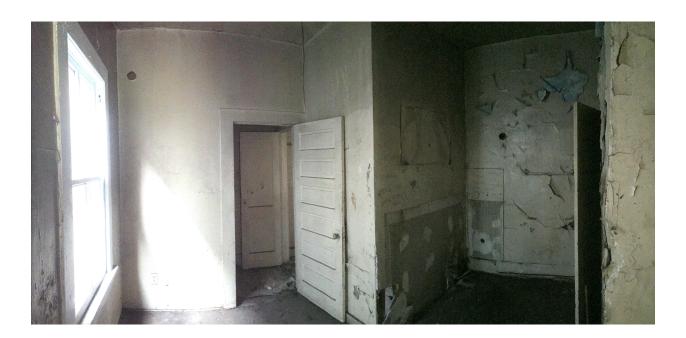
Interior views of 493 Auburn Avenue unit #2. Above is a west view of the east room (front room), and below is a southeast view of the east room.

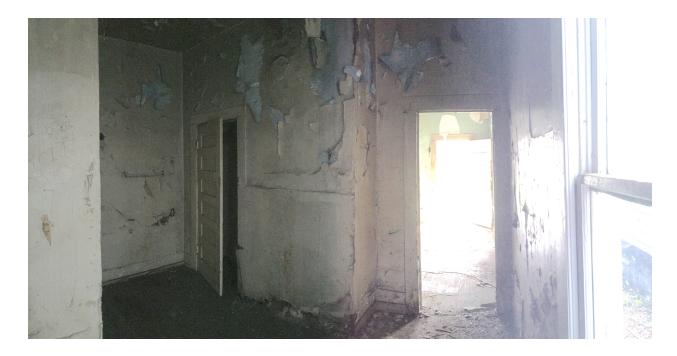
Interior views of 493 Auburn Avenue unit #2. Above is a northwest view of the west room (back room), and below is a northeast view of the west room.

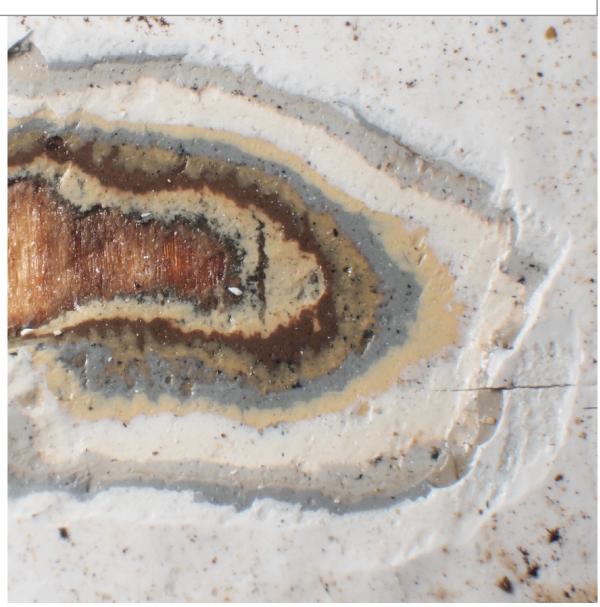
Micrograph of finishes applied to 493-2 east window fascia.

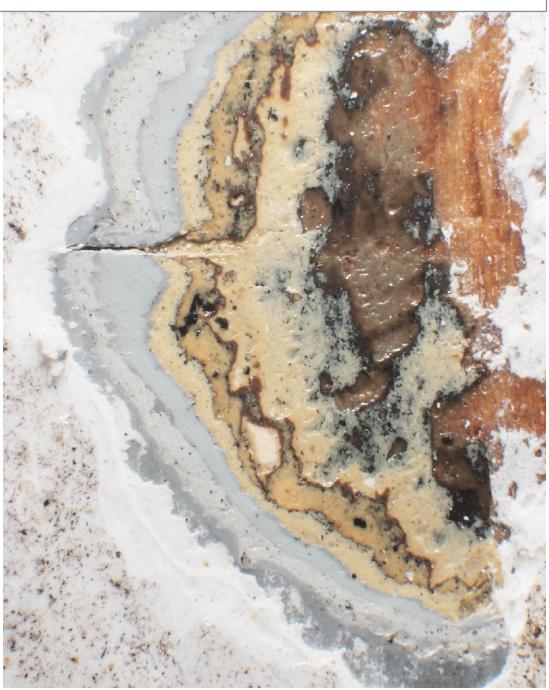
Micrograph of finishes applied to 493-1 east window fascia.

Observations: The window and door fascia and the cornice were painted a medium yellow-green at the third finish period, estimated to correspond to ca. 1930, and a dark red-tan at the fourth finish period, estimated to correspond to ca. 1940.

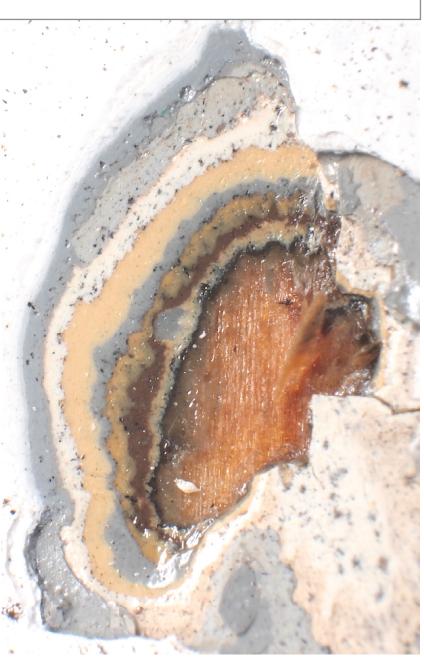
Micrograph of finishes applied to 493-1 east door fascia.

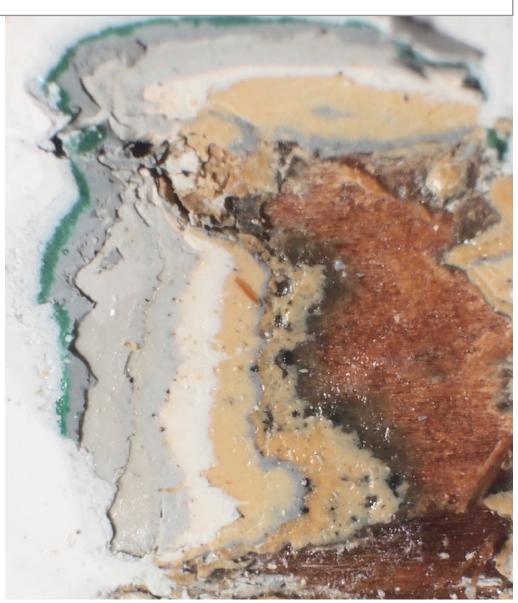
Micrograph of finishes applied to 493-1 north cornice fascia beneath soffit.

Observations: The cornice fascia and soffit were painted a medium yellow-green at the third finish period, estimated to correspond to ca. 1930, and a dark red-tan at the fourth finish period, estimated to correspond to ca. 1940. The first four finishes on the cornice match those applied to the window and door fascia.

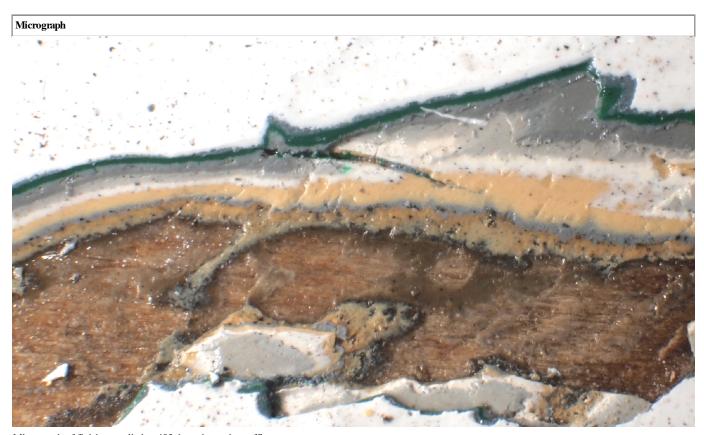
Micrograph of finishes applied to 493-1 north cornice soffit.

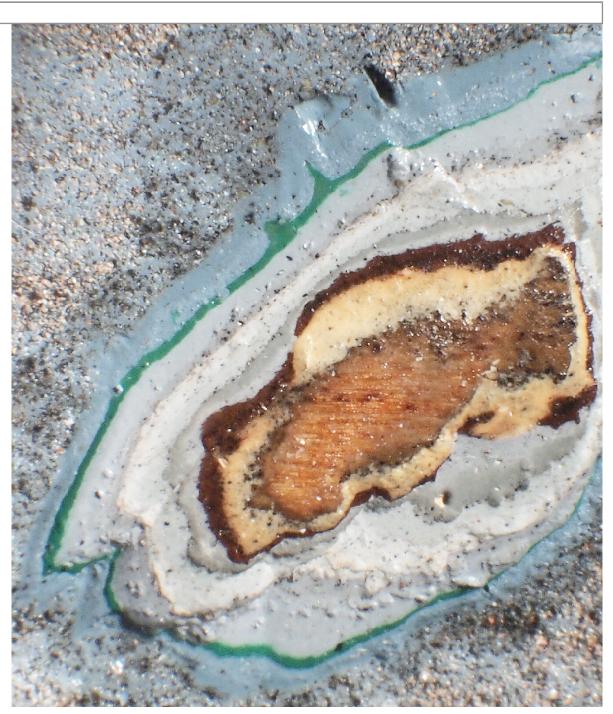
Micrograph of finishes applied to 493-1 east clapboards.

Observations: The clapboards were painted a light yellow-cream at the third finish period, estimated to correspond to ca. 1930, and a rose-cream at the fourth finish period, estimated to correspond to ca. 1940.

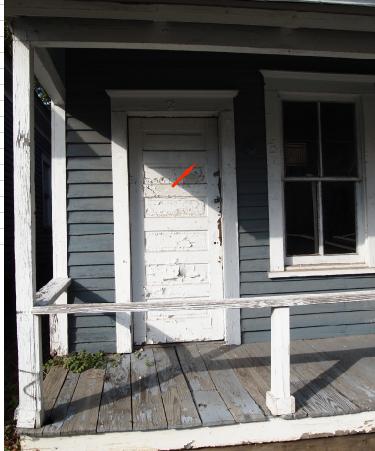
Chromochronology Work Sheet: MALU-493-2-008 2 of 2 Sheets

Description	Munsell Notation	Munsell Collection	Surface Finish
	Description	With Soft Hotation	Withsen Concensi	Surface I misn
Substrate	millwork			
1.	. medium yellow-green	7.5Y 5/2	Glossy	medium gloss
2.	dark yellow-green	5Y 4/1	Glossy	medium gloss
3.	. medium yellow-green	7.5Y 7/2	Glossy	medium gloss
4.	rose-cream - east porch added, replaced or enlarged	10YR 9.25/1.5	Nearly Neutral	medium gloss
5.	light rose-cream - sash replaced			
6.	. off-white			
7.	. light rose-cream			
8.	light rose-cream			
9.	medium rose-cream			
10.	medium rose-cream			
11.	medium rose-cream			
12.	dark rose-gray			
13.	off-white			No.
14.	off-white			
15.	light tan			
	light rose-cream			The second second
17.	red-brown			The second second
18.	white			
19.	medium cream

Sample Location and Description: #2 east door rail

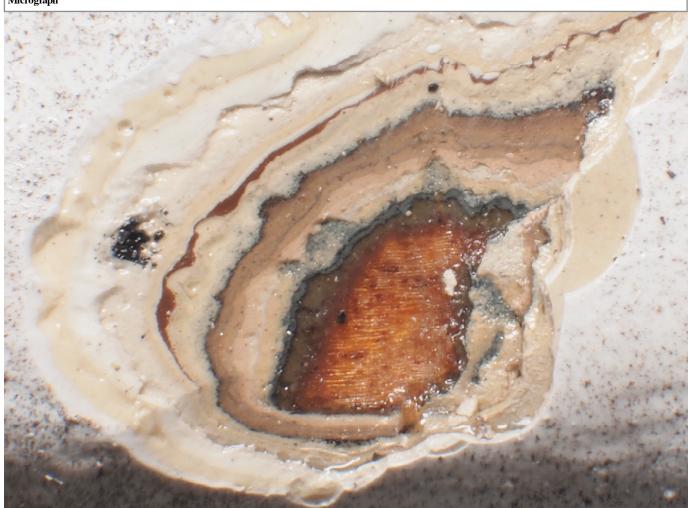
Micrograph of finishes applied to 493-2 east door rail.

Observations: The entry door at #2 was painted a medium yellow-green at the third finish period, estimated to correspond to ca. 1930, and a rose-cream at the fourth finish period, estimated to correspond to ca. 1940. The third period door color matched the contemporary color applied to the trim. At the fourth painting, the door was painted the contemporary clapboard color. This is only one of two east entry doors surviving on the six units. Doors on the unprotected west elevation match the design of the east doors, but are too weathered for analysis.

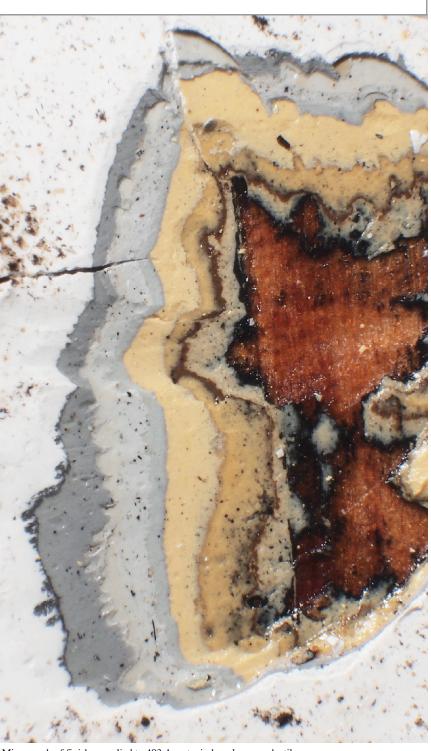
Micrograph of finishes applied to 493-1 east window, lower sash stile.

Observations: The sash were installed at the 4th or 5th painting of the exterior. The other two duplexes window sash were also installed at the this time.

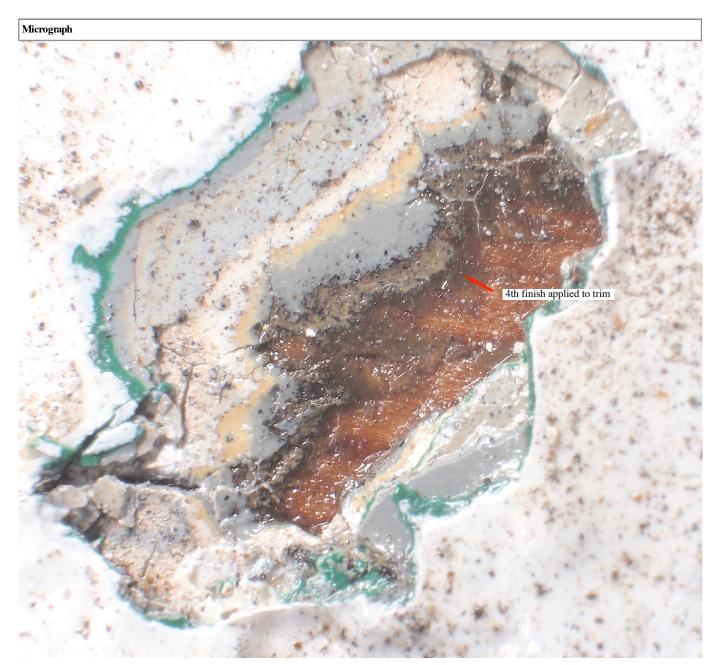
Micrograph of finishes applied to 493-1 porch plate.

Observations: The porch across the east elevation of #1 & 2 was added at the fourth painting of the exterior, estimated to be ca. 1940. The ceiling may have been replaced. The porch posts, gable boards, and rails date to later repairs.

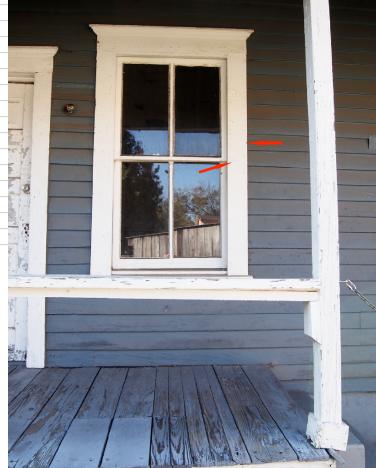
Chromochronology Work Sheet: MALU-493-4-011 2 of 3 Sheets

Description	Munsell Notation	Munsell Collection	Surface Finish
Substrate	millwork			
1.	medium rose-gray	5YR 4/1	Glossy	medium gloss
2.	dark yellow green	10GY 2/1	Glossy	medium gloss
3.	medium gray-tan	2.5Y 7/2	Glossy	medium gloss
4.	medium yellow-tan - east porch added, replaced or enlarged	10YR 6/3.0	Glossy	medium gloss
5.	medium gray - window sash installed			
6.	rose cream			
7.	red brown			
8.	medium gray			
9.	medium gray			
10.	red-brown			
11.	light gray			
12.	light gray			
13.	medium gray			
14.	off-white			
15.	light rose-cream			
16.	white			
17.	white			
18.				
21.

493-4 window.

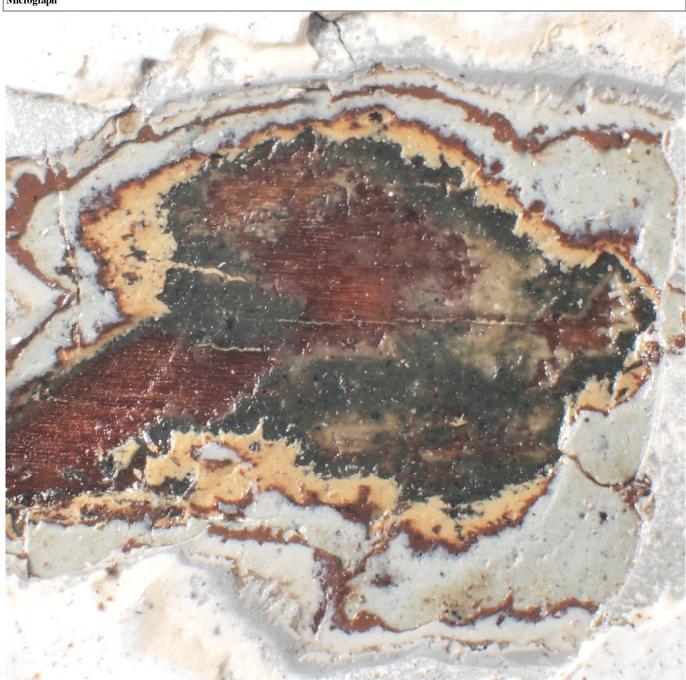
Micrograph of finishes applied to 493-4 east window fascia. See next sheet for overlapped clapboard colors onto fascia.

Observations: The window and door fascia and the cornice were painted a medium gray-tan at the third finish period, estimated to correspond to ca. 1930, and a medium yellow-tan at the fourth finish period, estimated to correspond to ca. 1940.

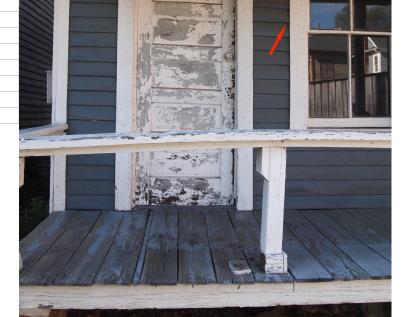
Chromochronology Work Sheet: MALU-493-4-013 2 of 3 Sheets

Description	Munsell Notation	Munsell Collection	Surface Finish
ubstrate	millwork			
1.	dark red-tan	2.5YR 3/2	Glossy	medium gloss
2.	medium gra- green	5GY 5/1	Glossy	medium gloss
3.	dark yellow-tan	2.5Y 4/1	Glossy	medium gloss
4.	medium yellow-gray - east porch added, replaced or enlarged	5Y 7/0.5	Nearly Neutral	medium gloss
5.	rose-cream - window sash installed			
6.	dark red tan			
7.	medium gray			
8.	rose-cream			
9.	light gray			
10.	off white			
11.	medium gray			
12.	light gray			
13.	bright green			
14.	dark gray	The same and the s	and here,	The state of the s
15.	dark gray	100		
16.				
			17	
20.			7217

493-4 clapboards.

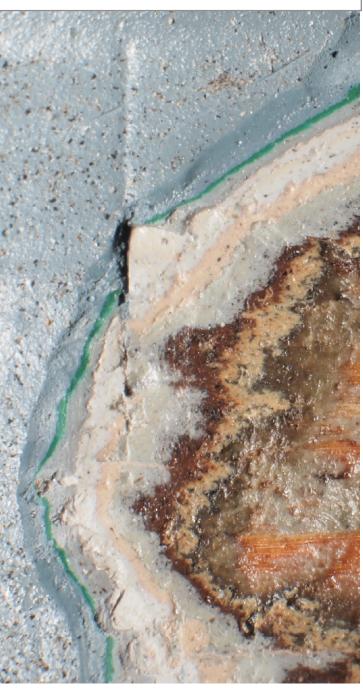
Micrograph of finishes applied to 493-3 east clapboards.

Observations: The clapboards were painted a dark yellow-tan at the third finish period, estimated to correspond to ca. 1930, and a medium yellow-gray at the fourth finish period, estimated to correspond to ca. 1940.

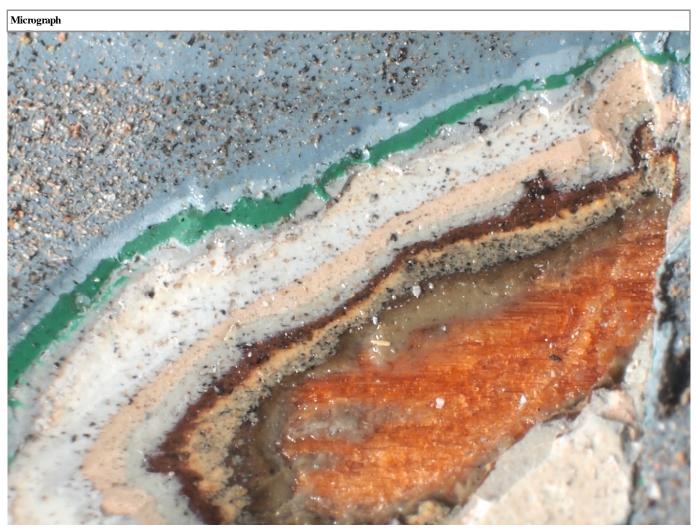
Micrograph of finishes applied to 493-3 east clapboards.

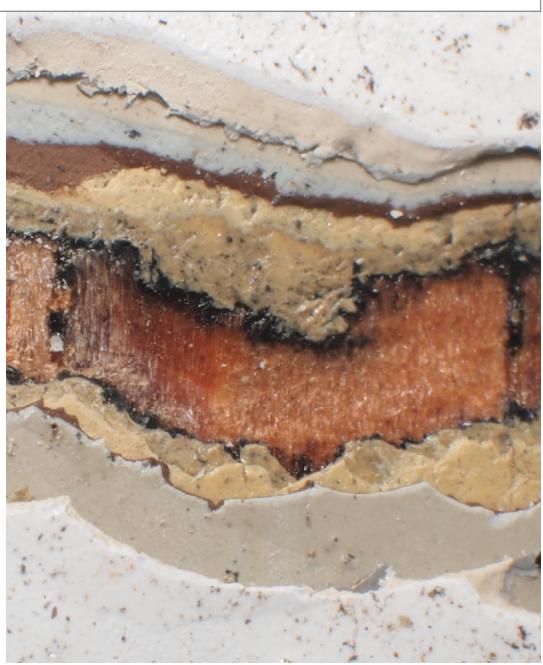
Micrograph of finishes applied to 493-3 east window sash.

Observations: The window sash were installed at the 5th painting of the exterior. Sash were also replaced at #1 and 2 and #5 and 6.

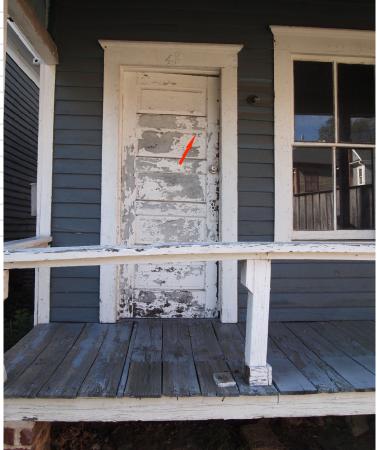
Chromochronology Work Sheet: MALU-493-4-016 2 of 2 Sheets

Description	Munsell Notation	Munsell Collection	Surface Finish
~ .		Transen 1, same	Transen Concession	- Surface I mish
	millwork			
	medium rose-gray	5YR 4/1	Glossy	medium gloss
2.	dark yellow green	10GY 2/1	Glossy	medium gloss
3.	medium gray-tan	2.5Y 7/2	Glossy	medium gloss
4.	medium yellow-tan - east porch added, replaced or enlarged	10YR 6/3.0	Glossy	medium gloss
5.	medium gray - window sash installed			
6.	rose cream			
7.	red brown			
8.	light gray			
9.	light gray			
10.	red-brown			
11.	white			
12.	off white			
13.	dark tan			
14.	white			
15.	rose-cream			
16.	medium gray			
	light rose-cream			
18.	white			
19.	white		17	
20.			72111

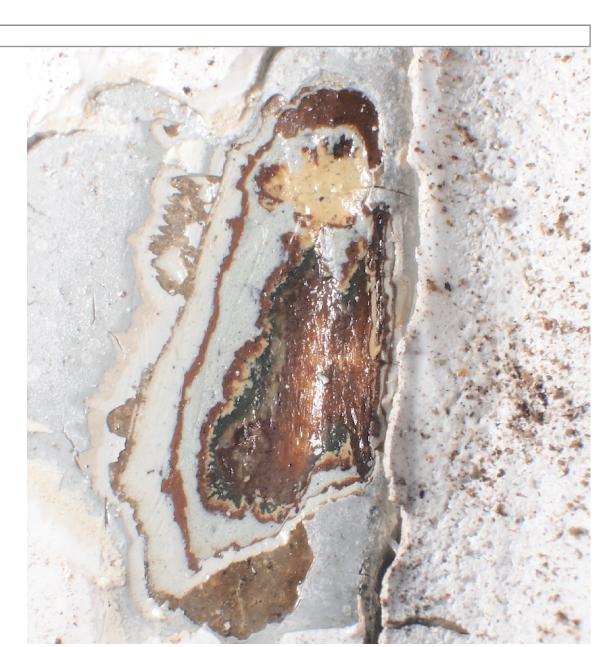
Micrograph of finishes applied to 493-4 east door stile.

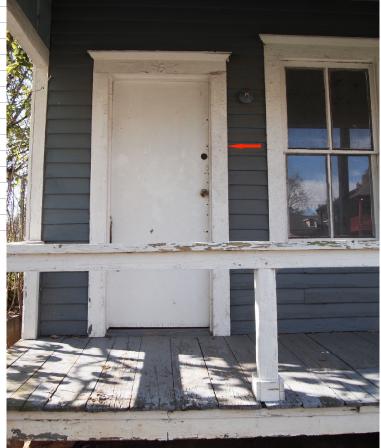
Chromochronology Work Sheet: MALU-493-6-017 2 of 2 Sheets

Description	Munsell Notation	Munsell Collection	Surface Finish
Substrate	millwork			
1.	dark rose-tan	7.5YR 2/4	Glossy	medium gloss
2.	dark gray-green	10Y 3/1	Glossy	medium gloss
3.	light cream	5Y 9/0.5	Nearly Neutral	medium gloss
4.	medium rose-gray	7.5R 4/2	Glossy	medium gloss
5.	medium yellow ochre - window sash replaced			
6.	light rose cream			
7.	medium yellow			
8.	medium yellow			
9.	medium gray			
10.	dark gray			
11.	white			
12.	off white			
13.	off white			
14.	white			
15.	white		AR SHEET WATER	6
16.				
18.				
				The second of the second

493-6 east door.

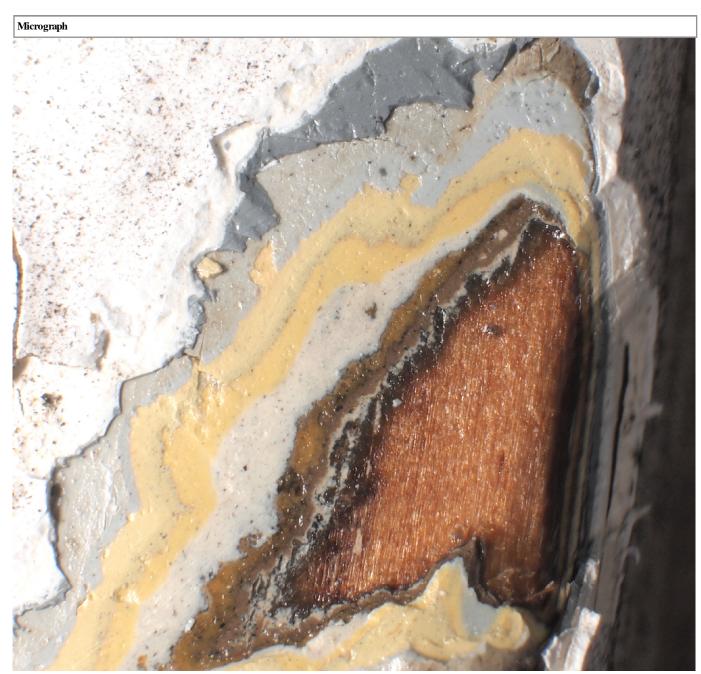
Micrograph of finishes applied to 493-6 east door fascia.

Observations: The window and door fascia on #5 and 6 units were painted a light cream in the ca. 1930 period and a rose-gray in the ca. 1940 period.

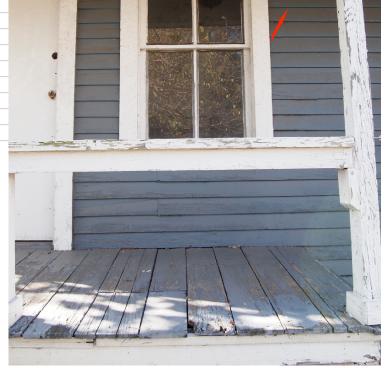
Chromochronology Work Sheet: MALU-493-6-018 2 of 2 Sheets

Description	Munsell Notation	Munsell Collection	Surface Finish
ubstrate	millwork			
1.	medium tan	10YR 5/2	Glossy	medium gloss
2.	red-tan	7.5YR 3/4	Glossy	medium gloss
3.	dark gray	N 3.5	Glossy	medium gloss
4.	red brown - east porch added, replaced or enlarged	10R 3/2	Glossy	medium gloss
5.	light rose cream - window sash replaced			
6.	medium gray			
7.	medium yellow green			
8.	light gray			
9.	light gray			
10.	medium gray			
11.	medium gray			
12.	bright green			
13.	medium gray			
14.	dark gray		4 4/2	
15.				
17.				
19.				KING THE RESERVE OF THE PERSON
				10/4
		1	The state of the s

493-6 window.

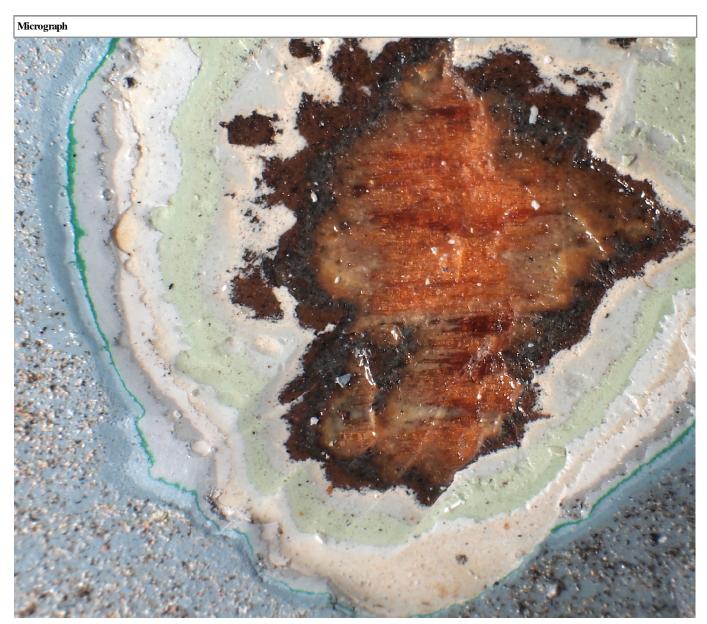
Micrograph of finishes applied to 493-6 east clapboards.

Observations: The clapboards on #5 and 6 units were painted a dark gray in the ca. 1930 period and a red-brown in the ca. 1940 period.

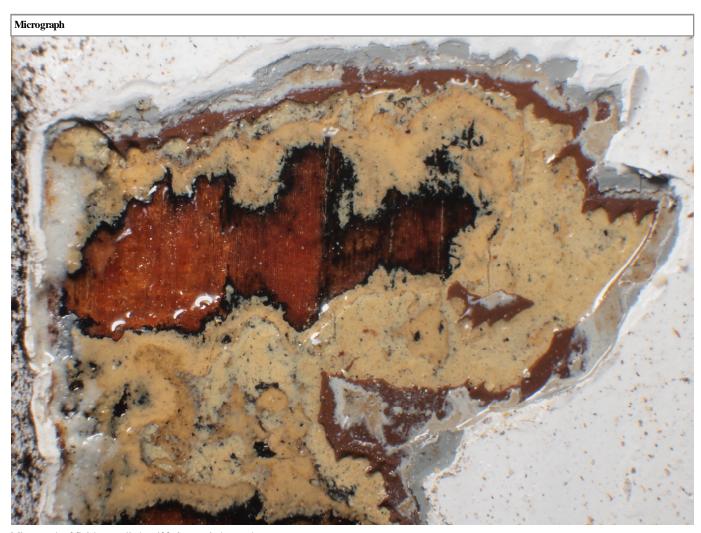
Micrograph of finishes applied to 493-6 east window sash.

Observations: The sash on #5 and 6 units were replaced at the 5th painting of the exterior.

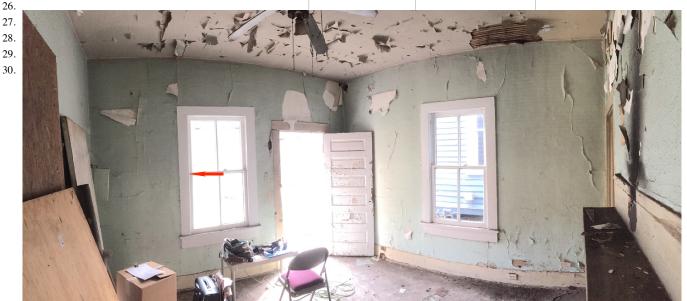
Chromochronology Work Sheet: MALU-493-2int-020 2 of 2 Sheets

Description	Munsell Notation	Munsell Collection	Surface Finish
ubstrate	millwork			
1.	medium blue-gray	5B 8/0.5	Nearly Neutral	medium gloss
2.	dark red-brown glaze over 1st finish - translucent	not opaque		
3.	medium blue-gray - ca. 1930	N 7.25	Glossy	medium gloss
4.	medium rose-cream - ca. 1940	5YR 8.5/2.0	Glossy	medium gloss
5.	light rose			
6.	light rose			
7.	light rose			
8.	medium gray-rose			
9.	medium gray-rose			
10.	light rose-cream			
11.	cream			
12.	cream			
13.	medium blue			
14.	white			
15.	light yellow-tan			
16.	cream			
17.	cream			
18.	white			
19.	white			
20.				
21.				
26.

Southeast view of unit #2's east room.

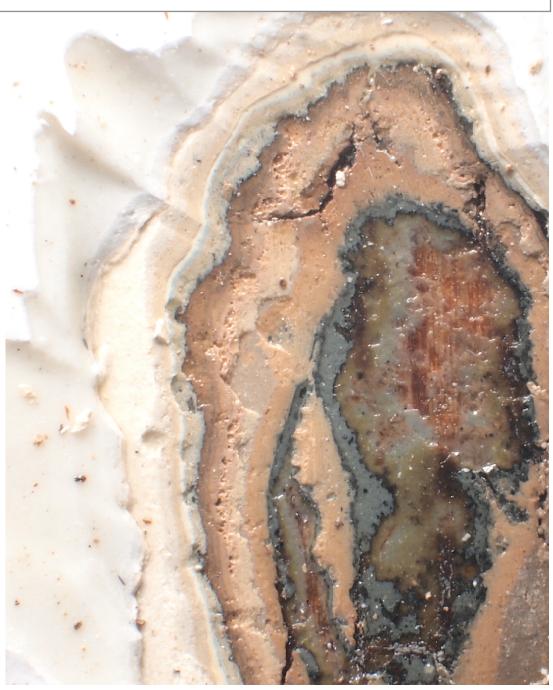
Micrograph of finishes applied to 493-2 interior east room window fascia.

Observations: The interior trim in unit 2 was painted a medium blue-gray in ca. 1930, and a medium rose-cream in ca. 1940.

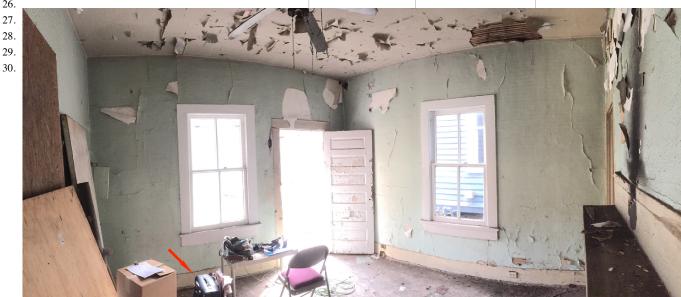
Chromochronology Work Sheet: MALU-493-2int-021 2 of 3 Sheets

Description	Munsell Notation	Munsell Collection	Surface Finish
strate millwork			
1. medium blue-gray	5B 8/0.5	Nearly Neutral	medium gloss
2. dark red-brown glaze over 1st finish - translucent	not opaque		
3. medium blue-gray - ca. 1930	N 7.25	Glossy	medium gloss
4. medium rose-cream - ca. 1940	5YR 8.5/2.0	Glossy	medium gloss
5. <u>light rose</u>			
6. <u>light rose</u>			
7. light rose			
8. medium gray-rose			
9. medium gray-rose			
10. light rose-cream			
11. cream			
12. cream			
13. medium blue			
14. white			
15. <u>light yellow-tan</u>			
16. cream			
17. cream			
18. white			
19. white			
20			
21			
22			
23			
24			
25			
26.		The state of the s

Southeast view of unit #2's east room.

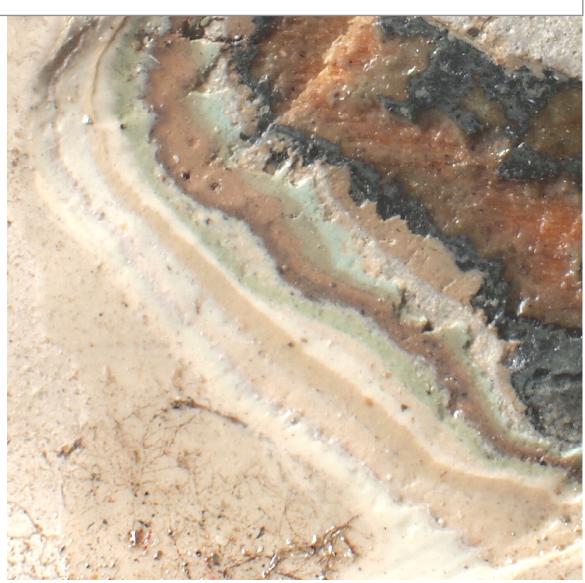
Micrograph of finishes applied to 493-2 interior east room baseboard.

Observations: The interior baseboards in unit 2 were painted a medium blue-gray in ca. 1930, and a medium rose-cream in ca. 1940. The sequence of finishes on the baseboards follow those applied to the door and window fascia.

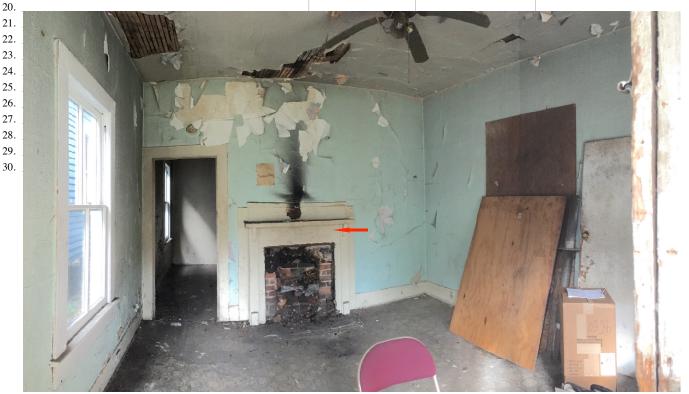
Chromochronology Work Sheet: MALU-4493-2int-022

Description		Munsell Notation	Munsell Collection	Surface Finish
Substrate	millwork				
1.	stained and varnished, dark red-brown		not opaque		glossy
2.	- first finish retained for undetermined	1 time –			
3.	rose-cream base coat	2 coat finish, post ca. 194	10		
4.	dark red-brown glaze - translucent				
5.	cream - finish #11 applied to window &	door fascia			
6.	cream				
7.	medium blue				
8.	white				
9.	light yellow-tan				
10.	cream				
11.	cream				
12.	white				
13.	white				
14.					
15.					
16.					
17.					
19.					
20

West view of unit #2's east room.

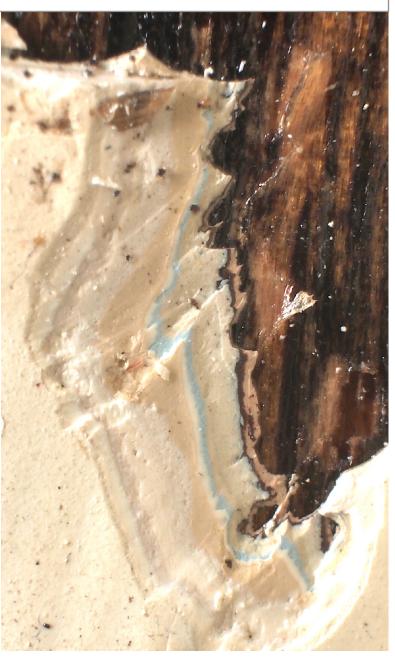
Micrograph of finishes applied to 493-2 interior east room mantle.

Observations: The east room mantle is a manufactured piece that likely arrived with a stained-and-varnish finish. The first period finish on the oak mantle remained exposed for some time, and likely was exposed during the ca. 1929 - 1940 period. This is suggested by the third finish applied to the mantle. This is a cream color that is the 11th period finish on the door and window fascia.

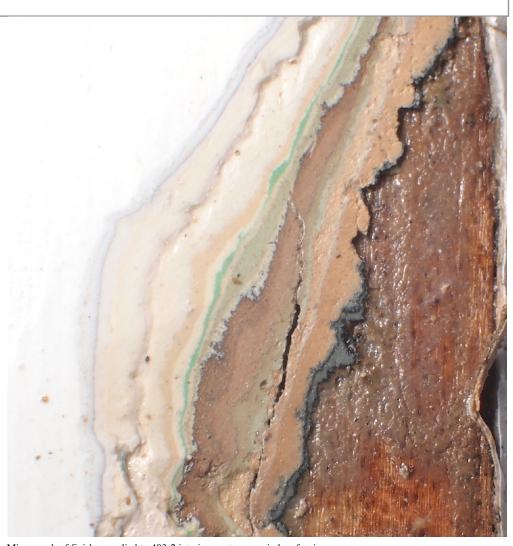
Micrograph of finishes applied to 493-2 interior west room window fascia.

Observations: The millwork in unit 2 was painted a medium blue-gray in ca. 1930, and a medium rose-cream in ca. 1940, matching the finishes applied in the east room. The doors have the same finish history as the door and window fascia. The sash were replaced post ca. 1940. The millwork in the west room was painted more frequently than the plaster walls and ceiling.

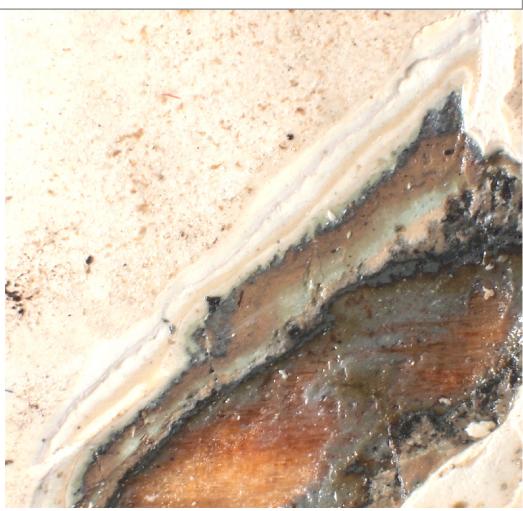
Micrograph of finishes applied to 493-2 interior west room closet door.

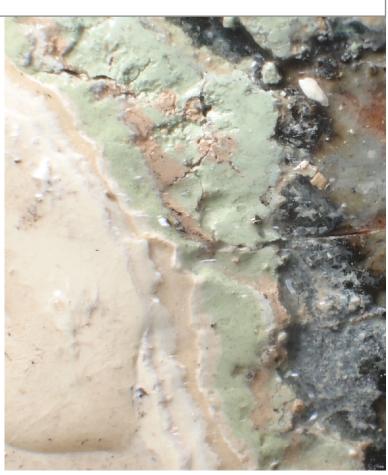
Micrograph of finishes applied to 493-2 interior west room baseboard.

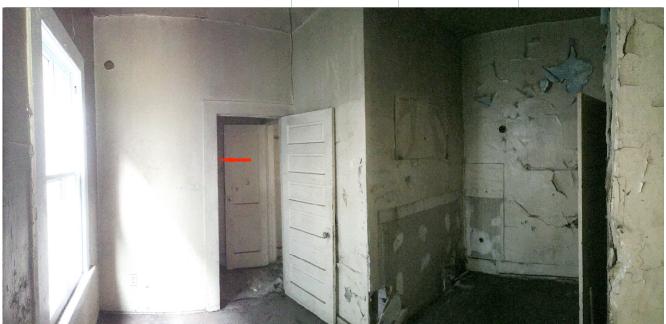
Chromochronology Work Sheet: MALU-493-2int-026 2 of 2 Sheets

Description	Munsell Notation	Munsell Collection	Surface Finish
Substrate	millwork			
1.	light blue-green - west alterations to west room, finish #6 on origina	1		
2.	medium tan			
3.	medium gray-rose			
4.	medium gray-rose			
5.	light rose-cream			
6.	medium yellow-green			
7.	cream			
8.	bright green			
9.	white			
10.	light yellow-tan			
11.	cream			
12.	cream			
13.	cream			
14.	white			
15.	white			
16.				
17.				
18.				
20.				
23.

Northwest view of unit #2's west room.

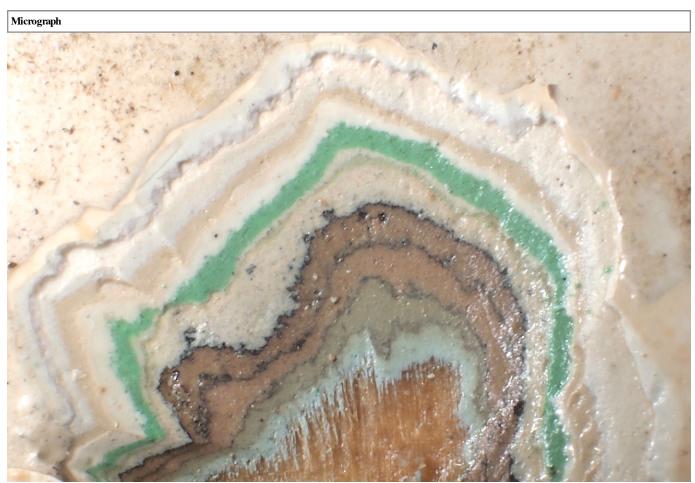
Micrograph of finishes applied to 493-2 interior west room west door fascia.

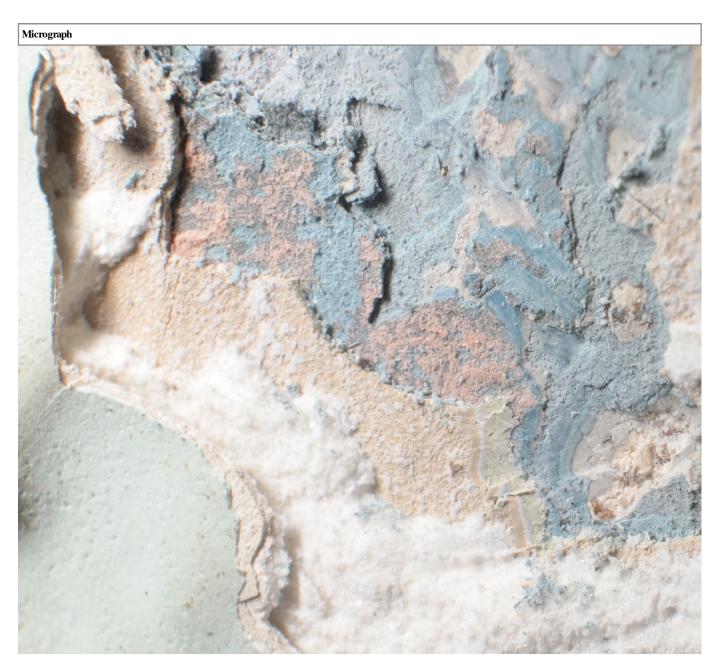
Micrograph of finishes applied to 493-2 interior east room wall plaster.

Observations: The plaster walls and ceilings in unit #2 were painted medium blue in ca. 1930 and in ca. 1940. The sequence of finishes on the ceiling follows those applied to the walls.

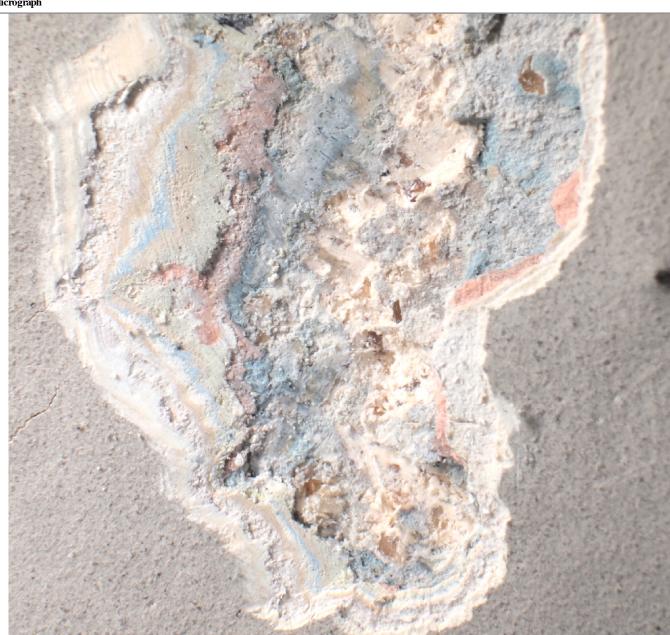
Micrograph of finishes applied to 493-2 interior east room ceiling plaster.

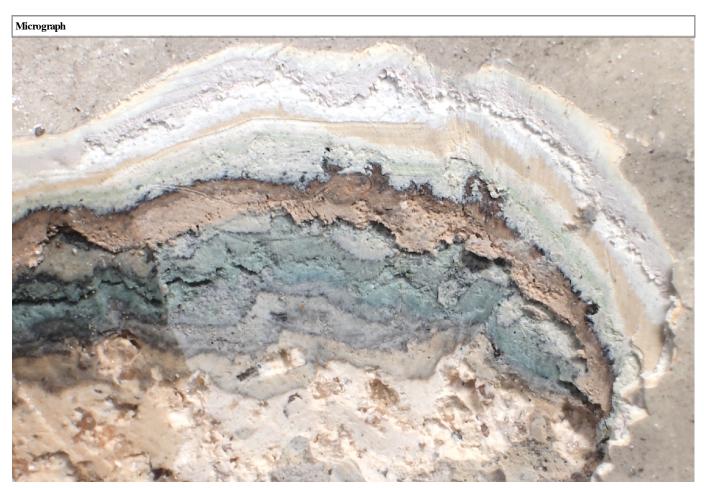
Micrograph of finishes applied to 493-2 interior west room wall plaster.

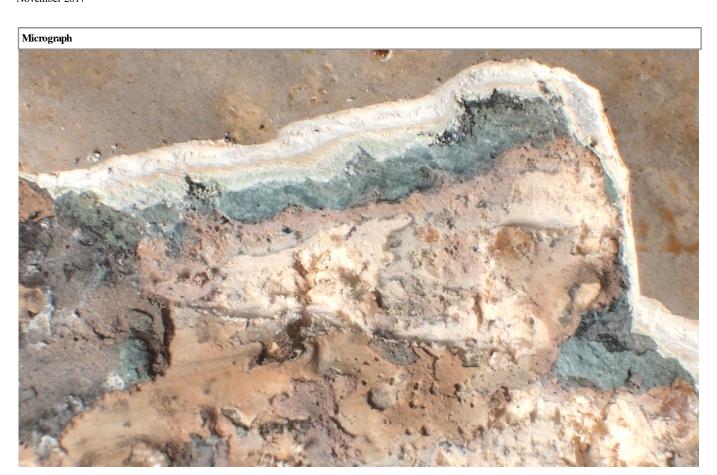
Micrograph of finishes applied to 493-2 interior west room ceiling plaster.
