**Historic Structures Report**

**Part III**

**Termite & Powder Post Beetle Treatment**

**Wick House**

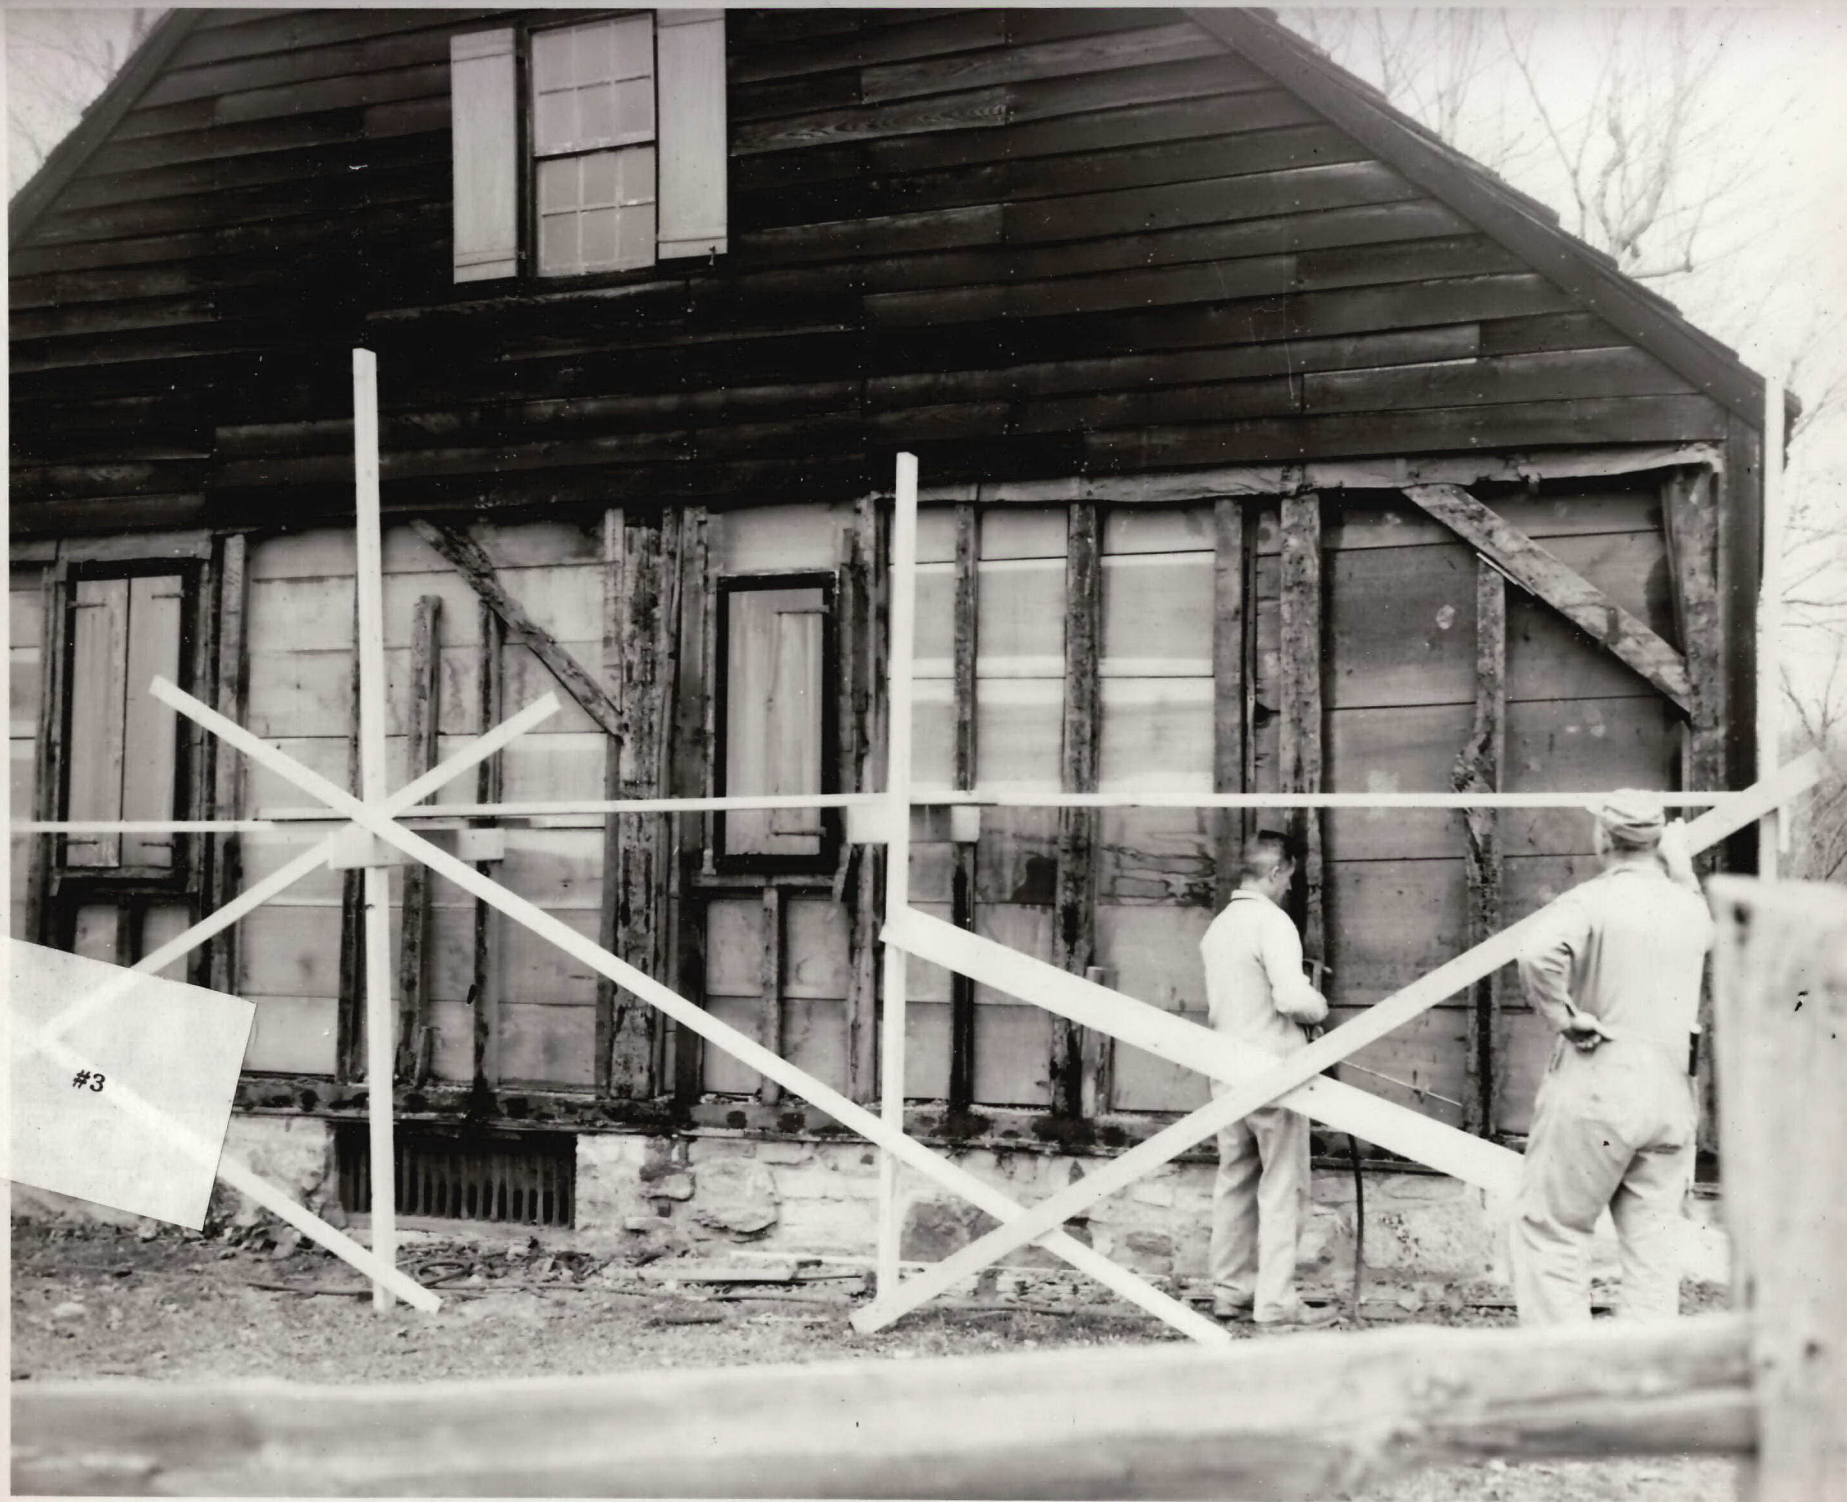
No new historical evidence was discovered during the project. However, structural decay was noted when the siding was removed from the house. Photograph #3, an overall picture of the south side of the house, shows deterioration of a number of structural members. Photographs #7, 8 and 9, give a close-up view of the condition of the structural members. What could not be photographed was the way the inside paneling was attached to the studs. Much of the paneling was not secure, or, where secured to the studs, the studs were so loose that sections of the paneling could be moved with only the slightest pressure applied to it. Minor repairs were made where possible by nailing paneling to studs.

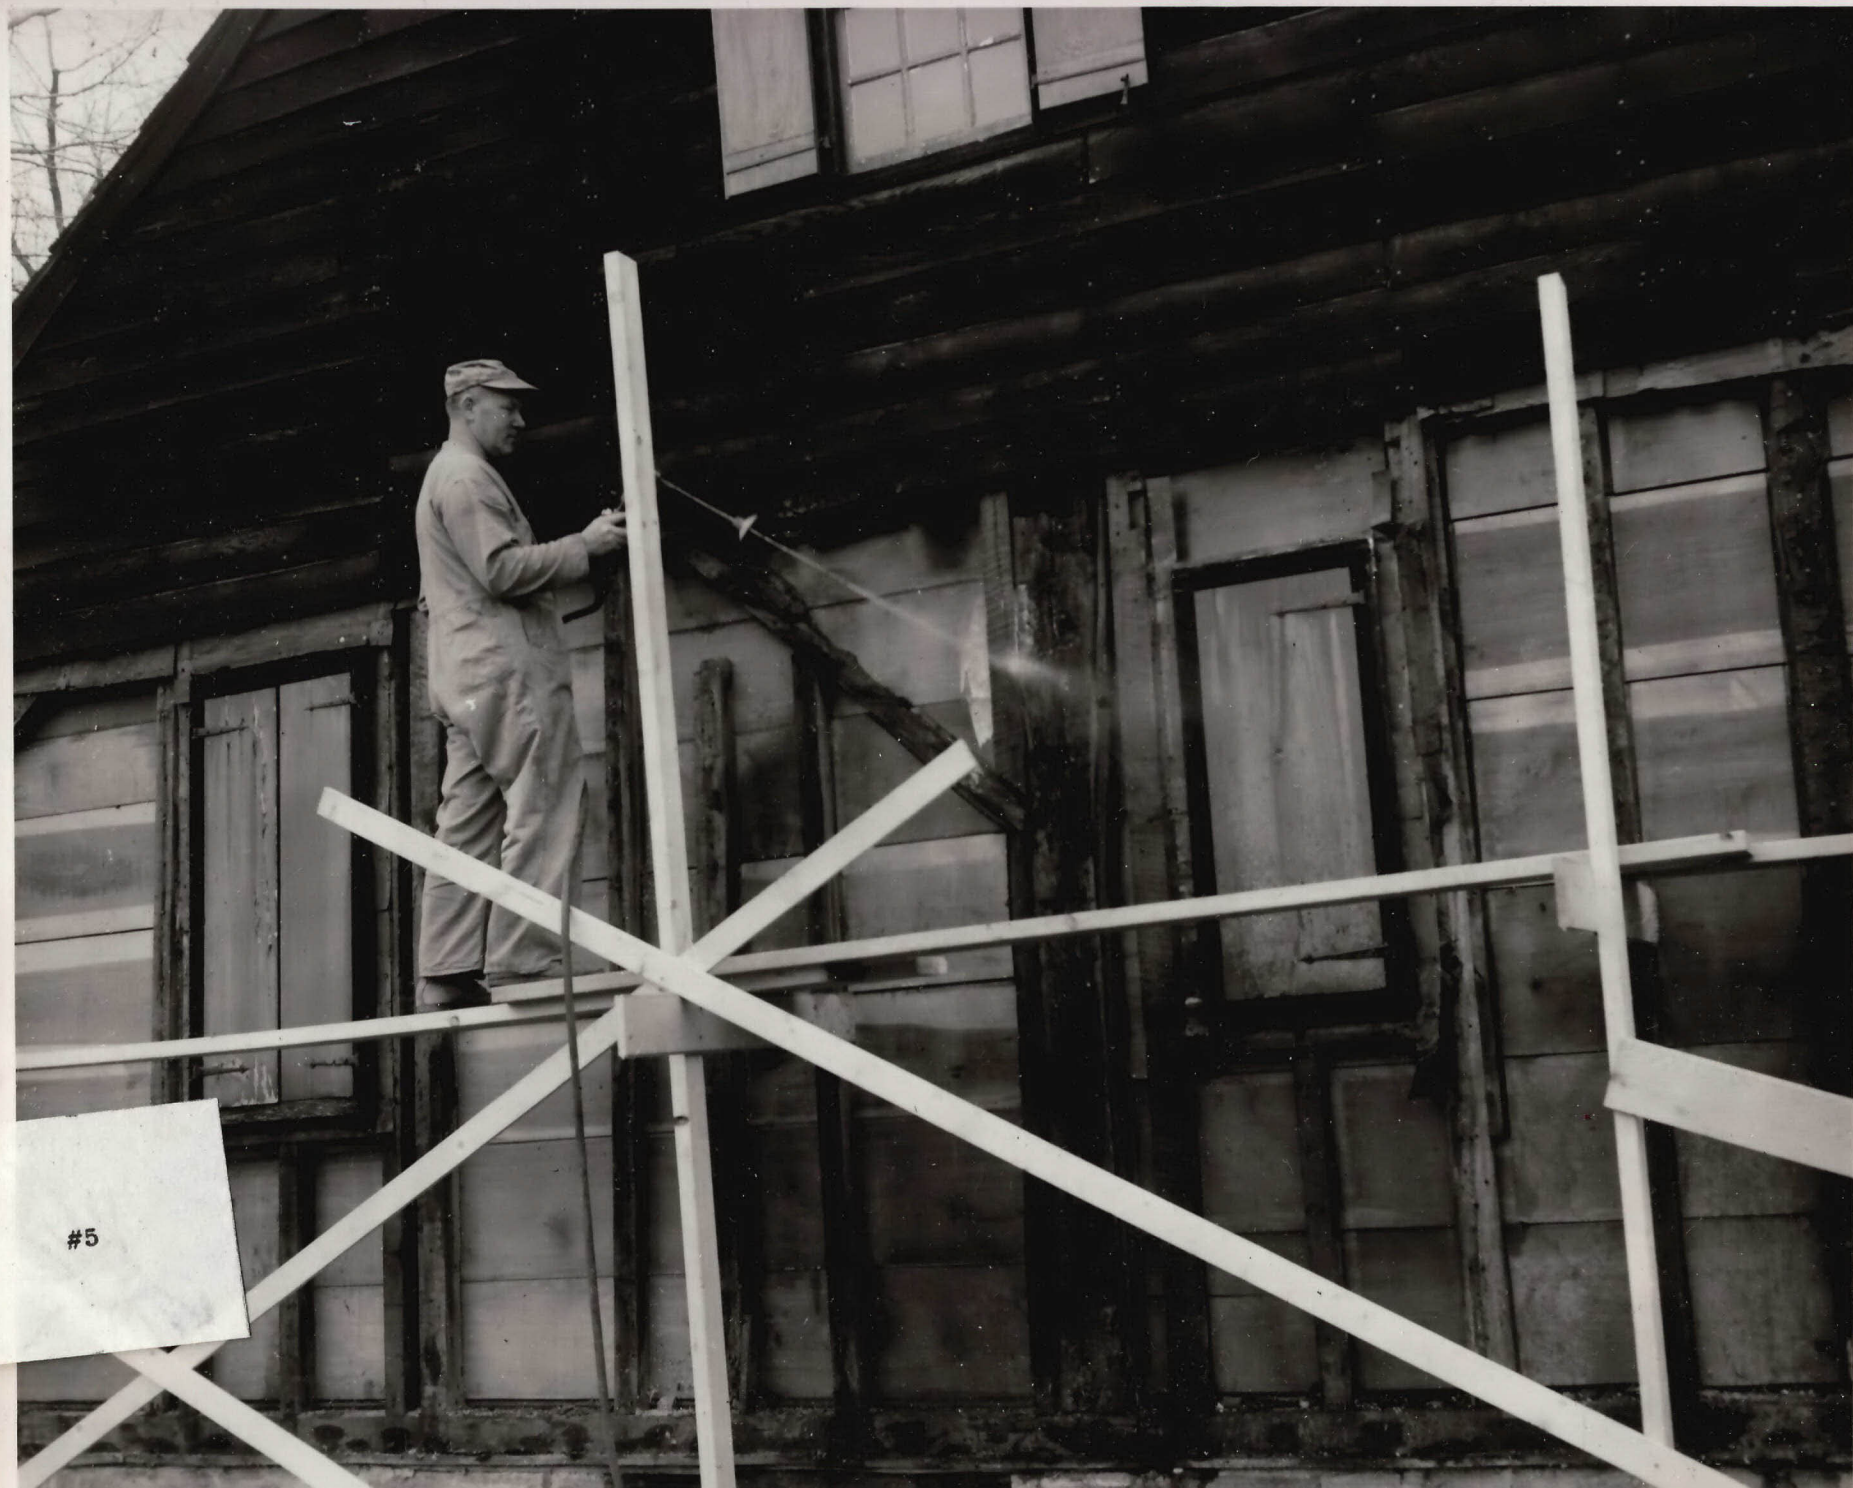
#4

After the siding or shingles and building paper was removed, the treatment was started. All structural members were drilled as per specifications listed in the purchase order and then the toxicant impregnated under 150-200 p.s.i. (photo #4). Upon

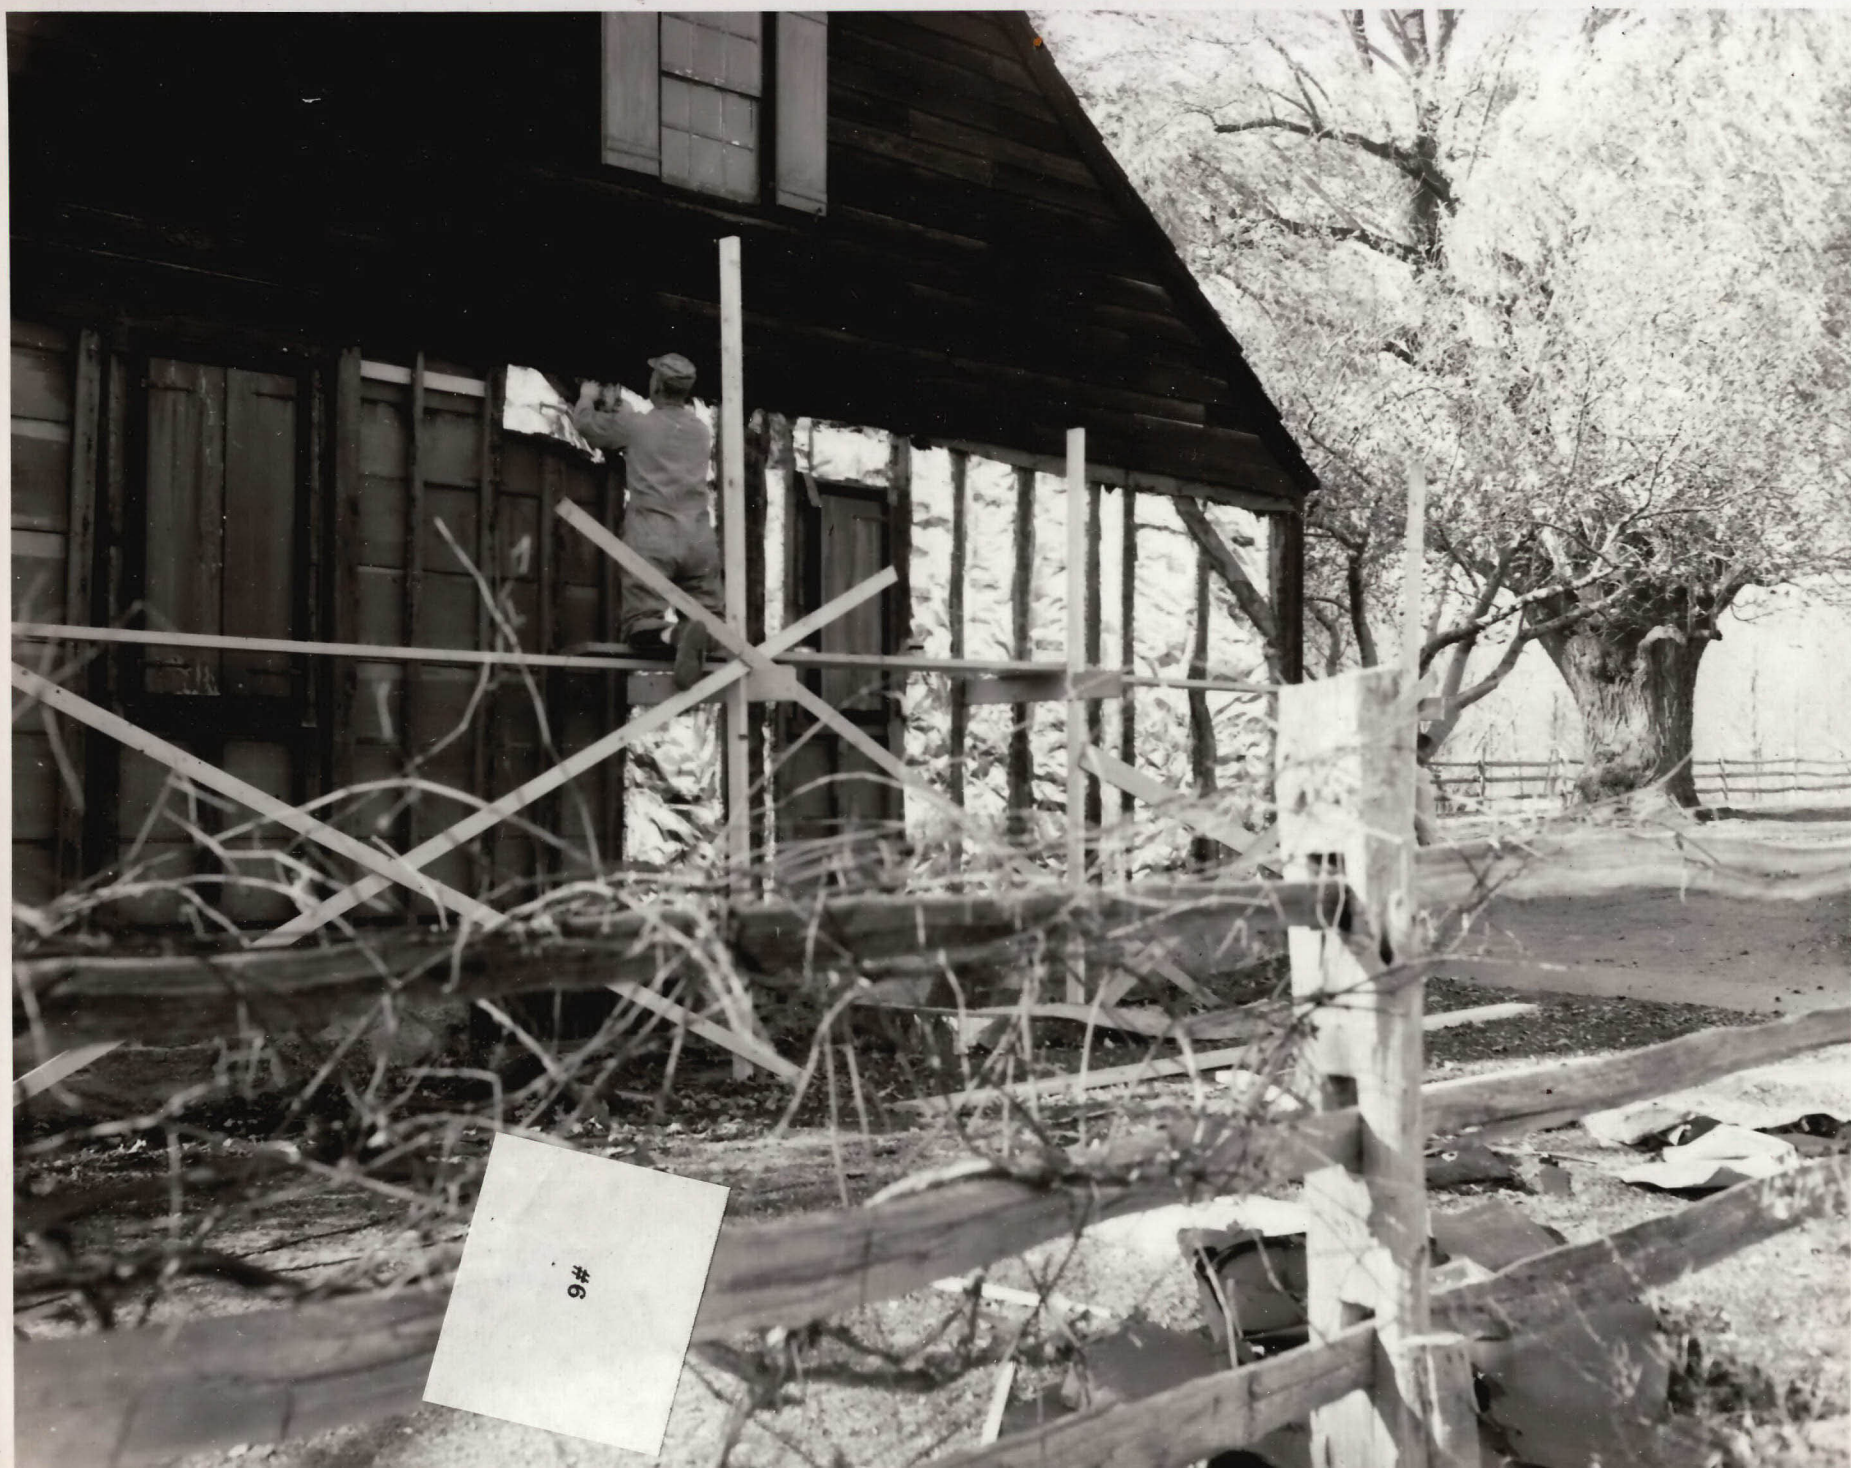
#5

completion of the impregnation of the structural members, all wood surfaces were then sprayed with the toxicant. (photo #5).

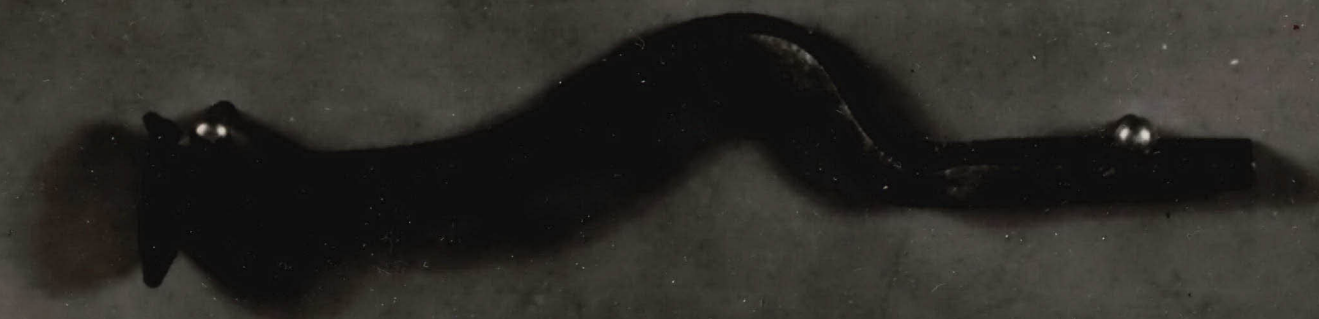
#10

The first part of the project was to remove the siding and shingles from the lower floor to expose the structural members. Difficulty was immediately encountered because of the shape of the nails used to secure the siding to the structural members.

(photo #10). This type nail was made by Mr. Strolley for this job. When the nails were pulled, the hole left in the siding was larger than a normal nail hole.

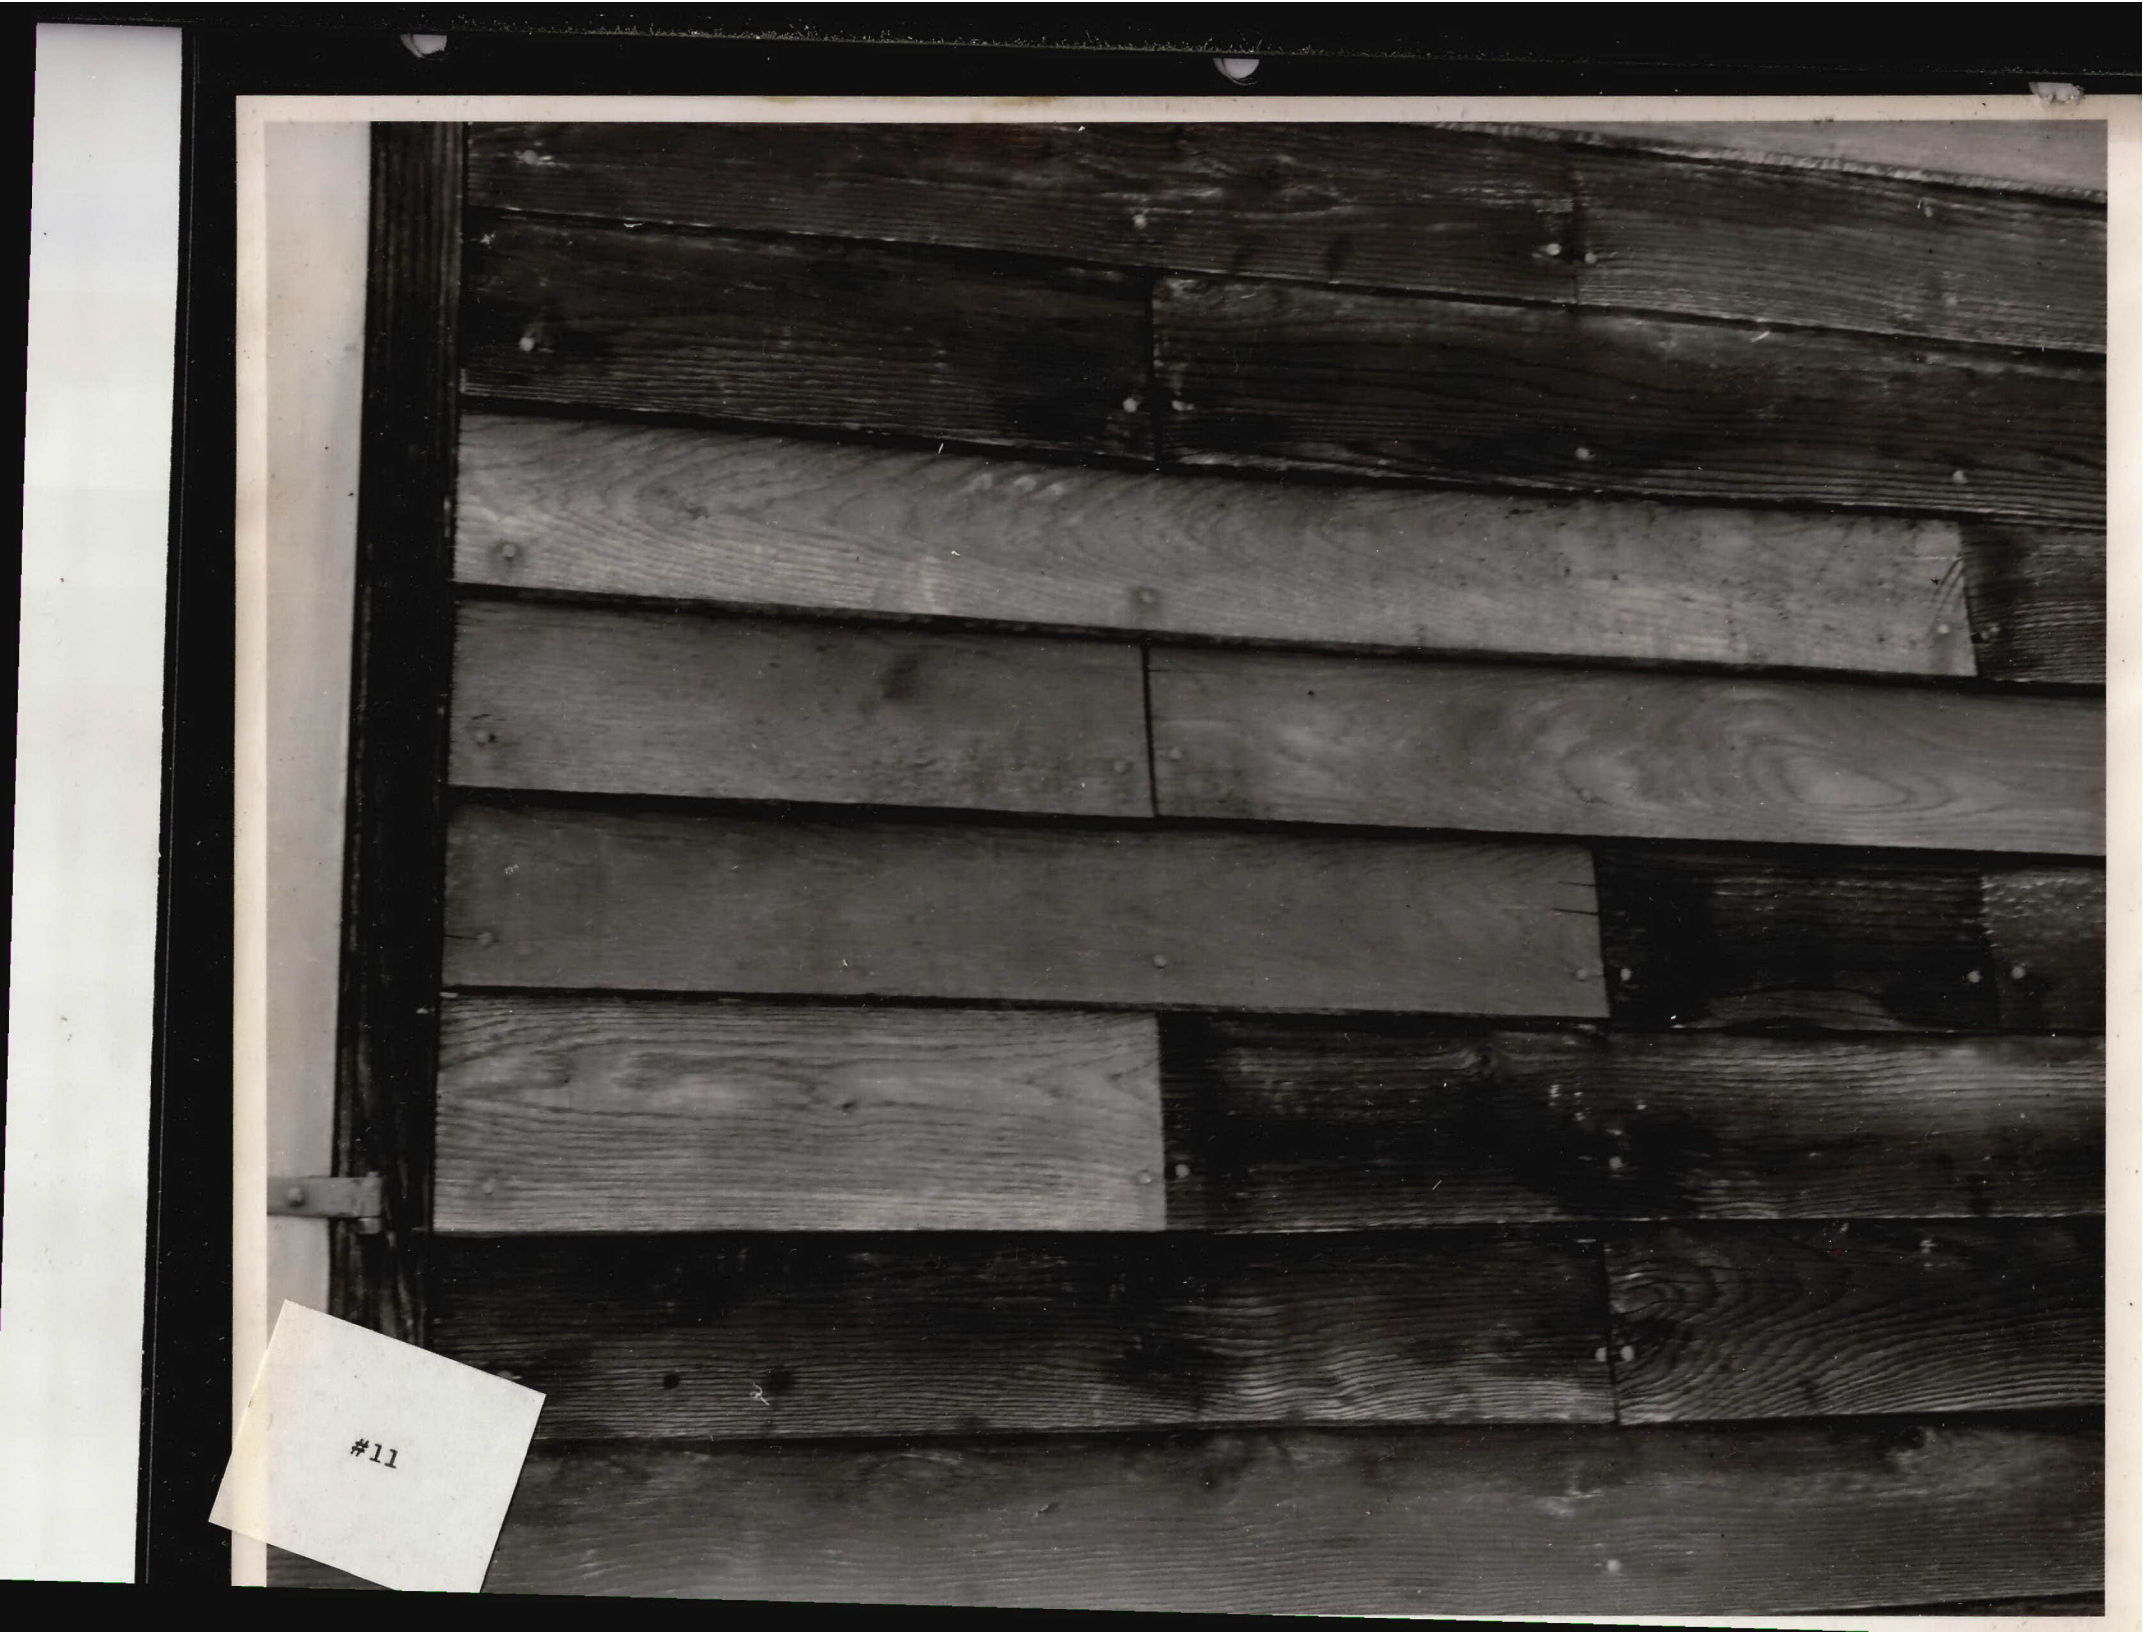
The new siding that was added to the south side of the house presented a more difficult problem because this is the side that is subject to the longest period of sunshine. A close-up view of the right side of the left window, (photo #11 & 12) shows the contrast in the siding. Photograph #11 was made immediately after the siding was installed. Approximately one month later, photograph #12 was made. Although still noticeable, the new siding is beginning to blend with the old.
