Restoration of Horseshoe Pond to a Coastal Lagoon/Tidal Estuary

Implementation Plan

POINT REYES NATIONAL SEASHORE
ONE BEAR VALLEY ROAD
POINT REYES STATION, CA
94956

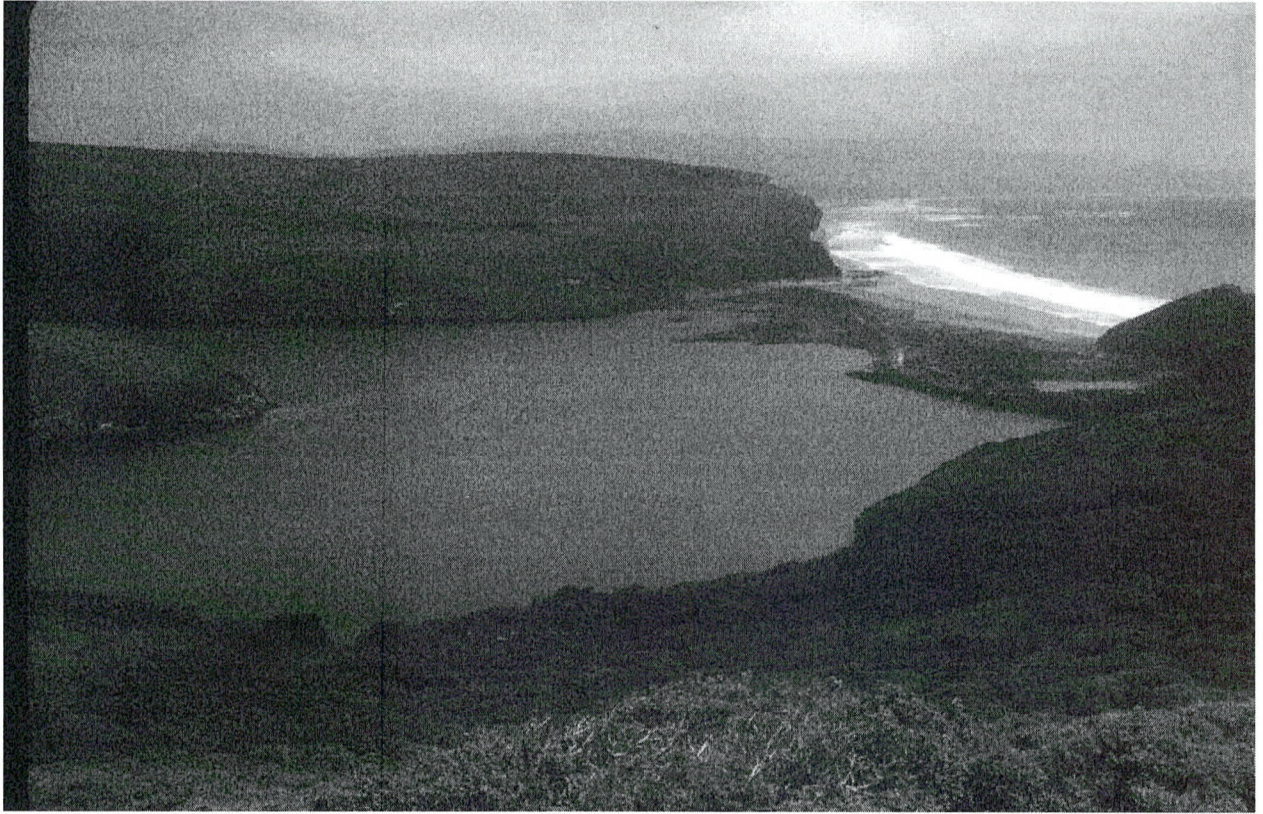
Figure 4. View looking towards the oceanside of Horseshoe Pond.

By 1974, the pond had reached its current observed water levels and the historic channel had almost completely filled with vegetation, presumably the same complex of saltgrass (*Distichilis spicata*) and rushes (*Juncus sp.*) present today (Figure 4). At some point prior to 1974, the culvert/bridge system was removed, perhaps due to failure, and the earthen berm sealed up completely with additional material from the quarry. The earthen dam existed in this state until the early 1980s. Storm events and high water levels in the pond began eroding the road and berm around the current outflow of the pond, such that by 1983 a significant portion of the dam had been lost and the remaining road up to the east pastures overlooking Drakes' Estero was only passable at low water. Severe storms in January 1982 may have accelerated this process.

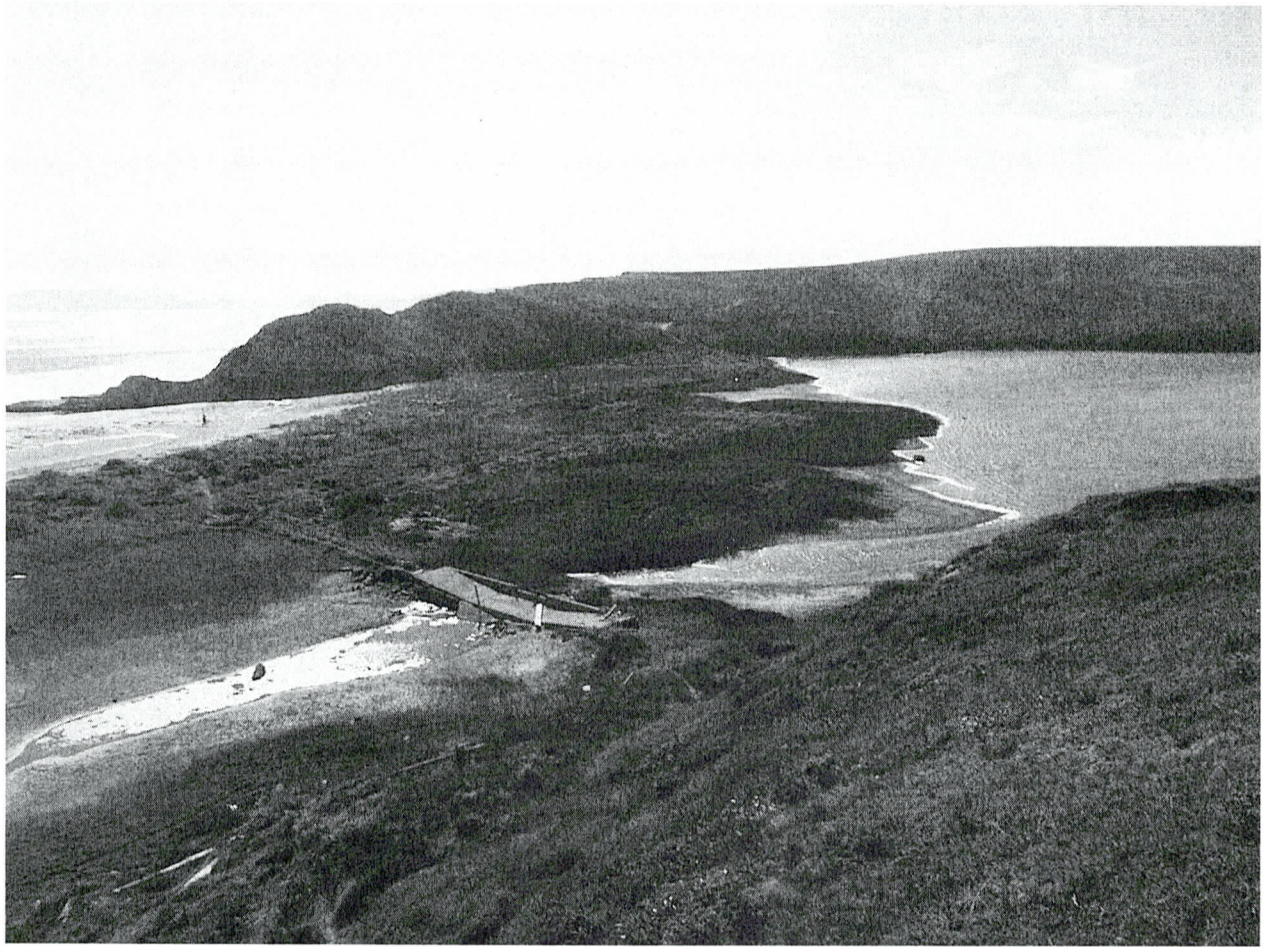
Figure 5. View of the concrete spillway in the southeast corner of Horseshoe Pond.

In 1988, the dairy operation received funding from the NRCS Agricultural Conservation Program to construct an alternate route to the east pastures (Figure 5). The existing 60-ft concrete spillway was built across the outflow of the pond in the east corner and reinforced with rip-rap. To allow vehicle passage, fill was taken from the adjacent slope and laid down on either side of the spillway, once again sealing off the pond to tidal exchange.

The road leading down from D-Ranch and across the front of Horseshoe Pond will access the concrete spillway and associated berm spanning the current outflow channel. Mechanized equipment might impact an area within 20-ft. of both sides of the spillway, a total of approximately 0.27-acres. The dimensions of the concrete spillway are 60-ft.x12-ft.x3-ft. The concrete spillway will be broken up and completely removed from the site, including all reinforcing rip-rap material. Remnants of the spillway will be stockpiled behind the dairy barns at the D-Ranch facility prior to transfer to a local landfill.

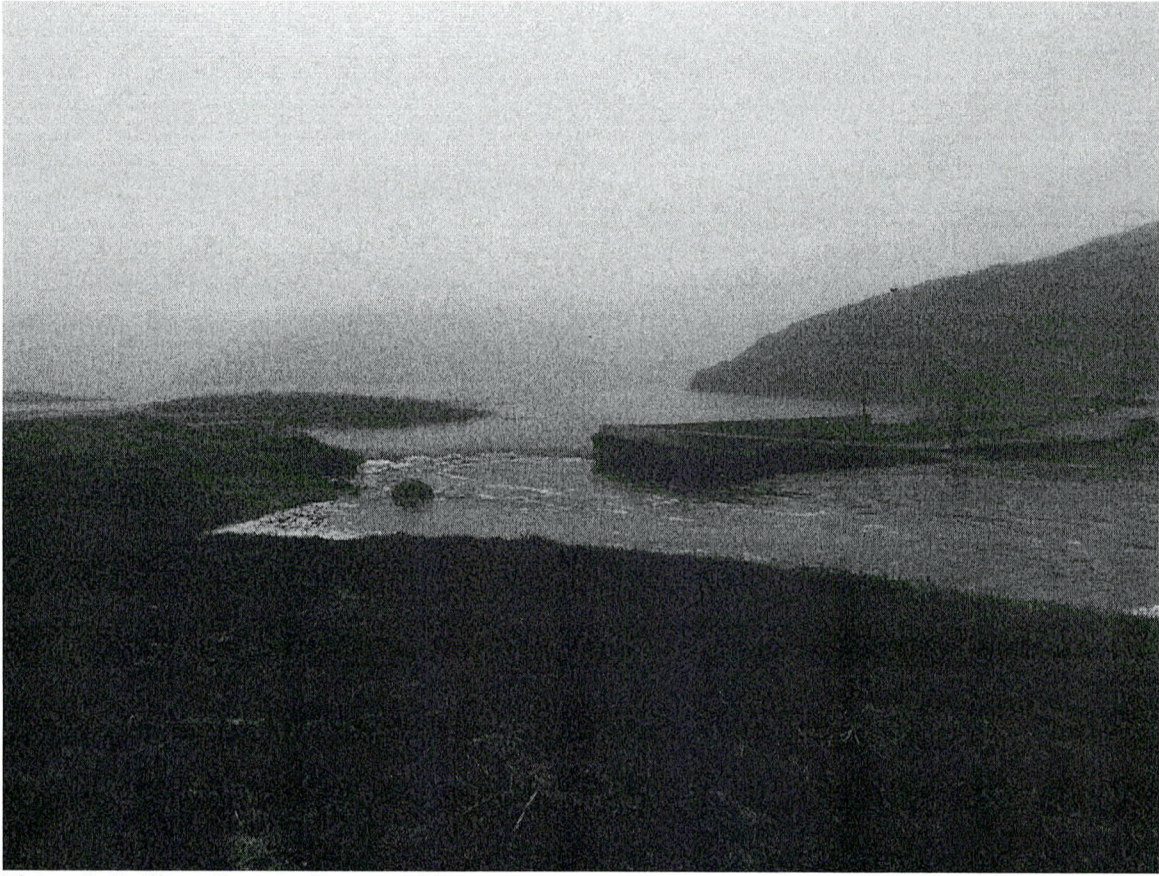
Figure 6. Spillway Breach - January 2002.

The special use permit under which the D Ranch operated was terminated in 1998, effectively closing the dairy operation. All dairy cows were subsequently removed from the project site and surrounding watershed. The earthen dam and concrete spillway remain in place, although a 15-ft section of material adjacent to the concrete spillway washed out in January 2002 (Figure 6). Ocean water now flows into Horseshoe Pond through a constricted opening during extreme high tide and storm events. In the summer 2002, the dam effectively cut off tidal action, and the lowered water level due to the dam breach in January 2002 resulted in the drying of Horseshoe Pond.
