ROCK CREEK WATERSHED CONSERVATION STUDY

ROCK CREEK PARK
WASHINGTON D.C.

UNITED STATES DEPARTMENT OF THE INTERIOR
NATIONAL PARK SERVICE
NATIONAL CAPITAL REGION
ROCK CREEK PARK

CH2M HILL
W12124.A0

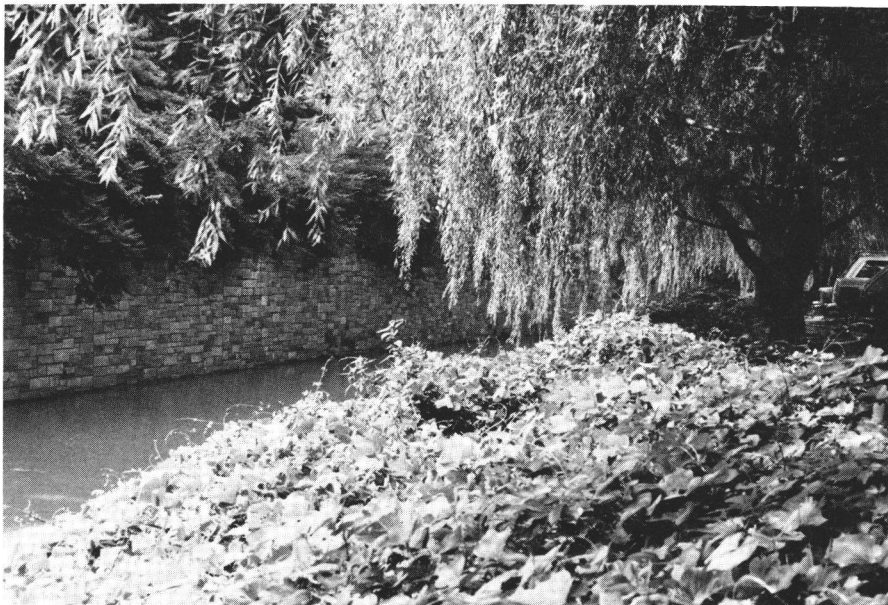
Figure 6-6 Retaining Wall Along Rock Creek
at the National Zoo

Rigid linings are concrete or stone walls which are built as a continuous, rigid unit to protect the natural bank. These structures are ideal where space does not permit the construction of a more natural protection. There are several drawbacks of rigid linings which tend to bias a designer toward flexible linings. Rigid linings usually have a much smoother surface than the natural banks, which allows higher velocities during floods. These higher velocities tend to scour the toe of the structure, undermining the foundation. When flaws or breaks develop in a rigid lining, it is a major project to make repairs, whereas the flexible lining lends itself more to small-scale repair. One of the rigid linings currently in place along Rock Creek near the National Zoo is shown in Figure 6-6.

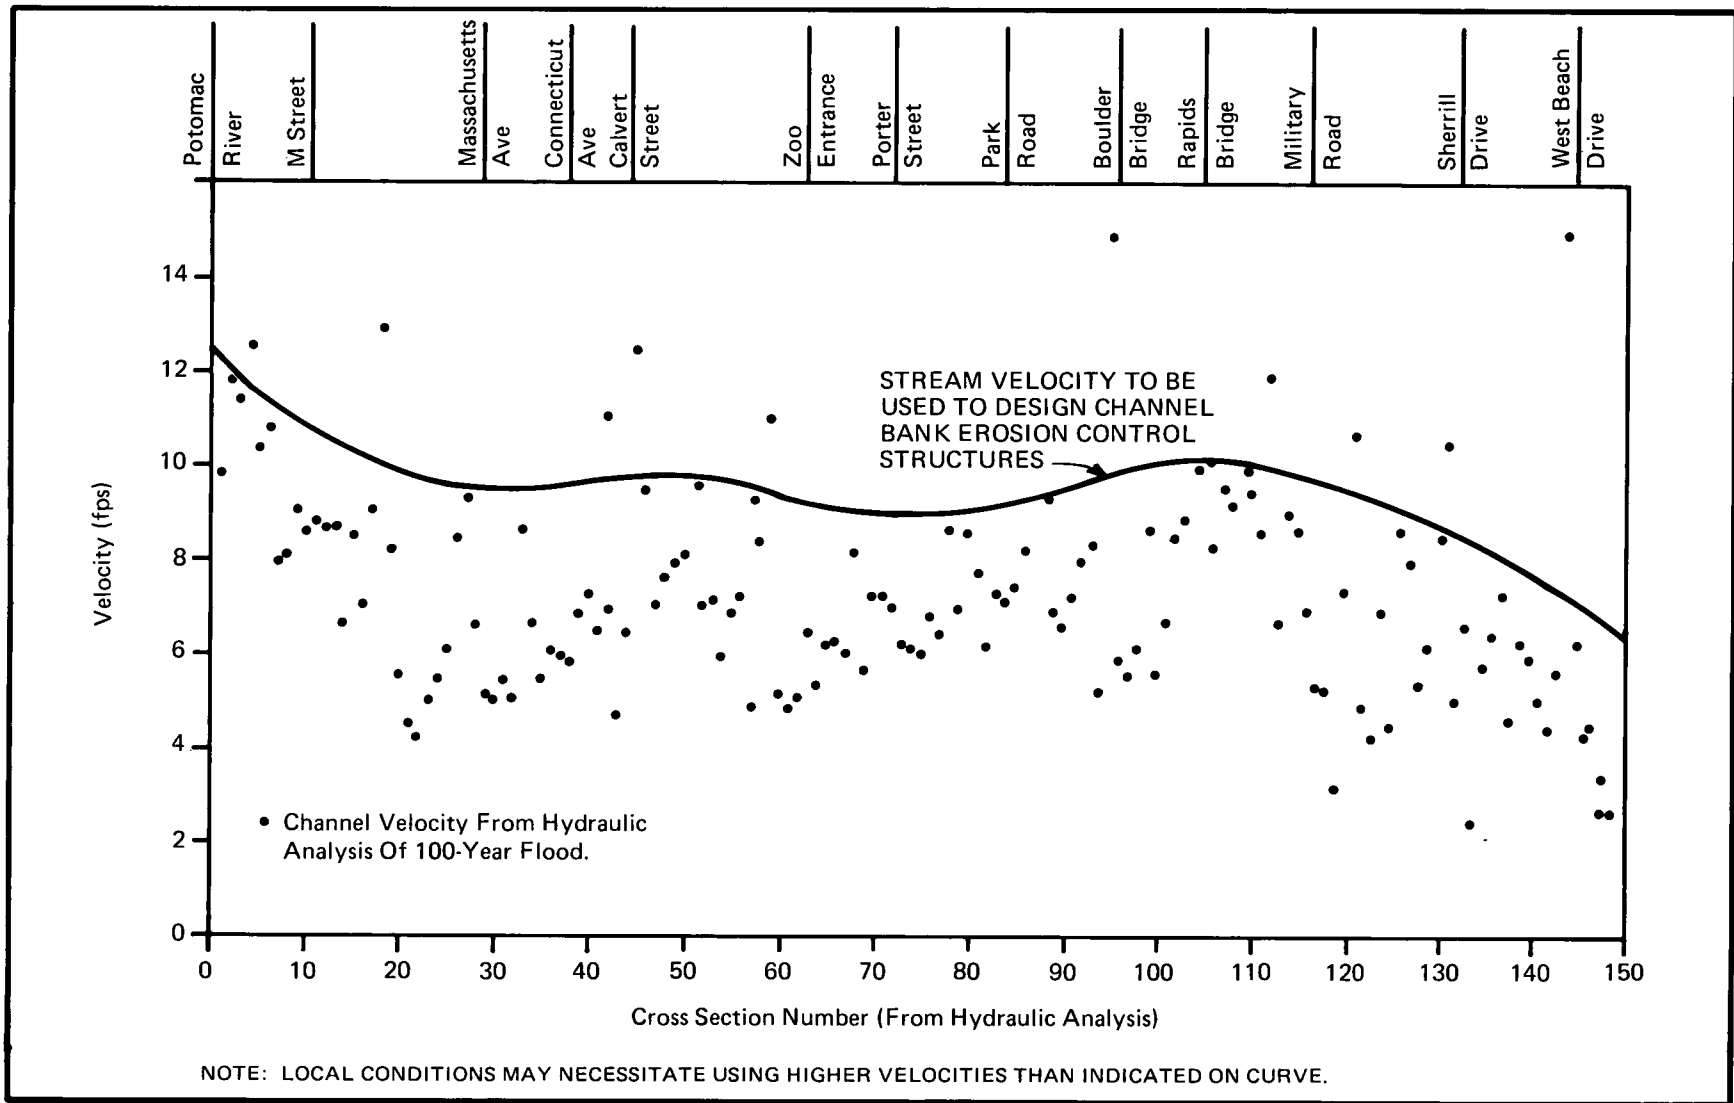
FIGURE 7-1: Stream Velocities for the Design of Stream Bank Protection Works

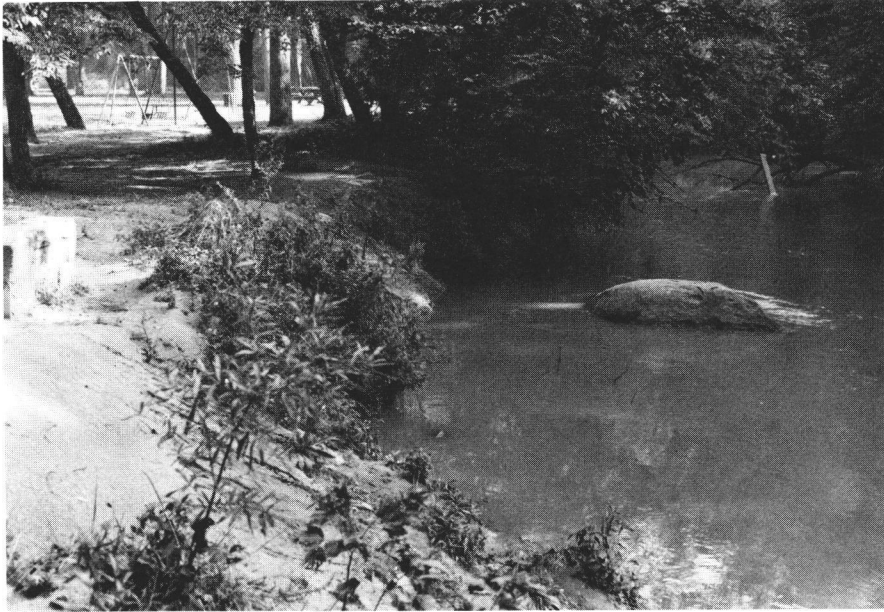
Figure 7-5 Stream Bank in Picnic Grove

As far as the channel banks are concerned, they should be allowed to widen and should be graded and vegetated at the new location. Since it has been the policy to push the channel back to its original location following a large flood, the present channel should be widened by

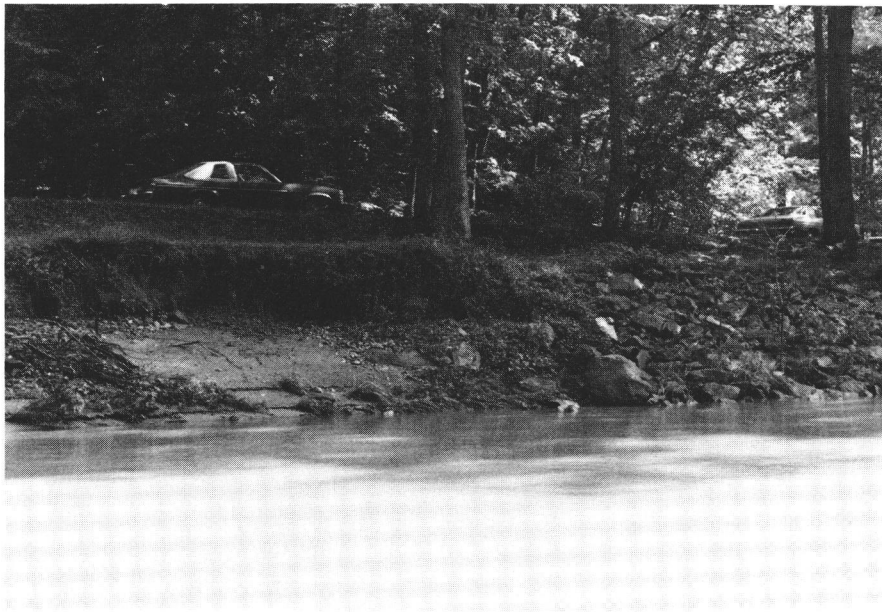
Figure 7-6 Inadequate Riprap Along Beach Drive

Due to the tendency of the Rock Creek channel to widen with the higher flows in recent years, the roadways in the flood plain are being threatened by the advancing erosion on the unprotected banks. Figure 5-1 shows the locations of this type of problem. In some of the areas shown, some protection is provided by riprap but, in general, this has proven inadequate. An example of inadequate riprap along Beach Drive is shown in Figure 7-6.

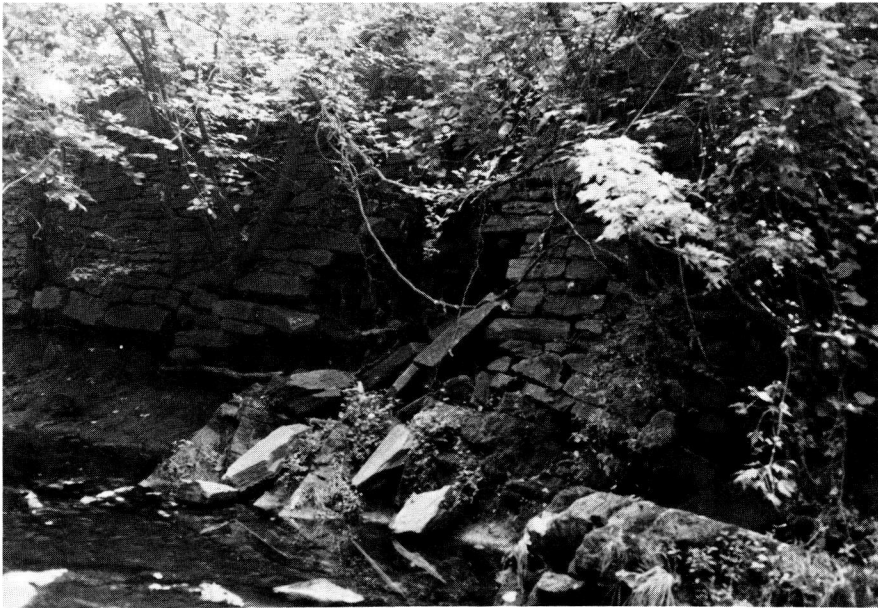
Figure 7-7 Retaining Wall Along Piney Branch

Piney Branch Parkway. Along Piney Branch, the retaining wall which protects Piney Branch Parkway has been badly undercut and is in serious peril. Large trees have grown among the rocks, further disrupting the effectiveness. This wall should be inspected by someone knowledgeable about the structural integrity of such walls, and the necessary repairs should be made. Figure 7-7 shows the condition of the wall.

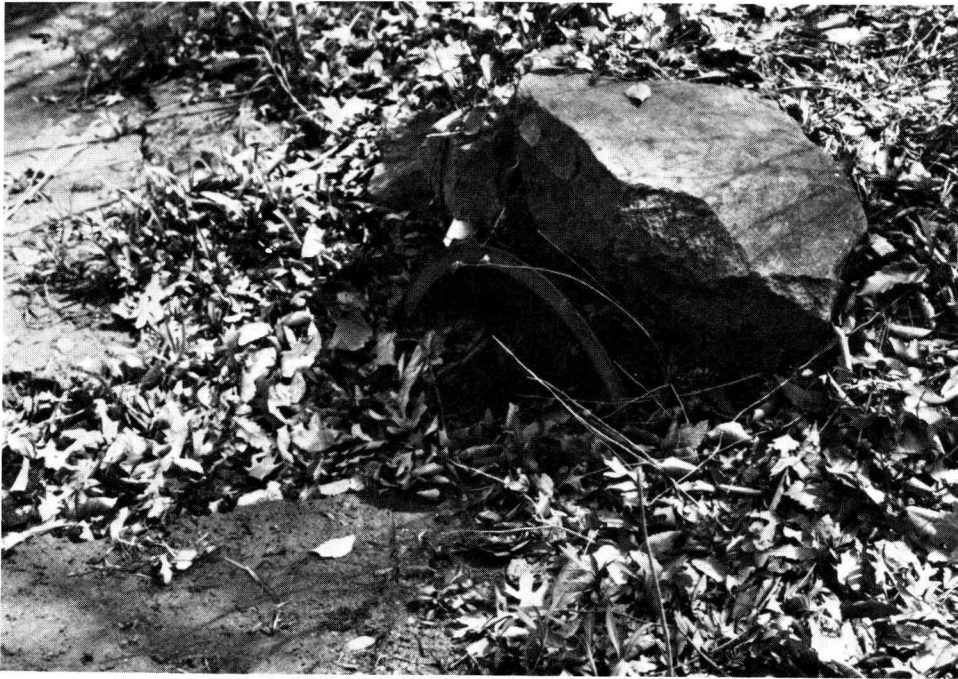
Figure 7-8 Culvert Choked by Leaves

Another form of bank erosion comes from culverts which discharge along or even at the top of the bank of streams. The concentrated flow cuts deep ravines down the bank as it rushes to the channel. An example of this condition is illustrated in Figure 7-10. This problem can be avoided by proper design of the culverts which will carry the water all the way to the stream. This may include extending the culvert to the mean water line, providing a non-erodible path down the bank, or dissipating the erosive energy by a stilling pond, kinetic energy dissipator, or flow dispersion. This type of bank erosion

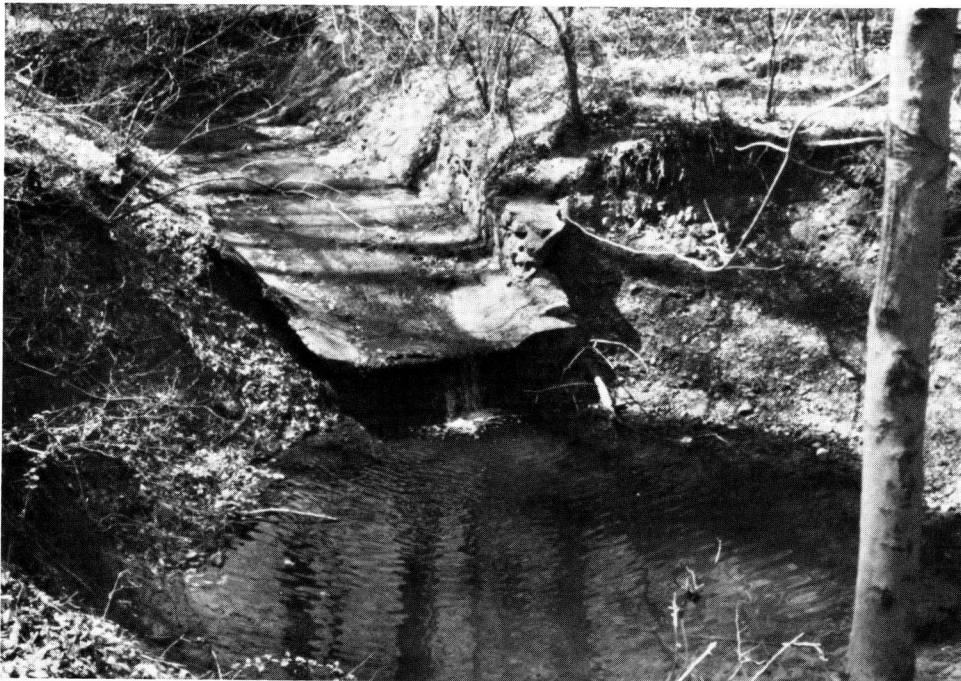
Figure 7-12 Scour at End of Concrete Apron

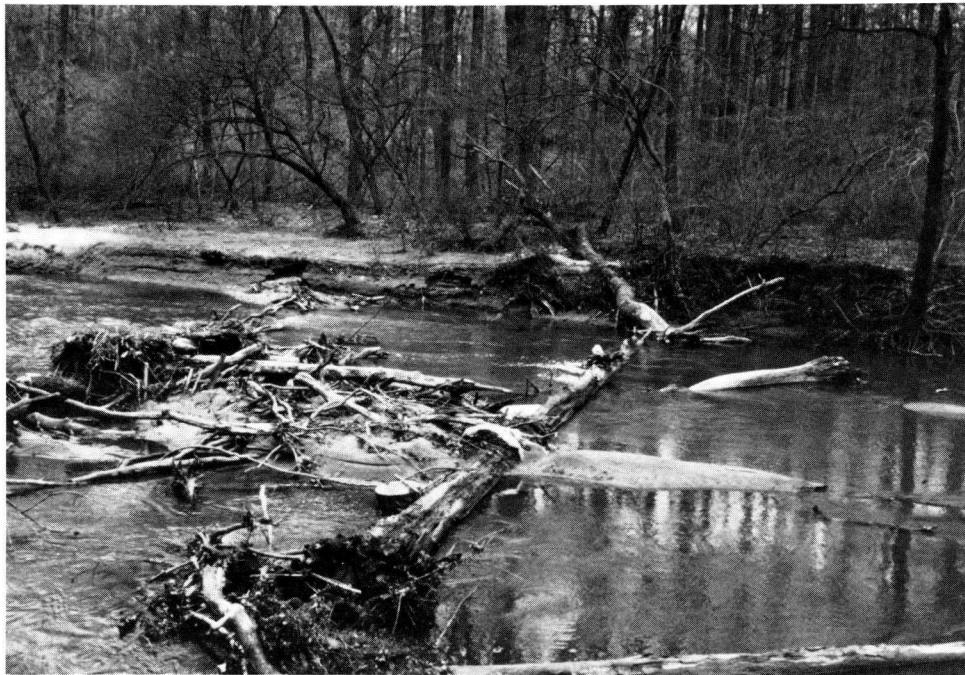
Figure 7-13 Debris and Siltation in Rock Creek Channel

Large obstacles blocking bridge openings or the channel of Rock Creek are more difficult to control. Large trees in the channel can be beneficial in localized control of erosion by slowing velocities and detaining floodwaters. However, logs left in the stream channel will cause siltation and channel aggradation as depicted in Figure 7-13. Such accumulations of debris and sediment reduce channel capacity, cause backwater problems, raise flood elevations, and promote downstream erosion. In addition, siltation at these locations destroys fish habitat. Problems arise when the downed trees float downstream during high water and become lodged where they can perform damage. Even trees which were standing at the start of a storm can fall or break off during storms, so merely clearing the downed trees in dry weather is not enough protection. There are also detrimental impacts to the practice of clearing and snagging of the stream channel. Pools that form at blockages and decaying detritus provide aquatic habitat and a food source that would be eliminated. Extensive clearing of streambank vegetation would raise water temperature. Fish behavior, territoriality and spawning could be impacted by clearing and snagging.

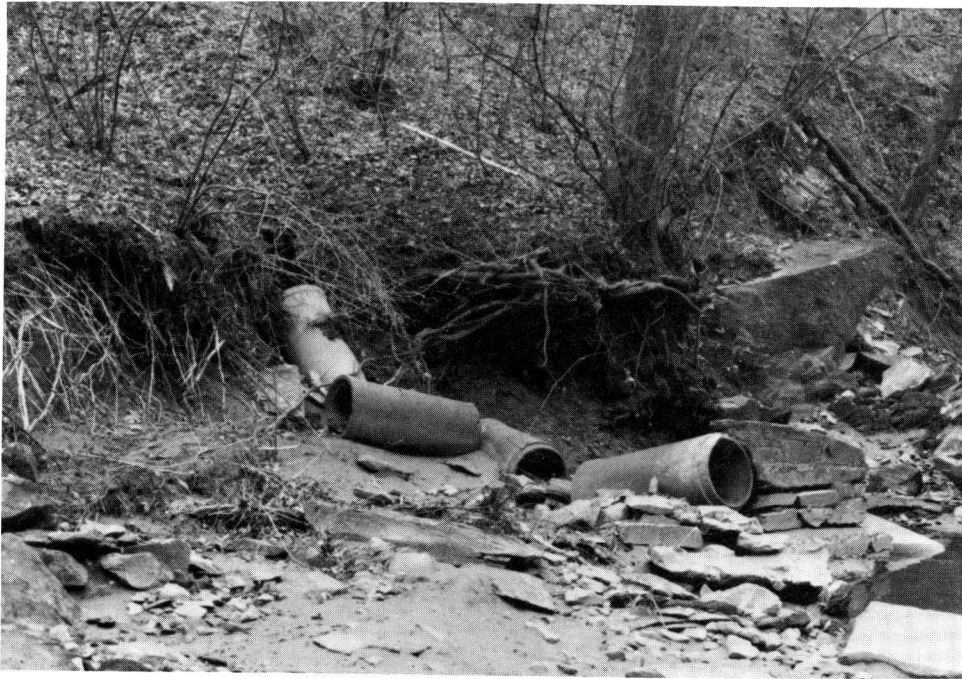
Figure 7-14 Damaged Storm Sewer and Headwall on Rock Creek

An additional source of debris is that created by erosion and damage to storm sewer outfalls. Widening and meandering of the channel has undermined and/or exposed outfalls and sewer lines in numerous areas (see Figures 7-14, 7-15, and 7-16) along Rock Creek and its tributaries. As a result, pipes, culverts, and headwalls are frequently found in the middle of the stream. There is an obvious lack of maintenance at these structures that result in collapse and cause additional erosion along the bank.

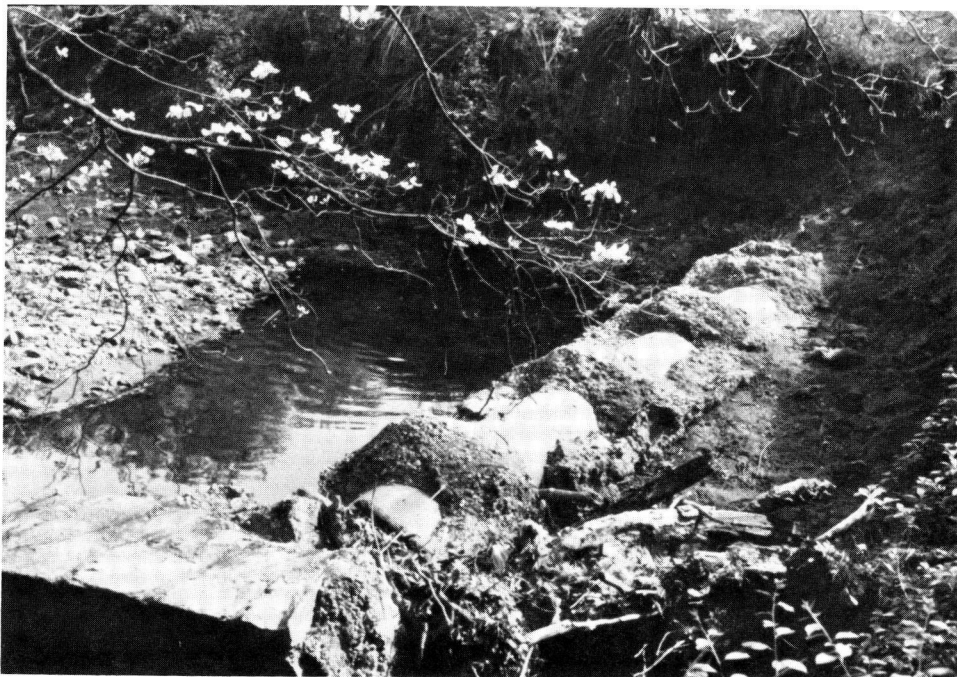
Figure 7-15 Erosion Exposes Sewer Line on Fenwick Branch

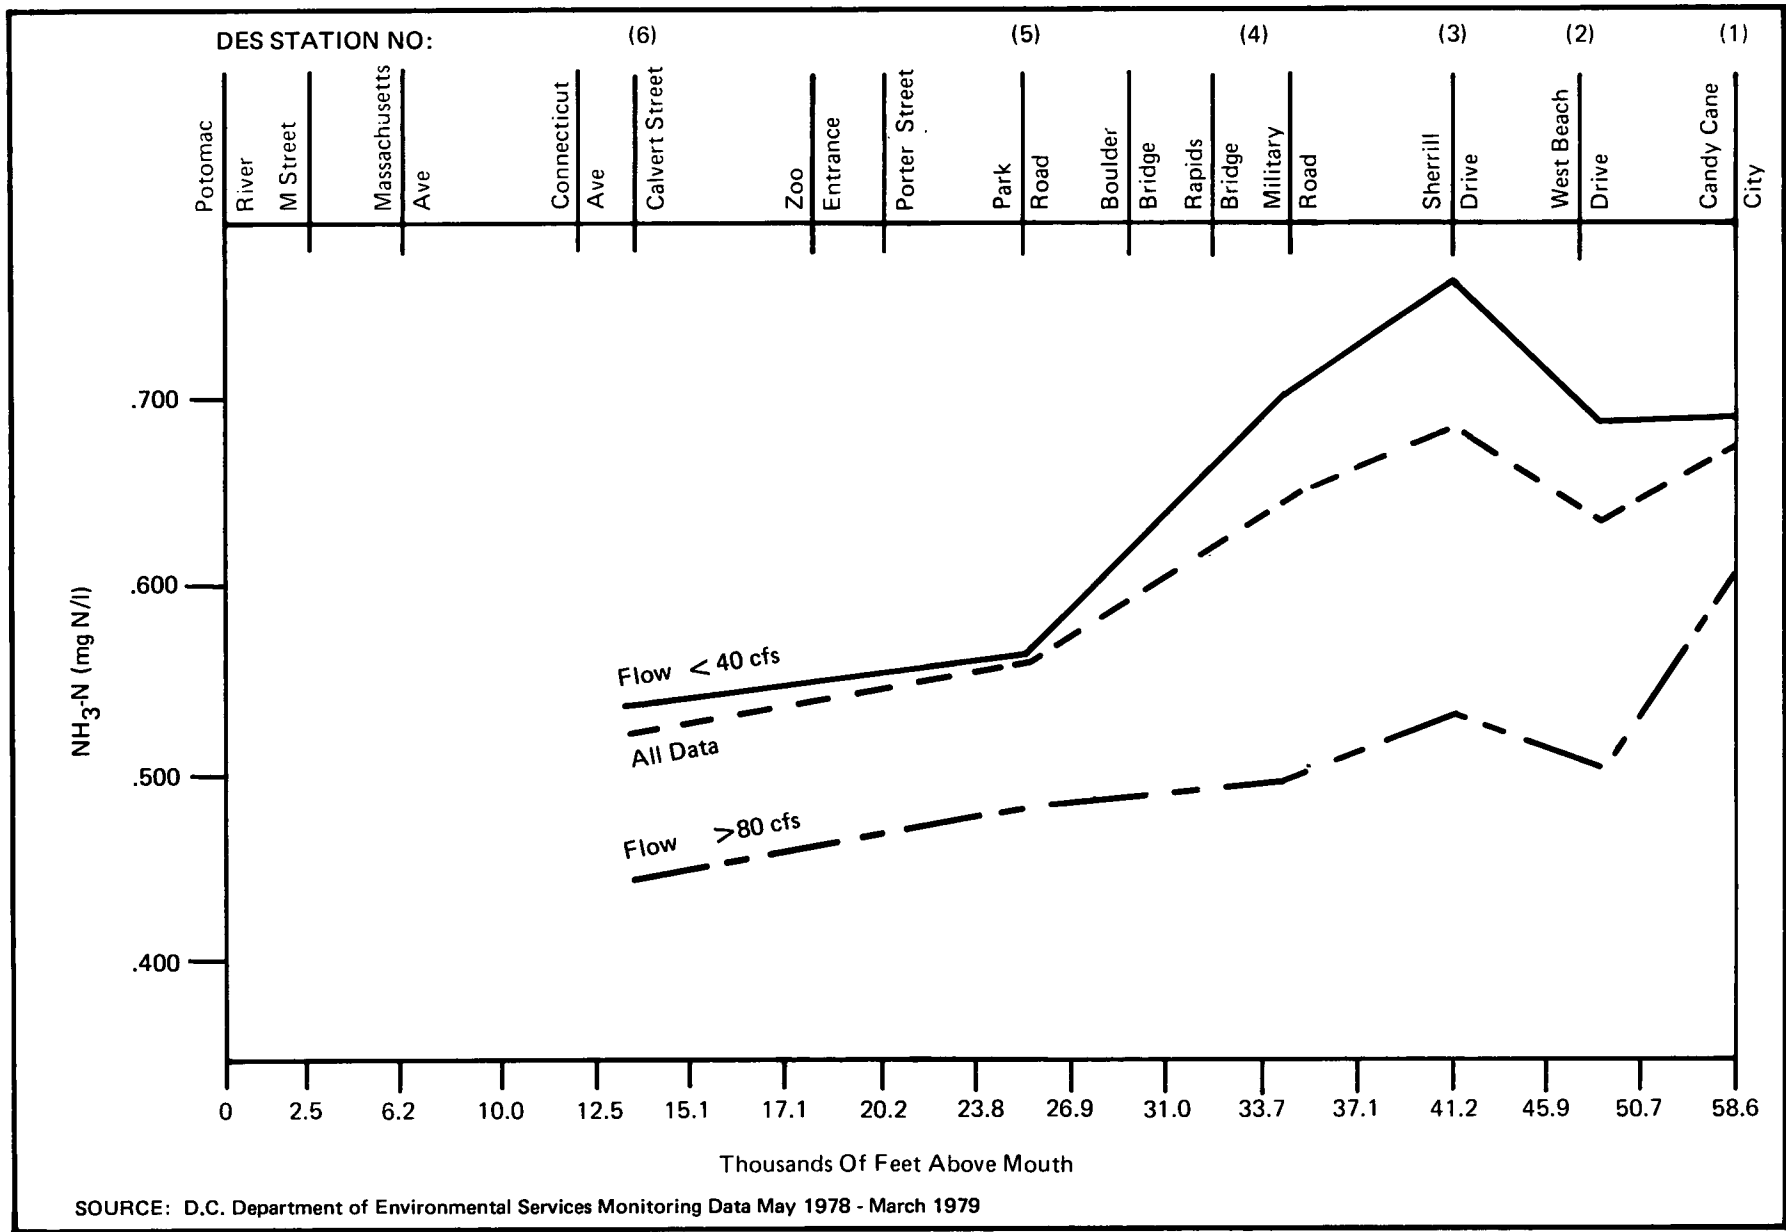
FIGURE 8-8 Stream Profiles of Ammonia Nitrogen Concentration

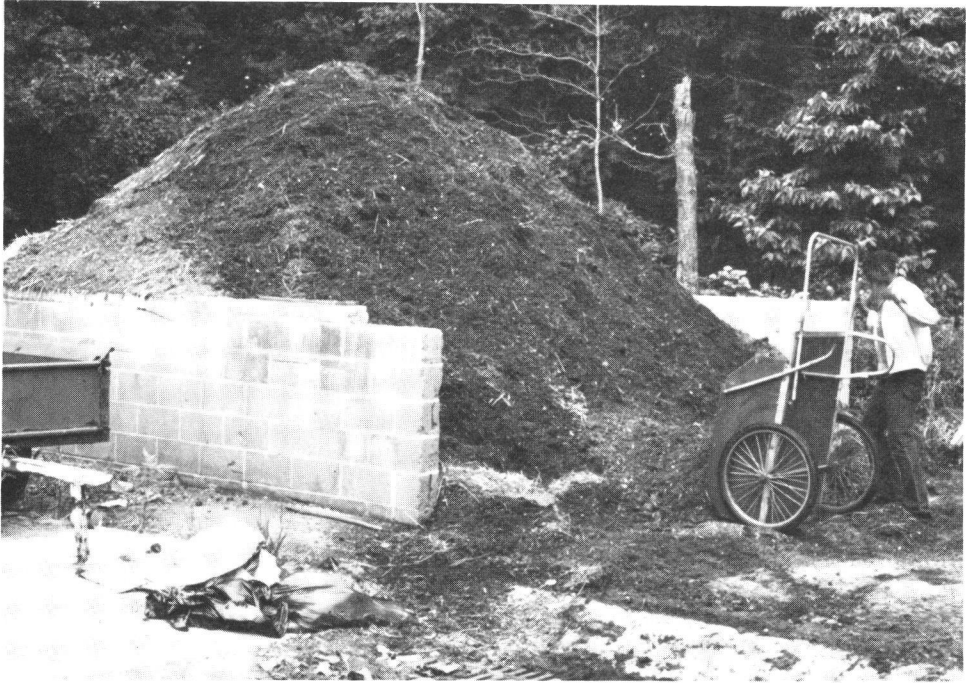
Figure 8-15. Horse Manure Pit and Storm Drain
