Transportation Study Rock Creek Park, Washington, D.C.

United States Department of the Interior National Park Service Denver Service Center

A/E Contract No. 1443 CX2000-96-013 Task Order No. 01

March, 1997

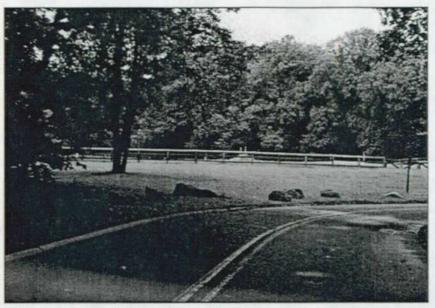
The large rocks on the shoulder of this curve on Glover Road are effective deterants to parking but are also significant roadside objects. They will compound the severity of any run-off-the-road incidents at this location. The rocks should be removed and replaced with conventional no parking signs.

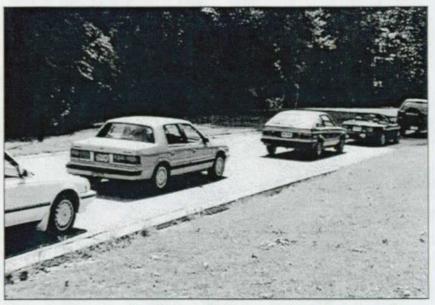
Notice that the elevation of the shoulder area behind the curb on this section of Beach Drive is 4-6-inches lower than the adjacent curb. This condition can compound the severity of a run-off-the-road accident due to the grade change.

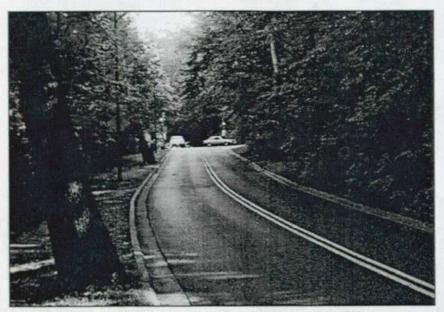
These two trees on the west side of Beach Drive south of Tilden are located immediately behind the curb line. Both trees show evidence of vehicle impacts.

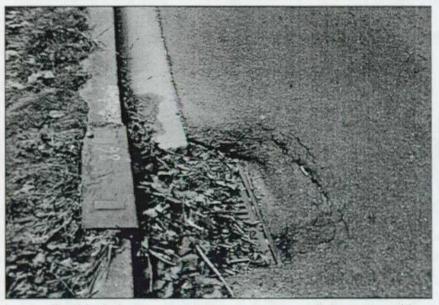
Leaves that block drainage grates are a common maintenance problem throughout the park. This condition can cause localized flooding during heavy rain showers.

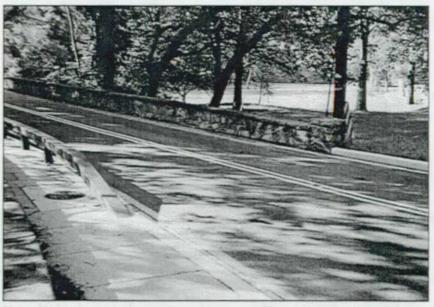
This photo of the west end of the bridge on Tilden Street shows two bridge end treatments used in the Park. The stone guidewall on the far side of the street is vertical and appropriately accompanied by a black and yellow object marker. The steel guardrail on the near side of this street is rolled down. Tilden Street and this bridge are under the jurisdiction of the DC DPW.

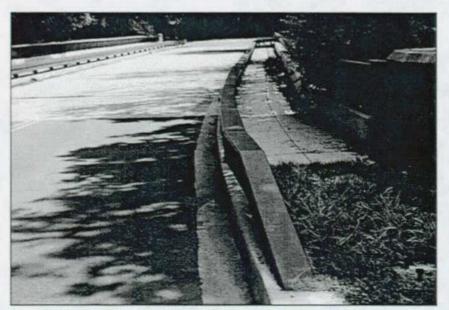
The steel guardrail on the Klingle Road bridge is located directly over the inside edge of the curb. The rail shows evidence of vehicle scrapes. Silver reflectors mounted on the face of this rail would help identify it for drivers at night. This bridge is under the jurisdiction of the DC DPW.

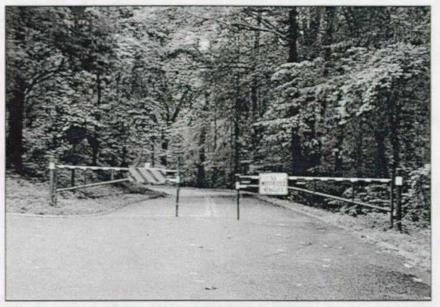
The Park uses gates like this one for temporary road closures. The supports and gate structure are well designed and appropriate for the conditions. The object marker signs on the gates should be red and white striped instead of yellow and black. Two of these object marker signs should be presented.

The mounting posts for the permanent gates are appropriately offset from the road, and the steel gates seem structurally sound. The signing on the gates and advance warning signing, however, is not standard. Many of the flashing lights mounted on the steel gates are not functional and need maintenance. The gates do have reflective signs and tape to help identify them during low-light conditions. Several of these permanent gates show evidence of low speed vehicle impacts. Advance warning should be provided for these gates through the use of hinged signs. **FIGURE 2-7** shows an appropriate signing treatment for this type of gate.

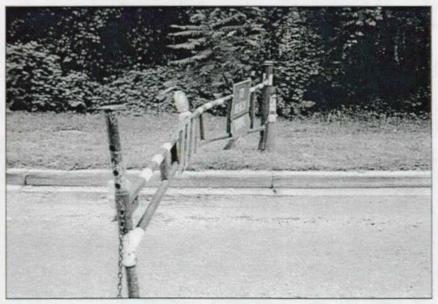
This gate shows evidence of repeated vehicle impacts. The signing on the gate is non-standard and there is inadequate advance warning signing identifying the road-closed condition.

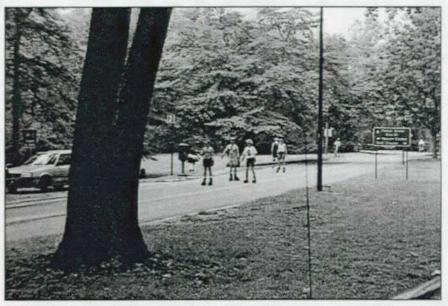
In-line skating has become popular in the last several years. Field observations indicate that skaters take up a wider portion of the road than bikers or joggers. It appears that an in-line skater requires about 6-feet of road width when in full stride.

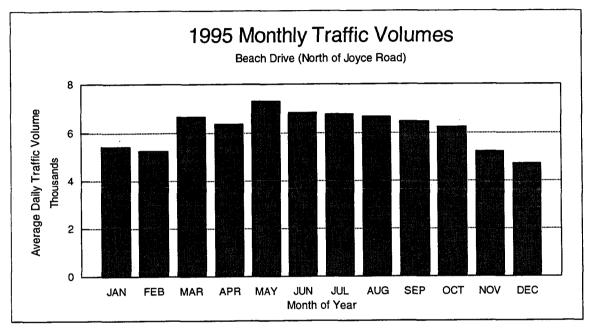
FIGURE 4-3

FIGURES 4-3 and 4-4 present a breakdown of monthly traffic in 1995 at the two permanent NPS counter locations. As shown in the figures, seasonal variations in traffic volumes at Rock Creek Park are not as extreme as those that might be seen at a traditional rural park. This consistency in traffic volumes is due to the high number of commuters using Park roads, and the Park's location within a large metropolitan community. The Parkway data shows even more consistent use throughout the year than does the Beach Drive data.

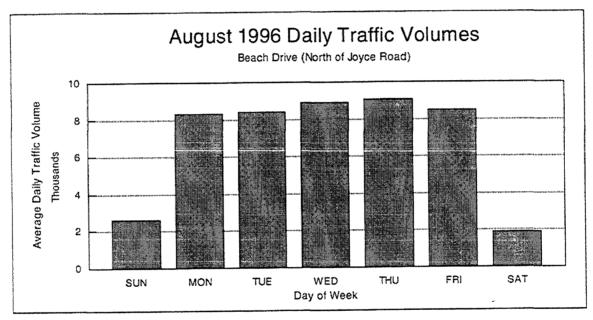
FIGURE 4-5

The permanent traffic counter data was used to further identify traffic volume characteristics on the Park road system. The typical daily traffic volume distributions shown in **FIGURES 4-5** and **4-6** are based on traffic volumes recorded on Beach Drive and the Parkway in August of 1996. The data indicates that there is little variation in traffic volumes during weekdays, when peak commuting conditions occur. Because the Beach Drive counter is located on a segment of road that is closed to through traffic, Saturdays and Sundays have significantly less traffic than an average weekday. The Parkway shows a slight drop in use on the weekends. At both locations, Thursdays had the highest traffic volume of all the days in the week.

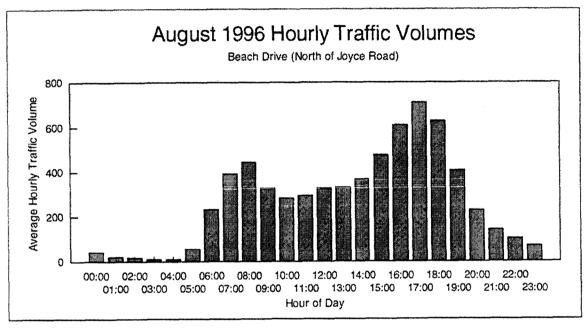
FIGURE 4-7

The typical daily traffic distributions by hour were developed from the NPS counts taken in August of 1996. **FIGURES 4-7** and **4-8** show the hourly variations in average daily traffic volumes (all seven days of the week were included) on Beach Drive and the Parkway. Both locations exhibit well defined A.M. and P.M. peaks that are characteristic of typical urban area travel patterns. The peak travel hours generally occur between 7:00 a.m. and 10:00 a.m. and 3:00 p.m. and 7:00 p.m. due to commuter traffic. Traffic volumes are extremely light between midnight and 6:00 a.m.

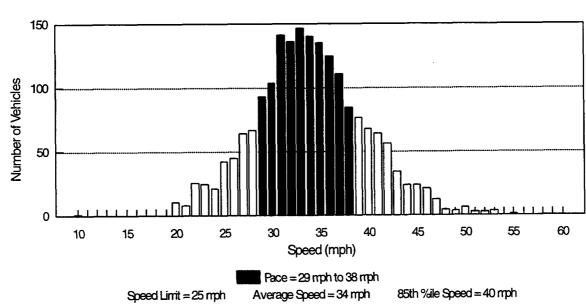
NORTHERN PARK SPEED DISTRIBUTION

Vehicle travel speed distributions were plotted for each of the spot speed study locations. From these distributions, a number of important travel speed characteristics were obtained. These characteristics include: the 85th percentile speed, the pace, and the average travel speeds. The 85th percentile speed is the speed at or below which 85 percent of the traffic is moving. This speed is the one characteristic of traffic speeds that is most indicative of a safe and reasonable speed limit.

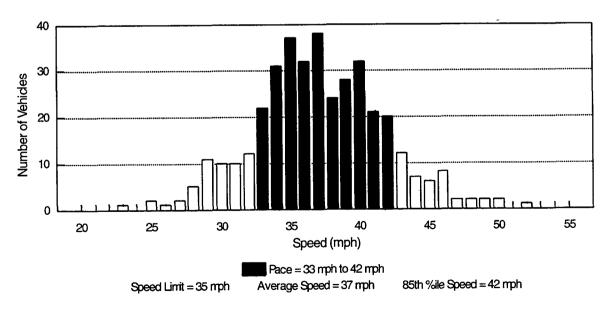
PARKWAY SPEED DISTRIBUTION

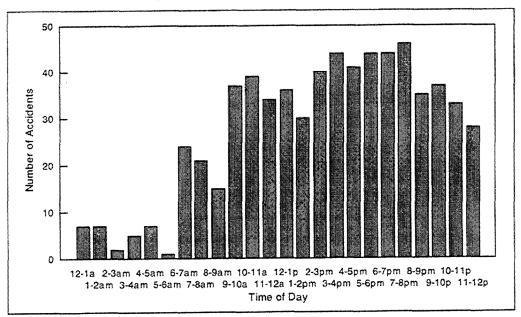
A review was made of the time of day that Parkway accidents occurred. The hourly distribution of accident data is shown in **FIGURE 6-2**.

FIGURE 6-2 Hourly Distribution of Parkway Accidents

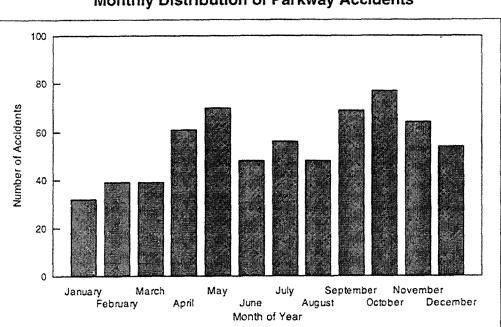
Seasonal variations were analyzed by reviewing the month in which each reported accident occurred. The monthly distribution of accidents on the Parkway is shown in FIGURE 6-4

FIGURE 6-4 Monthly Distribution of Parkway Accidents

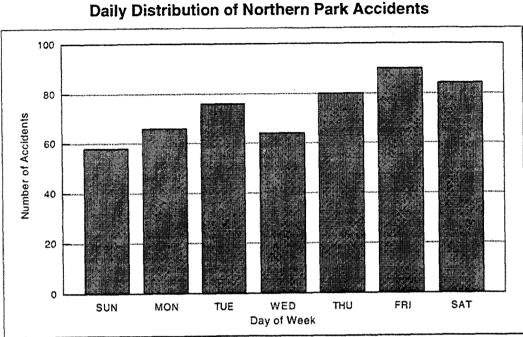
FIGURE 6-7 Daily Distribution of Northern Park Accidents

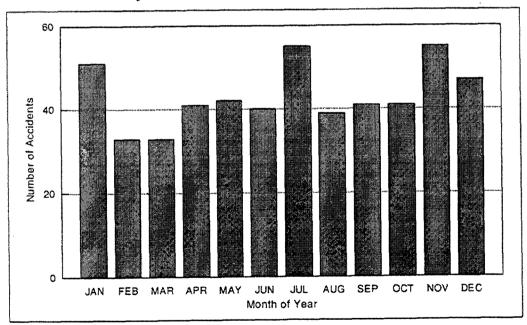
Northern Park seasonal variations were analyzed by reviewing the month in which each reported accident occurred. The monthly distribution of accidents is shown in **FIGURE 6-8**.

FIGURE 6-8 Monthly Distribution of Northern Park Accidents

January (51 accidents), July (55 accidents), and November (55 accidents) have noticeably higher accident frequencies than the other months of the year. Approximately 40 accidents took place during each of the other months. January is traditionally a bad weather month in the Washington area, and July sees high visitor use. There is no clear explanation for the high frequency of accidents in November.

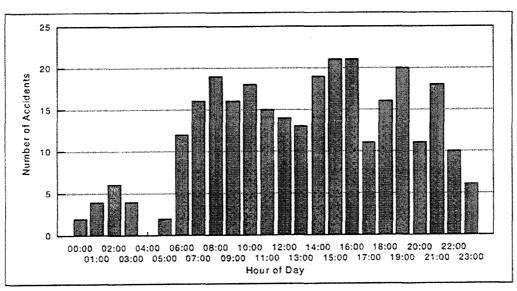
Beach Drive accidents were reviewed to determine what time of day they occurred. The hourly distribution of accident data is shown in **FIGURE 6-9**.

FIGURE 6-9 Hourly Distribution of Beach Drive Accidents

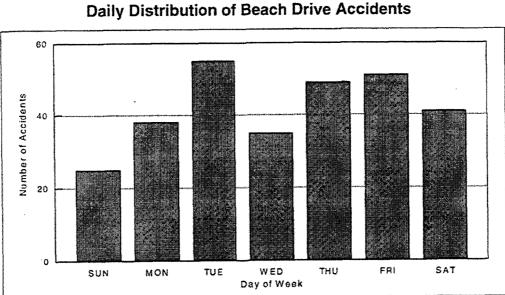
FIGURE 6-10 Daily Distribution of Beach Drive Accidents

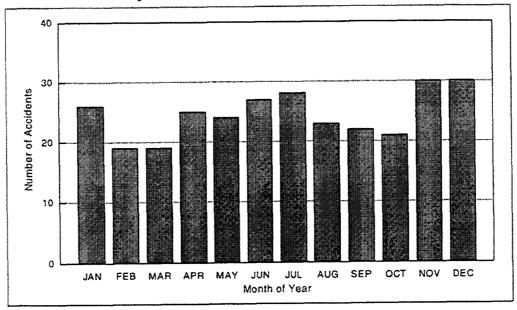
Seasonal variations were analyzed by reviewing the month in which each reported accident occurred. The monthly distribution of accidents on Beach Drive is shown in **FIGURE 6-11**.

FIGURE 6-11 Monthly Distribution of Beach Drive Accidents

More accidents occurred during the winter months of November, December and January than during the other months of the year. June and July also had relatively high accident rates.
