Environmental Assessment  
November 1995

Canyon Transportation System

**ZION**

# Environmental Assessment

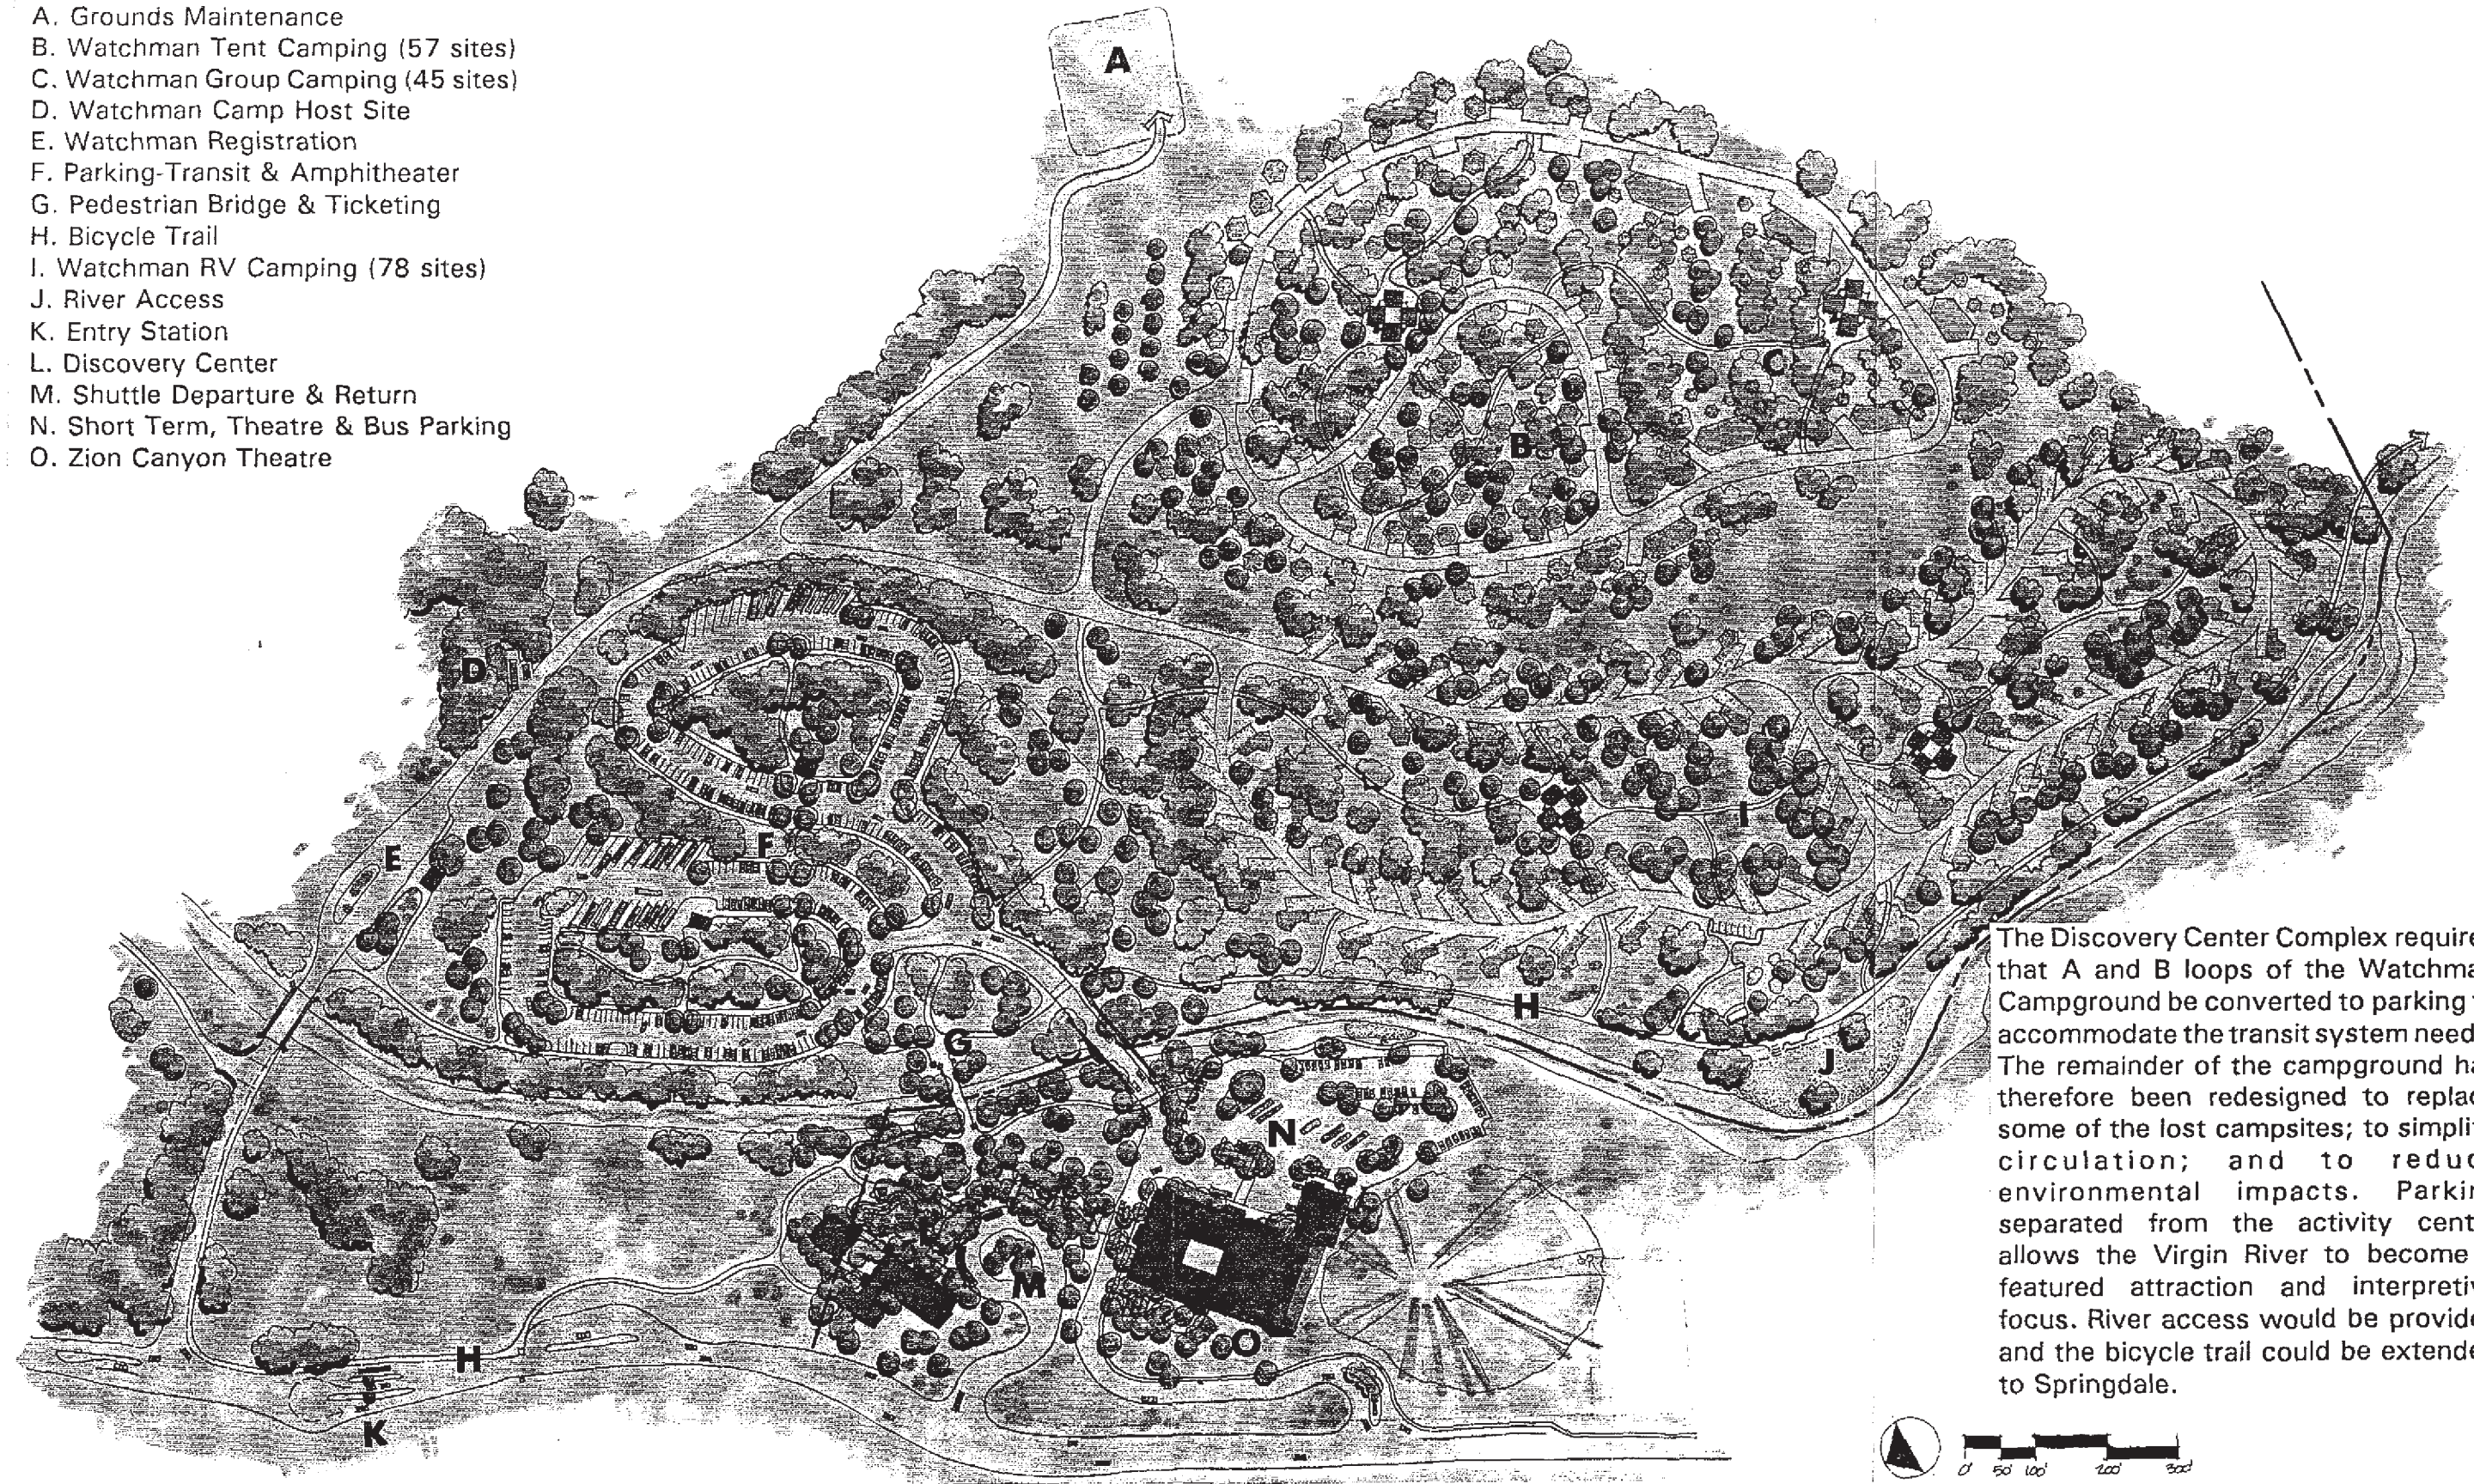
## Discovery Center Complex

The Discovery Center Complex required that A and B loops of the Watchman Campground be converted to parking to accommodate the transit system needs. The remainder of the campground has therefore been redesigned to replace some of the lost campsites; to simplify circulation; and to reduce environmental impacts. Parking separated from the activity center allows the Virgin River to become a featured attraction and interpretive focus. River access would be provided and the bicycle trail could be extended to Springdale.

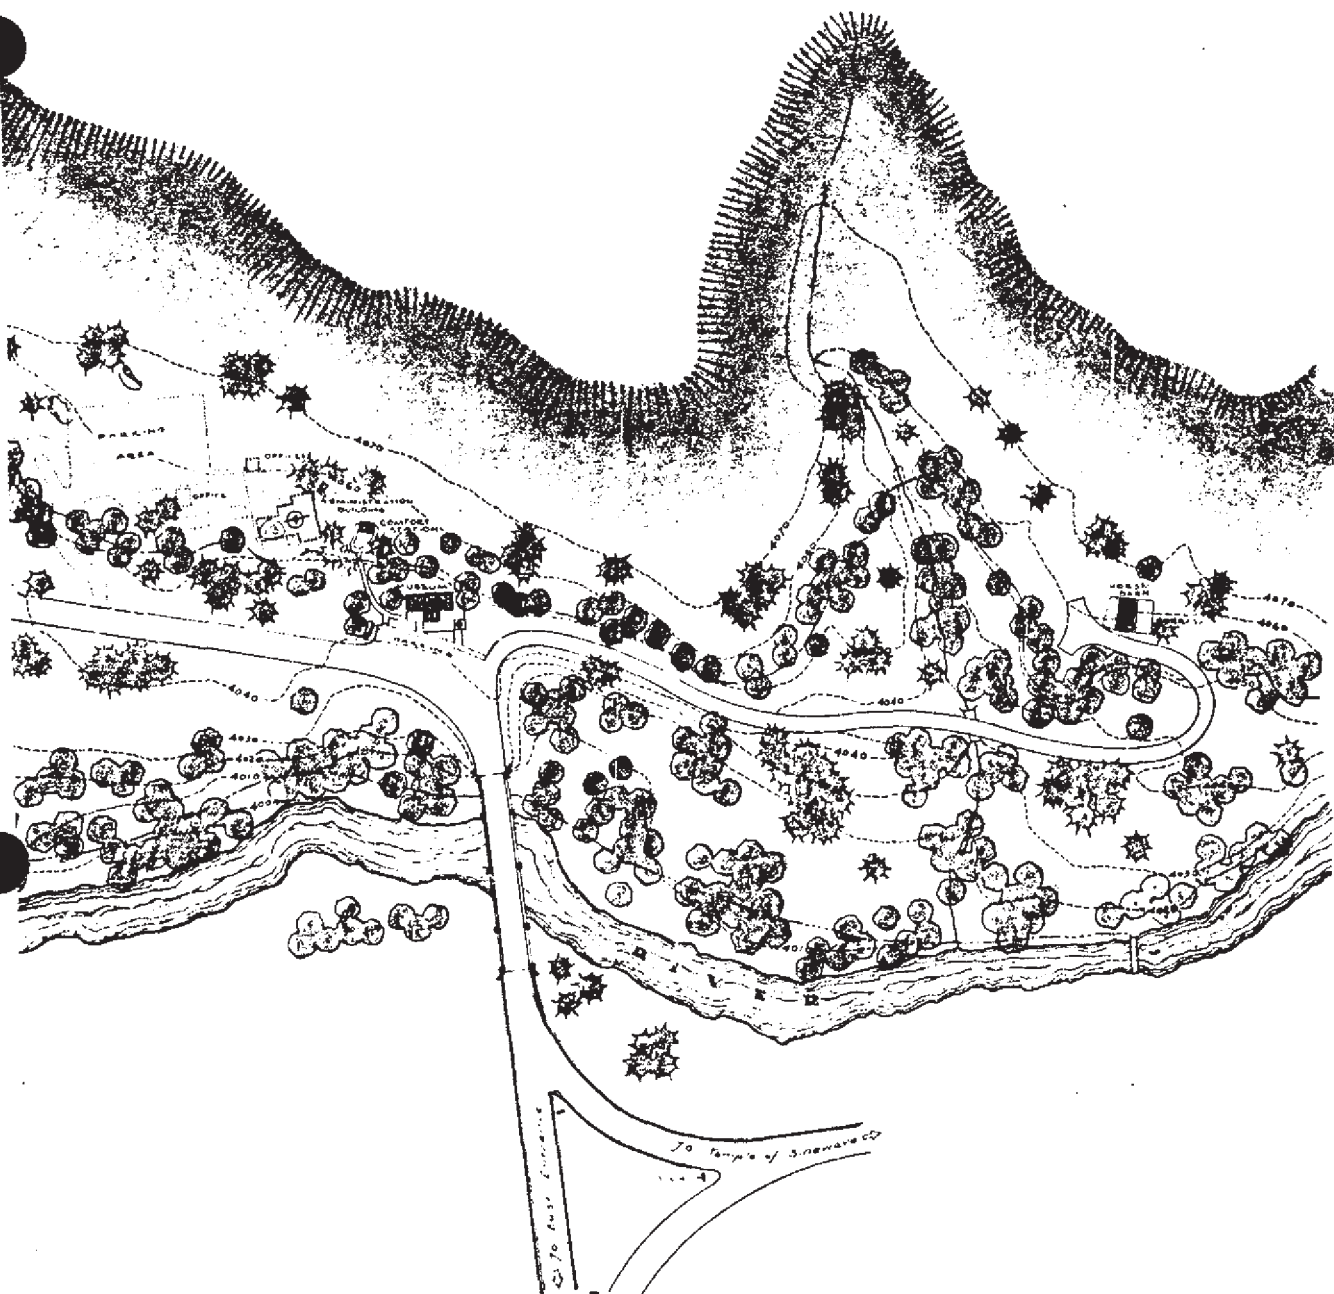
U. S. DEPARTMENT OF THE INTERIOR - NATIONAL PARK SERVICE  
**HEADQUARTERS DEVELOPMENT PLAN**  
 PART OF THE MASTER PLAN  
**ZION NATIONAL PARK**

SCALE - 1 INCH = 100 FEET  
 DRAWN BY THE BRANCH OF PLANS AND DESIGN FROM NATIONAL PARK SERVICE DATA AS OF JAN. 1941  
 CHECKED BY A. E. K. DRAWING NO. 20-2116

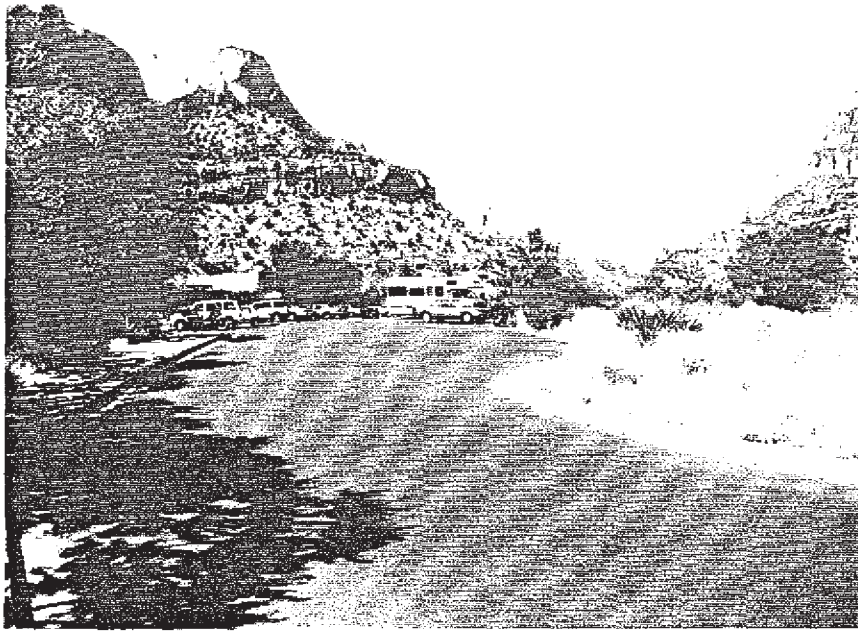
Overview of upper parking lot, east of the existing visitor center, where a proposed shuttle stop is to be located. View is looking north.
