Sitka National Historical Park

Coastal Hazards & Sea-Level Rise Asset Vulnerability Assessment
& Tsunami Vulnerability Case Study
December 2017

NPS 314/154045, December 2017

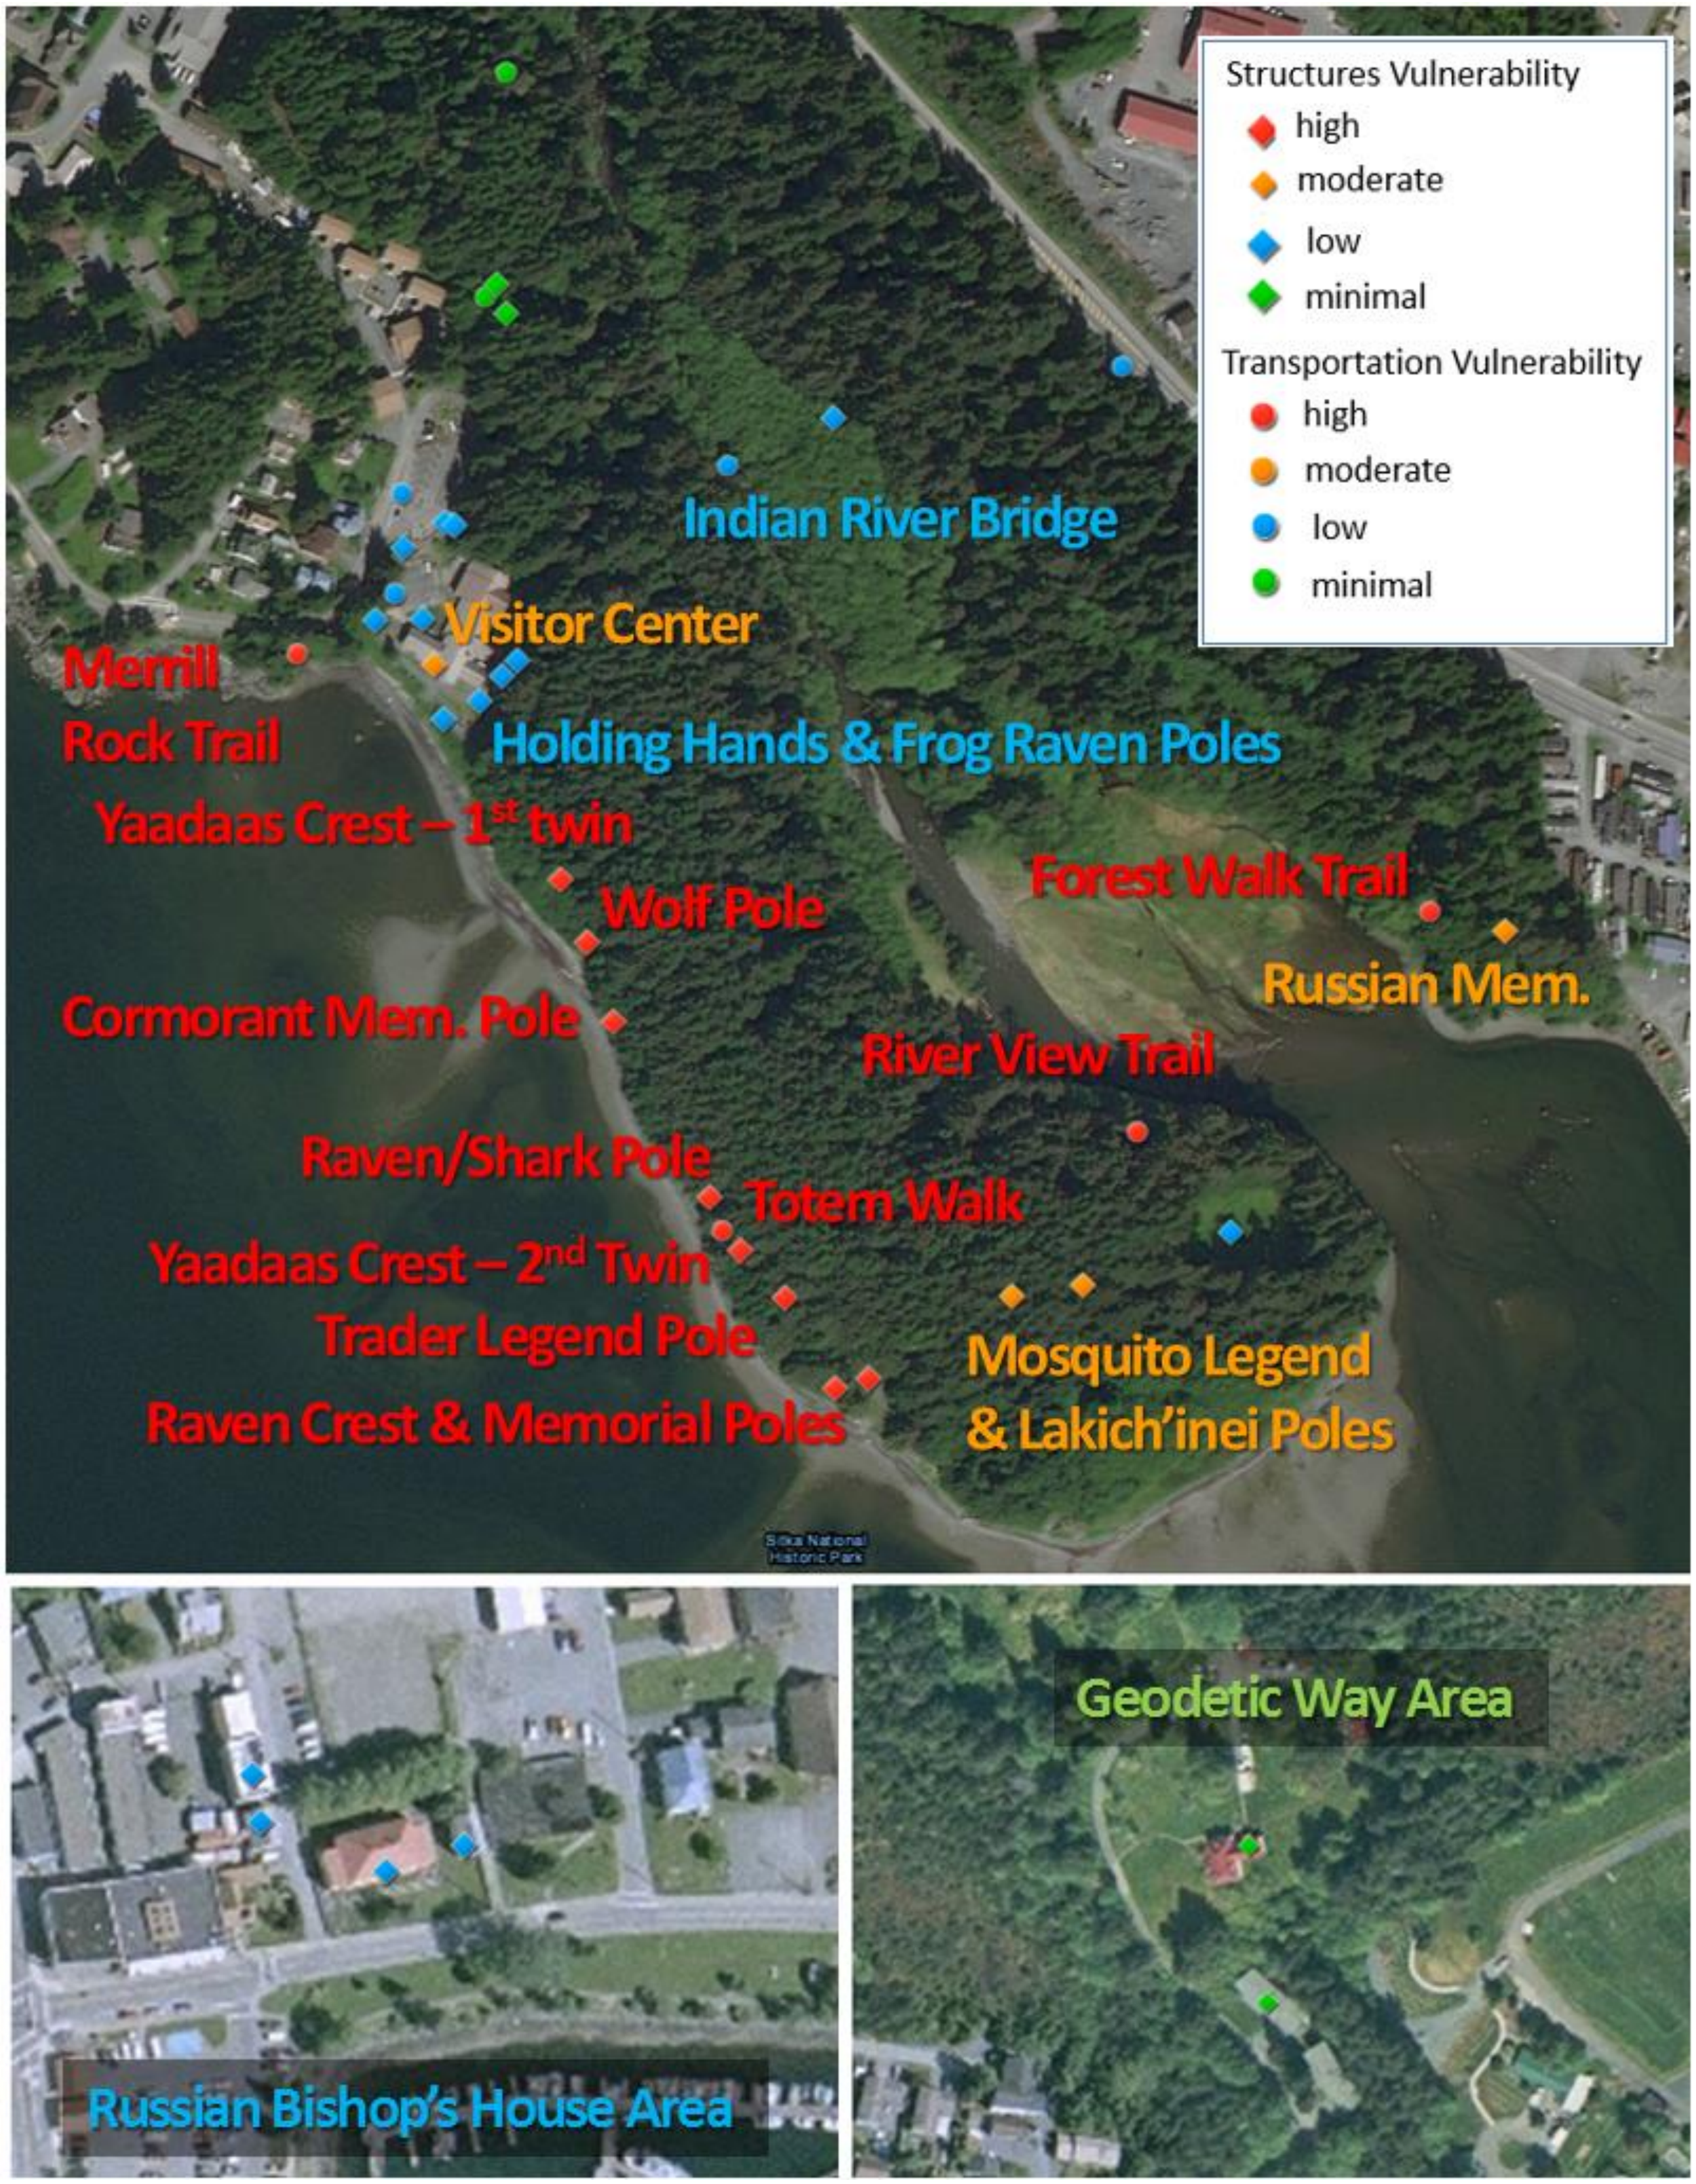
Eight of the totems at SITK (Yaadaas Crest Corner – First Twin, Trader Legend, Raven Memorial, Raven Crest, Raven Shark, Wolf, Cormorant Memorial, and Yaadaas Crest Corner – Second Twin) are the only structural assets with high vulnerability to coastal hazards and sea-level rise. These totems have the highest exposure scores of any assets, which combined with moderate sensitivity, yields high vulnerability. **In addition, all high vulnerability totems are high priority to the park and have a combined current replacement value of almost $1.3 million** (priority and value data taken from FMSS).

Four structures (buildings and totems) have moderate vulnerability to coastal hazards and sea-level rise. This includes the Visitor Center, which is the second most valuable structure (current replacement value in FMSS > $9 million) and one of the highest priority structures in the park (asset priority index in FMSS = 100). The highest value building in the park (current replacement value in FMSS > $10 million), the Russian Bishop's House, has low vulnerability.

Figure 6. Mapped vulnerability results for select SITK assets (not all assets are labeled, see Excel sheets for full results). Background is aerial imagery from ESRI streaming layer.

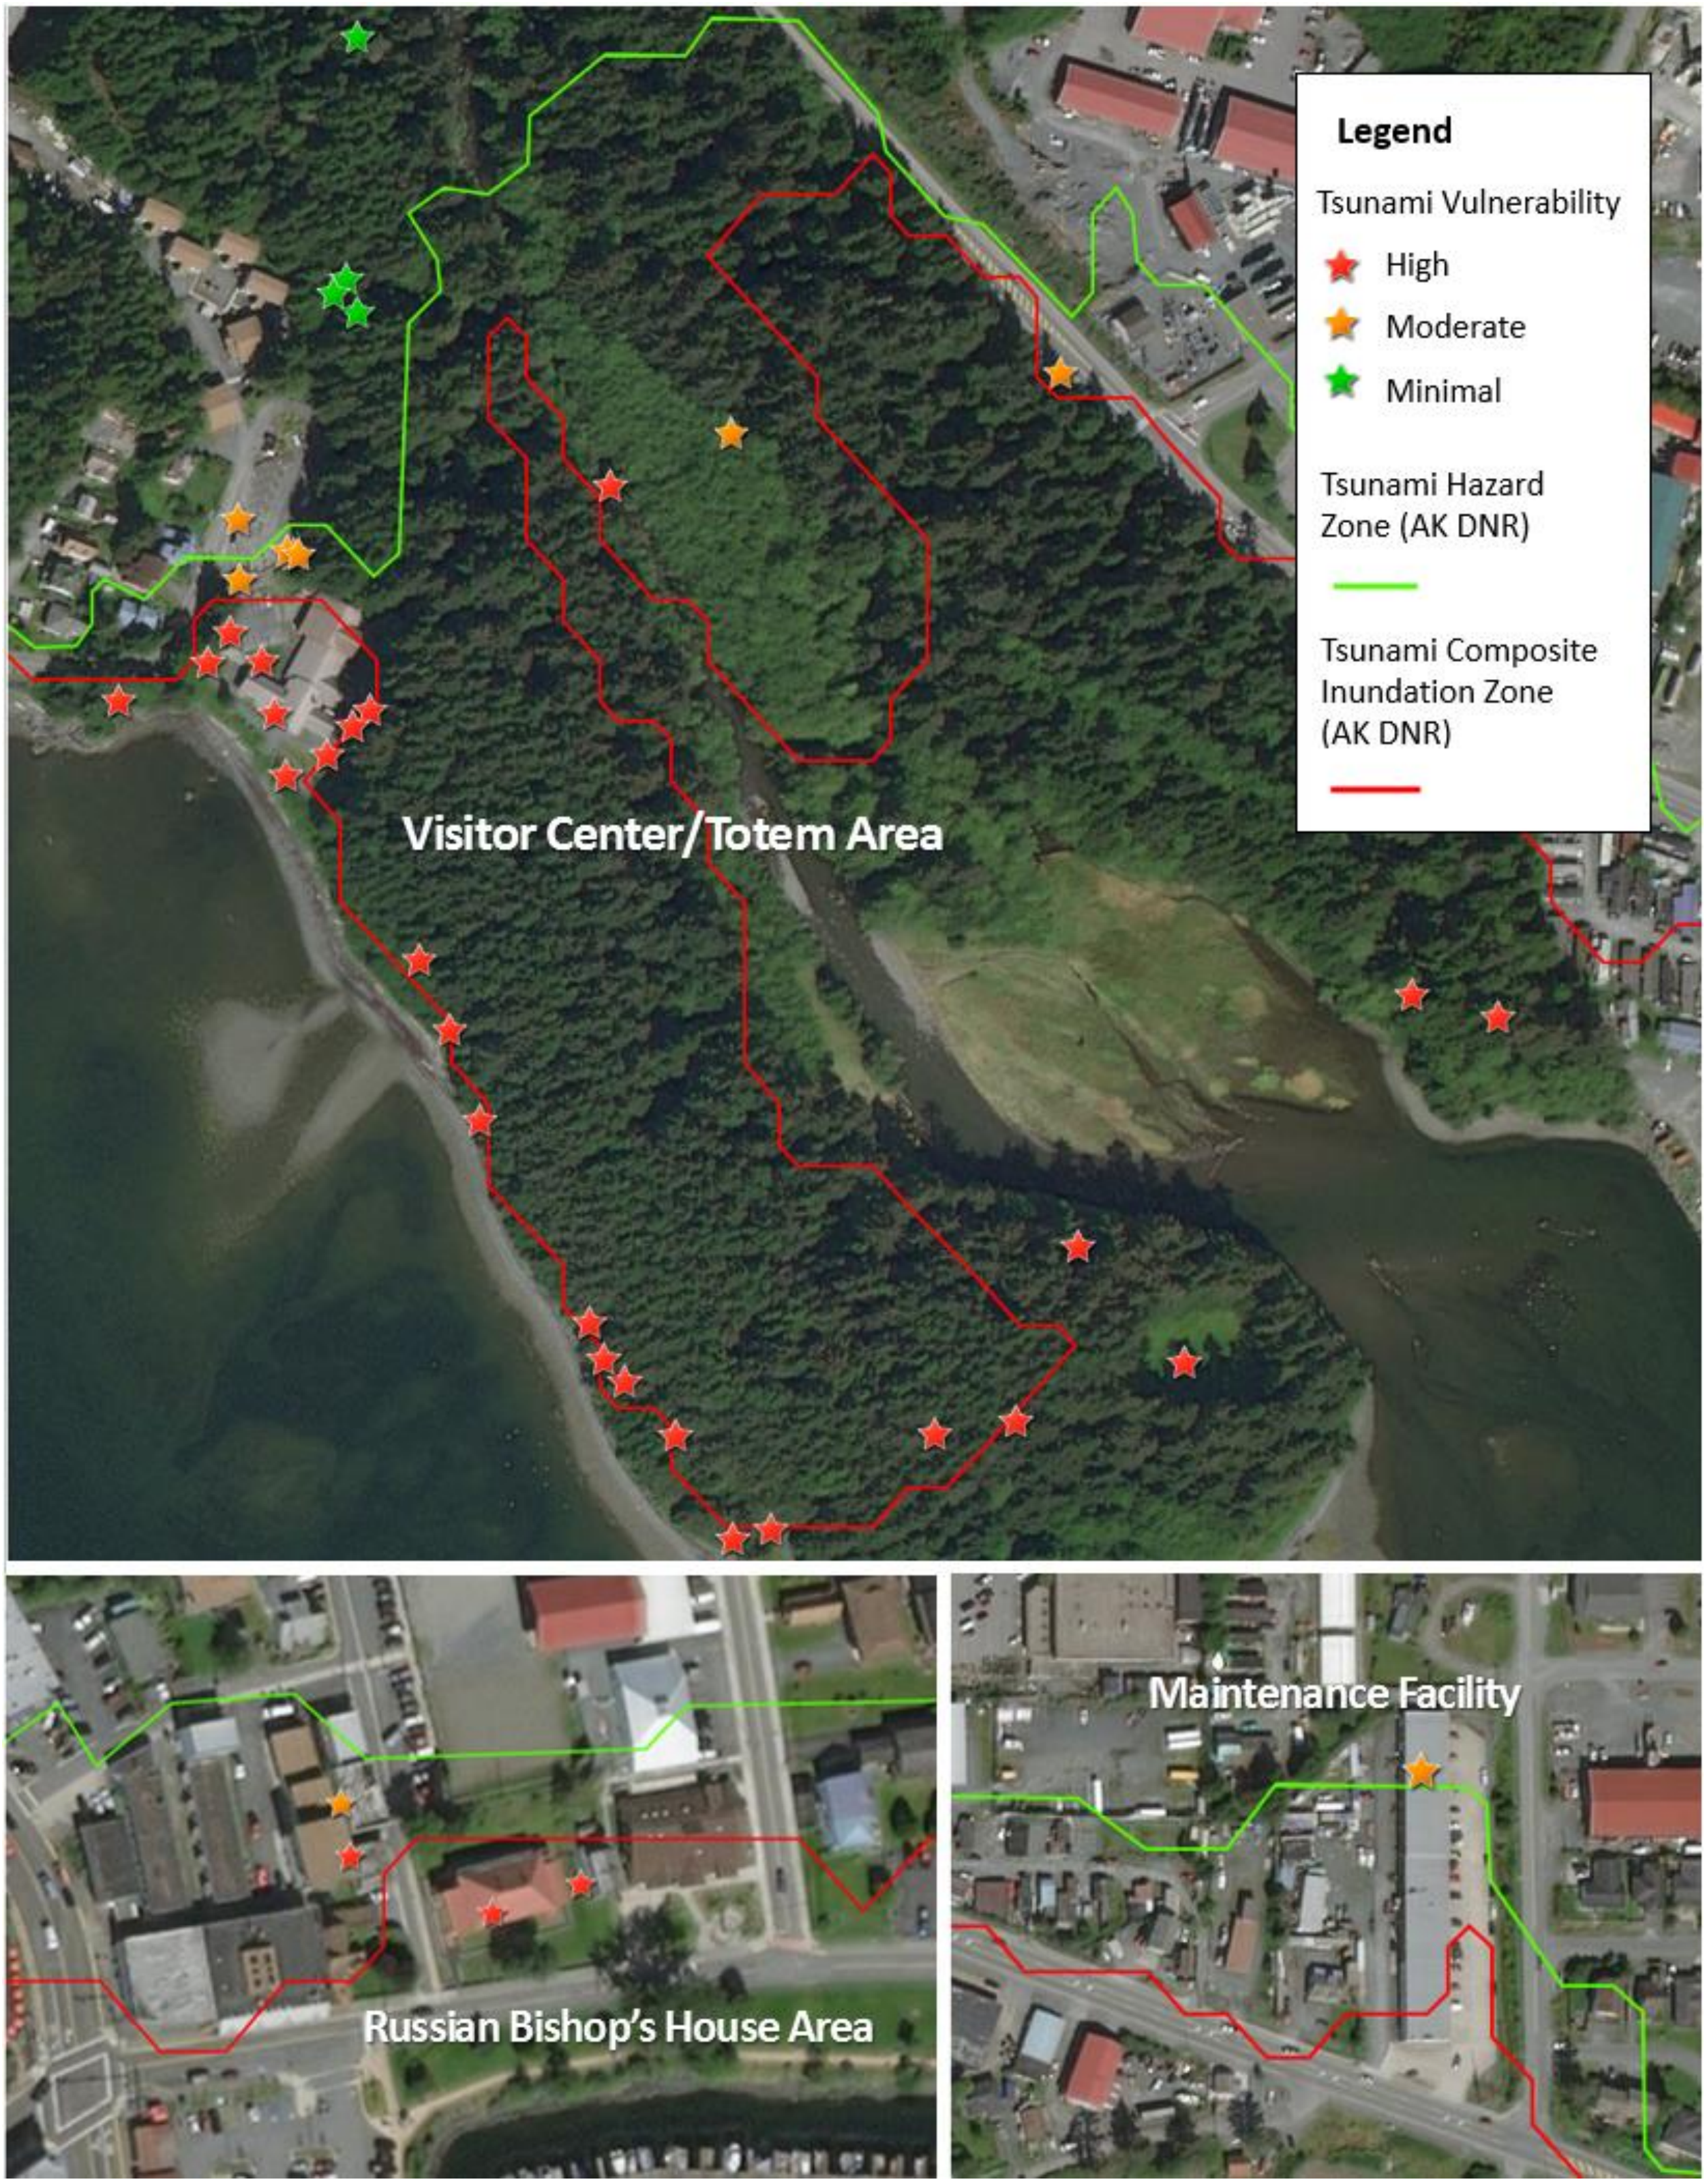
The results of the case study show two-thirds (65%) of the assets have high vulnerability to tsunamis (Table 6, Figure 7). These assets are located in both the tsunami composite inundation and tsunami hazard zones. Over 20% of the assets have moderate vulnerability to tsunamis, meaning they are located only within the tsunami hazard zone (not within the tsunami composite inundation zone). Finally, 14% of the assets analyzed have minimal vulnerability, meaning they are outside both mapped tsunami exposure zones (Table 6, Figure 7).

At SITK, 28 assets (65%) have high vulnerability to tsunami hazards and are primarily located in the vicinity of the Totem Walk Trail and Visitor Center. Structures account for 22 of the high vulnerability assets, including 15 totem poles, the Visitor Center, the Russian Bishop's House, Priests' Quarters, the Old School, Bally Building, Russian Memorial, and Totem Carving Shed. Six transportation assets have high vulnerability: the Visitor Center Lower Parking Lot, Totem Walk, Indian River Bridge, Merrill Rock Trail, River View Trail, and Forest Walk Trail (Table 5, Figure 7).

The nine moderate vulnerability assets are all situated outside the tsunami composite inundation zone, but within the tsunami hazard zone (Figure 7). The seven moderate vulnerability structures include: the G Sitka Building Park (Maintenance Facility), Romtec Restroom, Saanaheit Pole, Haa Leelk'u Ha's Kaasdaheeni Deiyi' Kooteeyaa Pole, Saanaheit House Post, Saanaheit House Post 2, and 105 Monastery Street - Unit A Leased Space. The two moderate vulnerability transportation assets are the Visitor Center Upper Parking Lot and East Entrance Parking Lot (Table 5, Figure 7).

Not surprisingly, the assets located on highest ground have minimal vulnerability to tsunami hazards. The six minimal vulnerability assets, located in three separate areas, include: the BPR Equipment Shed, Maintenance Storage Shed, and BPR Parking area; the 418 Geodetic Way House and 500 Geodetic Way Quarters and Resource Office; and the Diversion River Bridge (Table 5, Figure 7).

Figure 7. Mapped tsunami vulnerability results at SITK (Geodetic Way area not shown). A few assets were mapped just outside of the tsunami composite zone, but due to proximity to shoreline and/or ground elevation were determined to be at risk (and scored within the zone; see Excel results sheets). Background is aerial imagery from ESRI streaming layer.
