The Road Inventory for Cape Hatteras National Seashore

Road Inventory Program

Prepared By:
Federal Highway Administration
Eastern Federal Lands Highway Division
August 1999

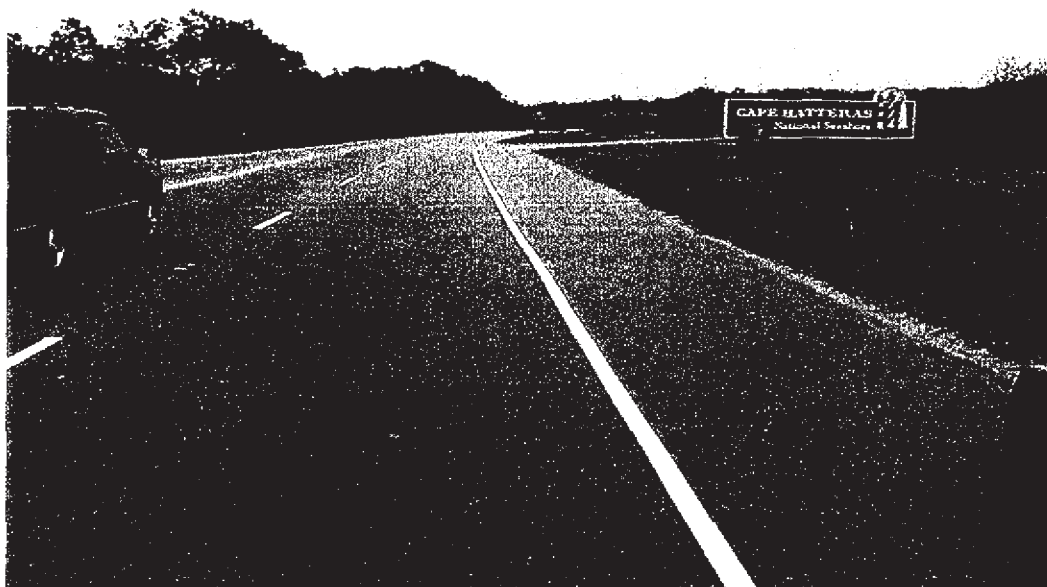
Photo #2909 - MP 0.00 Whalebone intersection—begin with four lanes

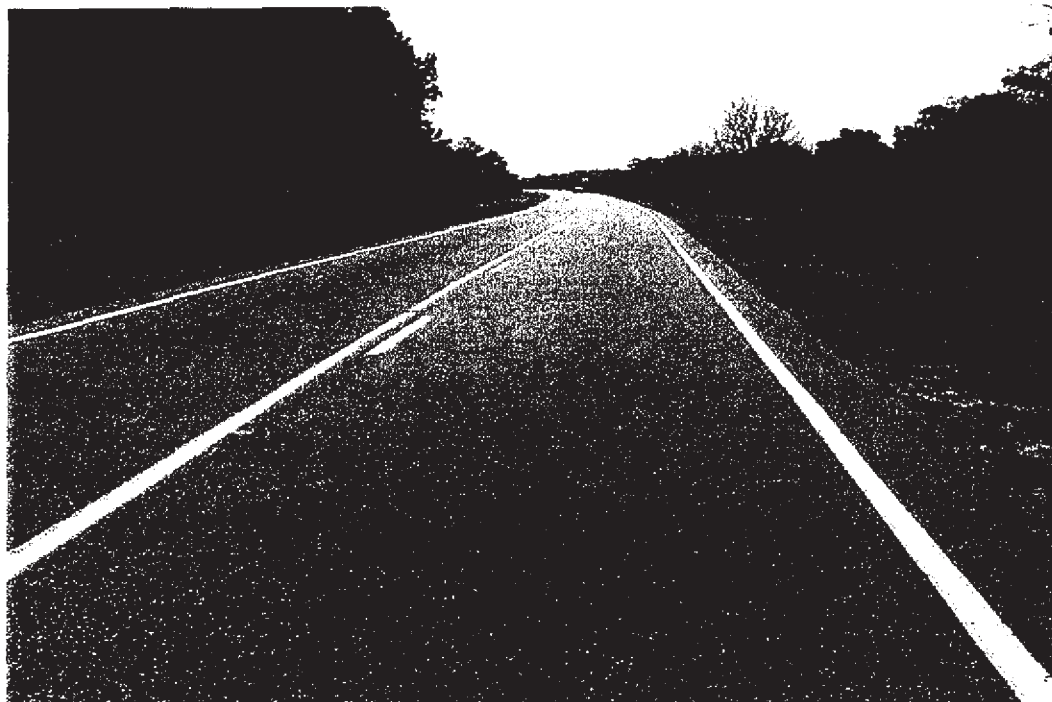
Photo #2910 - MP 0.20 - Roads tapers to two lanes—typical pavement section

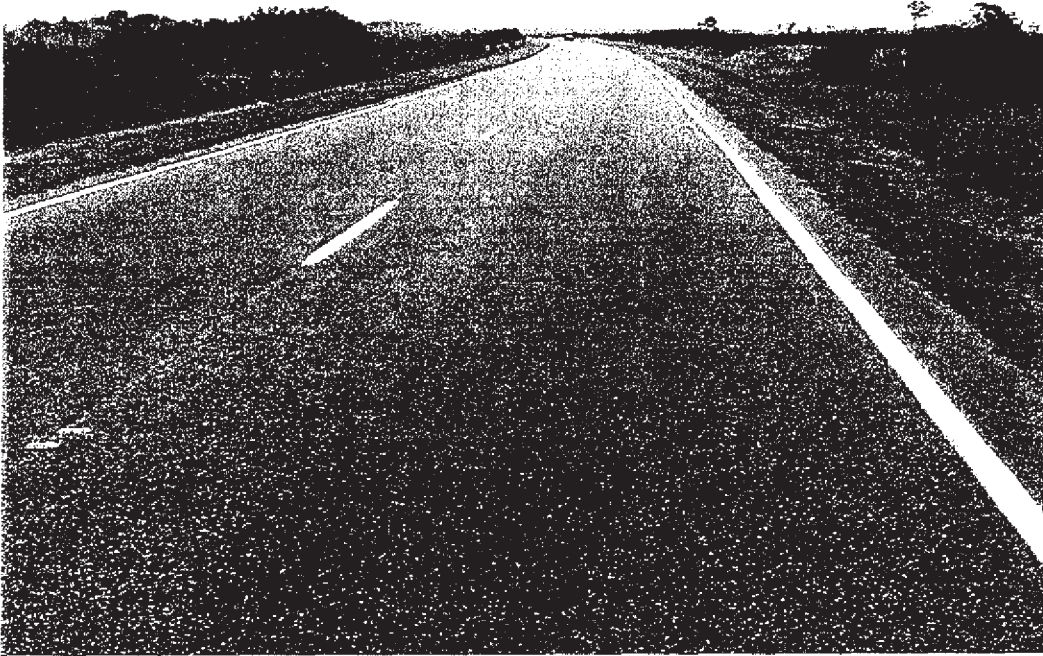
Photo #2911 - MP 3.30 - Typical pavement section with corrugations

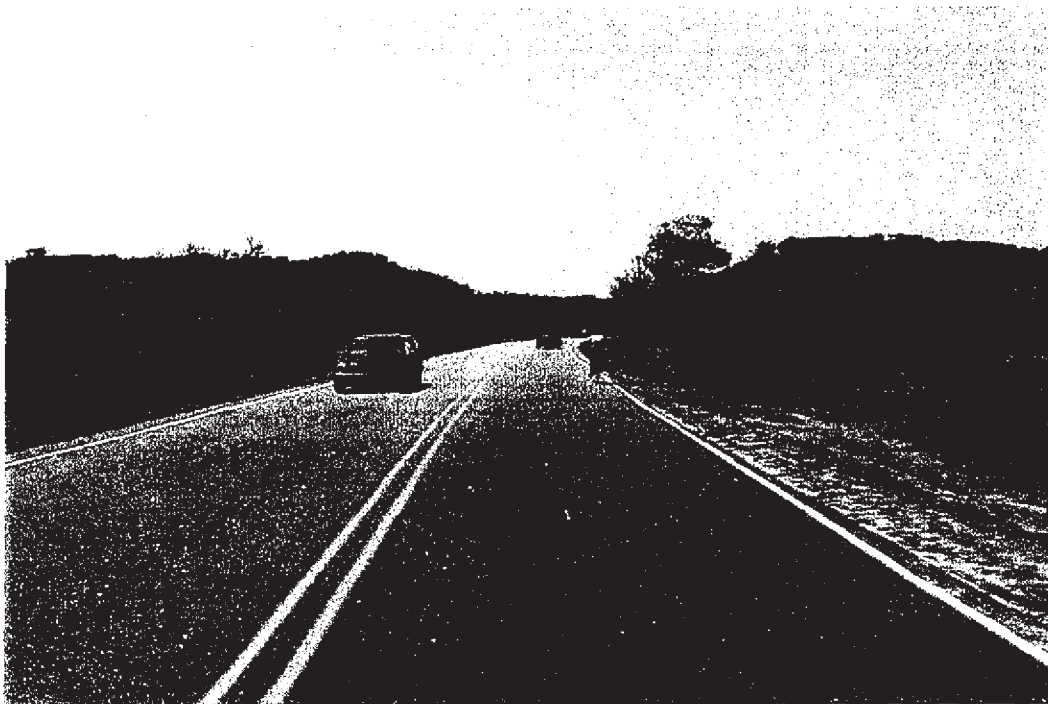
Photo #2 - MP 0.00 - Typical pavement section—beginning of route

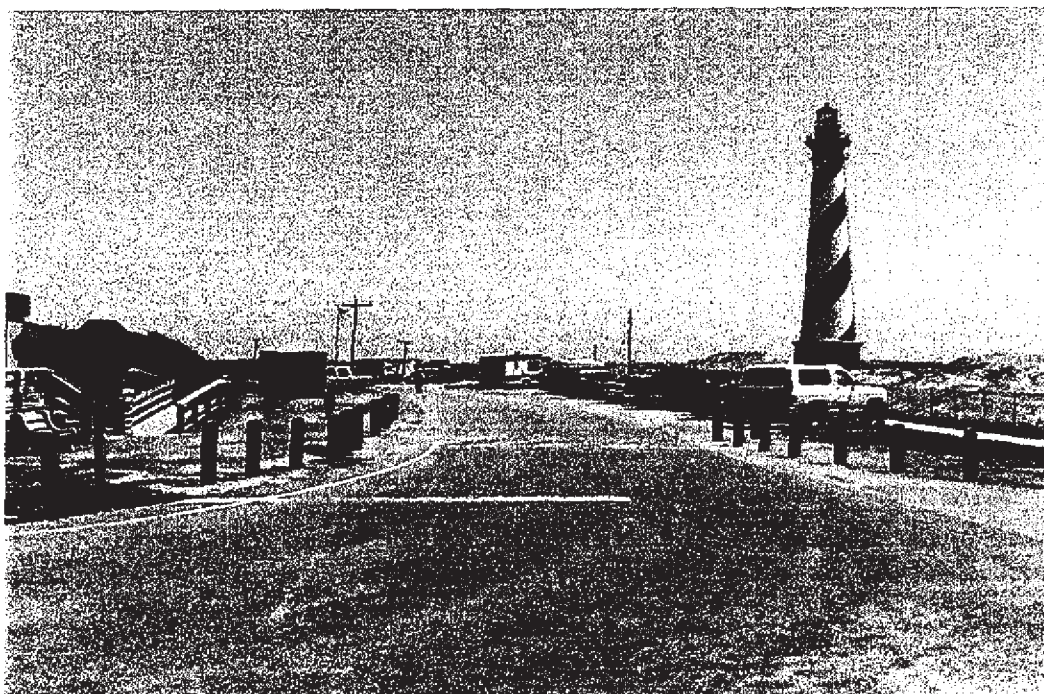
Photo #3 - MP 0.83 - Intersection with Rte 916 on right.

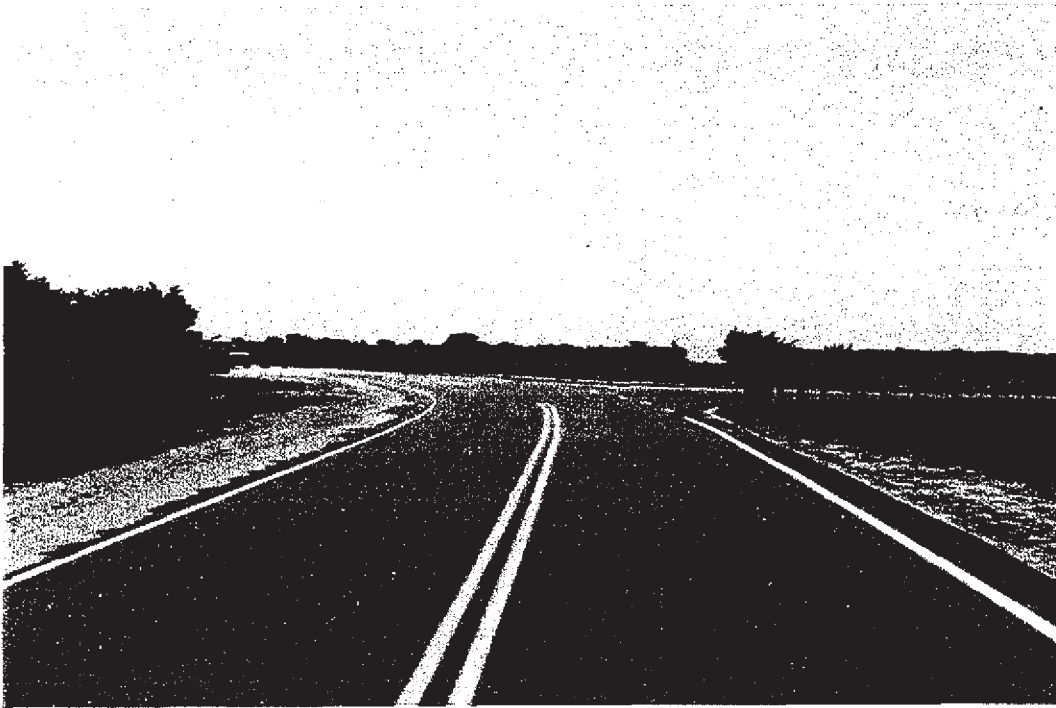
Photo #4 - MP 2.36 - Intersection with Rte 225 on right.

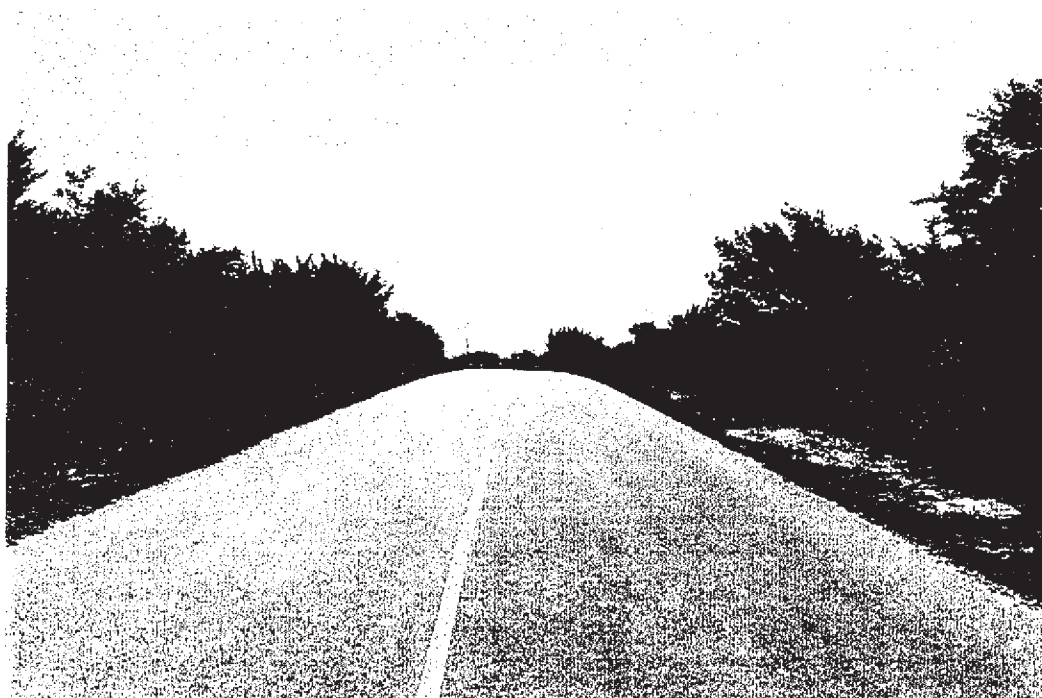
Photo #6 - MP 0.00 - Beginning of route—typical pavement section.

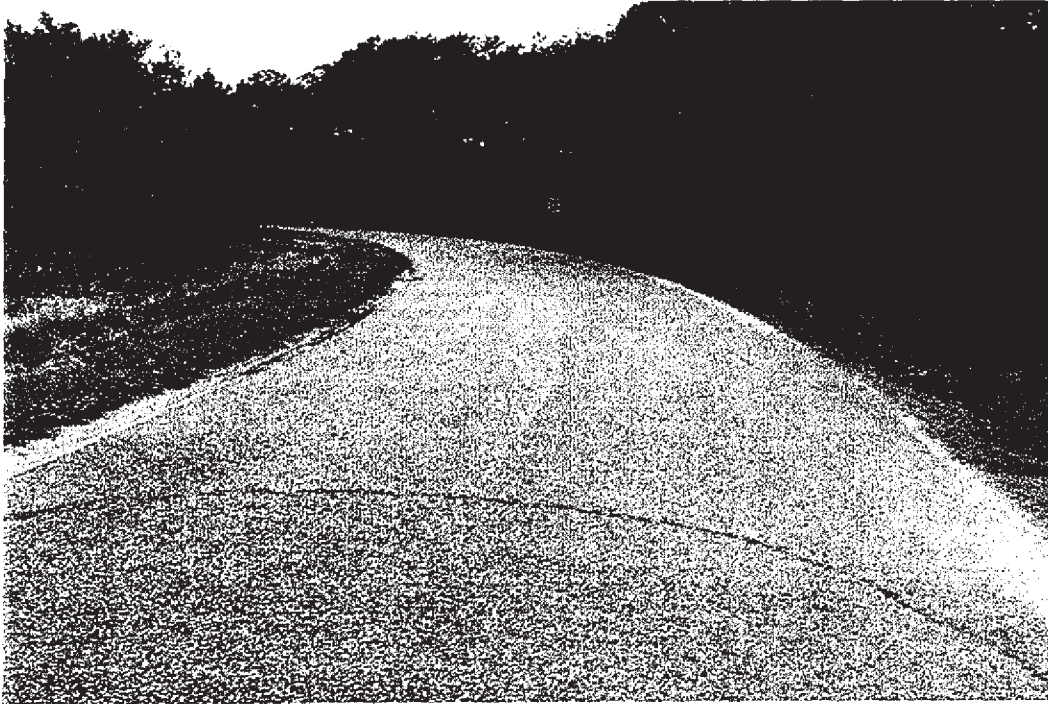
Photo #2914 - MP 0.02 - Begin route - typical pavement section

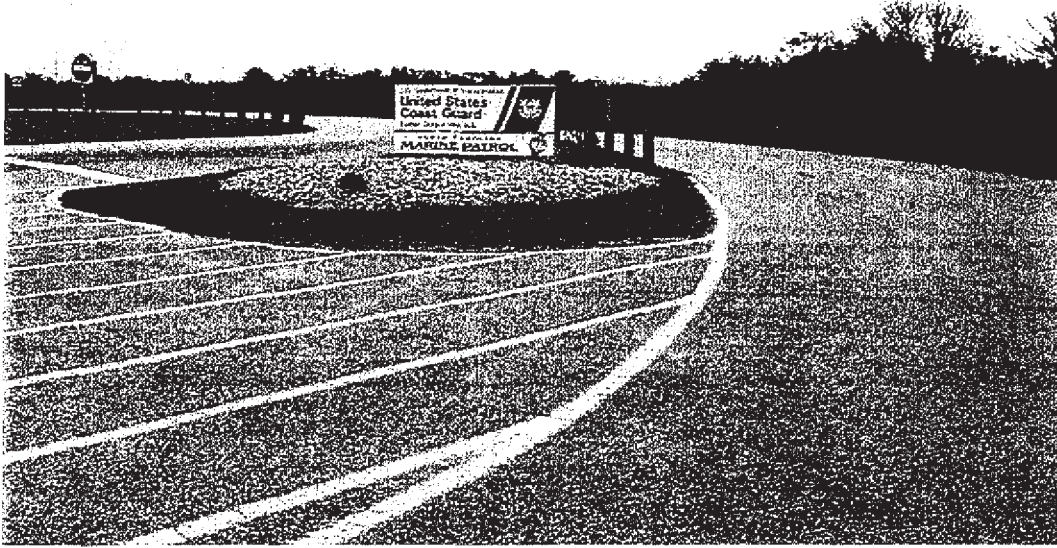
Photo #2919 - MP 0.00 - Begin route to USCS Station—typical pavement section
