THE CLIFF HOUSE

Golden Gate National Recreation Area
San Francisco California

HISTORIC STRUCTURE REPORT

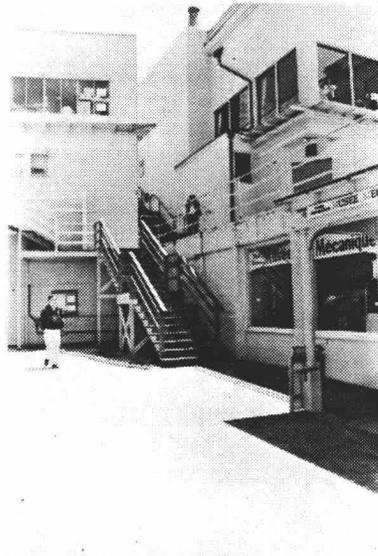
Figure 35 (Middle). North stair to Lower Terrace. 1987.

Primary access to the lower level viewing terrace, Musee Mechanique and the Visitors Center is currently provided by a steep, wood frame, open-riser stairway. The stair is in poor condition and should be replaced (See Figure 35.). At minimum a replacement stair should be constructed of more permanent materials in an improved design. If a more intensive scope of rehabilitation is contemplated, the method of access to the lower levels and the location of the Visitors Center itself should be reconsidered. Given the heavy level of use of the lower deck viewing areas, these improvements should be given a high priority.

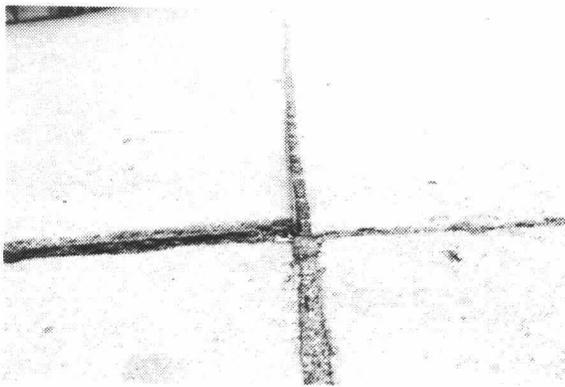
Figure 57. Lower terrace paving. 1987.

The paving of the lower level viewing terrace is settled and currently is an irregular and hazardous surface. Also surface-spalling of the concrete is ongoing. The entire lower level should be re-paved in conjunction with repairs to the perimeter wall. Sidewalks in front of the building are also in poor condition. They should also be repaired.

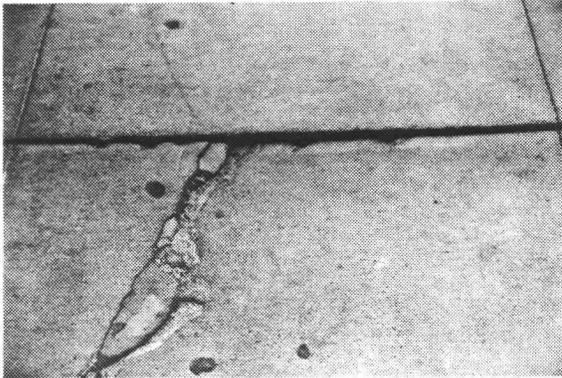
Figure 58. Sidewalk in front of Cliff House, 1987.

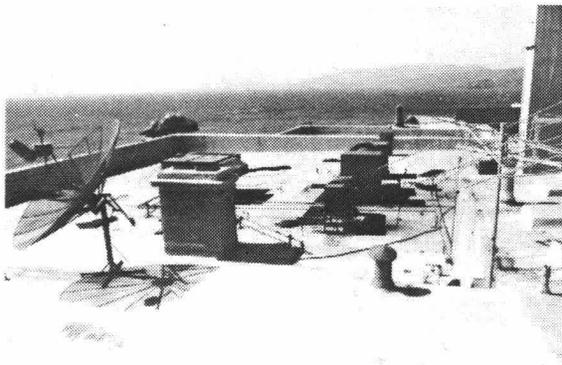
Figure 59. Roof over original building. Note slope to west. 1986.

The main roof is in fair condition. Currently the entire roof slopes to the west to two scuppers. This situation is not ideal since too much runoff is concentrated at the scuppers encouraging water to get into walls. When the building is re-roofed consideration should be given to modifying the roof pitches and adding additional downspouts.

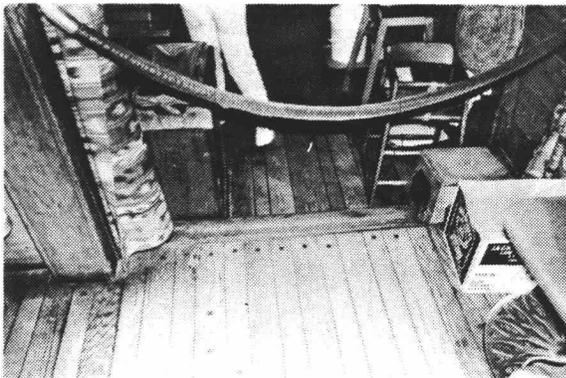
There are a number of problems with the exiting which should be addressed. The main dining level has two exits. One through the main stair and another through the P.T. Barnacle area. This second exit is poorly signed, and in addition it requires a person to go up and down stairs over a platform. A final potential problem might exist if the two facilities had different hours of operation. This issue should be reviewed with the concessionaire to assure that two exits are always available to this level. The main central stair provides an exit from all three levels, discharging through the main entrance at street level. This stair and corridor, and all openings into it should be of one-hour fire resistive construction. This does not appear to be the case, although it has been provided with an automatic sprinkler system which essentially gives it that rating. Rooms opening directly off the exit corridor, such as the office and gift shop, should be provided either with sprinklers or a rated door assembly.

Figure 68. Disabled access barriers in the P.T. Barnacle restaurant. 1987.

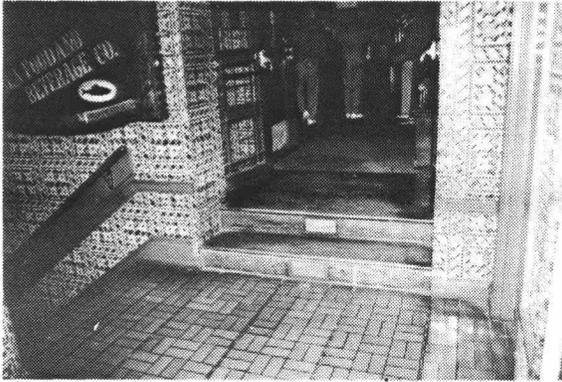
Figure 69. Disabled access barriers between the main entry and restaurant, second floor.
