HISTORIC STRUCTURES REPORT

ARCHITECTURAL DATA SECTION

SPRING AND WASH HOUSE

Hopewell Village National Historic Site

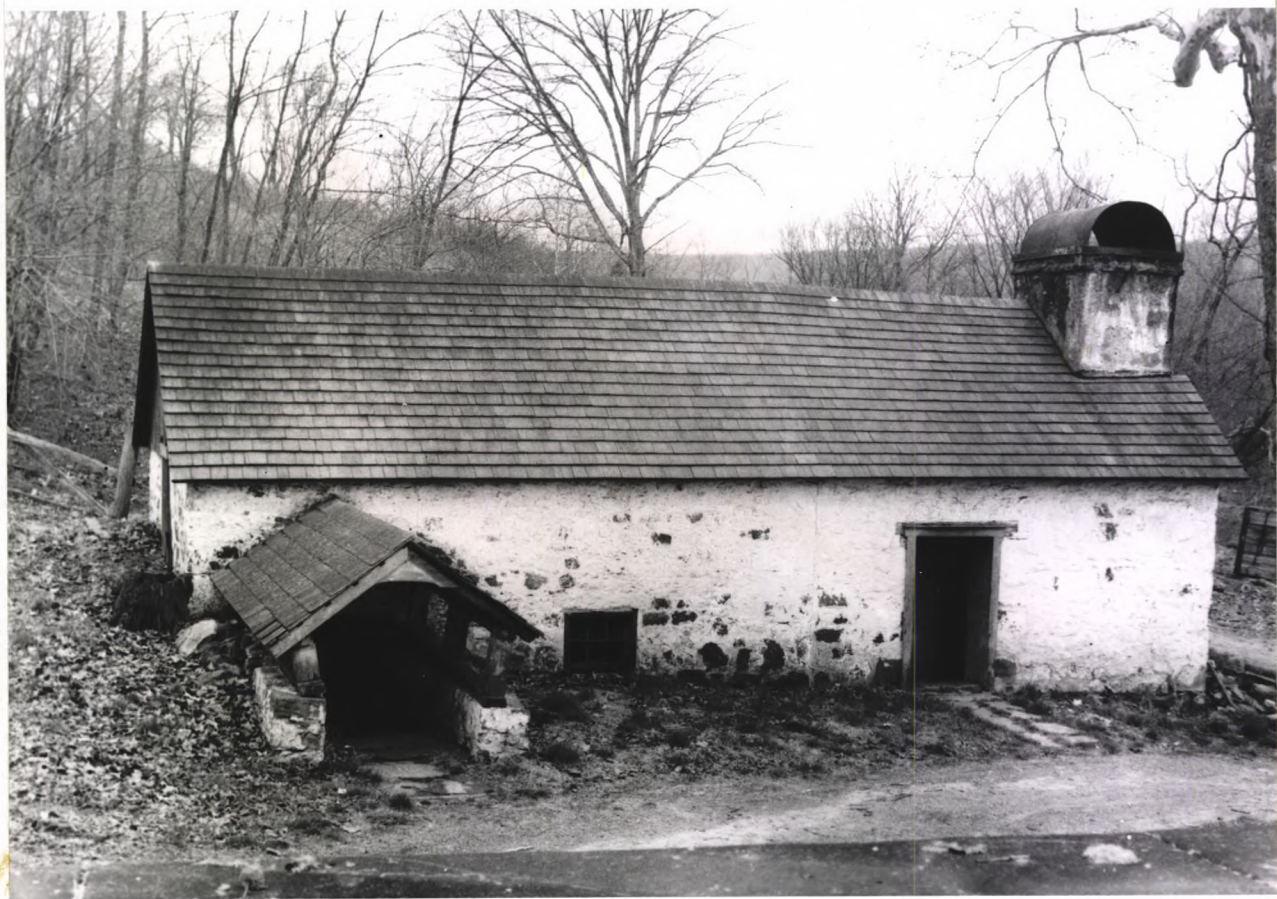
Visitor's View of the Spring House

The arrangements of the interior sections almost match the exterior construction. The original Spring House portion has a 12½ x 6 foot entrance area and a 12½ x 12 foot cooling section, separated by a masonry wall. The "lard kitchen" is 12½ x 15. A stone fireplace covers the southeast corner of this room. Two interior doors allow passage from section to section.

Basically, the removal of the concrete steps, floor and curbs and replacement with flagstone would return the Spring House to a period suitable with Village purposes.
