STATUS OF HISTORIC STRUCTURES REPORT

HOPEWELL VILLAGE
PARK 376/134742

Tenant House #1

TENANT HOUSE #1. BUILDING #19

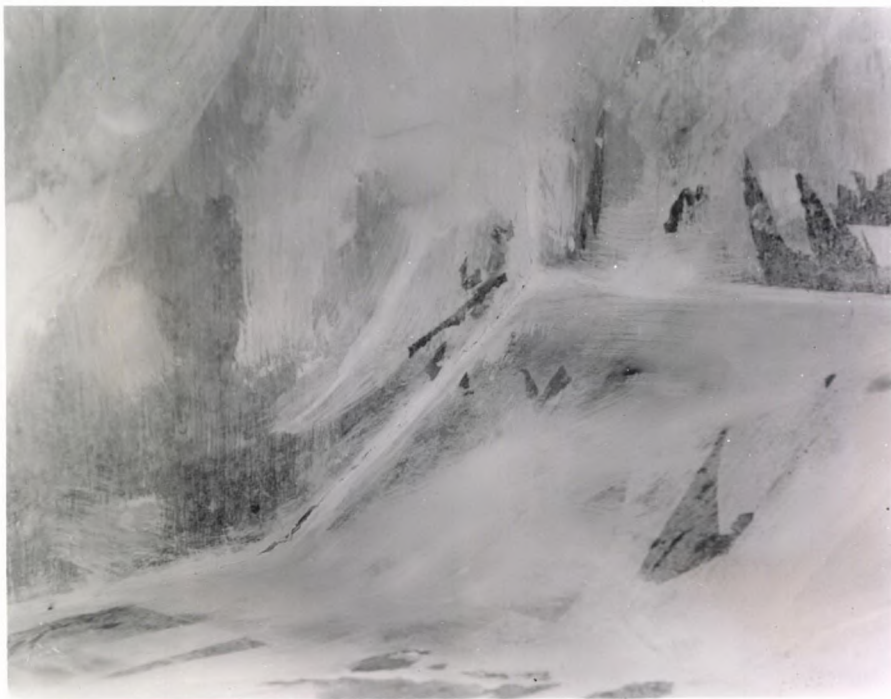
The second area needing attention was the wall in the northwest corner of the building. The underground stream in this area (mentioned earlier) had caused this entire corner of the building to settle. Water could enter from the roof also complicating the problem.

View of same corner as in previous photograph after repairs.

The exterior repairs accomplished in 1958 prevented further deterioration but the interior walls in that corner had to be repointed and plastered.
