HISTORIC STRUCTURES REPORT - PART I

LLOYD HOUSE (BUILDING 71) 207

Hopewell Village NHS
Elverson, Pa.

HISTORIC STRUCTURES REPORT
ARCHITECTURAL DATA SECTION, PART 1
PRELIMINARY TO THE REHABILITATION OF
THE LLOYD HOUSE
(BUILDING 71, Tract 21)

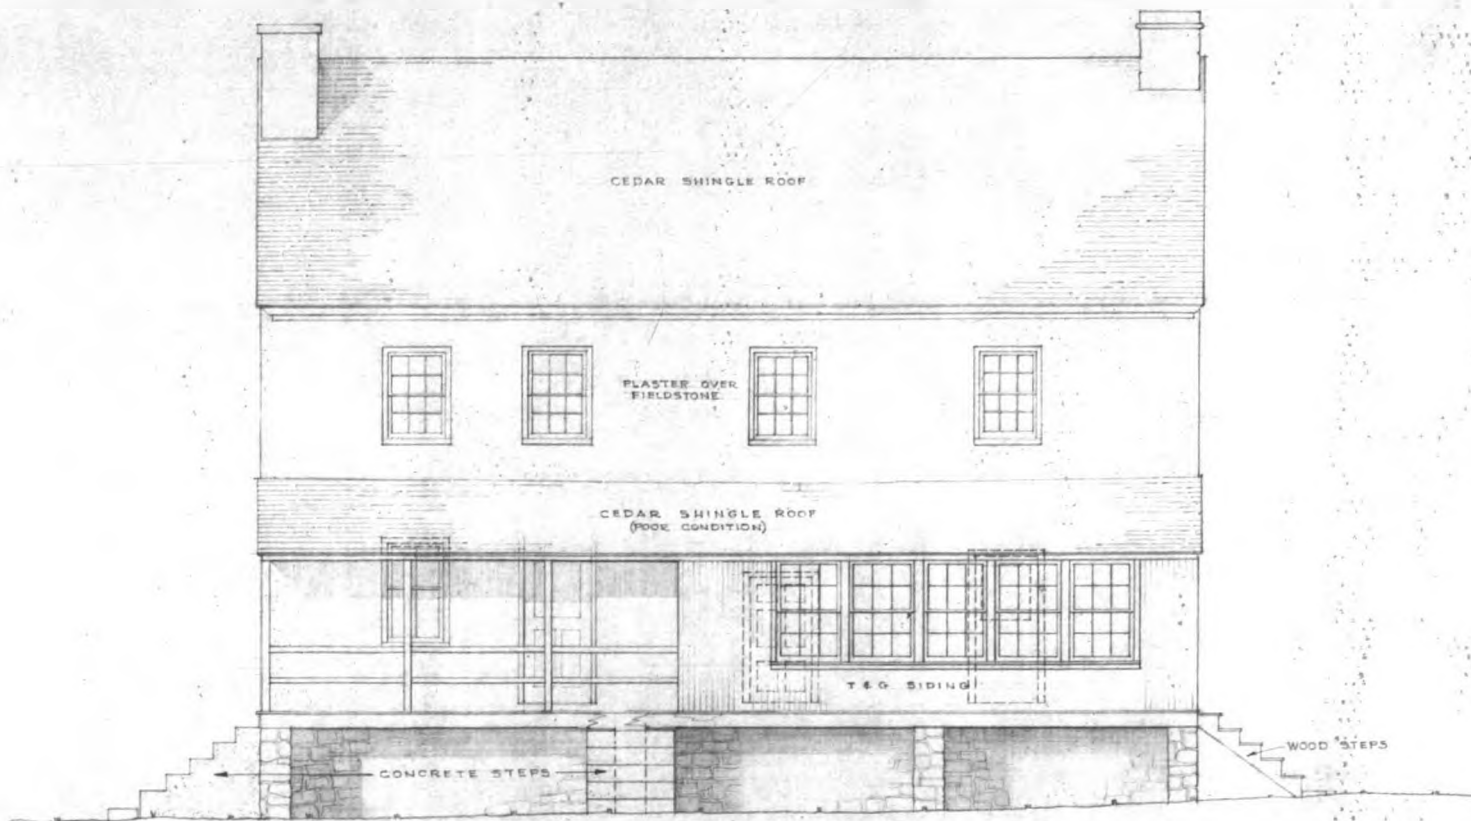
SOUTHWEST ELEVATION

South elevation. The enclosed portion of the porch approximately marks the length of the original house. Here can be seen the failing porch. The dark area over the porch merely indicates an incompleted paint job.

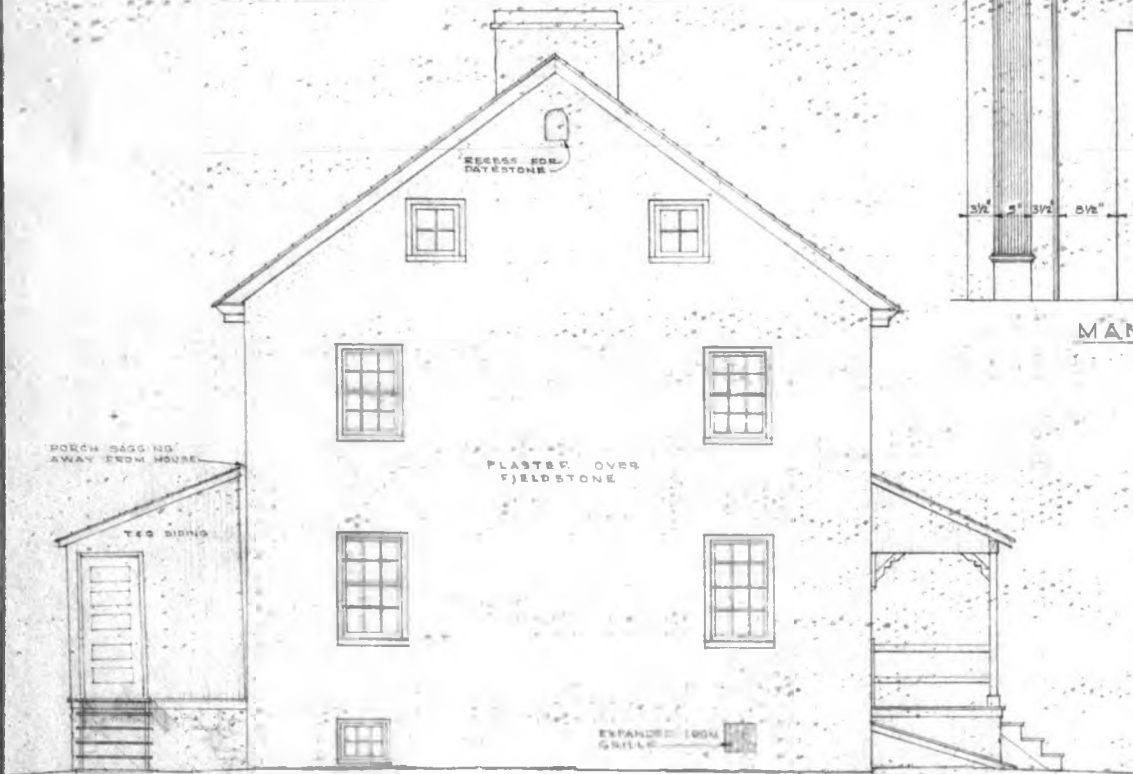
SOUTHEAST ELEVATION

The porches are later additions. The rear porch of more modern construction has deteriorated so as to have become unsafe because of the rotted condition of the joists, flooring and roof.

East elevation. At the left is the rear porch which is slipping away from the house and which must be replaced. The replacement to be in the period of the house.

As quarters, Building 71 requires maintenance. A late-period back porch, invisible from the road, needs complete replacement. Since EODC architect Norman Souder has drawings completed, repair of this house can proceed without loss of any feature.
