HISTORIC STRUCTURES REPORT
ARCHITECTURAL DATA, PART III

RESTORATION
OF
THE VILLAGE BARN

HOPSWELL VILLAGE NATIONAL HISTORIC SITE
Hopewell, Pa.

by
Norman M. Souder
Architect
November 1962

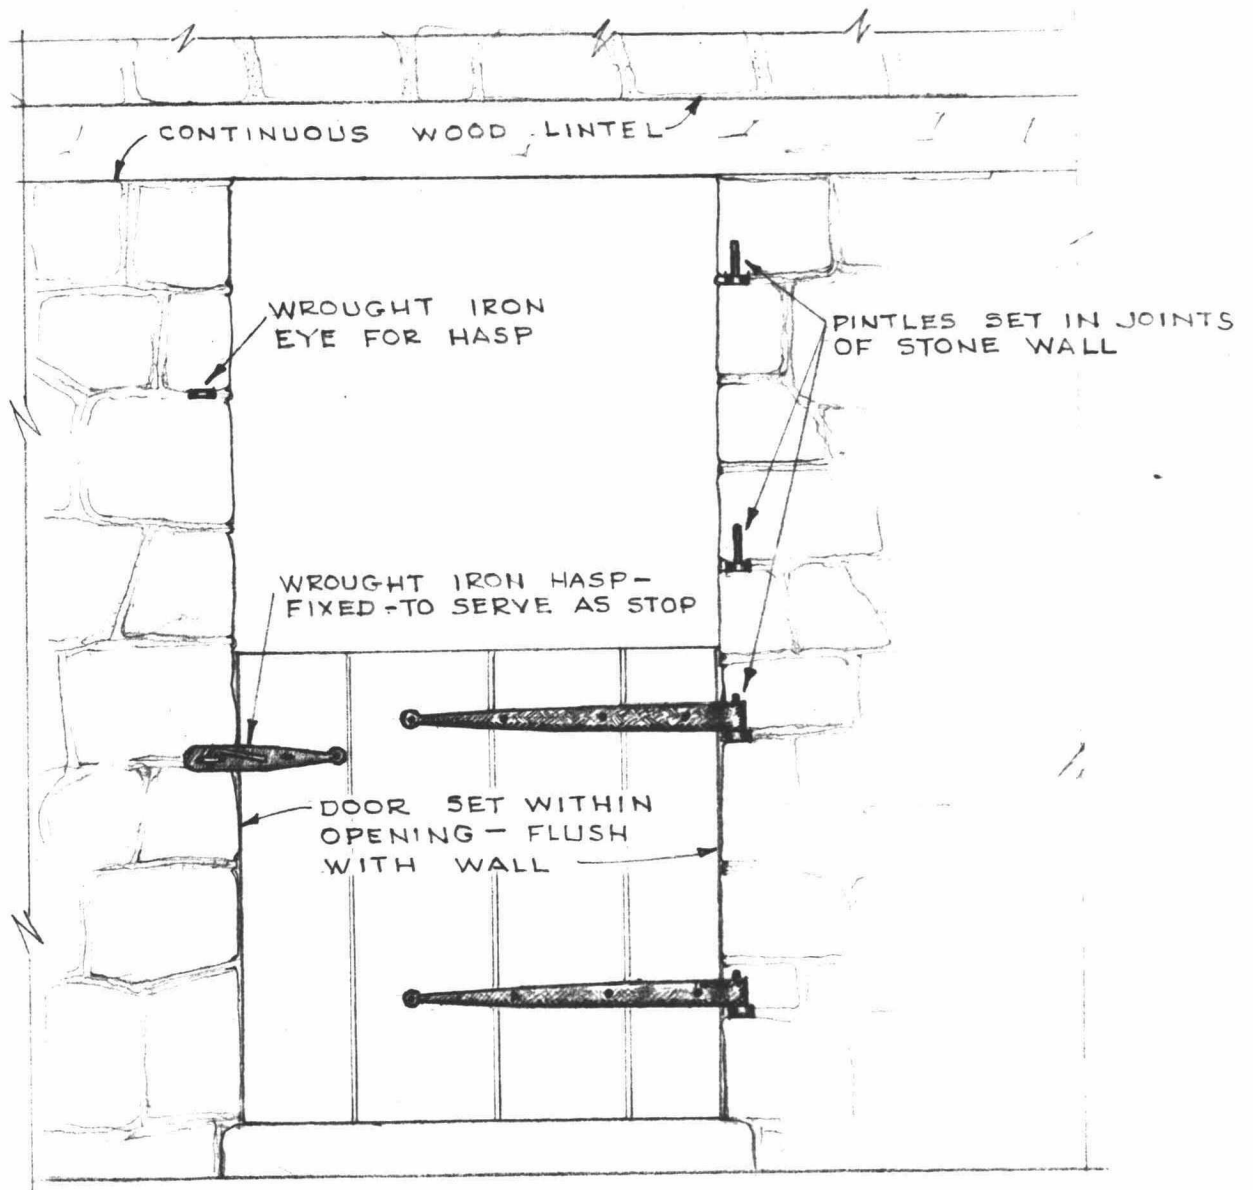
STONE JAMBS - STABLE DOORS

HASP EYE AND PINTLE WITH ANCHOR FOR SETTING IN STONE JOINTS. ORIGINALS WERE FOUND IN PLACE BUT BROKEN. COPIES WERE MADE FOR THE RESTORATION.

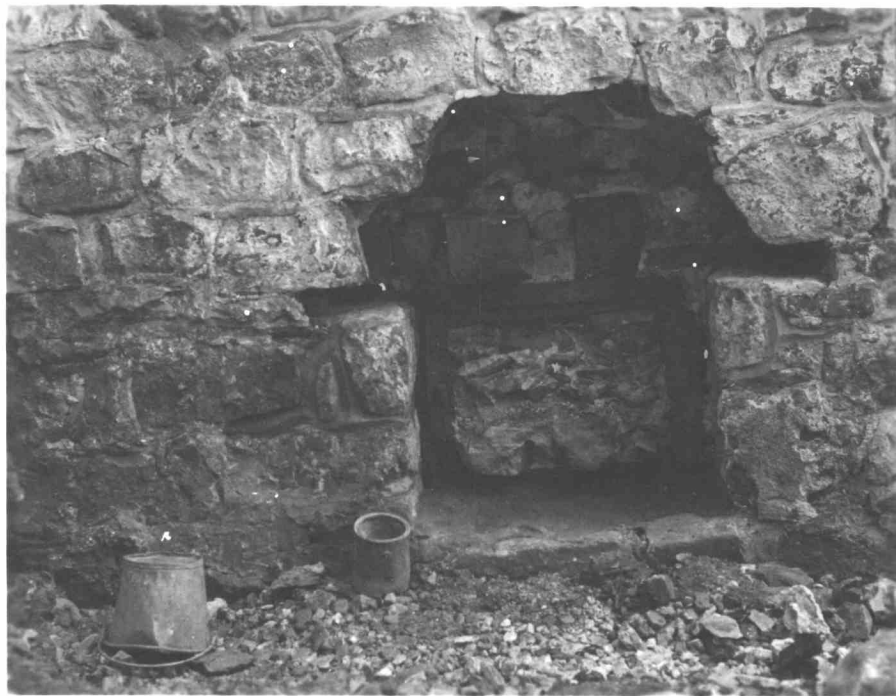
ILLUSTRATION NO. 2

Progress photo showing the demolition of modern barn, the stabilization of the stonework of the east wall and the stone arch restored.

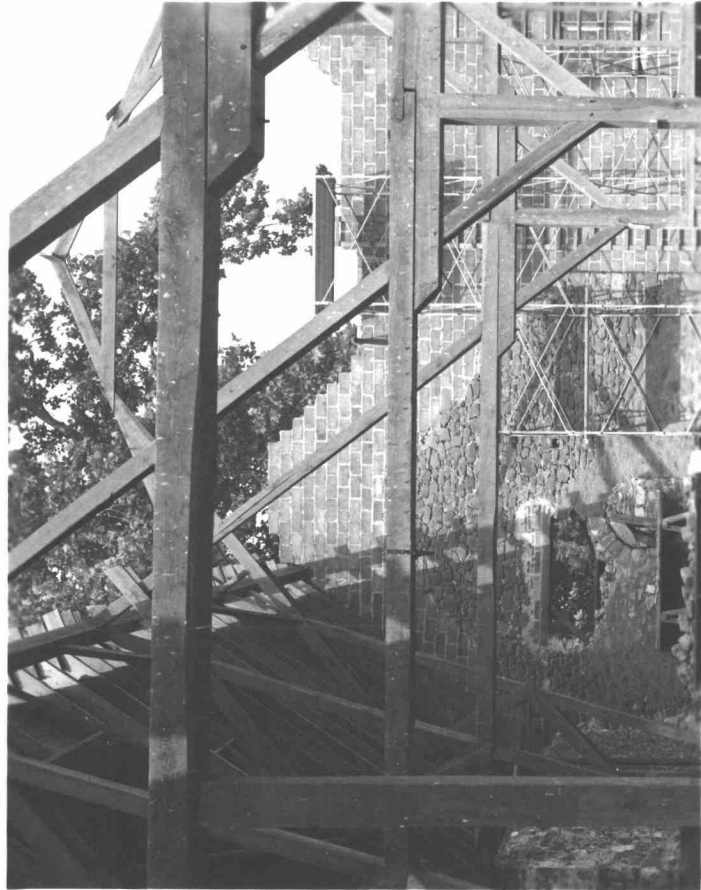
ILLUSTRATION 10

The modern barn is in the process of demolition. The half nearest the house contains the old barn walls. The south half was completely removed.

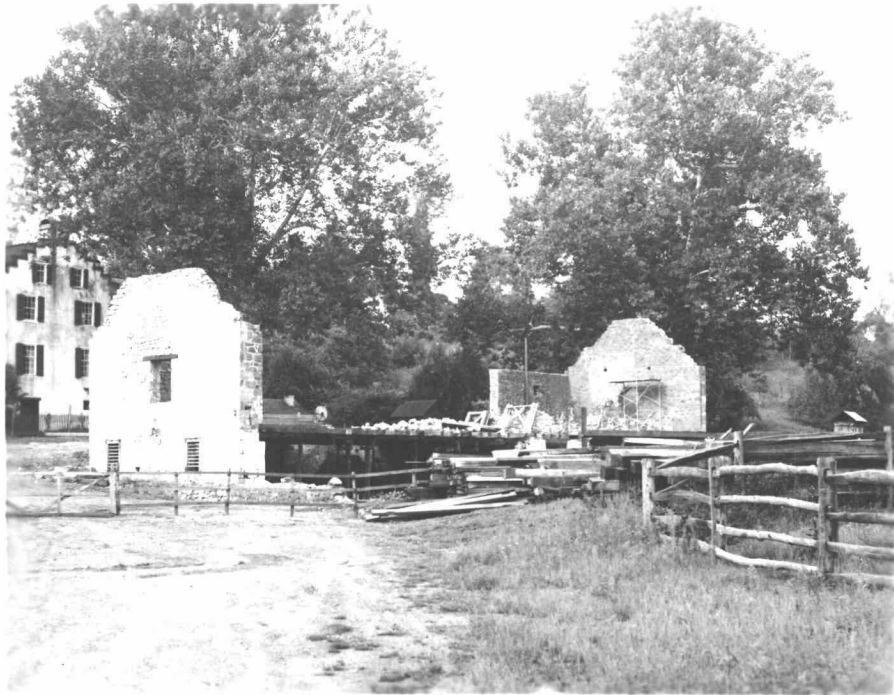
ILLUSTRATION NO. 19

The setting of the log joists-the first step in the erection of the framing. The poplar poles in the foreground later became pole rafters.

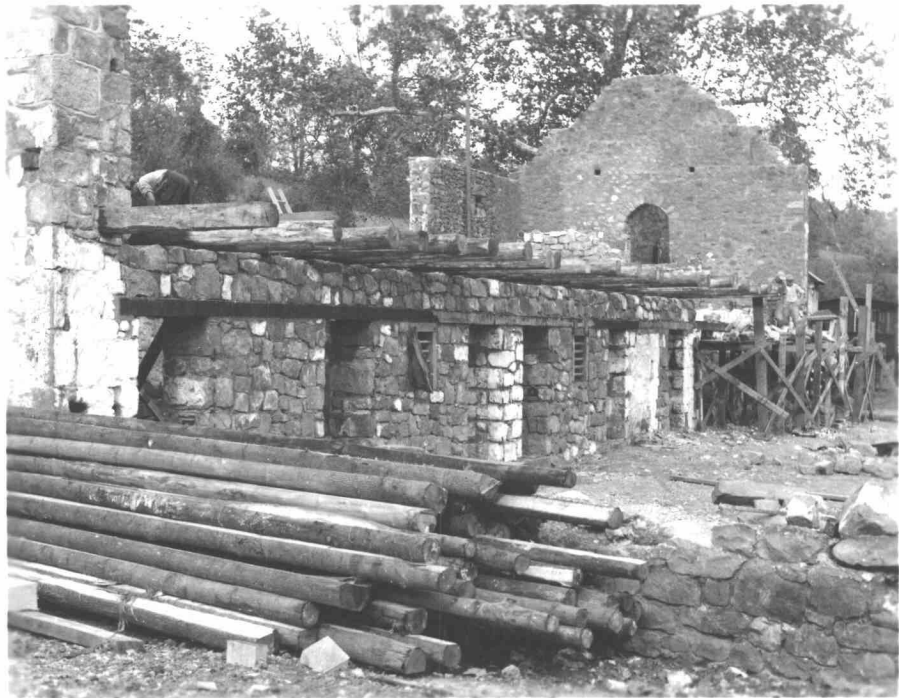
ILLUSTRATION NO. 20

The assembling of the framing section before it is raised into place. Note the recess left for the tie beam in the stone wall.

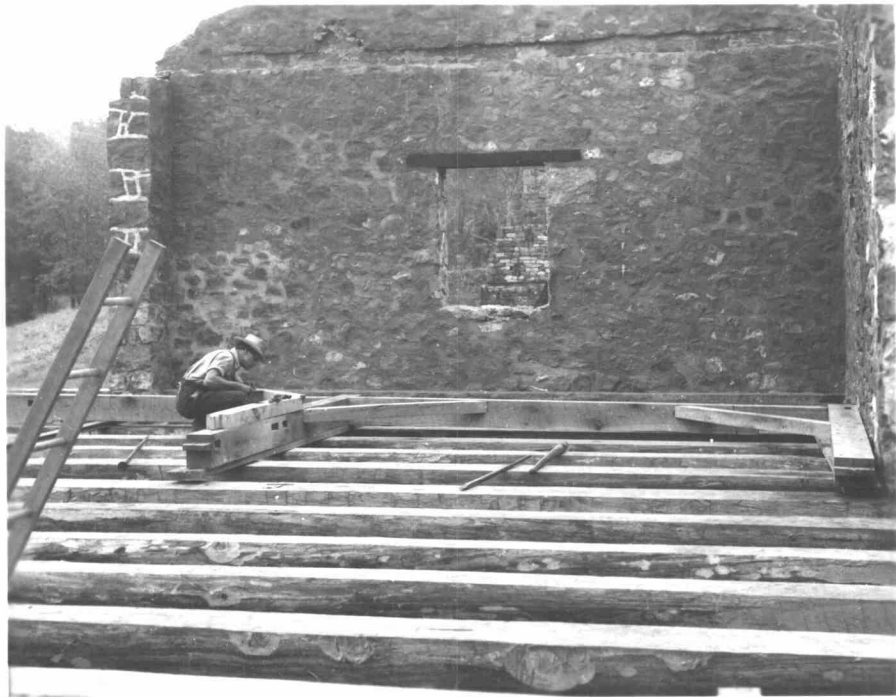
ILLUSTRATION NO. 21

The use of modern tools in an old method of construction.
Here a power saw is being used to cut tenons. A pile of
completed knee braces is at the left.

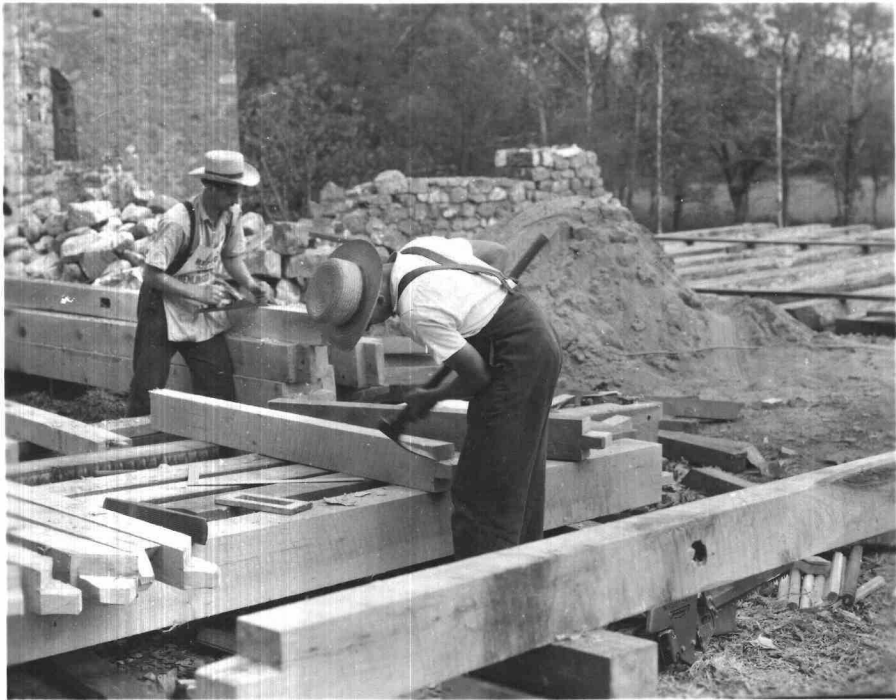
ILLUSTRATION NO. 23

The Amish crew preparing structural timbers.
The man at the right is using an adz to cut a splice.

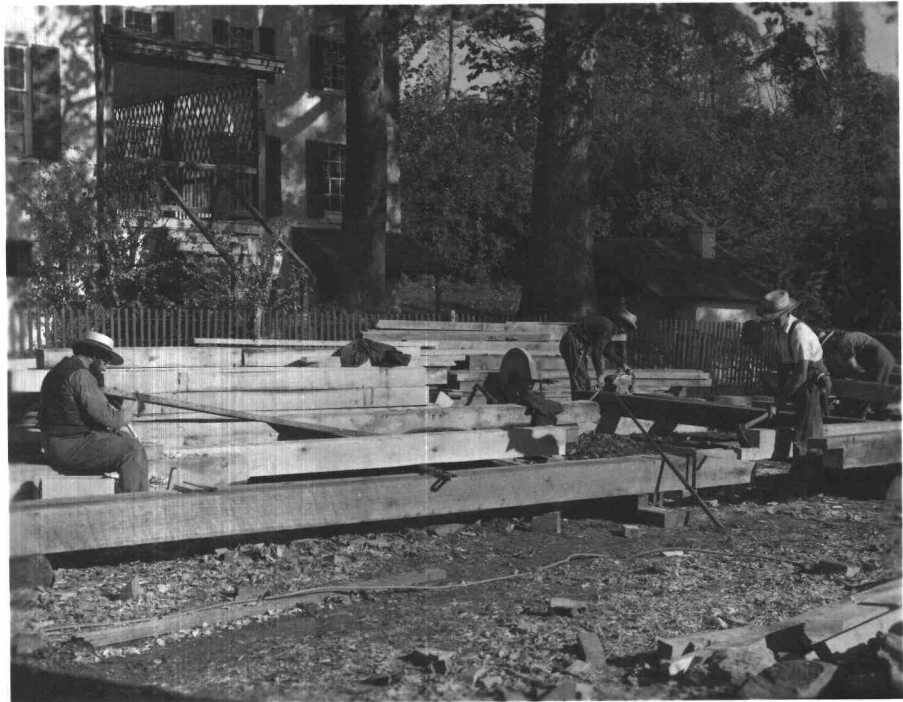
ILLUSTRATION NO. 24

The Amish crew preparing the lumber for erection.

The man in the center is making oak pins. The one on the left is cutting mortises.

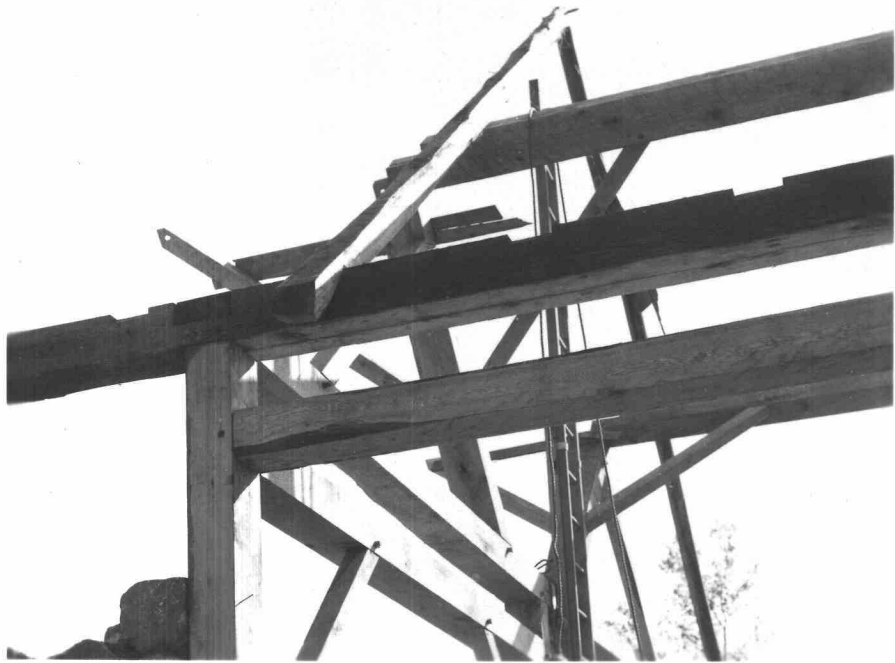
ILLUSTRATION NO. 26

Part of the framing in place. The plates and purlins in the first bay have been set.

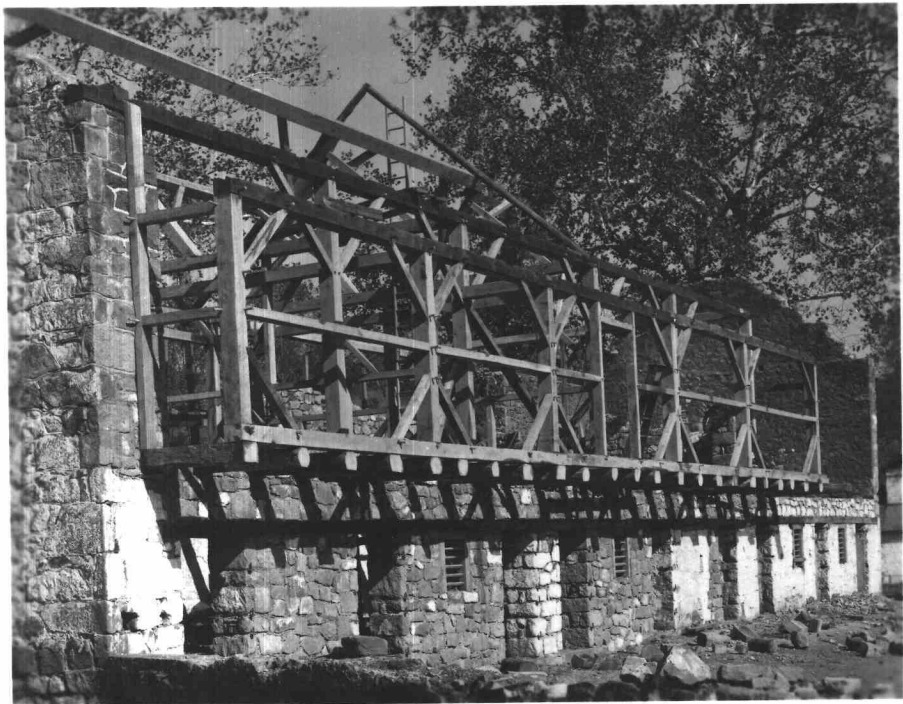
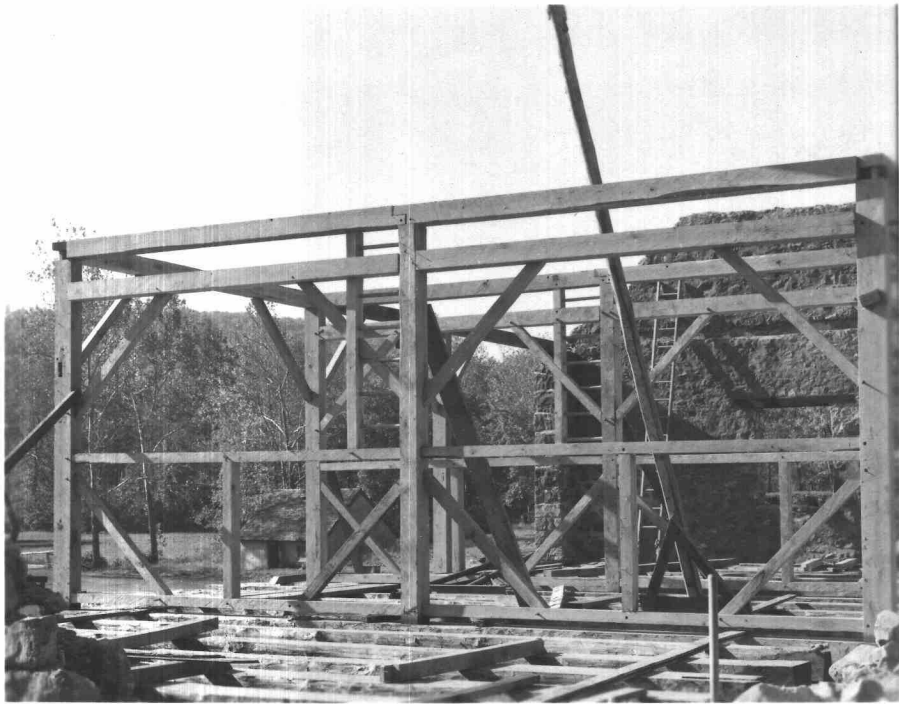
ILLUSTRATION NO. 27

Detail of framing--south side--showing mortise and tenon and lap joint at the plate line. The mortise lower on the upright is for the knee brace of the next section of framing.

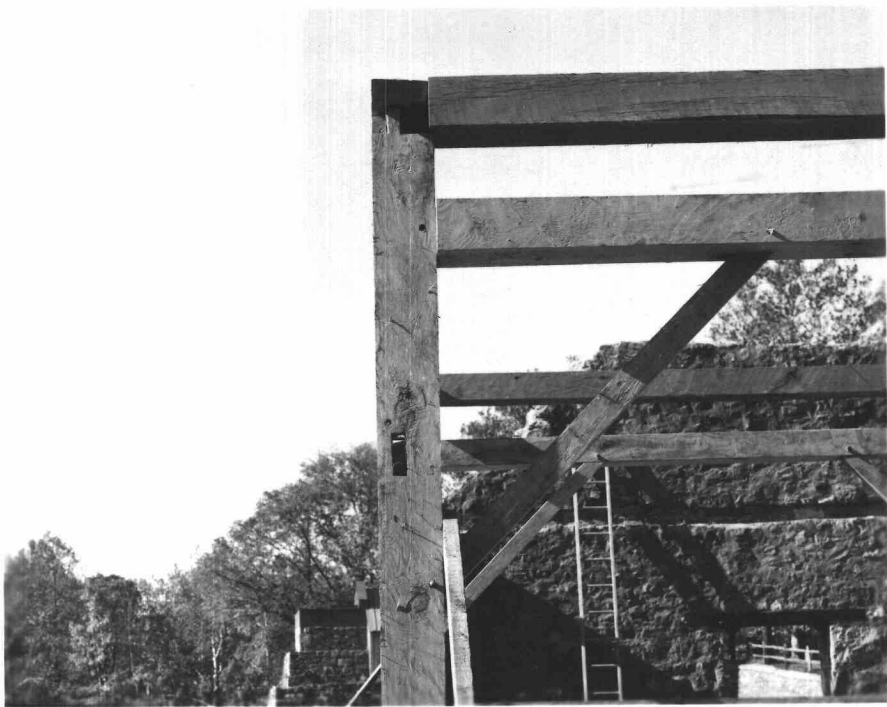
ILLUSTRATION NO. 28

The first two sections of framing in place.

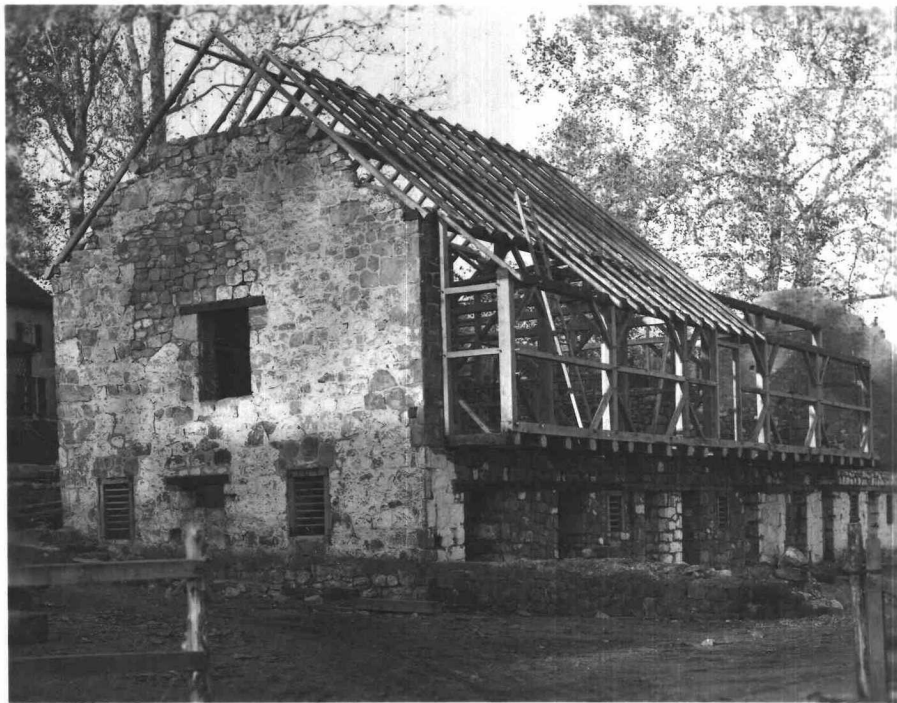
ILLUSTRATION NO. 30

The raising of the last section of framing
at the east end of the barn.

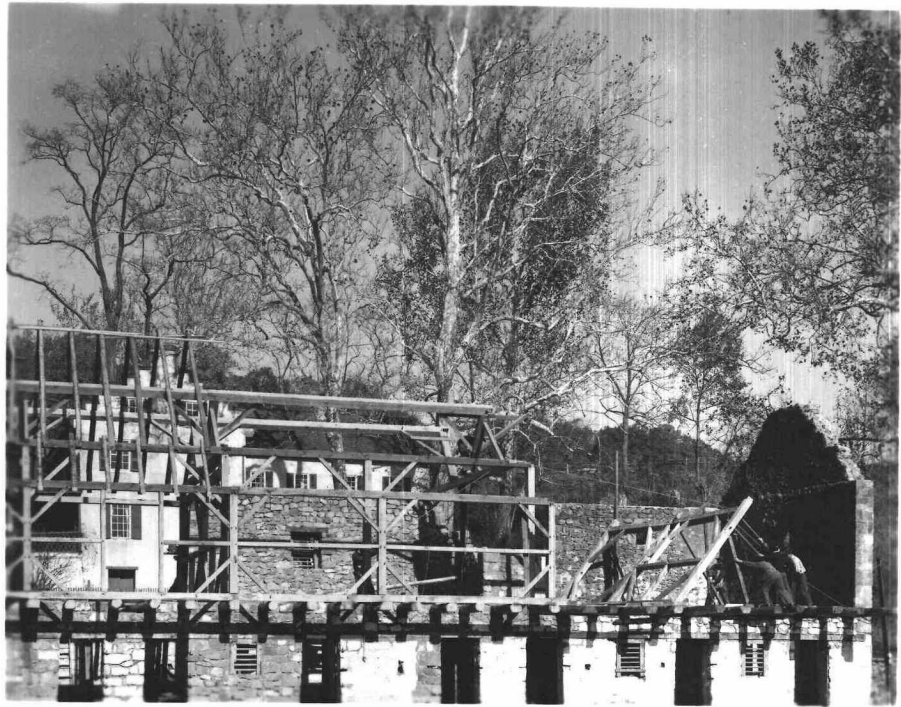
ILLUSTRATION NO. 31

Progress photo--The forebay siding and the
shingling lath are being applied.

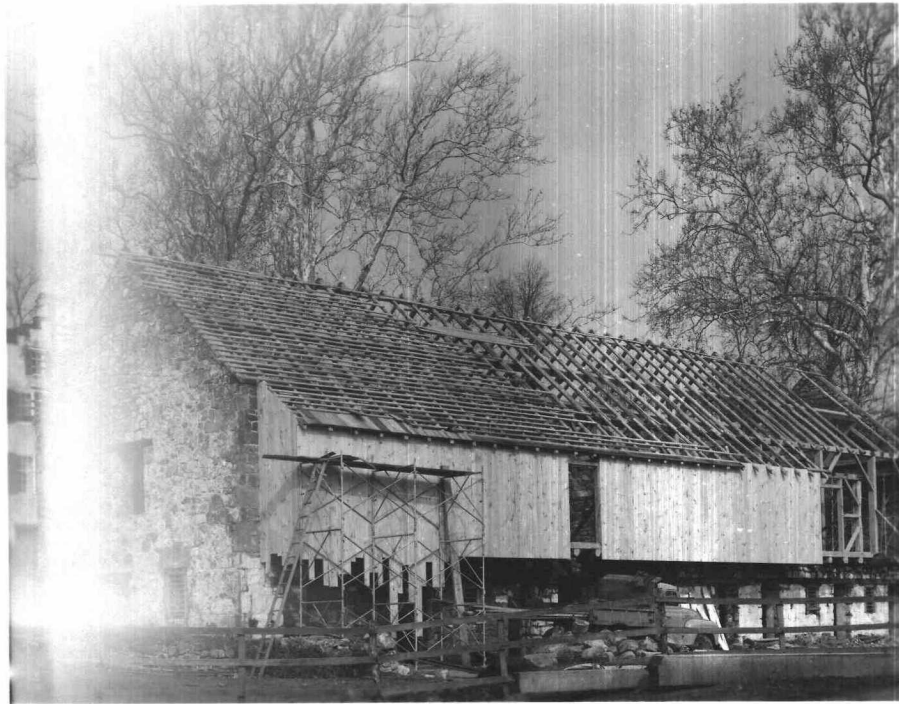
ILLUSTRATION NO. 32

View of the barn from the north during the restoration process. Here the rafter placing is nearly complete and the shingling begun. The Amish carpenters are in the foreground.

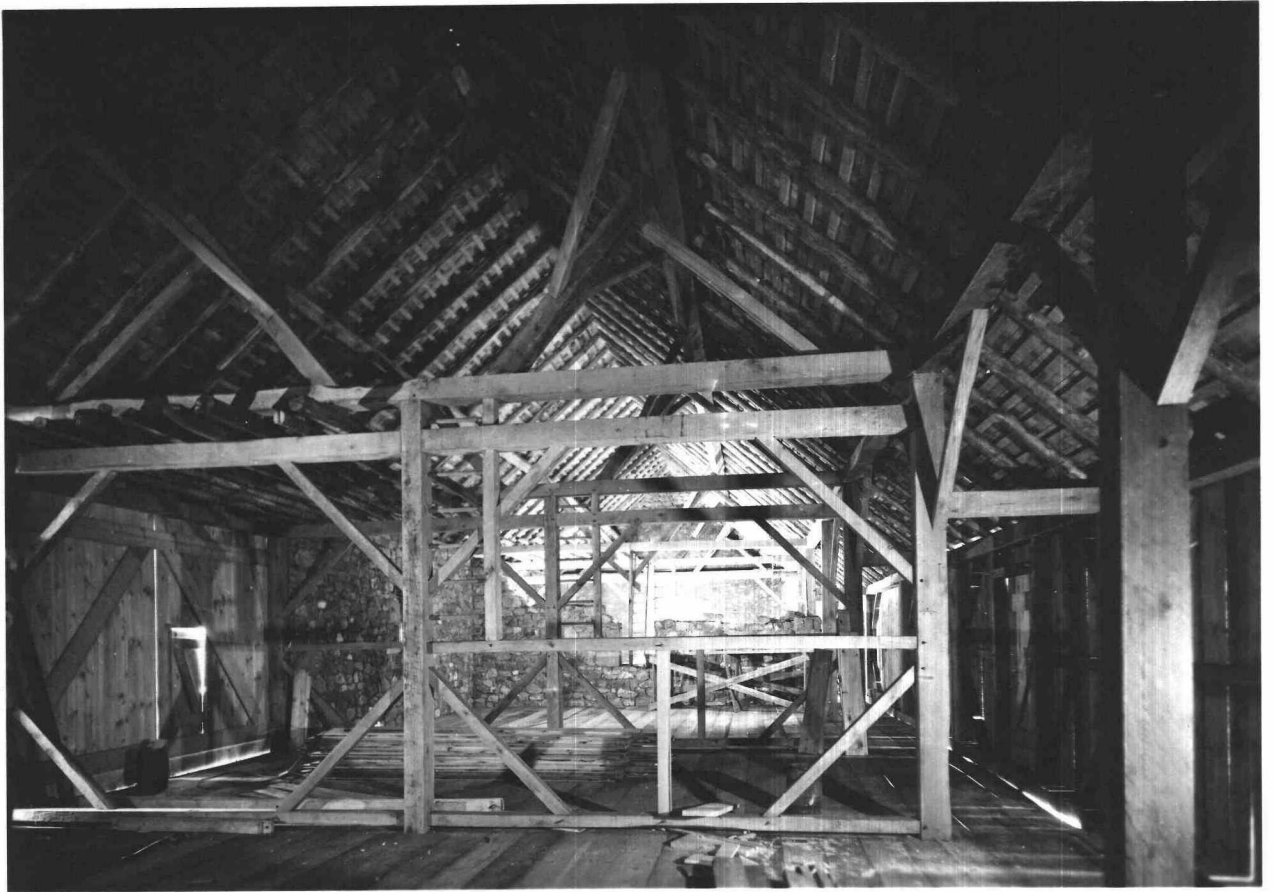
ILLUSTRATION NO. 34

Mow level, west end, showing roof framing,
shingling completed and sub flooring in place. The
enclosure at the left is the granary.

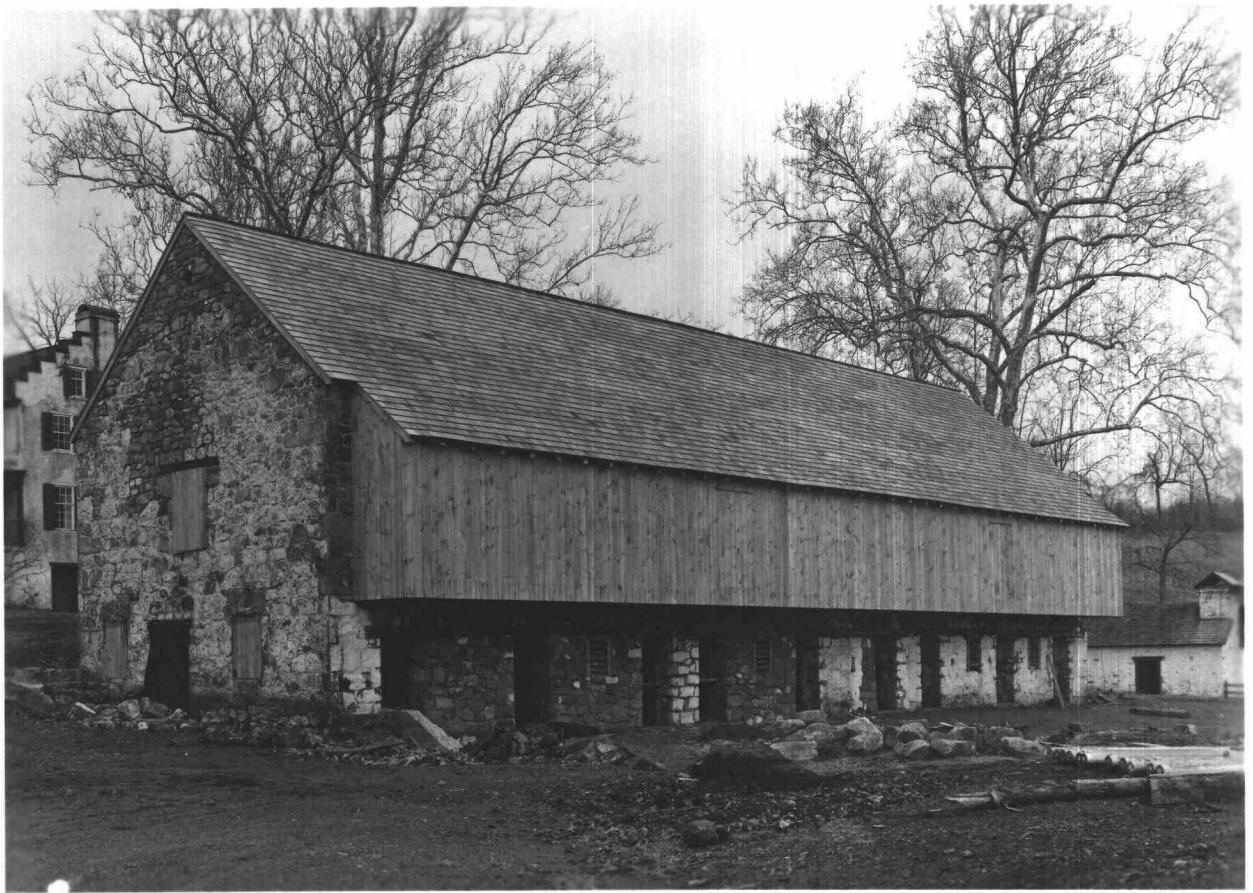
ILLUSTRATION NO. 45

The west end of the barn showing the regraded area between the Ironmaster's house and barn, and between the store shed (left) and the barn. The old west stable entrance has been restored. This was made possible by lowering the grade to its original level.

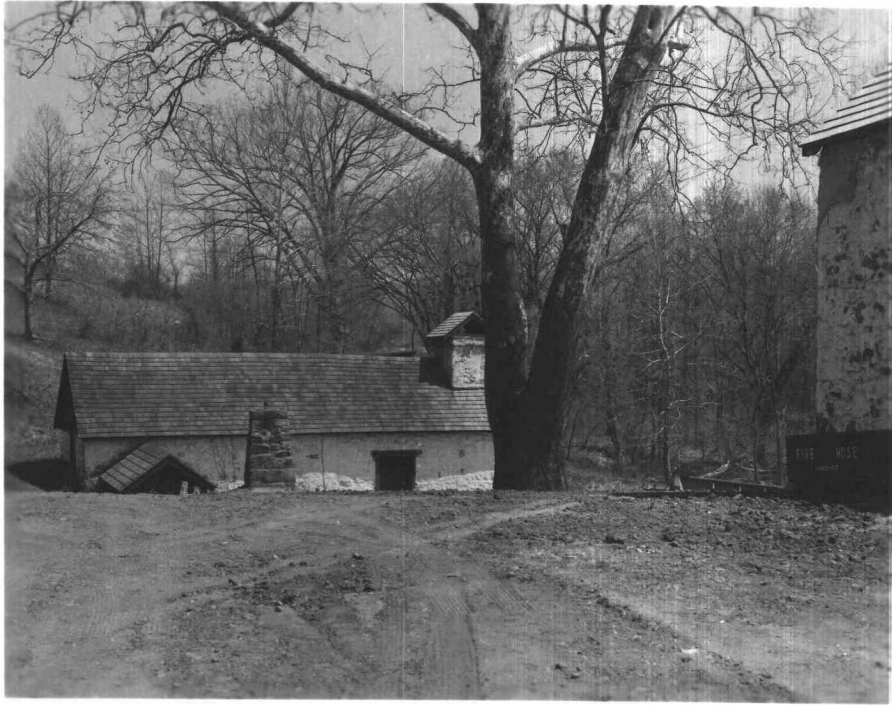
ILLUSTRATION NO. 47

East end of the barn after regrading. The stone retaining wall along the north wall of the barn and the north-south wall behind the drinking fountain have been removed.

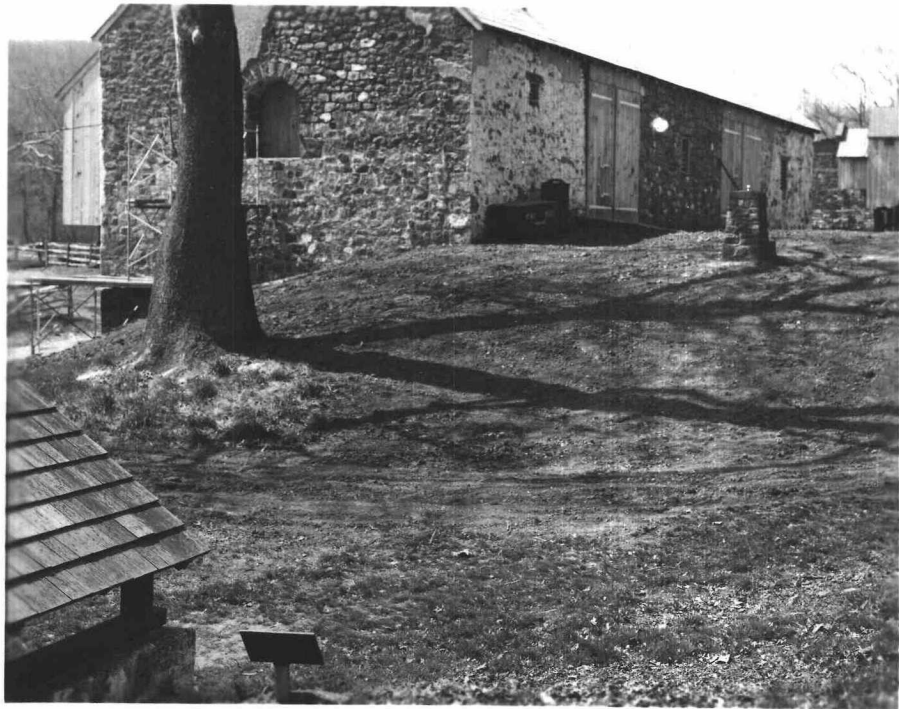
ILLUSTRATION NO. 48

In connection with the regrading of the area at the north of the barn the stone walls around the sycamores at the rear of the house were removed and the former grade restored on the south side of the Ironmaster's house.

Since this photo was taken a flight of stone steps was built by the superintendent between the two trees to the kitchen aresway.

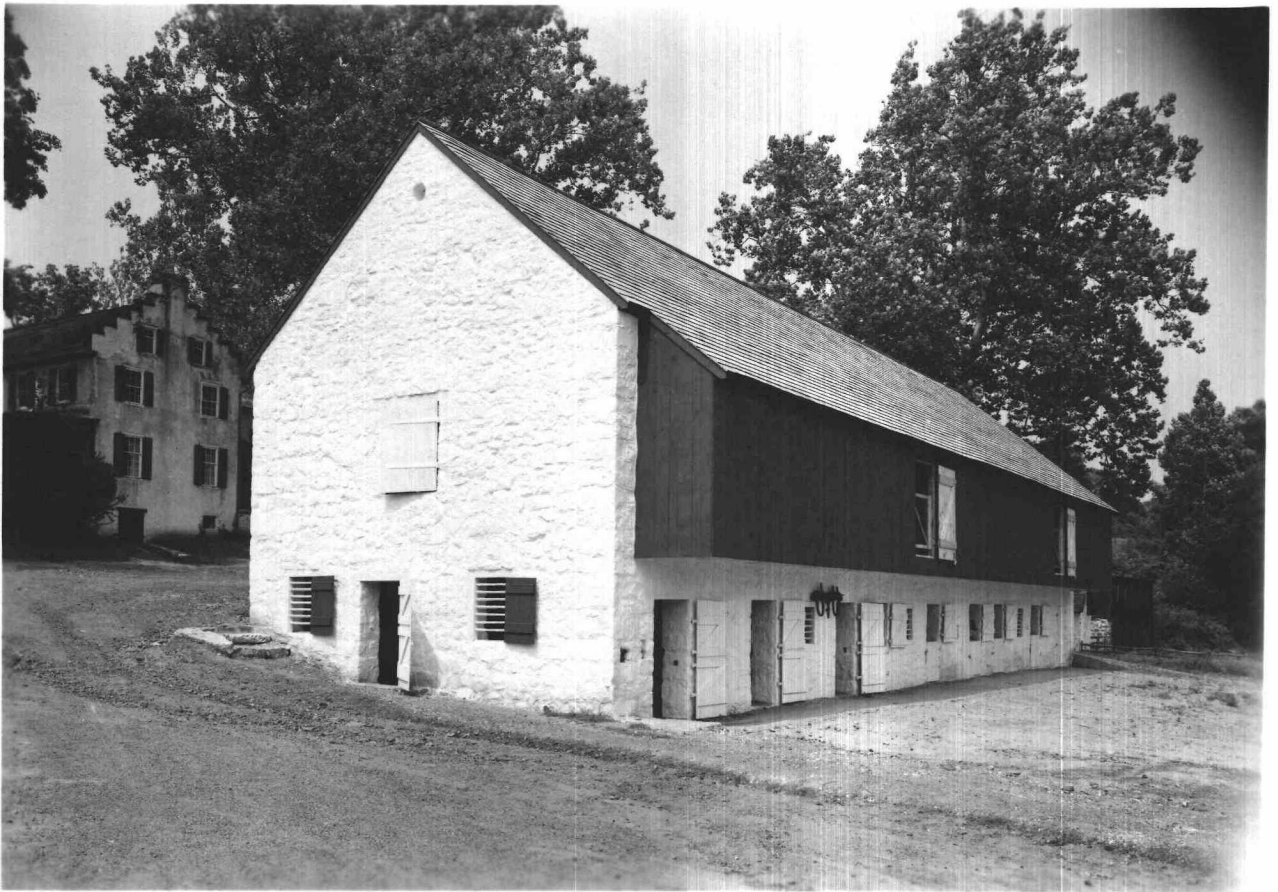
ILLUSTRATION NO. 50

The east and north elevations of the completed barn. The regrading has been completed and the stone drinking fountain in the left foreground retained for the convenience of the visitors.
