HISTORIC STRUCTURES REPORT

RESTORATION OF THE VILLAGE BARN - STRUCTURE NO. 2

HOPWELL VILLAGE NATIONAL HISTORIC SITE

DECEMBER 11, 1962

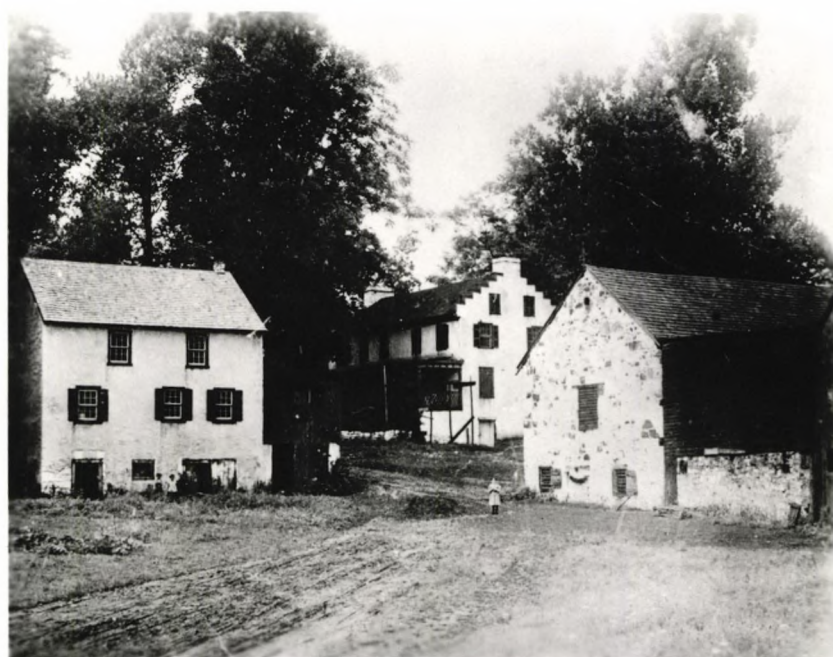
ILLUSTRATION NO. 2

The west side of the barn showing the original structure before the 1926 dairy barn was constructed over it as shown in this Stauffer photo dated 1920.

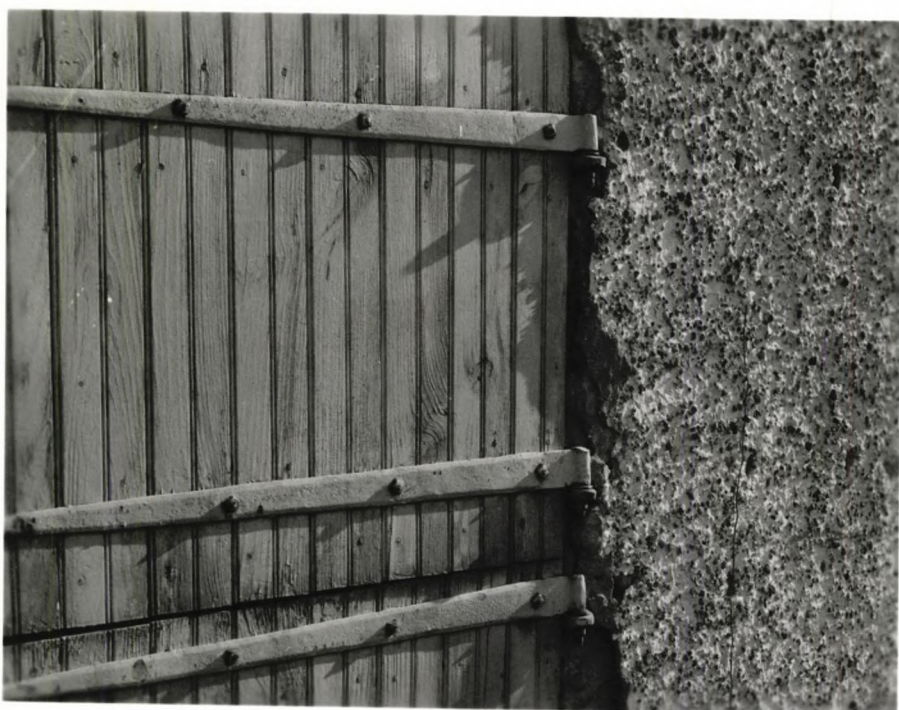
ILLUSTRATION NO. 6

Stable door Charles Messner farm, Gibraltar, indicating examples of early wrought barn hardware. The hasp and hook shown here is arranged to drop. The hasp on the Hopewell barn had to be fixed to serve as a stop against the stone jamb.

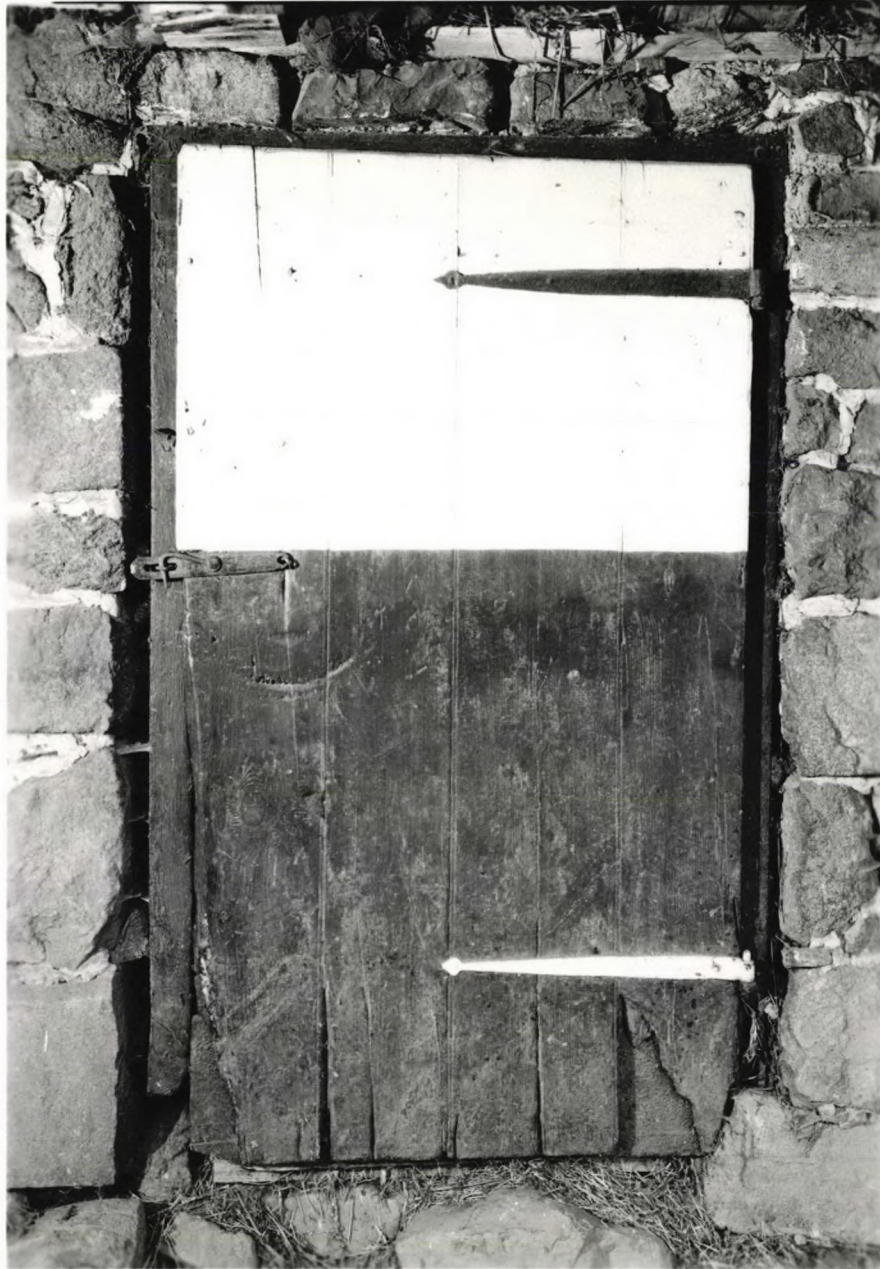
ILLUSTRATION NO. 7

Barred window and solid frame with the typical stone sill. Barn at "Norleigh," Lionville, Chester County, Pa. Several similar jambs with the bars missing were intact in the old walls at Hopewell.

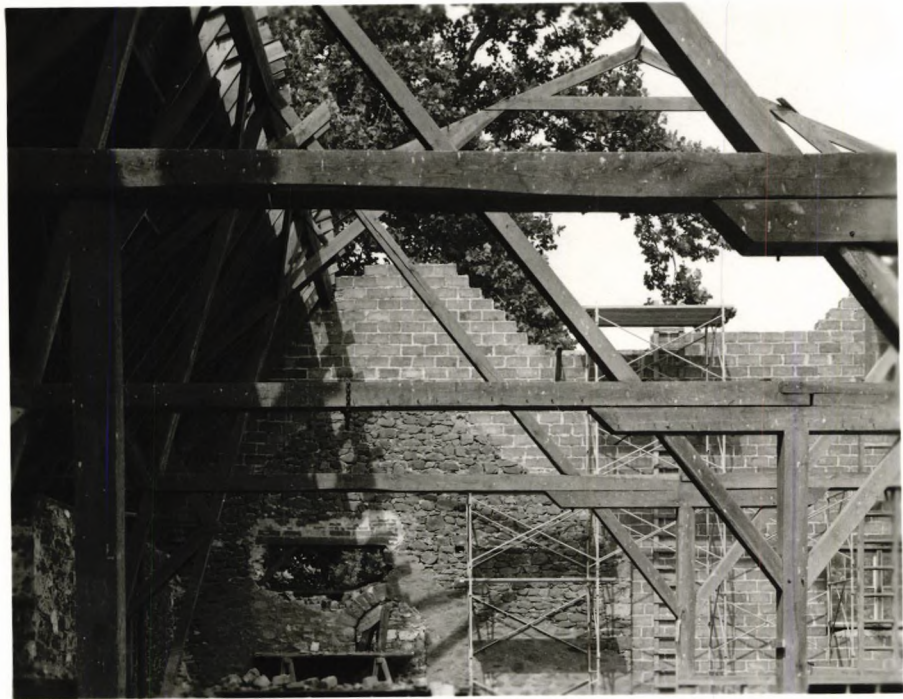
ILLUSTRATION 10

The modern barn in the process of demolition. The half nearest the house contains the old barn walls. The south half was completely removed.

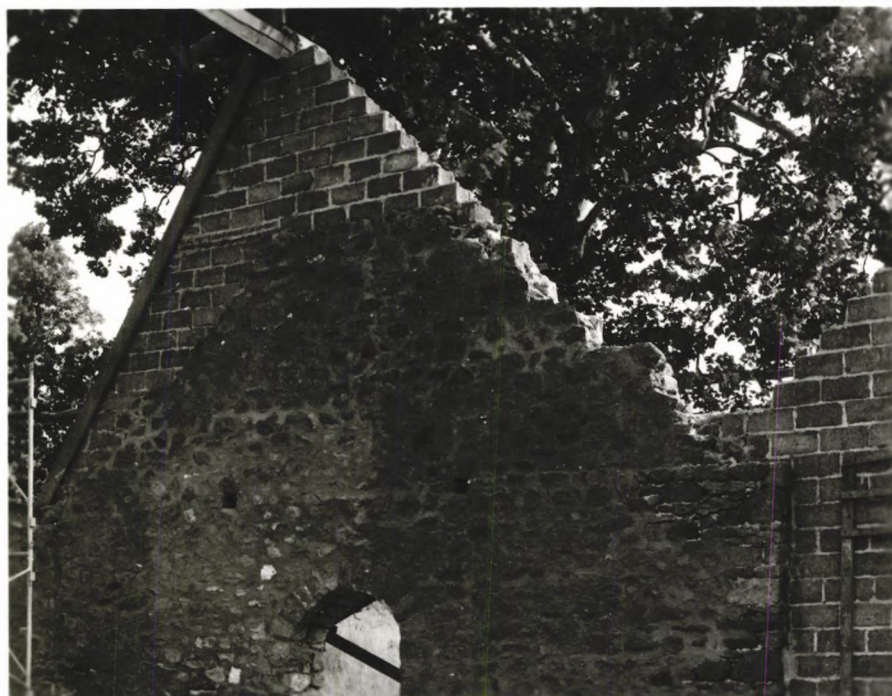
#13

The stone east wall stabilized before the modern
portion was completely removed.

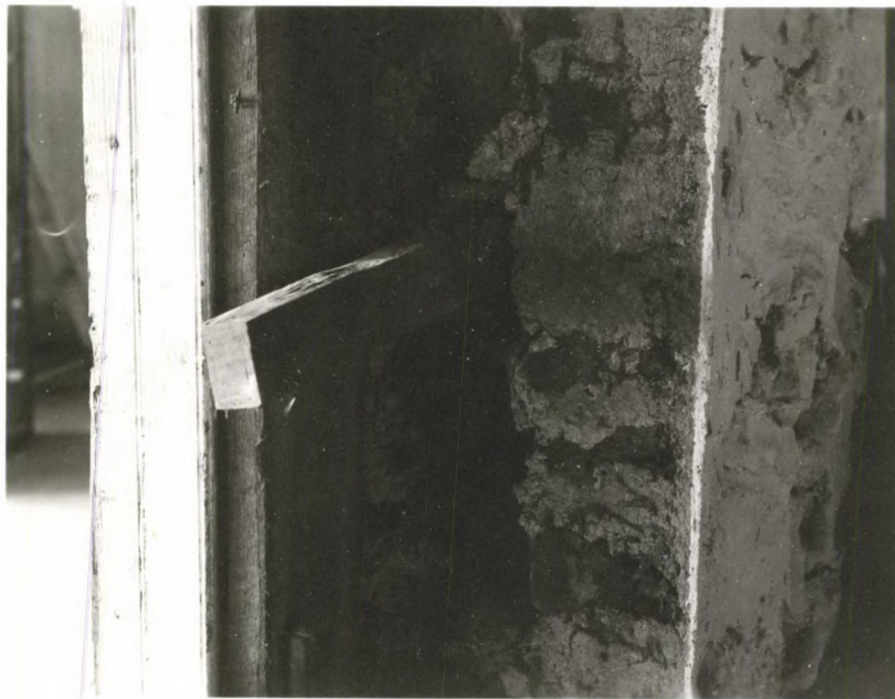
#15

The remains of the wood draw bar found in the jamb
of the enlarged doorway.

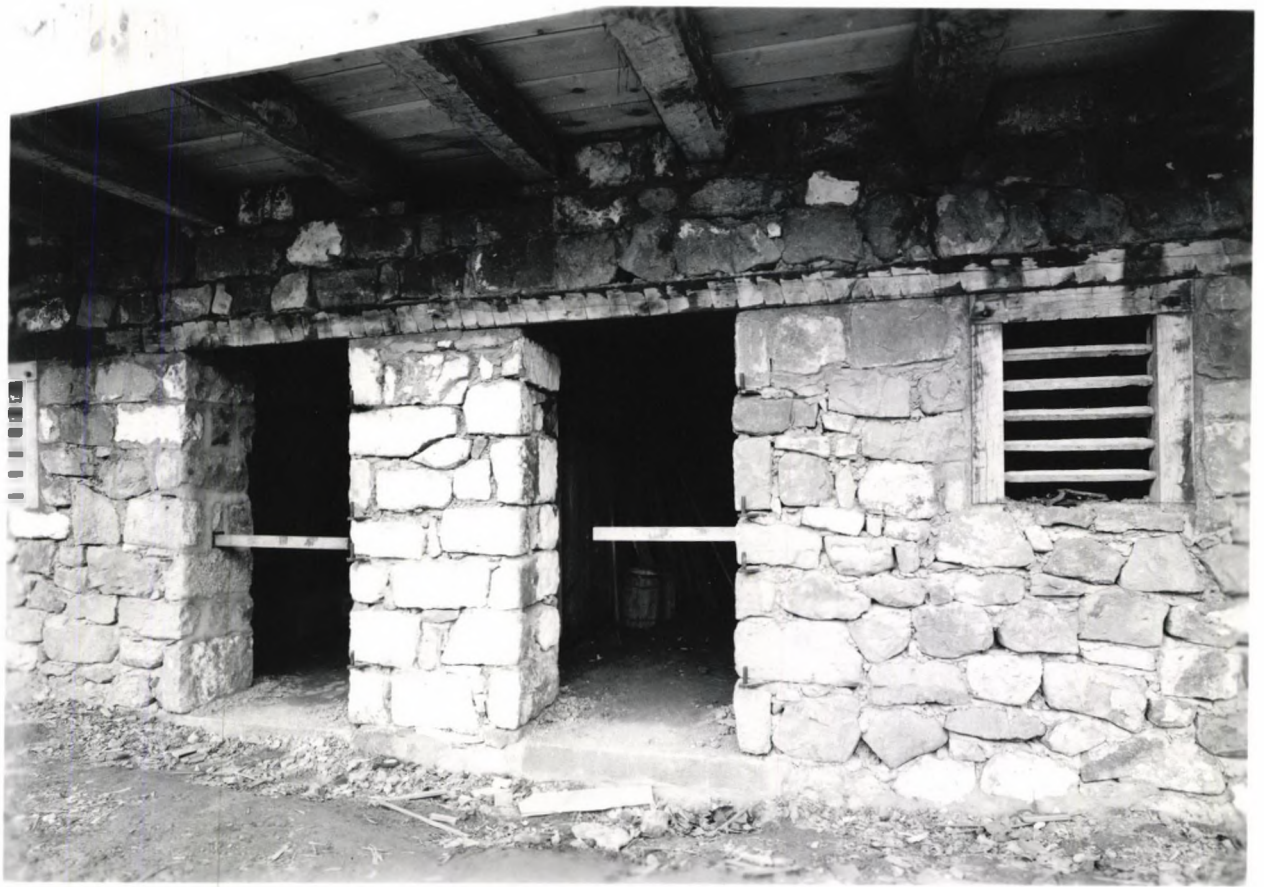
ILLUSTRATION NO. 18

The old stone portions remaining after the removal
of the modern barn.

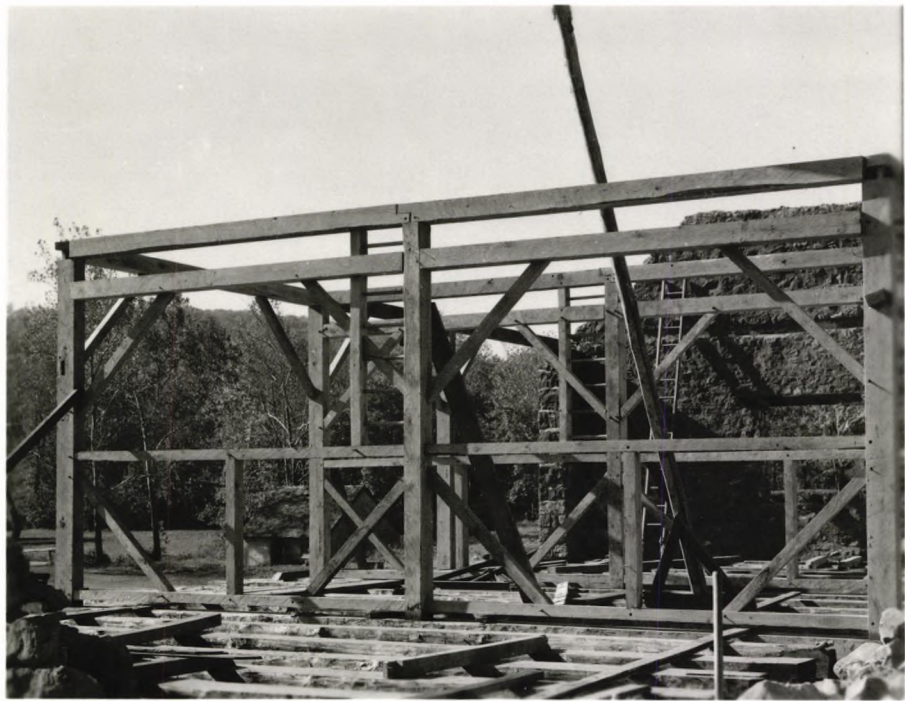
ILLUSTRATION NO. 29

The barn framing being started at the west end.
The rafters were erected as the framing progressed.

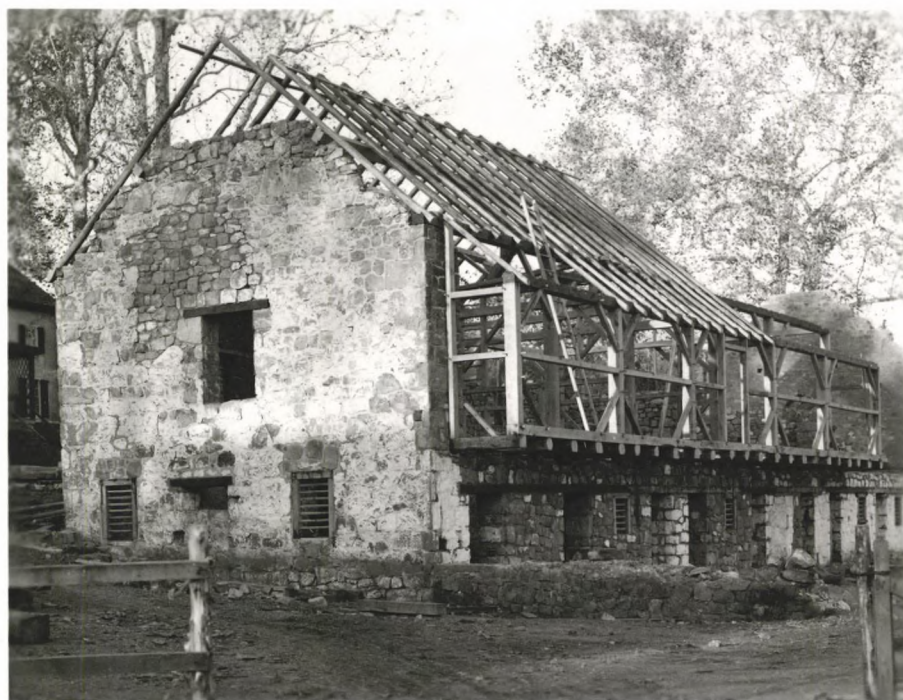
ILLUSTRATION NO. 30

The raising of the last section of framing
at the east end of the barn.

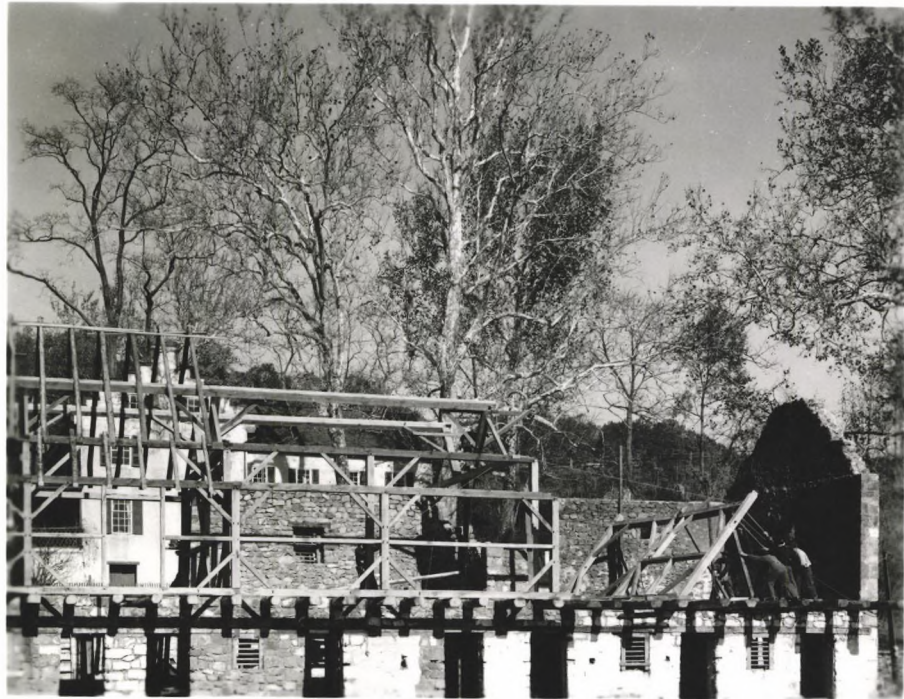
ILLUSTRATION NO. 31

Progress photo--The forebay siding and the
shingling lath are being applied.

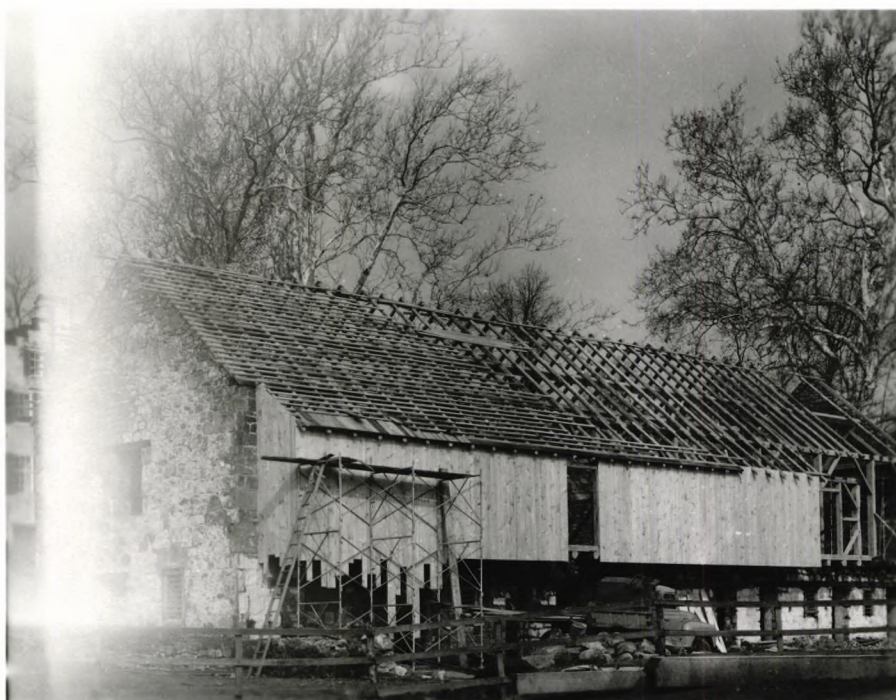
ILLUSTRATION NO. 32

View of the barn from the north during the restoration process. Here the rafter placing is nearly complete and the shingling begun. The Amish carpenters are in the foreground.

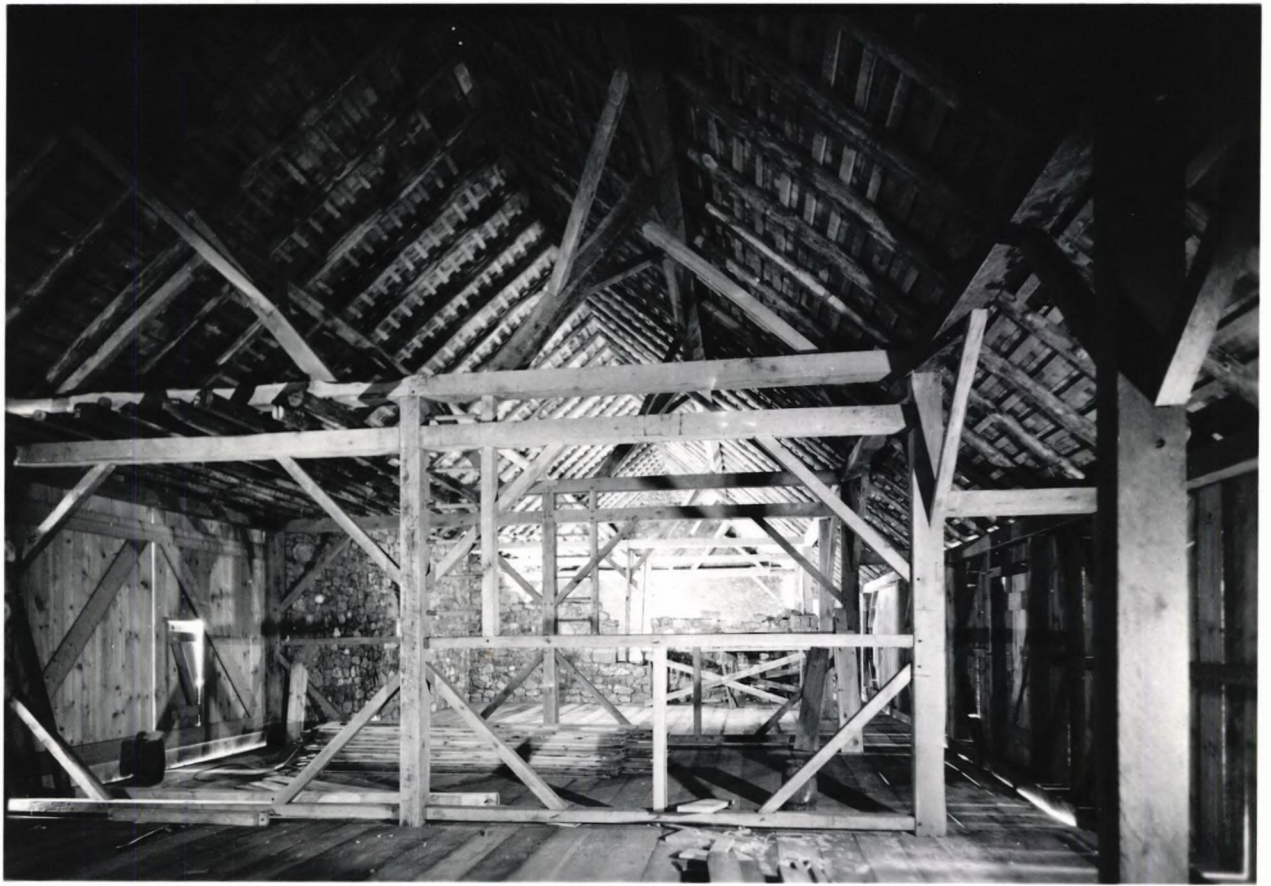
ILLUSTRATION NO. 34

Mow level, west end, showing roof framing,
shingling completed and sub flooring in place. The
enclosure at the left is the granary.

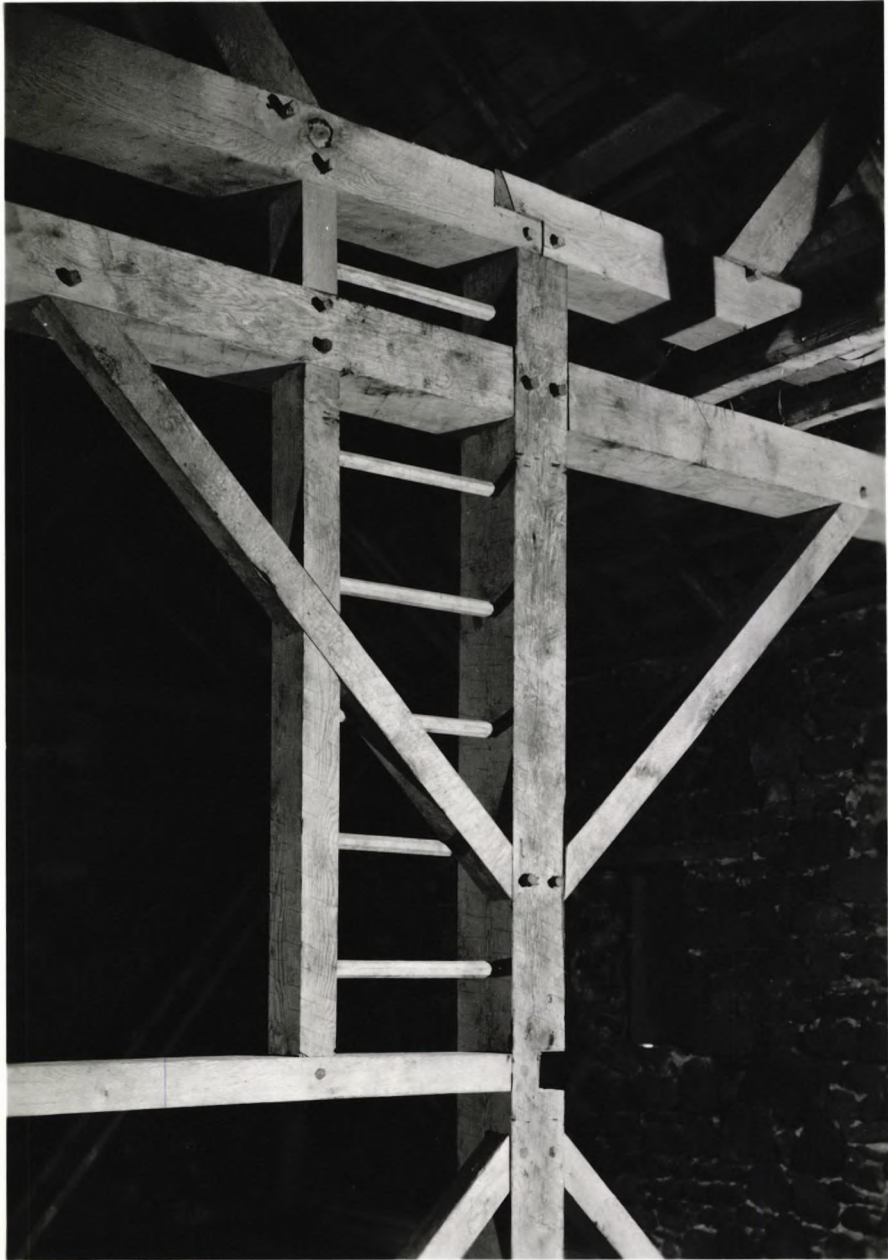
ILLUSTRATION NO. 40

Stable level framing showing the log joists,
beam and manger ties in place.

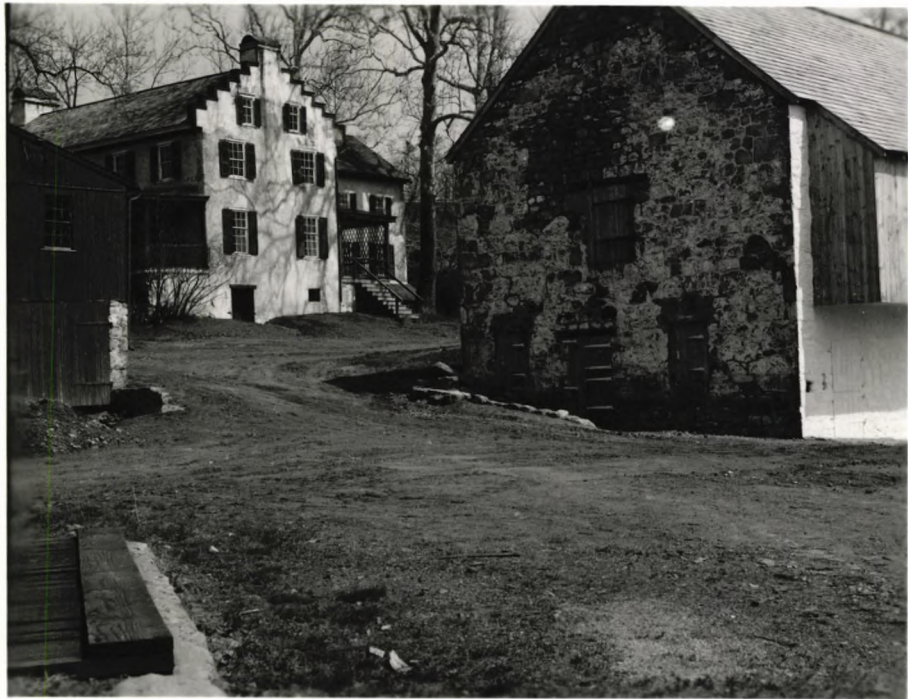
ILLUSTRATION NO. 46

East end of the barn after retaining walls were removed and the old grade was restored.

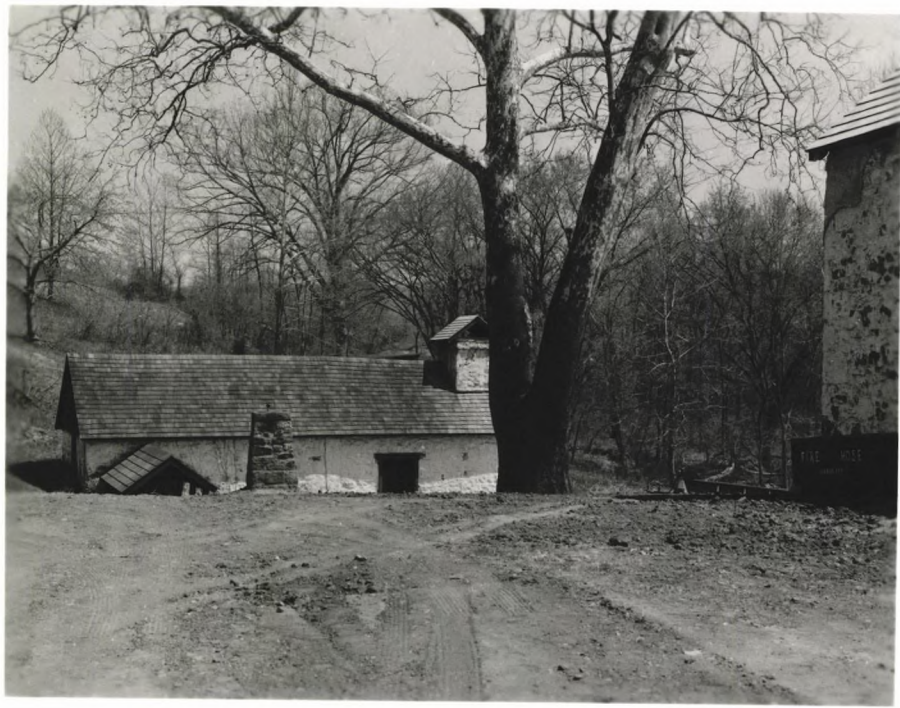
ILLUSTRATION NO. 47

East end of the barn after regrading. The stone retaining wall along the north wall of the barn and the north-south wall behind the drinking fountain have been removed.

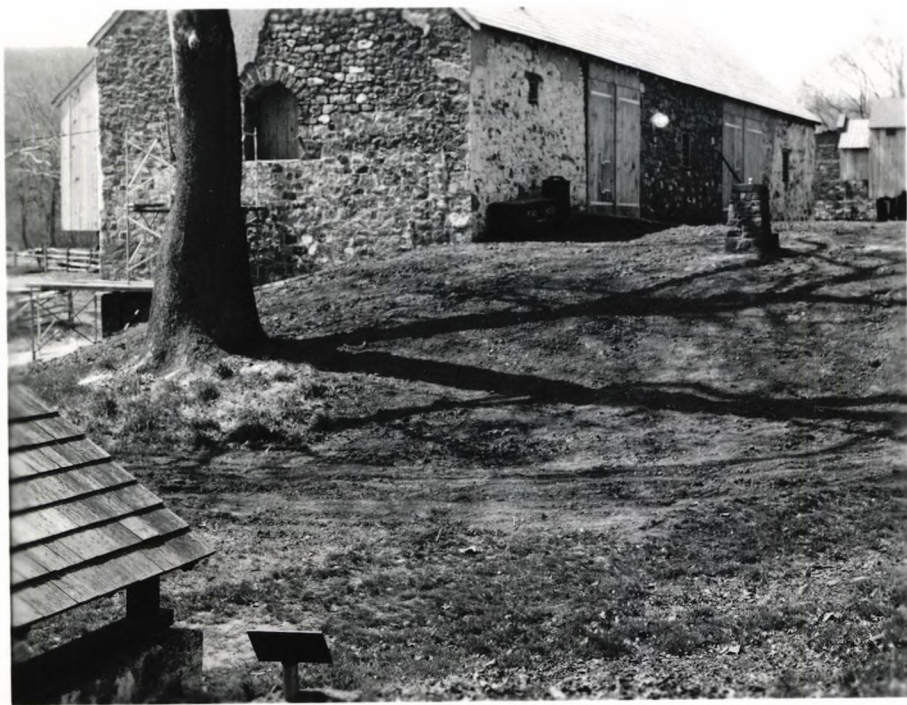
ILLUSTRATION NO. 48

In connection with the regrading of the area at the north of the barn the stone walls around the sycamores at the rear of the house were removed and the former grade restored on the south side of the Ironmaster's house.

Since this photo was taken a flight of stone steps was built by the superintendent between the two trees to the kitchen areaway.

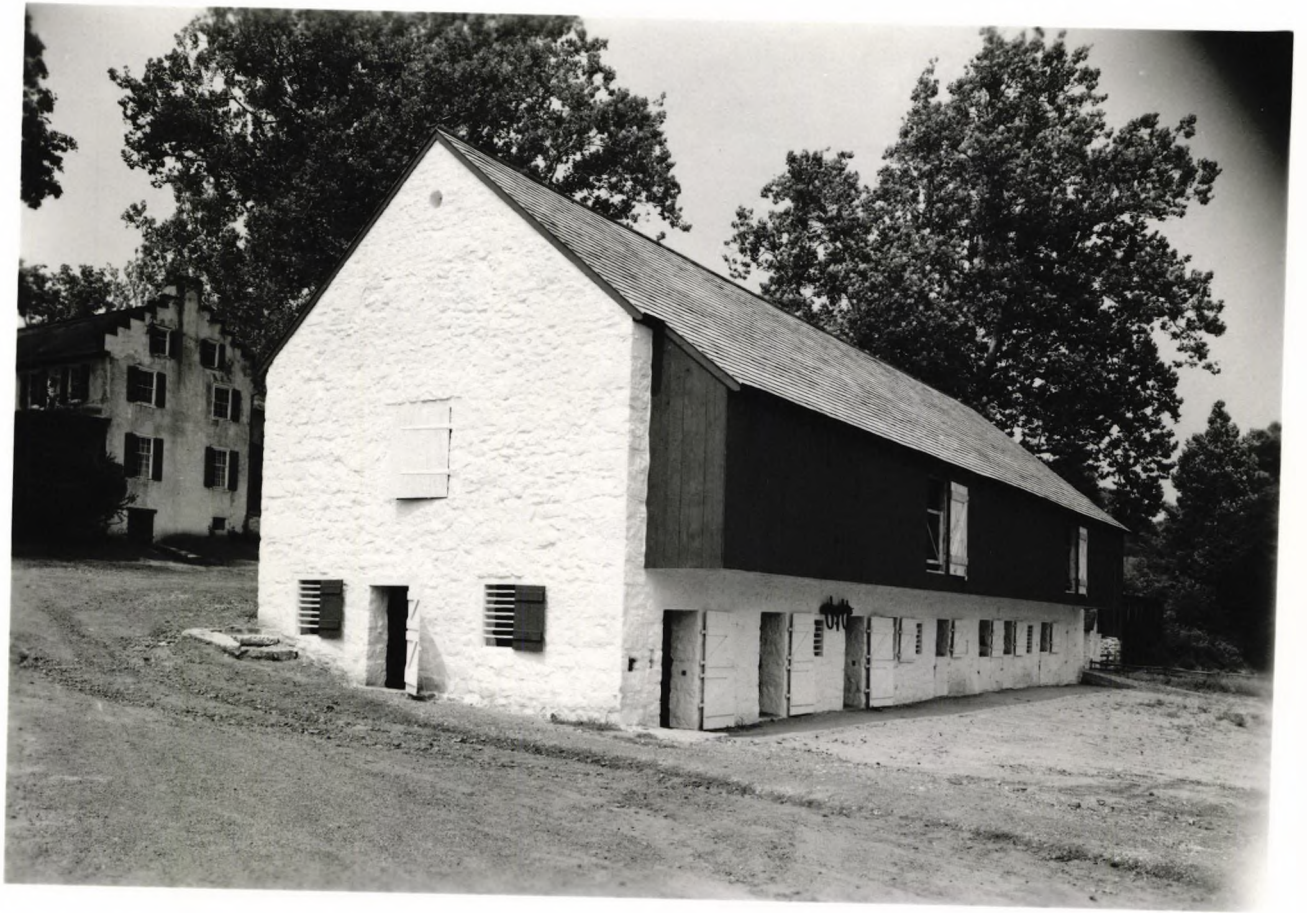
ILLUSTRATION NO. 50

The east and north elevations of the completed barn. The regrading has been completed and the stone drinking fountain in the left foreground retained for the convenience of the visitors.
