STRUCTURAL REPORT
FOR THE
BILLINGS CARRIAGE BARN
WOODSTOCK, VERMONT

MARCH 30, 1988

Billings Carriage Barn
Woodstock, Vermont
Project #8806

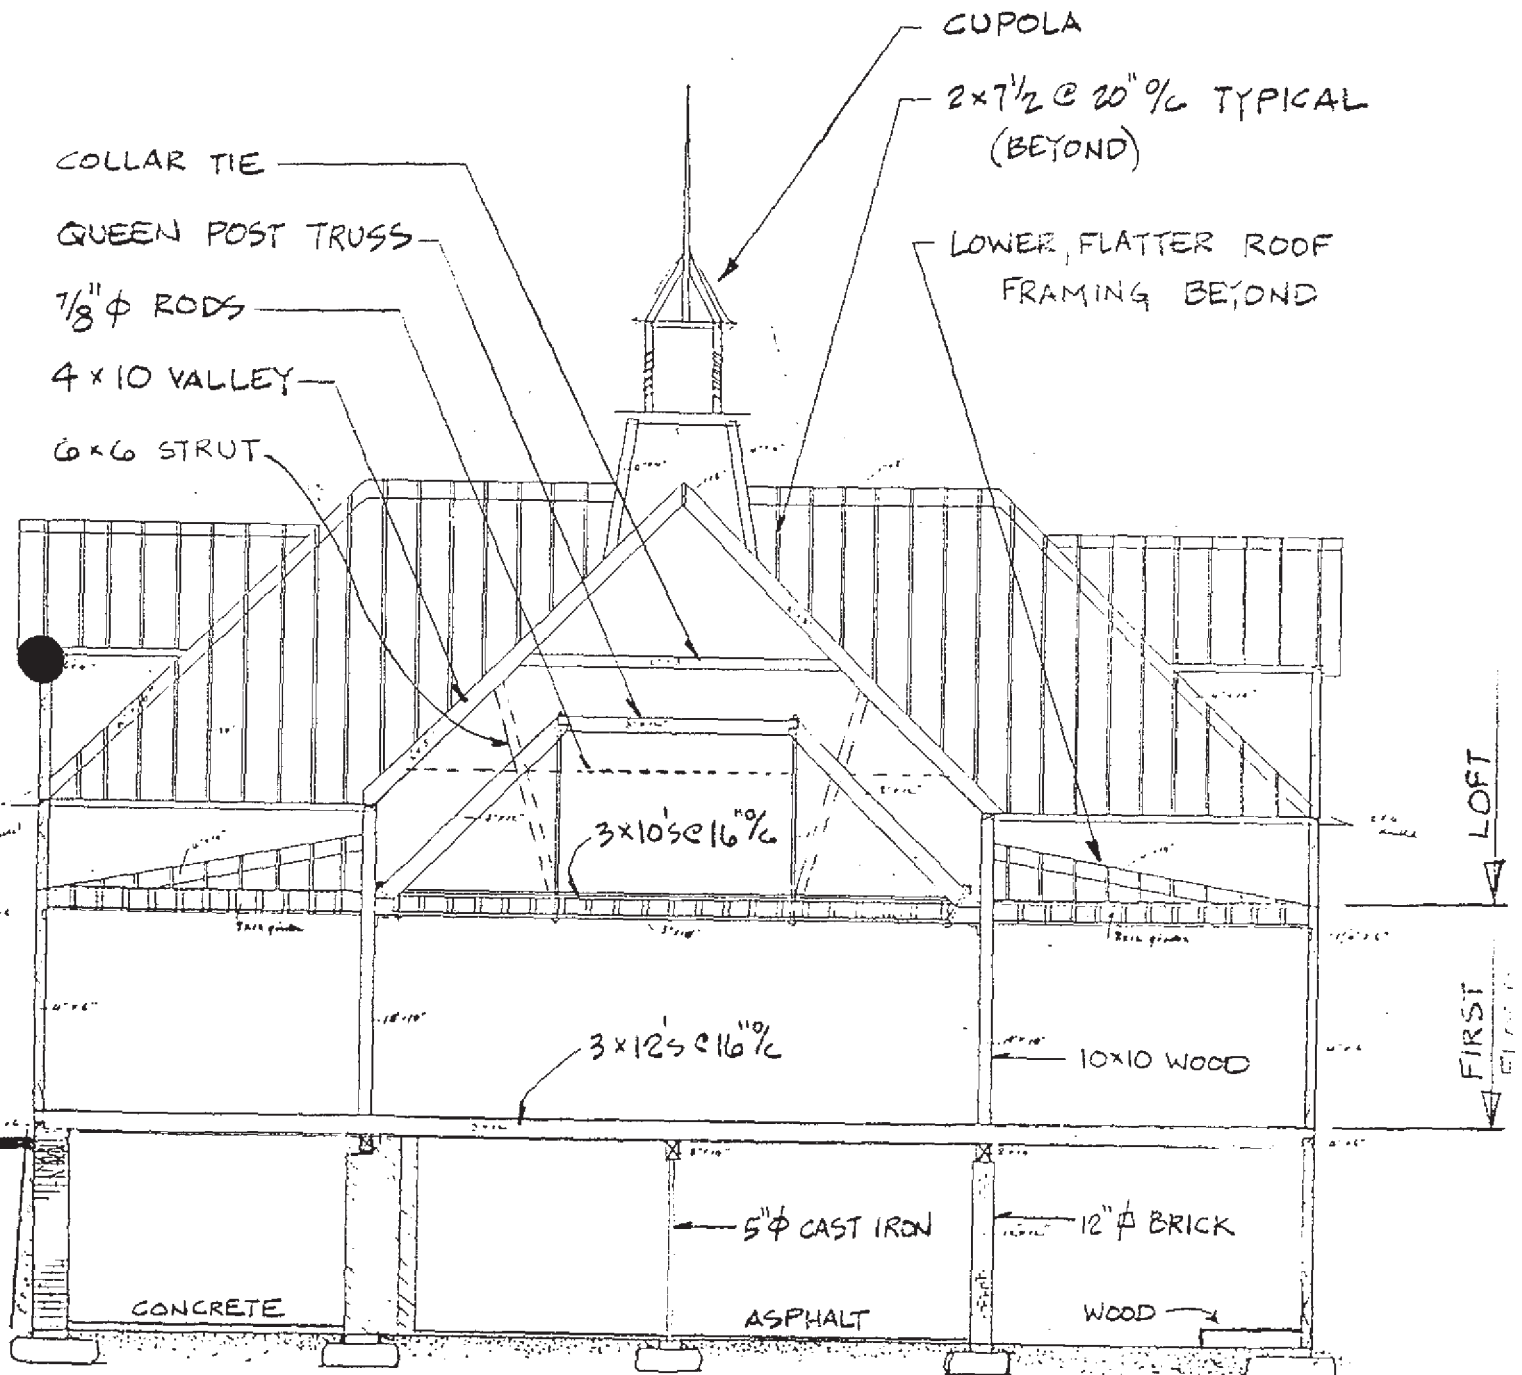
SECTION

We recommend that the 4 line truss be strengthened if any loft level live loads are added and that the 2 line truss be strengthened if the loft level is used for more than attic type loading. The strengthening would involve replacement of the vertical rods with steel of higher strength and better bracing of the top chords. We were not able to observe the bearing conditions of these trusses. They should be exposed to verify their capacity.
